## Educational Suitability Summary Report

Johnson (LBJ) High School and LASA – BLDG #014

Date: 10/13/2016 (Rev1 – 11/14/2016 CAC comments)

**Score 42% Unsatisfactory**

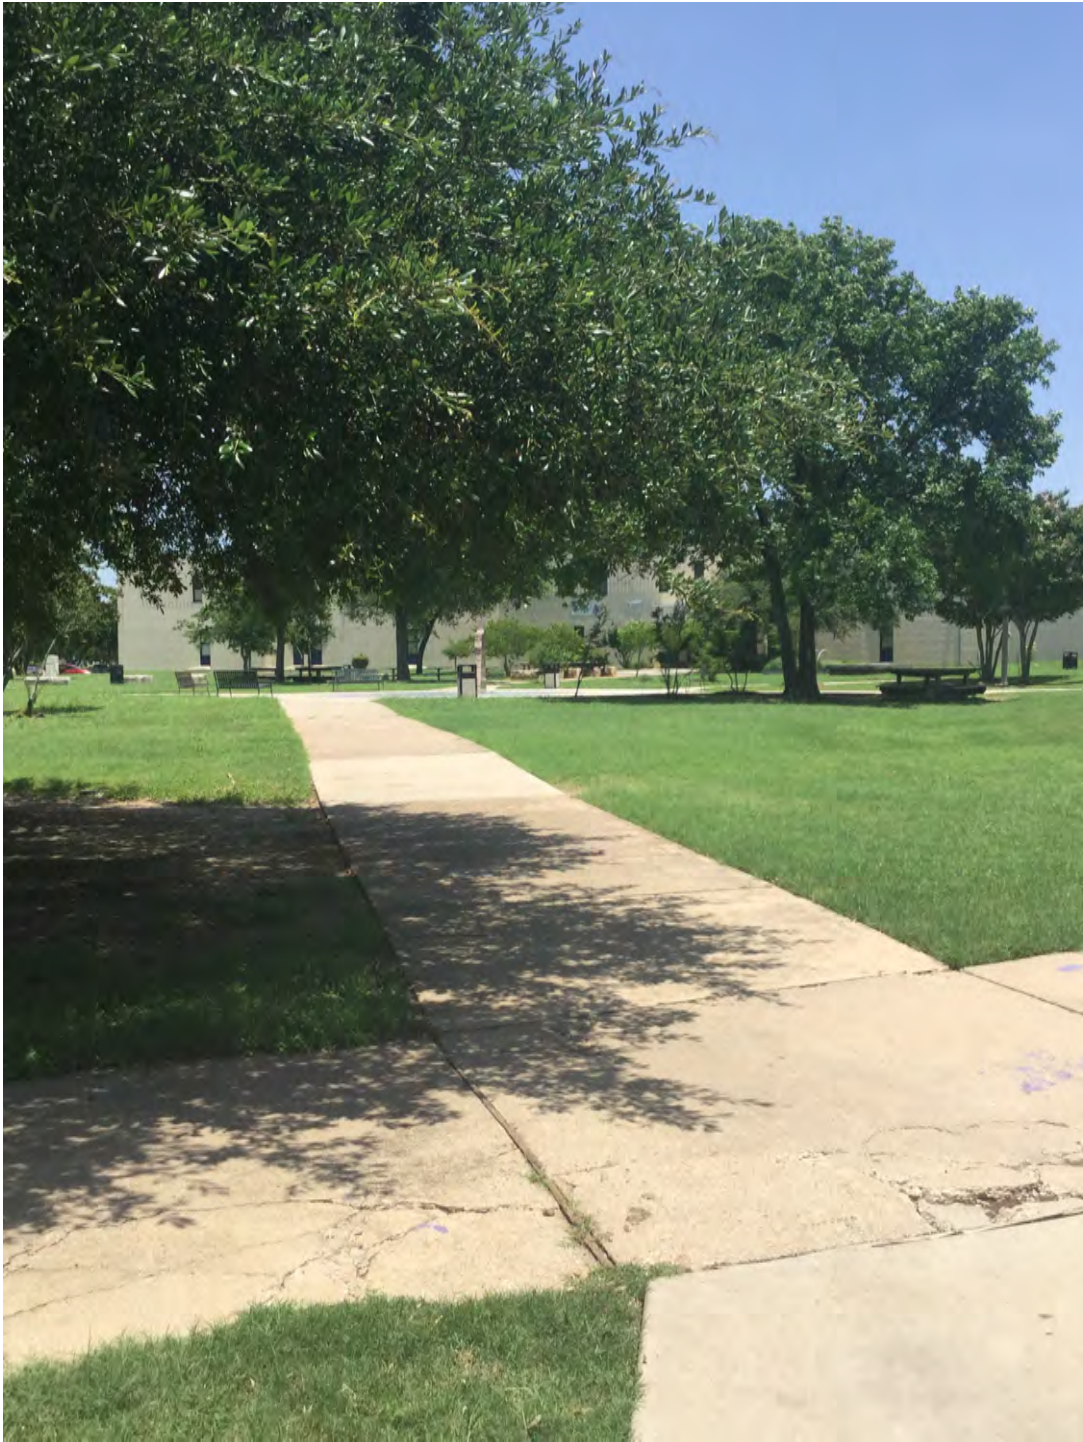
1.2 Courtyard

1.2	Are opportunities provided for outdoor learning (outdoor classrooms, gardens, etc.)?		2					1.00 <b>2.00</b>
	<p>1) Outdoor space exists is not developed</p> <p>2) Outdoor space for learning exists but not connected to classroom learning areas.</p> <p>3. Outdoor learning spaces exist and are accessible but not in good condition.</p> <p>4. Outdoor learning spaces need minor improvements to function well.</p> <p>5. Outdoor learning spaces are in excellent condition.</p> <p>N/A) Does not apply.</p>							<p>There are many exterior spaces, including a large courtyard space, but they are in need of maintenance. There are no outdoor learning spaces.</p>

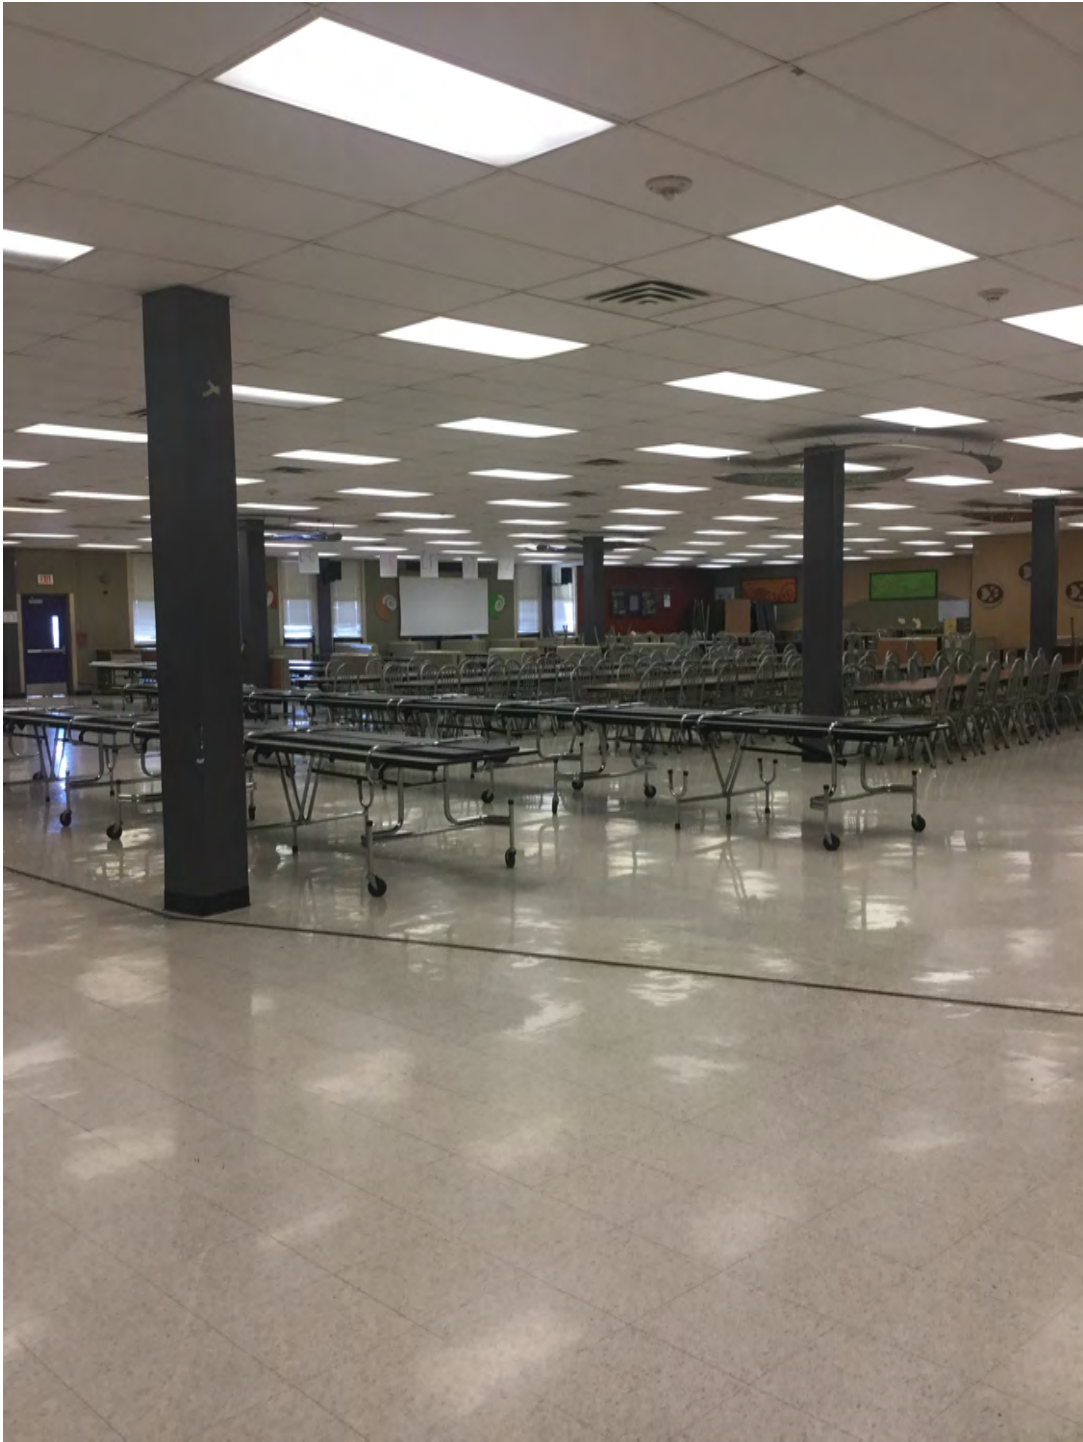
3.16 Cafeteria

3.16	Are the student dining facilities appropriately configured?								3					Comments	1.003.00
1) Very unsatisfactory - Too small, poor circulation, inflexible seating in poor condition 2) Unsatisfactory - Too small or inadequate circulation, seating in poor condition 3) Average - moderate size, with adequate circulation, seating in okay condition 4) Good - good size, adequate circulation, seating in good condition 5) Very good - good size, adequate circulation, seating in good condition, with more than one option for eating space (ex: connection to outdoor eating space) N/A) Does not apply.													There are a variety of seating options in the cafeteria. The space is sized adequately for lunch purposes. Other assembly or group function are ill-suited for the space, due to acoustics and layout of space.

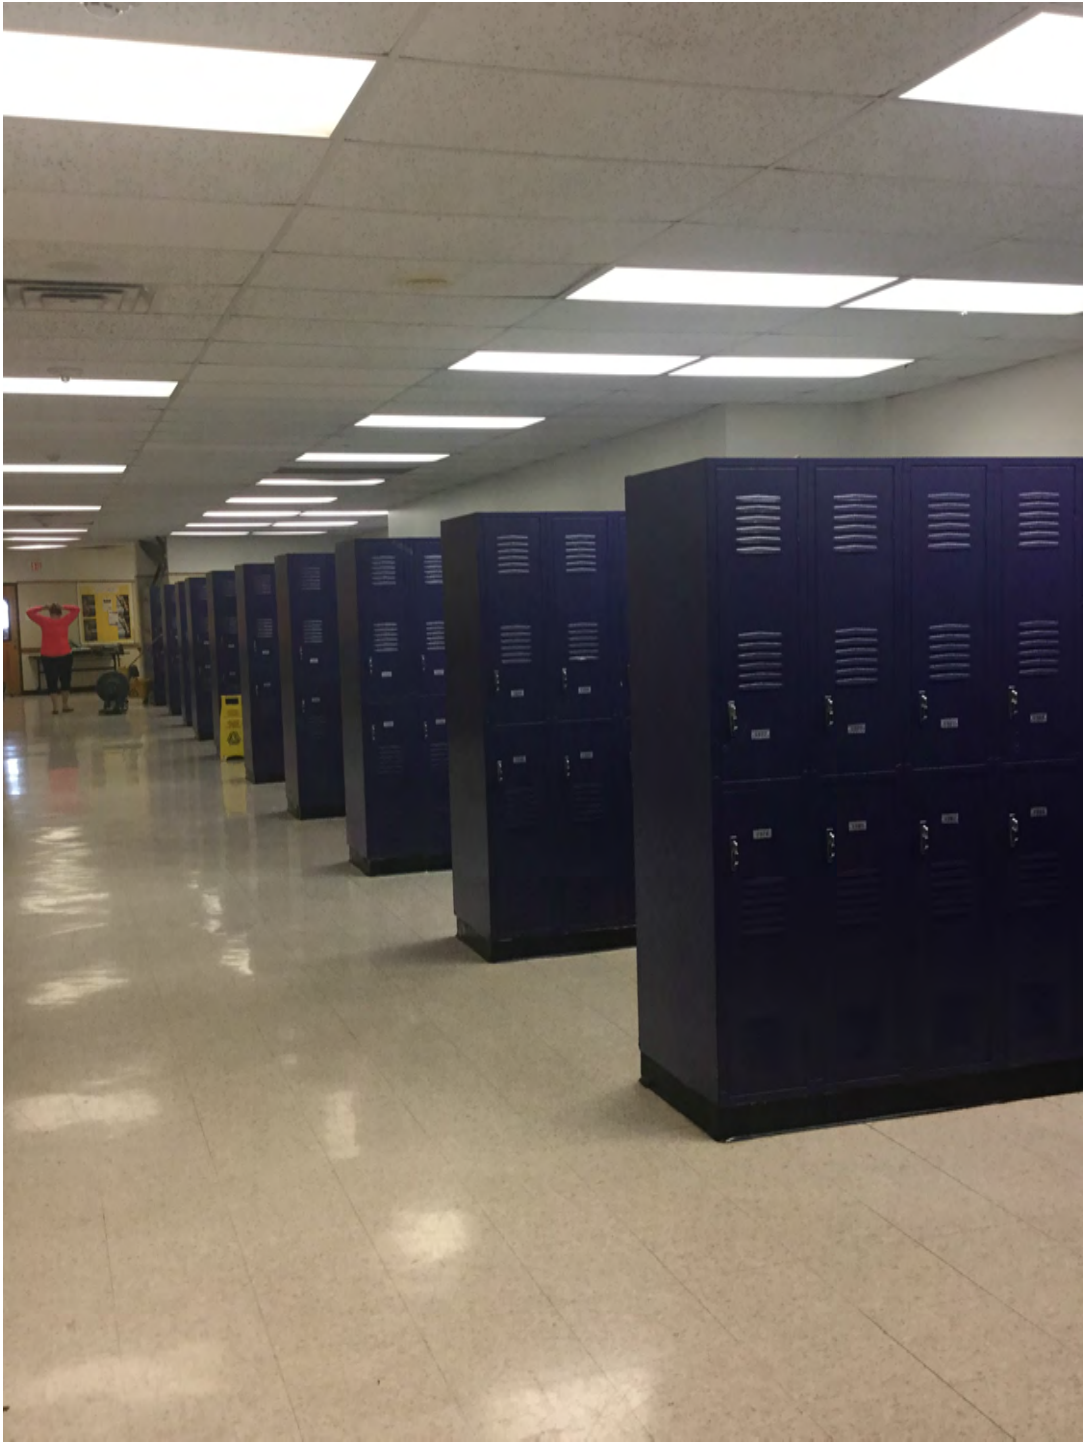
4.6 Potential Interaction

4.6	Does the building provide opportunities for informal interaction?	1						Comments	1.00 <b>1.00</b>
1) Very unsatisfactory - no gathering areas or areas in very poor condition 2) Unsatisfactory - one exterior or interior common space with no seating or unsatisfactory condition 3) Average - one exterior or interior common space with seating needing updates 4) Good - 2 exterior or interior common spaces with appropriate seating/good condition 5) Very good - multiple exterior and interior commons spaces with appropriate seating in excellent condition N/A) Does not apply.							There are no identified break out spaces for informal gathering.

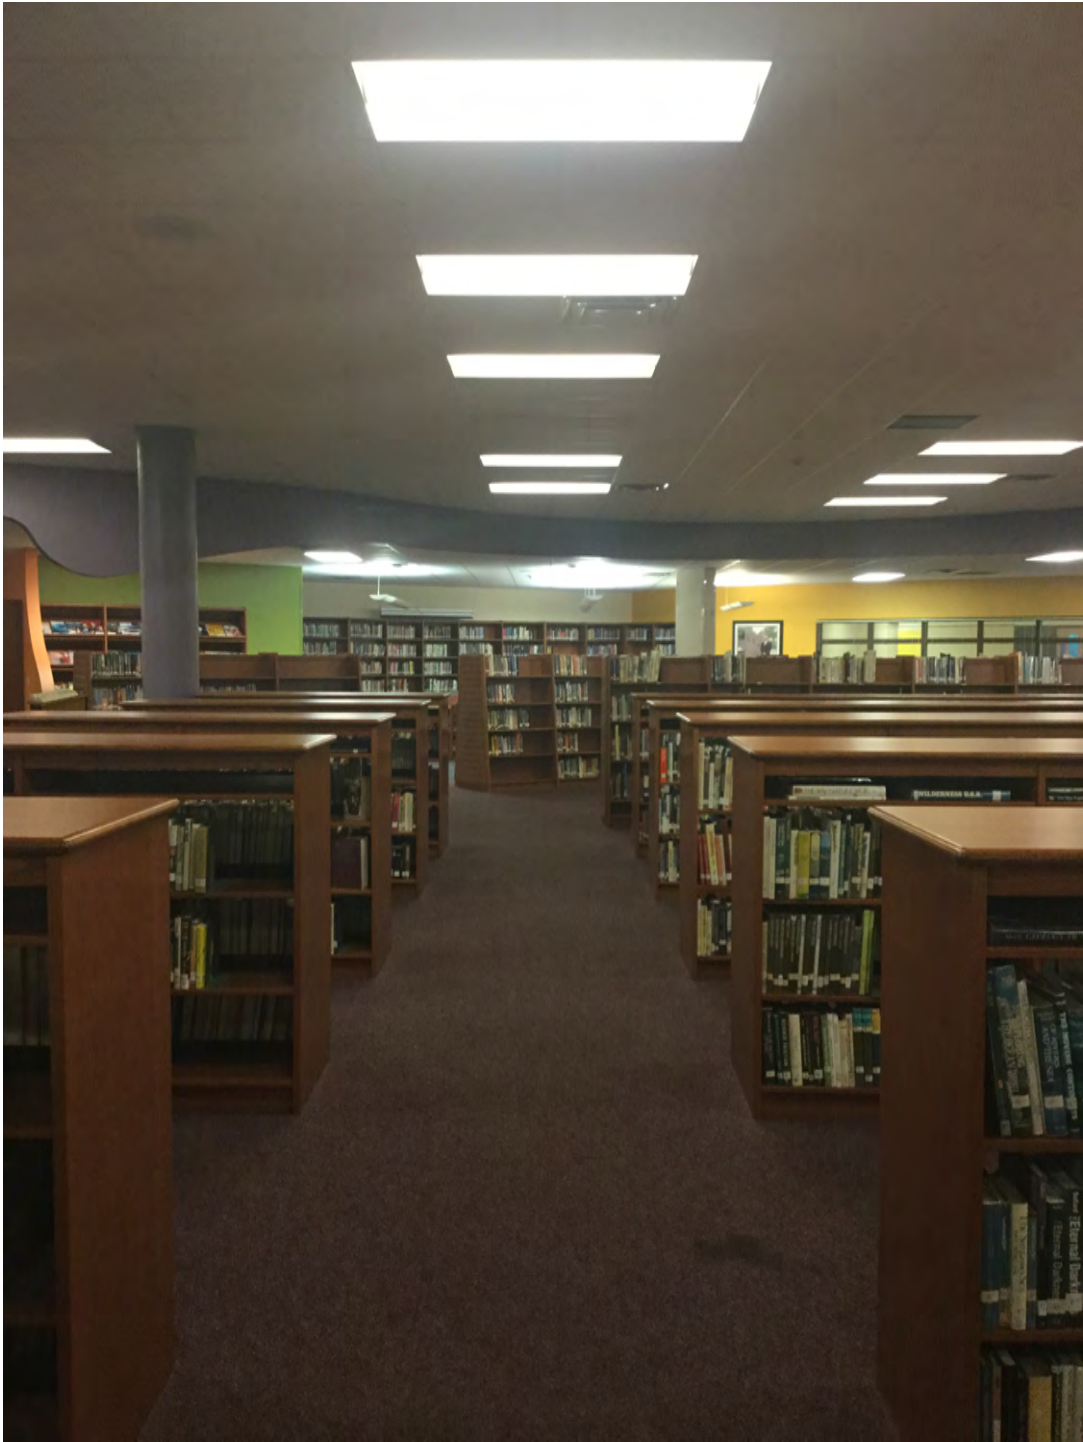
5.1 Library

1) Very unsatisfactory 2) Unsatisfactory 3) Average 4) Good 5) Very good N/A) Does not apply.							The library is located on the second floor in the center of the building and currently provides no natural lighting. The poor artificial lighting is inadequate. There is no direct access for the exterior.

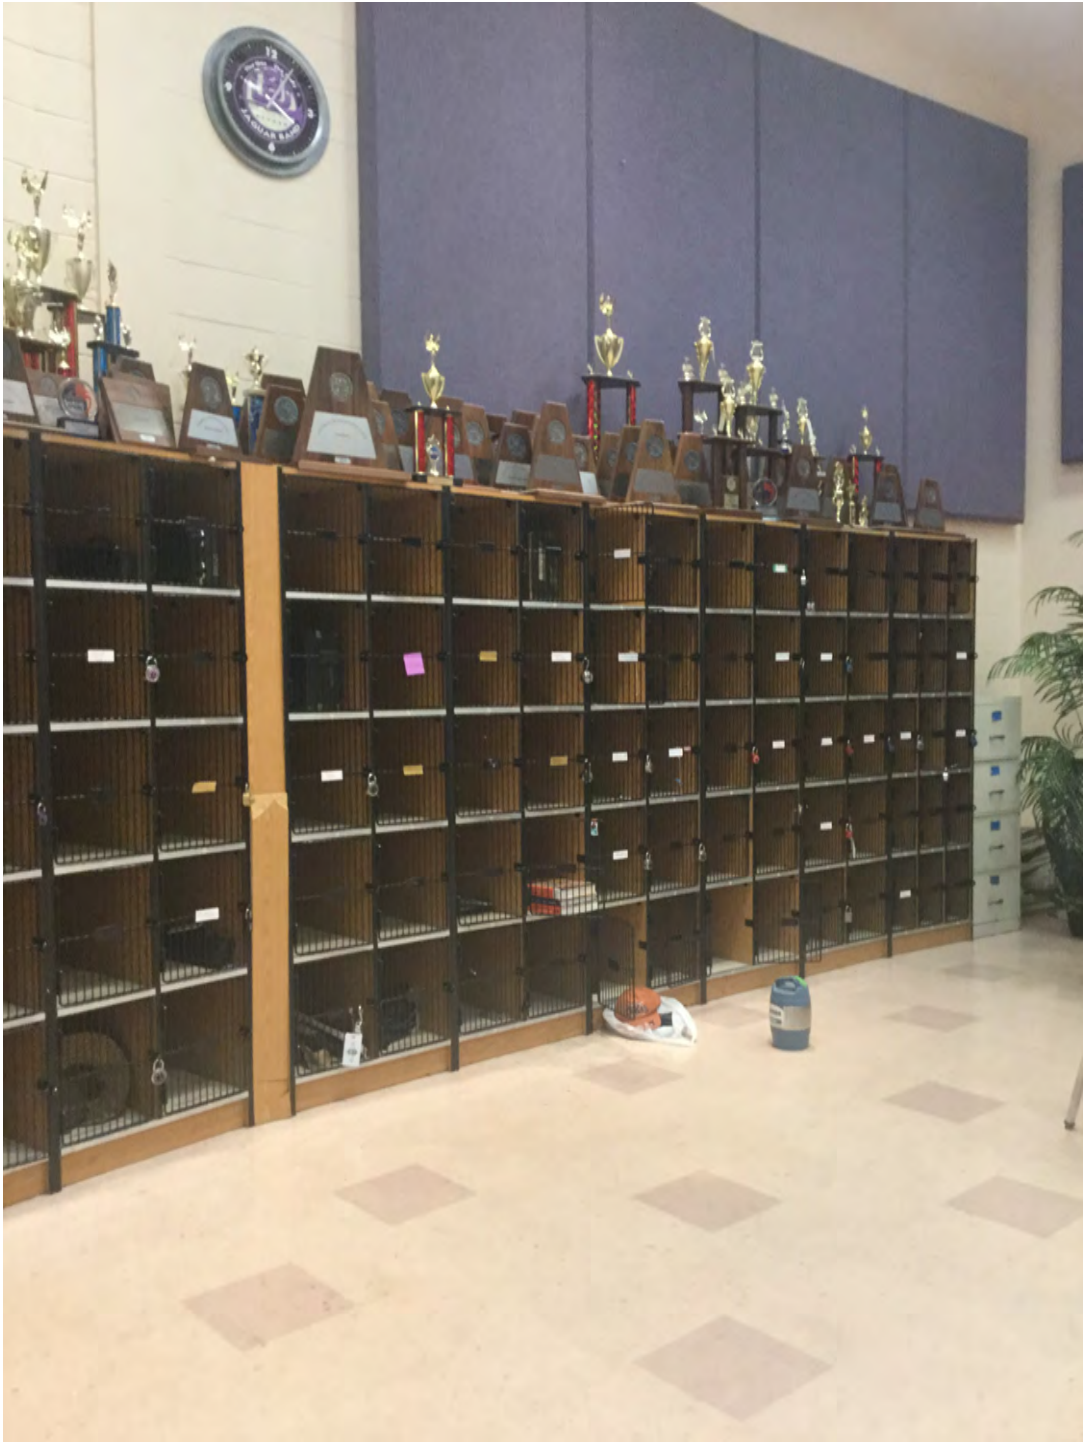
8.1 Storage

General building storage is inadequate, and is a primary concern of the faculty. The majority of classroom storage is in the form of built-in cabinets and loose furniture pieces provided by the faculty. Teacher storage options are limited to their personal desk space, and the furniture they provide. Some of these loose furniture pieces cause security concerns, because they are blocking a second means of egress in larger rooms. Student storage is accommodated by several locker areas throughout the building. The school expressed the desire to repurpose these spaces for general storage or collaboration space for students. There are no Orchestra lockers and students have to carry their instruments around or store them in their own lockers. Utility closets and electrical rooms are currently housing various storage items
