Allan Elementary School Site Summary

Address	4900 Gonzales Street Austin, TX 78702
Number of Permanent Campus Facilities	3
Original Year of Construction	1957
Total Campus Building Area (combined)	112,679 SF

Introduction

Main School Building – BLDG-142A

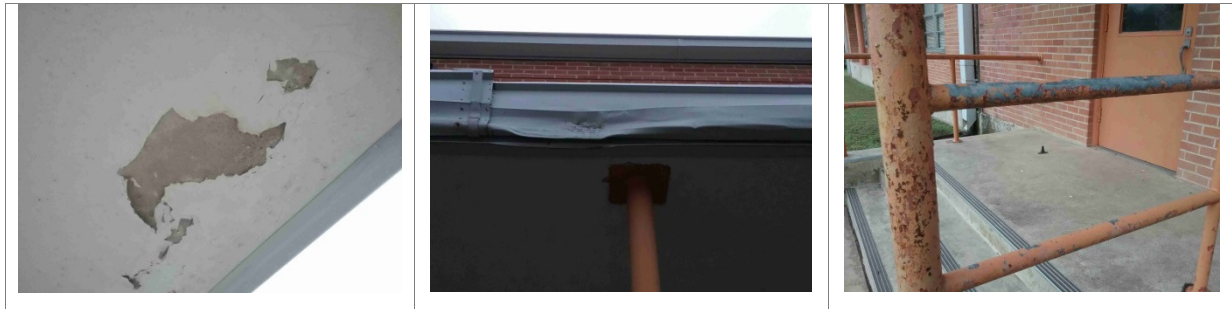
System	Subsystem	Condition and Deficiency Overview	System Condition Rating
Exterior	Exterior Walls	The exterior of the building consists of a brick façade. The exterior of the building appeared to be in average condition. There was soffit paint peeling throughout the campus. There was a bent gutter over the kitchen area loading dock.	Average
	Exterior Windows	The windows are single-pane aluminum metal-framed inset into the brick façade. The newer library area windows are double-pane. The windows appeared to be in good condition. Some of the single-pane original window putty was cracked, and some windows were caulked in place.	Good
	Exterior Doors	There are many double exterior metal doors with lites throughout the building. Some exterior doors are solid metal with no lites. The courtyard doors are single-pane residential-type sliding doors. The exterior doors appeared to be in good condition. Paint on the door frames and the inside of the doors was chipped in well-used areas.	Good

1. Repair and repaint soffits where paint is peeling.
2. Repair or replace the bent gutter near the kitchen loading dock.
3. Repair all windows that have cracks or are caulked in place.

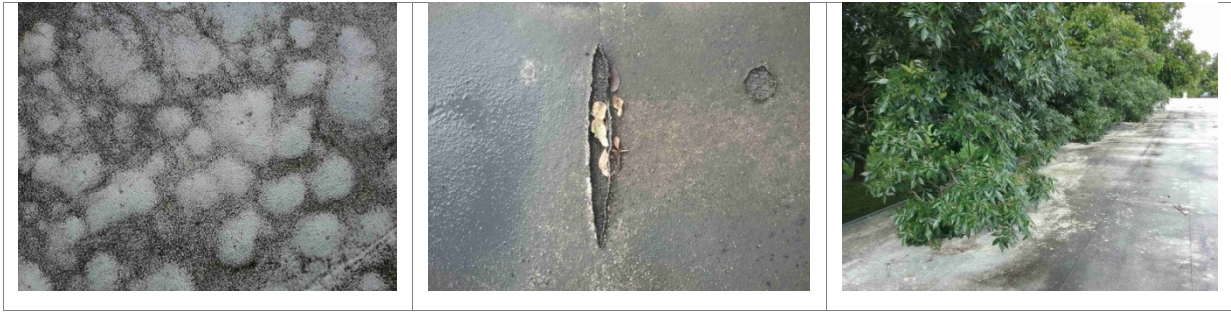
Roofing Deficiency Examples

Roofing	The main building has a single-ply roof covering. The entire roof appeared to be in good condition. Roof A01 was significantly bubbled and had a large tear. On the southeast corner, there were many tree branches lying on the roof surface.		Good

1. Trim trees so they are not touching roof areas.
2. Investigate and repair roof A01 for significant bubbling throughout the roof and a tear in the material.

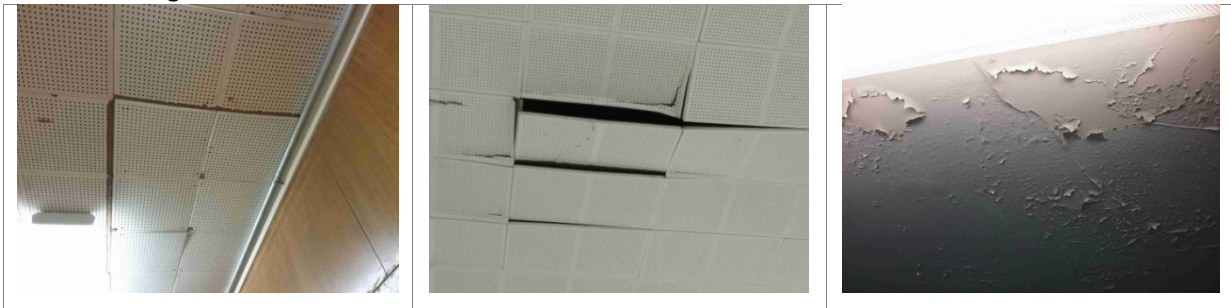
Interior Ceiling Finishes	The interior ceilings are acoustical ceiling tile in metal grid in the classrooms and lobby. There are 12x12 perforated tiles on the ceiling in the lobby, administration, library, and cafeteria areas. There are gypsum board ceilings in the restrooms and the library.	Average

System	Subsystem	Condition and Deficiency Overview	System Condition Rating
		<p>The gymnasium has tectum acoustical panels in metal grid.</p> <p>The ceiling systems were observed to be in average condition. The perforated tiles were coming loose in the cafeteria and faculty corridor. The ceiling paint was peeling in the second floor male restroom.</p>	
Conveying		<p>The building is outfitted with a 2,100-pound, hydraulic, two-story elevator on the north end of corridor 6, constructed by Schindler Elevator Corporation. The machine room, which houses the elevator's hydraulic sump, pump, and programmable logic controller, is located adjacent to the car and accessed at the east end of corridor 5.</p> <p>The last documented inspection was in October 2015. The elevator and all associated equipment appeared to be in operable condition. The emergency stop and communication equipment were not tested. The car was sent successfully to the second floor and back down to the first floor.</p> <p>The conveying equipment was observed to be in good condition.</p>	Good

1. Replace or repair perforated ceiling tiles in the cafeteria and the faculty corridor where tiles are hanging loose.
2. Clean the carpet in the family library to eliminate stains.

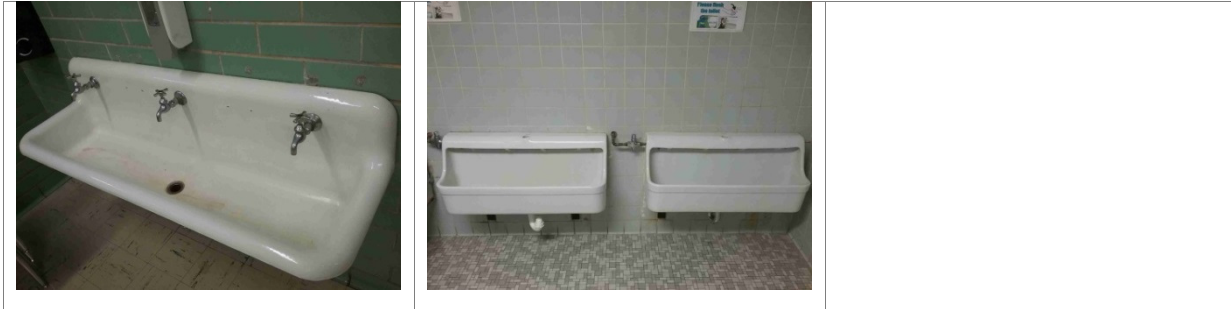
Plumbing	Plumbing Fixtures	<p>The facility contains multiple plumbing applications that service two levels, consisting of student restrooms, staff restrooms, janitorial closets with service sinks, and one commercial kitchen.</p> <p>The restrooms typically have vitreous china floor-mount toilets with manual flushing valves and vitreous china sinks with manual or metering faucets. The classrooms are typically equipped with laminated particle board vanities with stainless steel sink/bubbler combinations mounted inside the vanity. There are also wall-mounted service sinks in the janitorial closets.</p> <p>Staff reported that the female restroom on the east side of corridor seven was recently remodeled for handicap access and the adjacent janitorial closet (CC120) was renovated in 2015. The Staff also reported that all plumbing fixtures in this building should be renovated due to their excessive age. Additionally, it was reported that the janitorial closet wall-mount sinks should be replaced with floor sinks. Lastly, the Staff reported that many of the classroom sinks have had multiple maintenance repairs due to leaks.</p> <p>The building's plumbing fixtures were observed to be in good condition.</p> <p>The plumbing fixtures observed throughout the building were aged, and some appeared to be from the facility's original construction. Though the fixtures were aged, they were all functioning at the time of assessment. The 100-wing restrooms contained original porcelain</p>	Good

System	Subsystem	Condition and Deficiency Overview	System Condition Rating
		fixtures, such as trough urinals, toilets and sinks. Another observed deficiency was that restroom partitions were corroding throughout the building. Additionally, the gymnasium contained outdated porcelain water fountains and the janitorial closets contained old porcelain wash sinks.	
	Domestic Water Distribution	<p>The plumbing fixtures in the commercial kitchen appeared to be serviced by one vertical gas water heater located in a mechanical room adjacent to the commercial kitchen. The water heater has the ability to produce 200 MBH and hold 100 gallons.</p> <p>The Staff reported that the cast iron domestic water distribution piping located in the crawlspace under the building needed to be replaced.</p> <p>The domestic distribution system appeared to be in good condition. No major deficiencies were observed for the domestic water distribution system during the assessment.</p>	Good

1. Continue preventive maintenance on aged plumbing fixtures and plan for replacement of the fixtures in the future as they continue to age.

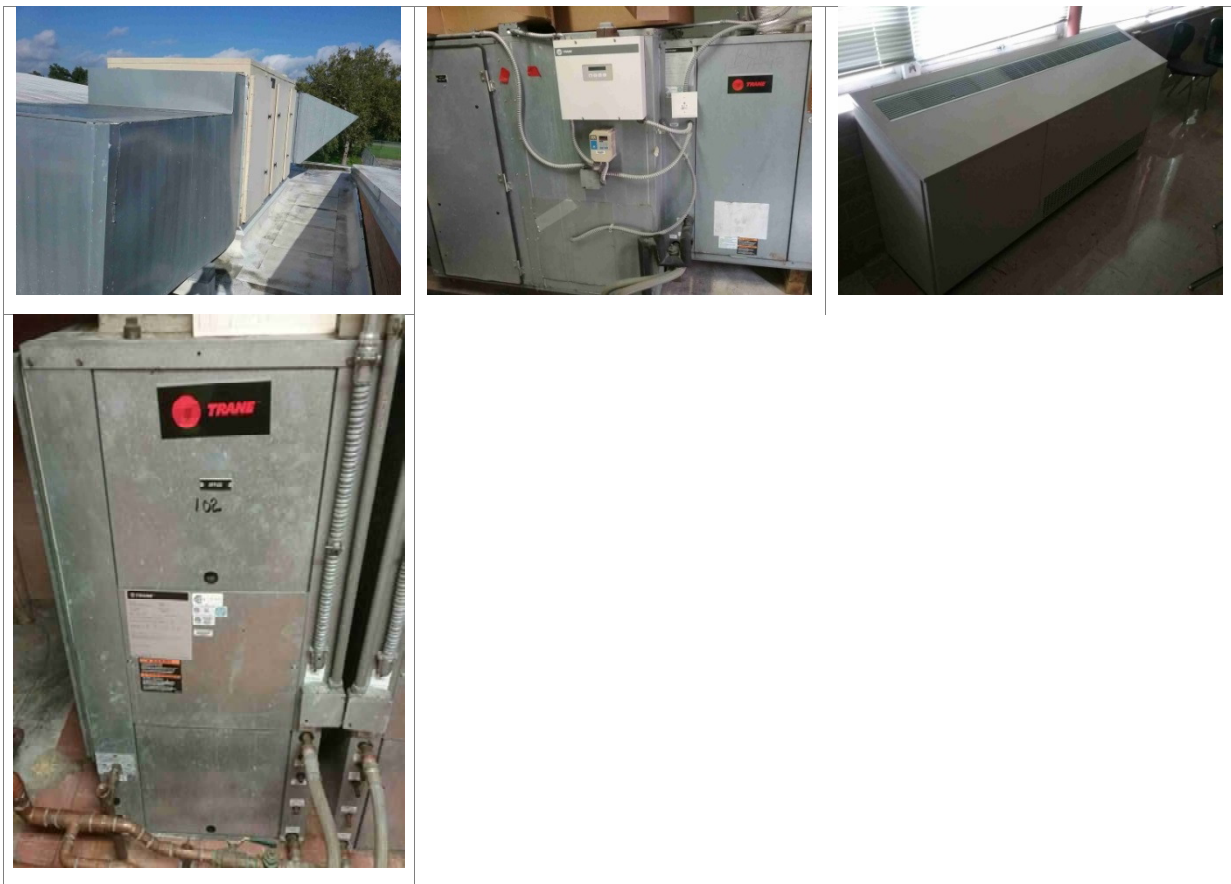
Mechanical/HVAC System Deficiency Examples

System	Subsystem	Condition and Deficiency Overview	System Condition Rating
		Many of the deficiencies observed were aging of equipment and enclosure and piping/insulation damage due to excessive corrosion. Another widespread observed deficiency was the use of outdated R-22 refrigerant in the existing HVAC systems. Additionally, all of the horizontal classroom units on the first and second floors were observed to potentially utilize R-22 refrigerant. Also, the large outdoor air units on the first and second floors had surpassed their typical design service life and utilized R-22 refrigerant. Lastly, the outdoor air unit located on the west side of corridor 1 on the second floor appeared to be out of service because the electrical disconnect was in the off position.	
Fire Protection	Fire Alarm	The building has a fire alarm system that consists of alarm and signaling devices such as horns/annunciators, strobes, horn/strobe combinations, pull stations, and detectors. The fire alarm system is controlled by a Silent Knight control panel. The fire alarm system was observed to be in good condition. The main electronic control panel indicated all systems were normal.	Good

1. Plan for and track equipment that uses R-22 refrigerant. The refrigerant is being phased out of manufacturing and construction use in the near future and will make all equipment that utilizes R-22 refrigerant obsolete.
2. Continue conducting preventive maintenance checks and services for HVAC systems. Plan to repair or replace all aged and out-of-date HVAC equipment.
3. If any of the HVAC equipment is to be replaced, such as AHUs or packaged units, replace with an updated asset that includes an integral dehumidification wheel that will assist with humidity issues.

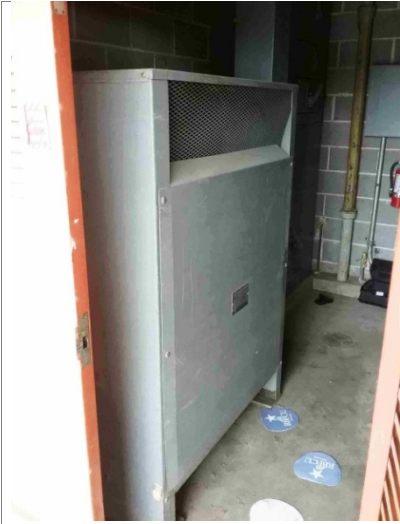
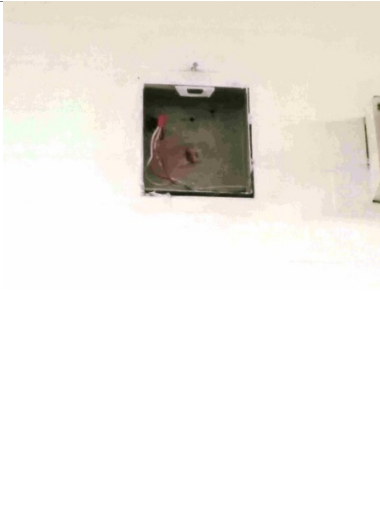
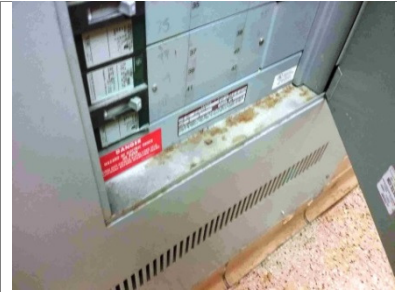
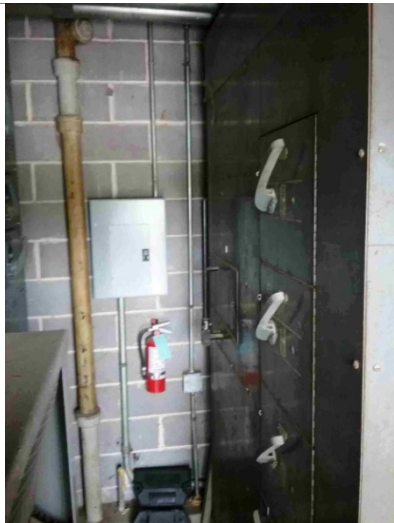
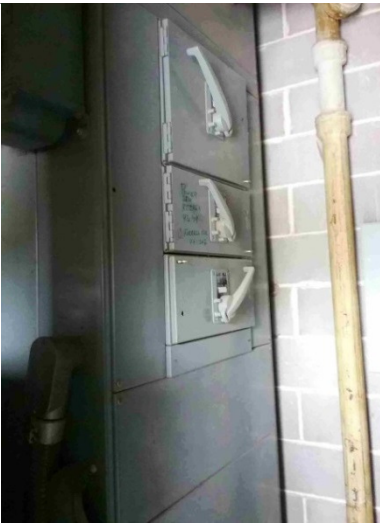
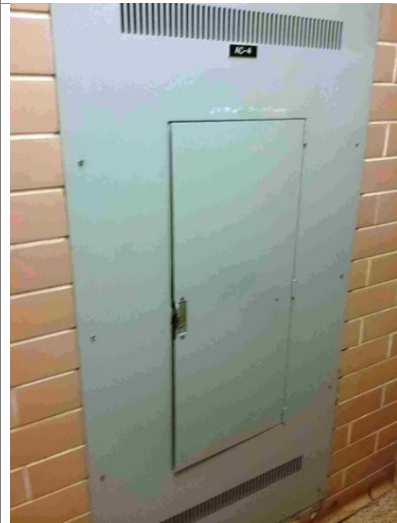
Fire Protection/Suppression	The building is not equipped with a fire sprinkler/suppression system. It is protected by portable fire extinguishers stationed throughout the building. All portable fire extinguishers observed were inspected within the last year.	N/A
Electrical	Electrical Distribution	The electrical service (utility transformer, exterior switchboard, and capacitor bank for the facility) appear to be located on the west side of the complex adjacent to the kitchen. There are two electrical rooms housing the initial electrical distribution equipment, including 480VAC 2000 amp, 240VAC 1200 amp, and 480VAC 1600-amp switchboards supplying transformers and subpanels throughout the building. Additional transformers and panels are located in corridors, electrical rooms, the kitchen, and the stage and feed power throughout the building. The electrical distribution equipment was observed to be in average condition due to age. There were numerous panels that had been replaced as additional load was required. The 500-kVA transformer located in the northern electrical room adjacent to the kitchen was nearing the end of its typical service design life. Panelboard AC-4, located adjacent to the male restroom in corridor 8, was showing considerable corrosion inside the panel door. The Wilson 240VAC 1200-amp switchboard, located in the northern electrical room adjacent to the west kitchen wall, was nearing the	Average

System	Subsystem	Condition and Deficiency Overview	System Condition Rating
		<p>end of its typical service design life. The Square D 408VAC 1600-amp switchboard, located in the northern electrical room adjacent to the west kitchen wall, was nearing the end of its typical service design life. A wall plate located in corridor 3 had become detached, leaving exposed cabling. A junction box located in corridor 2 was missing an enclosure cover, leaving cabling exposed.</p> <p>Rocker-style switches exist for corridor lighting, which are outdated and difficult to find replacement parts.</p> <p>Various exterior lighting illuminate by photocells and not timers, which often need replacing.</p> <p>The facility requested lighting be installed in crawl spaces and additional receptacles be added in classrooms.</p>	
	Lighting	<p>The exterior of the building is outfitted with what appears to be wall-mount HID (high-intensity discharge) fixtures located near the roofline of the building. There are exterior-style flood fixtures mounted at certain corners of the building, and covered walkways are illuminated by surface-mounted ceiling fixtures. The parking lot and property areas are illuminated with pole lights. The interior lighting consists of troffer, flush ceiling-mount, and hanging fluorescent fixtures. Most closets and mechanical rooms are illuminated with screw-type fixtures. The stage is equipped with specifically designed lighting to support stage productions, and the gymnasium contains hanging fluorescent fixtures.</p> <p>The lighting was observed to be in average condition.</p> <p>The exterior lighting seemed to be sparse. An exterior flood-style fixture was inoperable. The exterior lighting was observed to be in average condition.</p> <p>There are exit signs at every exit. Various signs were not illuminated..</p>	Average

1. Consider replacing panels and transformers that are nearing the end of their typical service design life.
2. Assess the exterior lighting in the west parking lot for additional illumination. Replace exterior fixtures that are deficient.
3. Replace rocker-style switches for corridor lights with an updated option.
4. Determine whether the exterior lighting on photocells can be added to a centralized timer.
5. Install additional lighting in crawlspace areas.
6. Install additional receptacles in classrooms.
7. Assess Panelboard AC-4 for excessive corrosion.
8. Install and secure covers on junction boxes that present exposed cable.

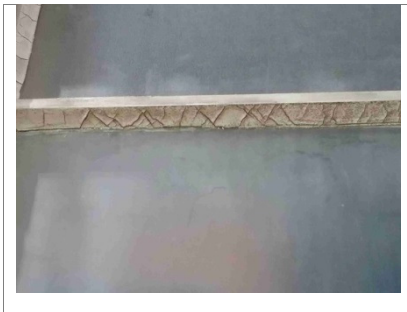
System	Subsystem	Condition and Deficiency Overview	System Condition Rating
Exterior	Exterior Walls	The exterior of the building consists of a brick façade. The exterior of the building appeared to be in good condition.	Good
	Exterior Windows	The windows are single-pane aluminum metal-framed inset into the brick façade. The exterior windows appeared to be in average condition. The putty around the windows was cracked, especially in the restrooms.	Average
	Exterior Doors	There are double exterior metal doors with lites throughout the building. There are also single doors with lites to individual classrooms. The exterior doors appeared to be in good condition. Some exterior door windows were scratched and faded.	Good
Roofing	The building has a single-ply roof. The roof appeared to be in good condition.		Good
Interior Construction	Interior Walls	The interior walls are gypsum board in the classrooms and glazed ceramic tile in the corridors. The walls appeared to be in good condition.	Good

1. Repair or replace window putty where it is cracked and chipped.
2. Replace windows in exterior classroom doors that are scratched.

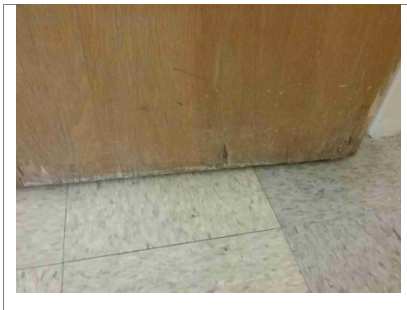
Interior Doors	The interior doors are wood veneer with a lite in metal frames. Some are solid wood doors without side lites. The interior doors appeared to be in good condition.	Good
	Interior Specialties	System not present.	N/A
Stairs	Exterior Stairs	System not present.	N/A
	Interior Stairs	System not present.	N/A

1. Repair doors that are delaminating and scratched from use.

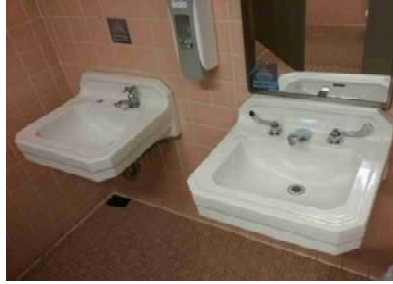
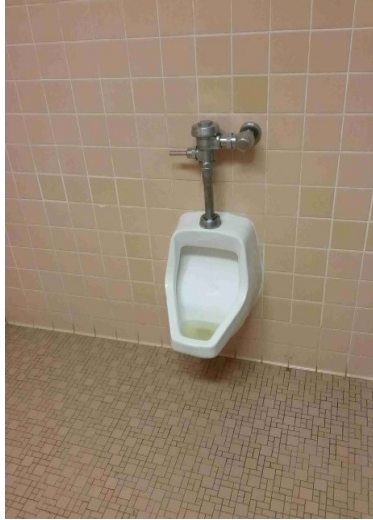
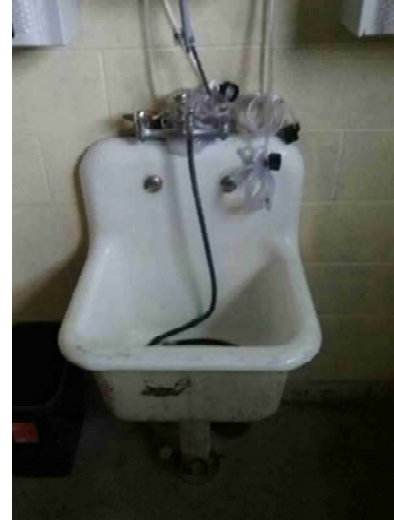
System	Subsystem	Condition and Deficiency Overview	System Condition Rating
Interior Finishes	Interior Wall Finishes	The interior walls are painted gypsum board in the classrooms. The corridors are gypsum board at the top and glazed ceramic tile. There is ceramic tile in the restrooms. The wall finishes were observed to be in good condition.	Good
	Interior Floor Finishes	The interior floor finishes are VCT in the corridors and classrooms. The main corridor floor is suspected to be asbestos tile. Ceramic tile is in the restrooms. The floor finishes appeared to be in good condition.	Good
	Interior Ceiling Finishes	The interior ceilings are ACT in metal grid in the classrooms and corridors. There are gypsum board ceilings in the restrooms. The ceiling finishes appeared to be in good condition.	Good
Conveying	System not present.		N/A
Plumbing	Plumbing Fixtures	The facility contains multiple plumbing applications that service one floor level, consisting of student restrooms, staff restrooms, and janitorial closets with service sinks. The restrooms typically have vitreous china floor-mount toilets with manual flushing valves and vitreous china sinks with manual or metering faucets. The classrooms are typically equipped with laminated particle board vanities with stainless steel sink/bubbler combinations mounted inside the vanity. There are also wall-mounted service sinks in the janitorial closets. The Staff reported that all plumbing fixtures in this building should be renovated. The Staff also reported that the aged janitorial closet wall-mount sinks should be replaced with floor sinks. The building's plumbing fixtures were observed to be in average condition. The restrooms appeared to contain original porcelain fixtures, such as toilets and hand-washing sinks. Though the fixtures were aged, they were all functioning at the time of assessment.	Average

1. Continue preventive maintenance on aged plumbing fixtures and plan for replacement of the fixtures in the future as they continue to age.

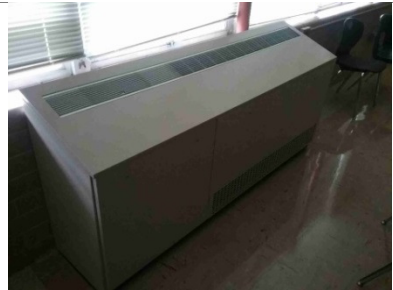
Mechanical/HVAC System Deficiency Examples

System	Subsystem	Condition and Deficiency Overview	System Condition Rating
HVAC		<p>major mechanical equipment consists of floor-mounted horizontal packaged unit ventilator systems and a large outdoor air unit.</p> <p>There are 11 HVAC systems throughout the building. The refrigeration capacities of the individual classroom unit ventilators range from 1.5- to 20-TON.</p> <p>The mechanical/HVAC systems for this facility were observed to be in average condition. The classroom HVAC units observed in the facility had estimated installation dates of 1989 and had surpassed their typical service design life. The units were also potentially charged with R-22 refrigerant. R-22 refrigerant is being phased out of use and eventually will render the equipment that utilizes it obsolete. Outdoor air unit 5 was installed in 1995 and was nearing the end of its typical service design life. This unit also utilized R-22 refrigerant.</p>

1. Plan for and track equipment that uses R-22 refrigerant. The refrigerant is being phased out of manufacturing and construction use in the near future and will make all equipment that utilizes R-22 refrigerant obsolete.
2. Continue conducting preventive maintenance checks and services for HVAC systems. Plan to repair or replace all aged and out-of-date HVAC equipment.

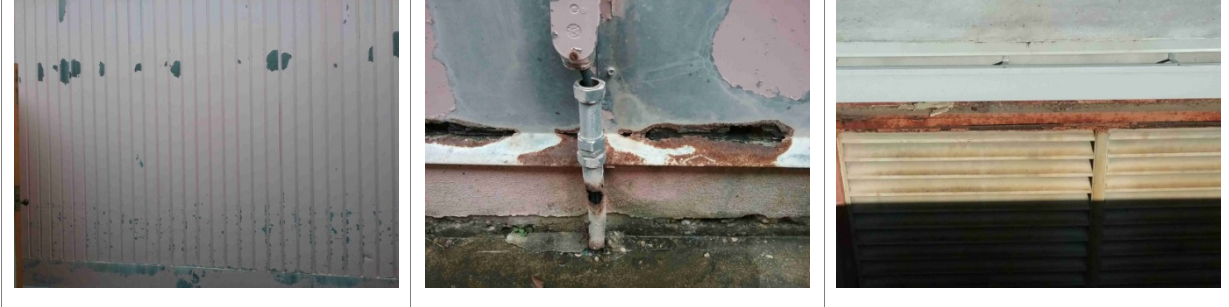
System	Subsystem	Condition and Deficiency Overview	System Condition Rating
Exterior	Exterior Walls	The exterior of the building consists of a brick façade on the north and south sides and metal siding on the east and west sides. The exterior of the building appeared to be in average condition. The paint on the metal siding was peeling. The bottom of the siding was badly rusted where the siding met the slab. The top of the louver on the east side was rusted.	Average
	Exterior Windows	System not present.	N/A
	Exterior Doors	There is one set of double exterior metal doors. The doors appeared to be in good condition.	Good
Roofing	The building has a single-ply roof. The roof appeared to be in good condition.		Good
Interior Construction	Interior Walls	The interior walls are metal siding on the east and west walls and CMU on the north and south walls. The walls appeared to be in average condition. The metal siding was rusted where the siding met the slab. Water was infiltrating at this location.	Average

1. Replace or repair the rusted metal siding.
2. Replace or repair the rusted louver.

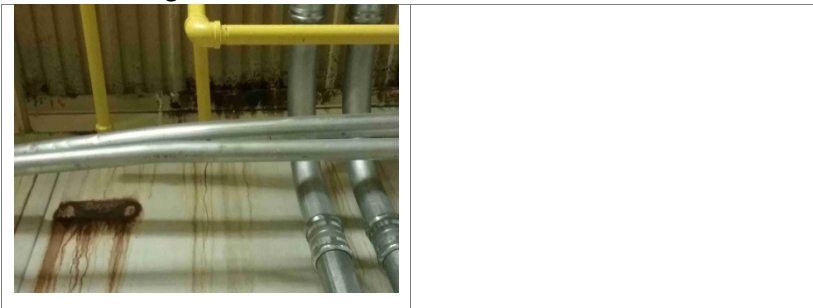
System	Subsystem	Condition and Deficiency Overview	System Condition Rating
		finishes were observed to be in average condition.	
	Interior Floor Finishes	The interior floor is a concrete slab. The finish appeared to be in good condition.	Good
	Interior Ceiling Finishes	The interior ceilings are corrugated metal on bar joists. There was significant rust at various connections. The ceiling appeared to be in poor condition.	Poor
Conveying	System not present.		N/A
Plumbing	Plumbing Fixtures	System not present.	N/A
	Domestic Water Distribution	System not present.	N/A
	Other Plumbing	The drains for this facility are predominantly designed with an external-type drainage system equipped with gutters and downspouts. The other plumbing appeared to be in good condition.	Good
Mechanical/ HVAC	This building houses the horizontal gas-fired boilers and the fluid cooling tower (located on the roof) along with all associated piping that is part of the common loop HVAC system utilized throughout BLDG-142A and BLDG-142B. The mechanical/HVAC system for this facility appeared to be in good condition. Fluid cooler CT-1's (SC020815) fill material was aged, dry rotted/cracked, and dirty/scaled.		Good

1. Replace or repair the rusted metal siding. Replace or repair the rusted corrugated ceiling.
