Andrews Elementary School Site Summary

Introduction

Main School Building – BLDG-102A

Gymnasium – BLDG-102B

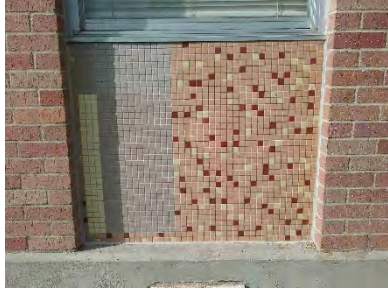
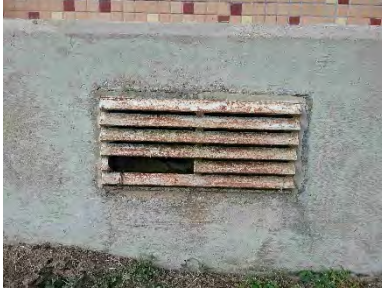
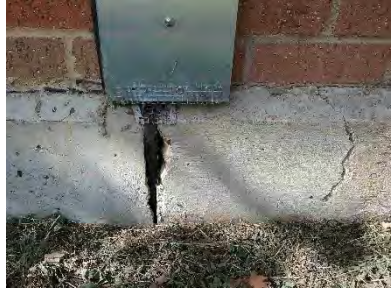
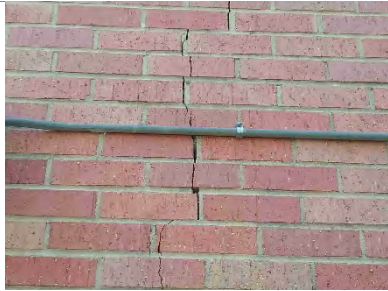
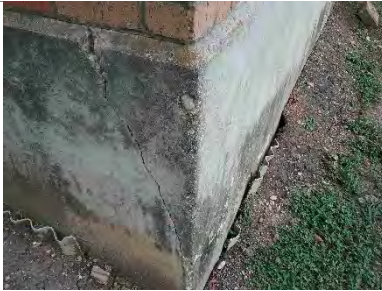
System	Subsystem	Condition and Deficiency Overview	System Condition Rating
Exterior	Exterior Walls	<p>The exterior walls of the main school building are composed of brick with accent areas of stone inlay. Many of the windows are accented with mosaic tile. Metal grilles are placed through the classroom walls to allow fresh air intake for the HVAC (heating, ventilating, and air conditioning) heat pump units.</p> <p>The exterior walls were observed to be in good condition, with few deficiencies. The mosaic tile accenting the windows was observed to be mismatched. The grilles at the base of the wall were observed to be rusted, and many were observed to have broken louvers. The rust was not observed to affect the host wall. A wide crack was observed in the concrete foundation wall, exposing material beneath the surface. A nearly vertical crack was observed to be stepping up through a brick wall, possibly due to settlement or upheaval of the foundation. Typical hairline cracks were also observed at some corners of the building.</p>	Good

1. Acquire mosaic tile to match existing in order to properly replace broken tiles in the future.
2. Replace rusted and broken louvers.
3. Repair broken window panes and frames, and replace all corroded sealant.
4. Apply perimeter treatment to building to prevent further insect intrusion.
5. Scrape excess paint from window pane edges on exterior doors.
6. Repaint worn handrails.
7. Further investigate condensation in windows. Reinstall affected panes and seal properly.
8. Patch cracks in foundation walls. Determine possible damage caused by wide crack specifically.
9. Monitor width of nearly-vertical crack in brick wall. Engage structural engineer immediately to assess structural conditions.

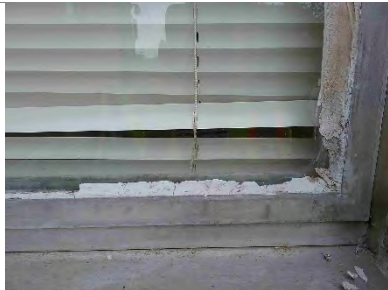
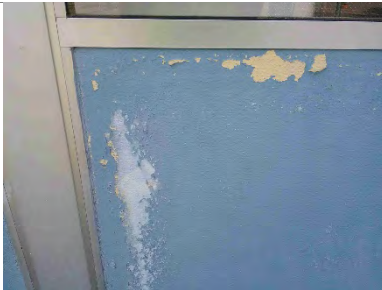
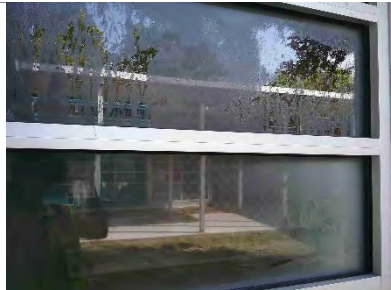
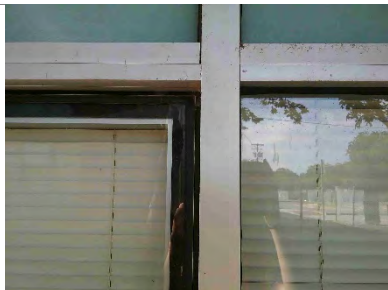
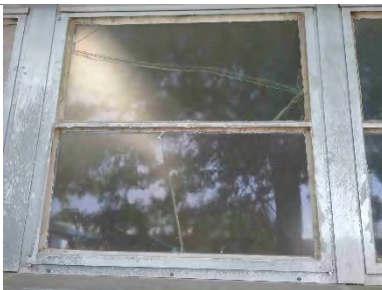
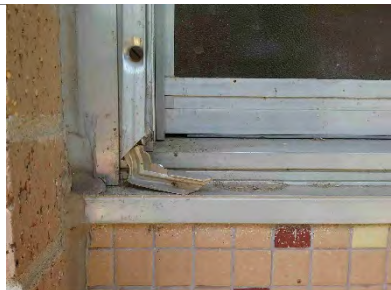
Exterior Windows	<p>The exterior windows are a combination of newly installed aluminum storefront and older aluminum framed storefront and single-hung windows. All windows have single paned glazing.</p> <p>It was reported that new windows have been installed in the office, the 300-wing, and one-half of the 100-wing, and cafeteria. It was reported that remaining windows are in poor condition, and that they are not operational. The sealant on the older windows was observed to be</p>	Average

System	Subsystem	Condition and Deficiency Overview	System Condition Rating
		discolored and cracking from age. Some of the plastic paneling on the aluminum windows was observed to have chipped paint. Additionally, condensation was observed in a few panes of the newer storefront system and many of the older storefront system. It was observed that the operable windows in the newer storefront system were installed without a frame. The older single-hung windows were observed to rattle strongly when the wind blew. Some of the older single-hung window panes and frames were observed to be broken, exposing sharp metal edges.	
	Exterior Doors	<p>There is one main exterior entrance to the school. It consists of newly installed glazed doors set in an aluminum-framed storefront system. The remaining exterior doors are metal with glazing.</p> <p>The finishes of the exterior doors were observed to be in good condition, but their operation was not. It was reported that the majority of the door closers no longer work, and the closers were in fact observed to not engage. The paint on the exterior doors was generally found to be sloppy at the edges of the glass. A large stream of ants was observed to be passing through the exterior door near the kitchen dock. It was observed that the door is missing weather strip and deteriorated frame were potentially enabling the insect access.</p>	Poor

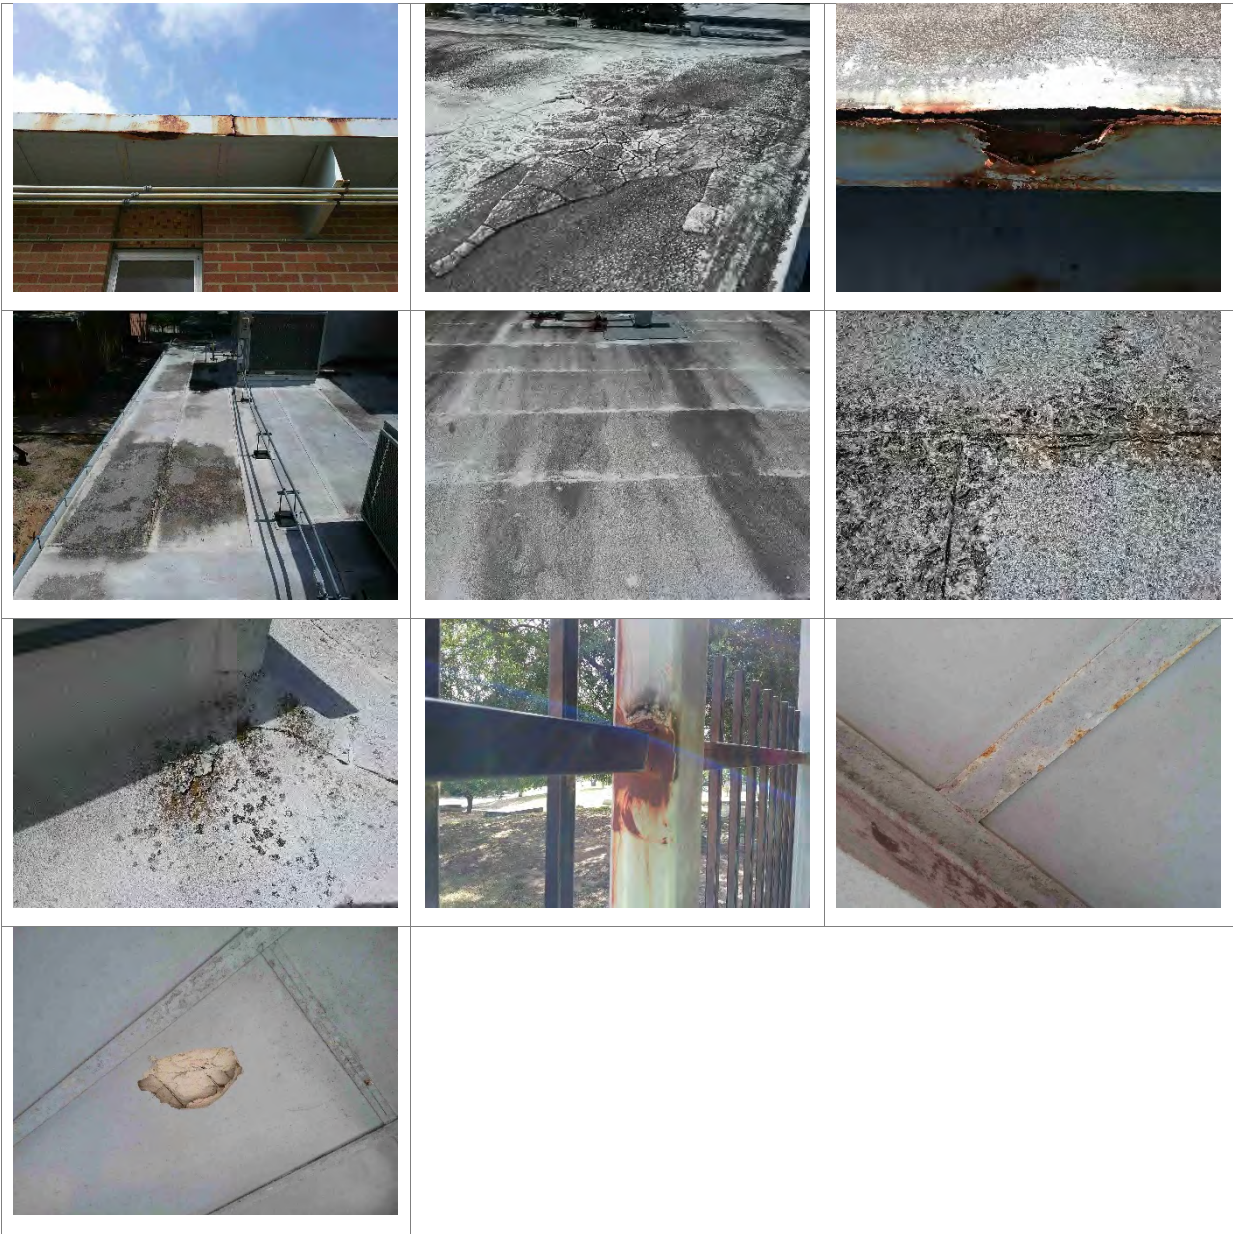
Roofing Deficiency Examples

Roofing		<p>The majority of roof material covering the building is a modified bitumen roofing system, but the installation dates of the roofs vary significantly. There is also a new single ply membrane roof on the small library extension. There are nine skylights on the roof of this building, three per classroom wing. The Main Building and Gymnasium are connected by a canopy over a concrete walk. The canopy is constructed of steel tube supports and thin concrete panel topping.</p> <p>The roof surfaces were observed to be in significantly different conditions ranging from failing to excellent. The modified bitumen roofs above the cafeteria, 100-wing, and part of the 200-wing were observed to be in a failing condition. Rust, age, and deterioration were prevalent, and the roof appeared to be at the end of its service life. Leaks were reported in the northwest corner of the cafeteria, but no interior damage was observed as the ceiling tile appeared new. Ponding was observed on roof A-03, and discoloration from water runoff was prevalent across the facility. A large area of organic growth was observed on roof A-12, and flowering organic growth was observed on the flashing of the skylights. The roof of the new library extension was constructed this year and is in excellent condition. The canopy over the exterior walkway appeared to be in poor condition. Rust was observed where the posts and railing met and on the support tees for the concrete panels. The overall appearance of the finish was observed to be dirty and dingy, and a large hole was observed through the facing of the material.</p>	Poor

1. Replace rusted fascia and determine future means of prevention.

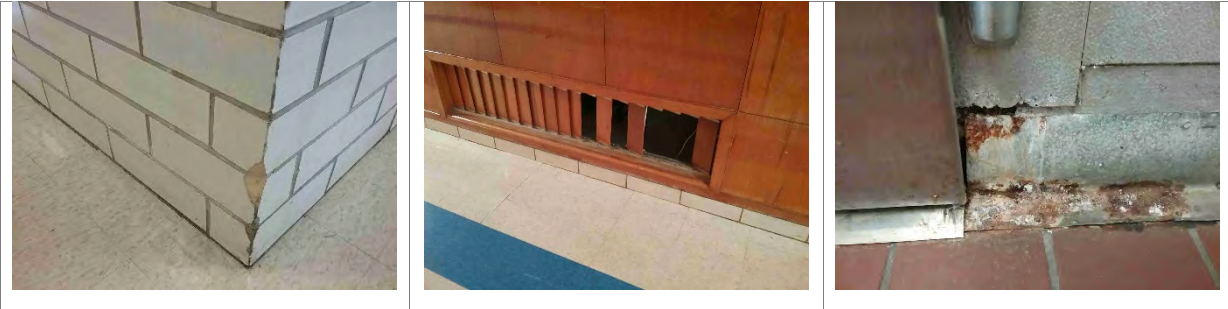
System	Subsystem	Condition and Deficiency Overview	System Condition Rating
Interior Construction	Interior Walls	<p>The interior walls are constructed of utility brick. The partitions between corridors and classrooms are constructed with louvered openings into the top of the classrooms. The classrooms are divided by fabric accordion partitions.</p> <p>The interior partitions appeared to be in average condition as instances of minor cracking and chipping were observed throughout all wall surfaces. Some of the louvers were observed to be broken or missing. The wall of the refrigerated food storage room was observed to be extremely deteriorated.</p>	Average
	Interior Doors	<p>The interior doors are generally wooden with metal frames and appear original to the building. Some of the classroom doors are half glass with metal grilles on the lower half. Many of the doors lites have wired glass.</p> <p>The closers were observed to barely engage when the doors were swung shut. Because of that, many of the heavy wooden doors shut with great force at a high velocity. The wood on many of the doors was observed to be worn. The paint on some door frames was observed to be worn and chipped.</p>	Average

1. Repair or replace damaged wall corners and wooden louvers in the building that are not covered in recommendation 4 below.
2. Replace deteriorating refrigeration wall in kitchen.
3. Repair interior door closers to fully engage.
4. Remove wooden louvers in lower 25% of classroom/corridor walls (initially for ventilation) and infill with compatible paneling or wall finish material.

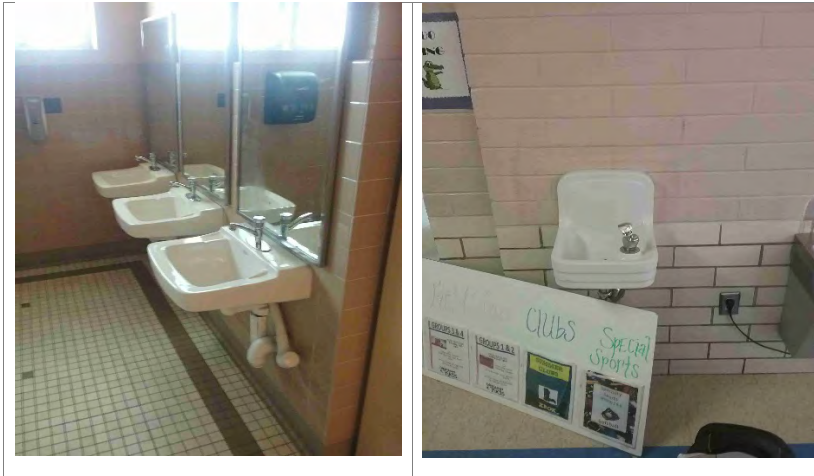
Conveying	The lift at the stage was observed to be in excellent condition.		Excellent
Plumbing	Plumbing Fixtures	<p>This building has a male and a female public restroom. The fixtures are mainly white, vitreous china with wall-hung urinals. The sinks have manual faucets and the toilets have manual flush valves. The public male and female restrooms do not have a hot water line. There are also restrooms located near the administration offices, but this area was inaccessible during the time of the assessment.</p> <p>In general, most sinks and toilets were operational. Some toilets did not flush properly and some sinks were not functioning. Some sinks appeared to be original construction fixtures.</p> <p>The kitchen was undergoing a renovation of the crawl</p>	Average

System	Subsystem	Condition and Deficiency Overview	System Condition Rating
		space piping. The kitchen sinks did not have hot water. The water cooler in the corridor next to the cafeteria was not operational. Two out of the three faucets in the GRR200 across from the lounge were not functioning.	
	Domestic Water Distribution	There are water heaters located near the faculty work room , kitchen, and administration areas. The water heaters located near the kitchen area had new distribution piping and appeared to be in good condition. However, the water heater near the kitchen was observed to operate inefficiently as the faucets did not have hot water. The water heater in the administration area was inaccessible and was not assessed.	Average
	Other Plumbing	System not present.	N/A
Mechanical/ HVAC	The HVAC system for this building mainly consists of packaged RTUs (roof top units) for each classroom, thru-wall heat pumps, and fan coil units. The fan coil units are mainly used to provide air conditioning in the corridors and lounge area. There were two small units on the roof in the northwest corner (A-08). These units were labelled "small CU on roof 1" and "small CU on roof 2." These units were observed to have rusted components and were in poor condition. The RTUs in the 100-wing were dumping humid air into the rooms. Exhaust fans looked to be in generally good condition. There were minimal signs of wear and tear. It was reported by AISD Construction Management that new RTUs were installed in all of the classrooms during the 2015 and 2016 school year and heat pump console units were removed from the classrooms.		Average

1. Replace water cooler in the corridor next to the cafeteria.
2. Repair faucets in GRR200.
3. Address hot water issues in the kitchen area.

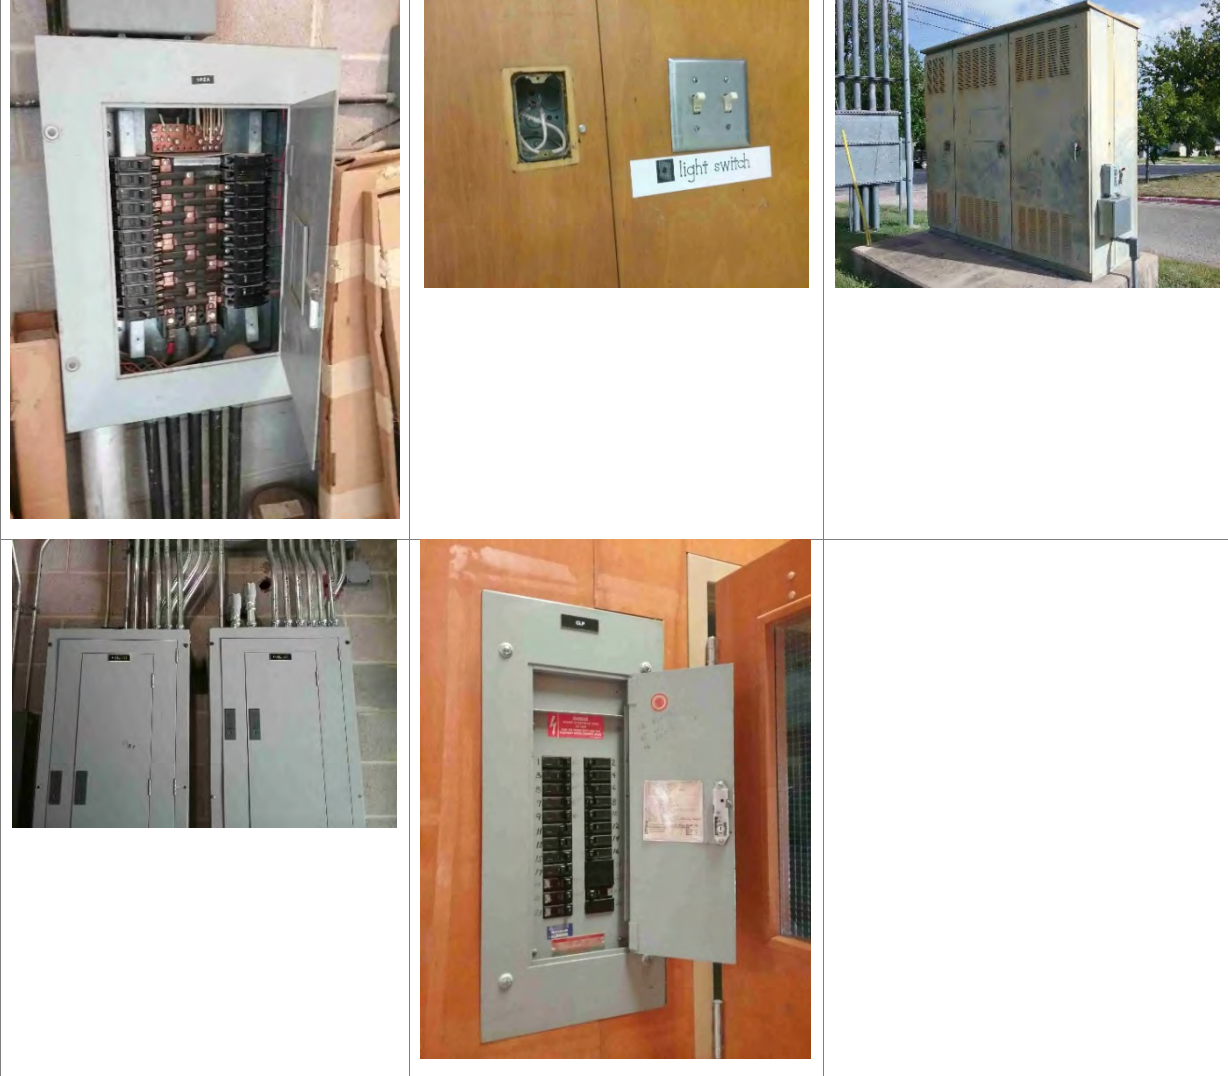
Electrical Distribution

System	Subsystem	Condition and Deficiency Overview	System Condition Rating
		<p>branch circuit panels in corridor C1.</p> <p>The electrical distribution equipment appeared to be in good condition. However, the main switchboard MSB and some distribution panels appeared to have corrosion. 95% of the electrical panels and switchgear were updated recently. Many of the panels are past their design life and need replacement. Specifically, it was reported that the electrical panel in the kitchen is old and is out of capacity. It was also reported that beginning 2016/2017 the school is going to begin serving breakfast in the classrooms, and this will most likely place additional demand on the available electrical service.</p> <p>Elec Mech Rm 200 was observed with a major life safety issue; panel 1PZA was observed with all bussing entirely exposed. It also appeared that the panel back-box was being utilized as a junction box to splice a feeder/branch circuits to the portable buildings.</p> <p>It was also observed that in most of the classrooms there is a junction box with exposed wiring, typically near the location of wall light switches.</p>

1. Replace all panelboards that are in the main school corridors as they appear original to construction and aged past typical design life.
2. Replace Panels AC1, AC4, and AC5 located in the mechanical room.
3. Replace Panel KP located in the kitchen with a larger capacity panel.
4. Provide dead-front for panel 1PZA immediately as it is a major life safety concern. Remove all foreign wiring from panel.
5. Redirect exterior building mounted cameras such that their coverage is not blocked by the portable buildings.

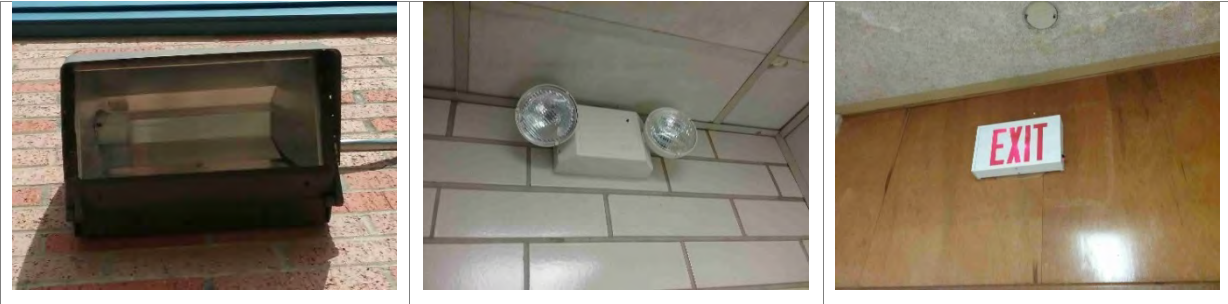
Lighting	<p>The 300-wing consists of pendant mounted 1x4 fluorescent light fixtures in the classrooms with dual switching. Most of the facility does not have emergency lighting or occupancy sensors, with the exception of recently renovated areas. There are some areas (such as the kitchen) that have emergency lighting but it is outdated and not functional.</p> <p>Corridors throughout the facility, in general, have surface mounted 1x4 fluorescent light fixtures. Corridor C4 has new surface mounted LED fixtures.</p> <p>Exit signs throughout the facility appear to be aged and many fixtures are not working.</p> <p>The 200-wing lighting and lighting controls are similar to the 300-wing, except classrooms do not have dual switching.</p> <p>The 100-wing lighting and lighting controls are similar to the 300-wing.</p> <p>Library lighting appears to have been upgraded in 2015. There are occupancy sensors throughout the library areas. Library administration areas have new 2x4 fluorescent light fixtures and the general library areas have indirect 1x4 pendant mounted fluorescent fixtures.</p> <p>The cafeteria has similar 1x4 surface mounted</p>	Average

System	Subsystem	Condition and Deficiency Overview	System Condition Rating
		<p>fluorescent fixtures similar to majority of the school, except there are also some 1x4 surface mounted parabolic fixtures. There are no occupancy sensors; all controls are manual.</p> <p>The kitchen has 2x4 recessed fluorescent light fixtures. There are no occupancy sensors, all controls are manual. All emergency and exit lights appeared to not be functional.</p> <p>Exterior lighting consists primarily of building mounted HID (high intensity discharge) light fixtures. Some fixtures are in good condition but most are worn out and outdated. There is no lighting at the playground area. The west side parking and drop off areas, kitchen loading area, and the staff parking lot have no lighting. School main entrance exterior canopy appears to be recently renovated and has new LED canopy lights. All exterior lighting appears to be controlled via timeclocks/photocells.</p> <p>The majority of the lighting for the building was observed to be in average-to-poor condition, with the exception of the recently renovated areas which were in excellent condition. Most interior lighting fixtures are in average condition and functional. Most of the exterior light fixtures appeared to be aged past their design life. Observed deficiencies include broken lenses, inconsistent color temperatures, and non-functional fixtures. Most exit signs appeared to be non-functional at the time of assessment and emergency egress lighting did not appear to exist in most of the facility. It was specifically reported as a life safety/security issue that the lighting in parking lots and in the area around the portable buildings is not sufficient. Most of the exterior lighting timeclocks are mechanical in nature and very outdated, with some that may not be functional.</p>

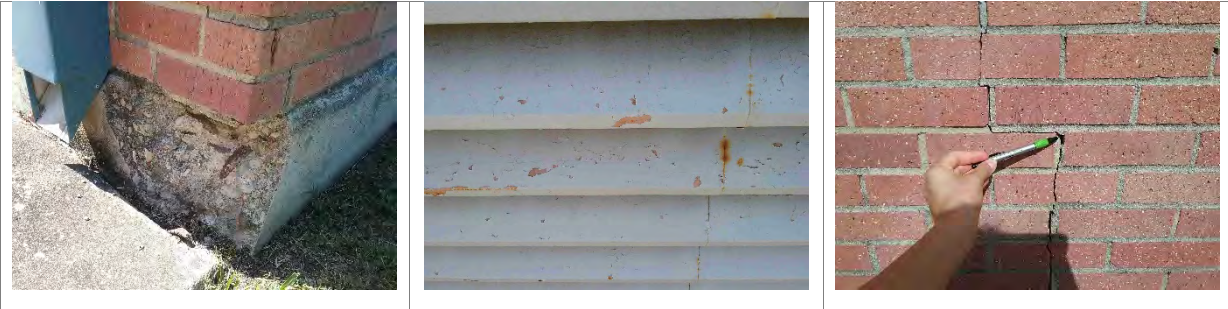
System	Subsystem	Condition and Deficiency Overview	System Condition Rating
Exterior	Exterior Walls	<p>The exterior walls are constructed of concrete masonry units (CMU) faced in brick. There are large metal louvers on the south side of the building.</p> <p>The exterior walls were observed to be in good condition, with the exception of a broken corner of concrete. The finish on the louvers was observed to be peeling slightly. An irregular crack in the brick was also observed.</p>	Good
	Exterior Windows	<p>There is one set of windows in the custodian closet and one set of clerestory windows above the main area.</p> <p>The windows by the custodian closet were observed to have very aged sealant and panes. Two of the panes were cracked or broken. The ceiling underneath the clerestory windows was damaged from water intrusion.</p>	Poor
	Exterior Doors	<p>The exterior doors are metal in metal frames.</p> <p>It was reported that the closers on the doors no longer function, and it was observed that the closer in fact did not activate properly. The door swung shut freely. Dents and worn paint were also observed.</p>	Poor

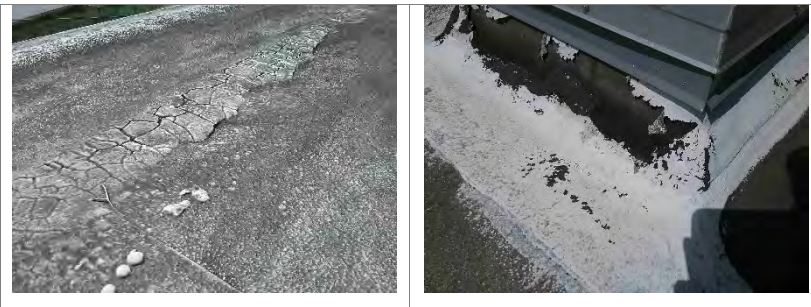
Roofing Deficiency Examples

Roofing	<p>The roof is covered with a modified bitumen roofing system with a white reflective coating. There are eight skylights in the roof.</p> <p>The roof was observed to be in failing condition. The white coating was observed to be completely worn off, and the bitumen membrane was observed to be bumpy, thick in areas, and deteriorated. The skylights were reported to be leaking, but only one skylight was observed to be in poor condition. The membrane around the skylight was nearly completely deteriorated.</p>		Fail

1. Replace the one skylight in poor condition. Monitor other skylights for leaking.

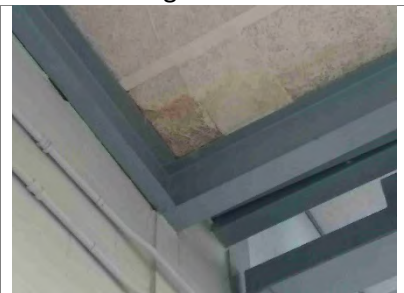
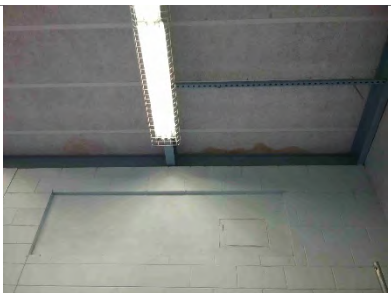
Interior Ceiling Finishes	The ceiling is finished with wood wool (tectum) panels. Discoloration and water damage were observed on the ceiling. It was reported that the skylights are leaking, however, the ceiling underneath the clerestory window exhibited water damage; the ceiling under the skylights did not. It was reported that there is leaking from the walls on the southeast corner, and damaged ceiling tiles were observed in that location.	Average
Conveying	System not present.		N/A
Plumbing	Plumbing Fixtures	This building has a male and a female public restroom. There is also a private restroom in the office. These restrooms generally have vitreous china hand sinks with manual faucets and toilets. The urinal in the male restroom is wall hung with a manual flush valve. Most of the fixtures were functional except for one urinal in the male restroom that did not flush properly.	Average
	Domestic Water Distribution	The water heater is located next to the female restroom. Although some electrical wires were exposed, this water heater was observed to be in good condition.	Good
