Baldwin Elementary School Site Summary

Main School Building – BLDG-187A

Building Purpose	Administration, Classrooms, Gymnasium, Kitchen, and Cafeteria
Building Area	86,896 SF
Inspection Date	August 2, 2016
Inspection Conditions	99°F - Sunny
Facility Condition Index

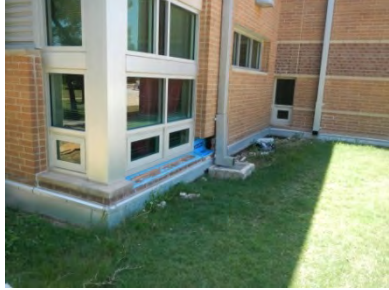
System	Subsystem	Condition and Deficiency Overview	System Condition Rating
Exterior	Exterior Walls	<p>The exterior of the building consists of a brick façade, corrugated metal covering, and aesthetic shotcrete paneling. The windows have an architectural metal sun shade.</p> <p>The exterior walls were reported and observed as being in good condition except for damage to the brick façade along the northwest corner and at a section on the north side of the facility. These areas were reported as having subgrade interior construction and had experienced water intrusion into the facility.</p>	Good
	Exterior Windows	<p>The exterior windows consist of single-pane glazing units with metal frames around the majority of the facility with double-pane windows in the classrooms with a lower transom casement.</p> <p>The exterior windows were observed and reported as being in good condition.</p>	Good
	Exterior Doors	<p>There is one main public entryway located along the northwest side of the building; these doors are hollow metal with glass storefronts and a hollow metal frame. The remaining service doors around the facility are hollow metal with glass storefronts and hollow metal frames. The exterior doors to access the mechanical and electrical rooms are solid hollow metal with hollow metal frames. A metal roll-up door is located on the west side of the gymnasium storage room.</p>	Good

1. Repair the exterior brick where water damage or water intrusion has occurred.
2. Identify and repair any potential locations for water intrusion to prevent future water damage.

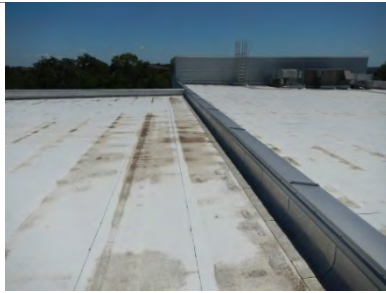
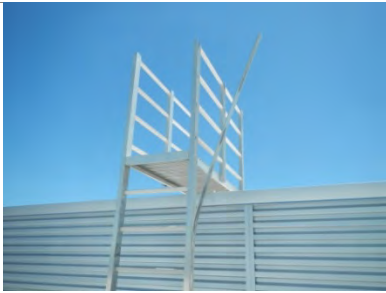
Roofing Deficiency Examples

System	Subsystem	Condition and Deficiency Overview	System Condition Rating
		The exterior doors were observed to be in good condition.	
Interior Construction	Interior Walls	<p>The interior partitions are predominantly constructed of gypsum board that is texturized throughout the classrooms, corridors, library, and administration offices. These spaces are painted. The kitchen and gymnasium consist of a painted concrete masonry unit wall.</p> <p>The interior partitions appeared to be in good condition with instances of minor chipping observed throughout all wall surfaces. It was observed that room "FCU-2-13" had a hole in the wall that required repair to the gypsum board.</p>	
Roofing	<p>The roof material covering the building consists solely of a white membrane EPDM (ethylene propylene diene terpolymer).</p> <p>The roof surfaces were observed to be in good condition with the exception of isolated areas where minor ponding was evident along the west edge of roof section A-12. It was observed that a metal access ladder from roof section A-17 to A-20 had trim that was separating.</p>		Good

1. Maintain and repair any areas of roofing where ponding is evident.
2. Replace all PVC roof drain covers with cast iron covers.
3. Repair the access ladder railing's current separation of metal siding.

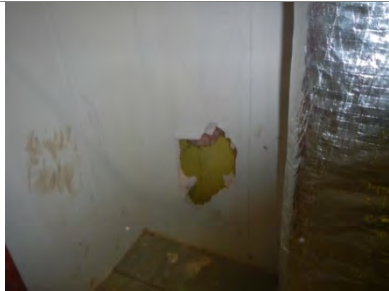
Interior Construction	Interior Walls	<p>The interior partitions are predominantly constructed of gypsum board that is texturized throughout the classrooms, corridors, library, and administration offices. These spaces are painted. The kitchen and gymnasium consist of a painted concrete masonry unit wall.</p> <p>The interior partitions appeared to be in good condition with instances of minor chipping observed throughout all wall surfaces. It was observed that room "FCU-2-13" had a hole in the wall that required repair to the gypsum board.</p>	Good
	Interior Doors	<p>The interior doors consist of solid core wood doors and hollow metal frames and metal-framed windows.</p> <p>The interior doors and frames were reported and observed to be in good condition.</p>	Good
	Interior Specialties	System not present.	N/A
Stairs	Exterior Stairs	<p>The exterior stairs located around the facility consisted of metal pan stairs with formed concrete steps.</p> <p>The exterior stairs were reported and observed to be in good condition.</p>	Good

1. Repair holes in the wall of mechanical room FCU 2-13.

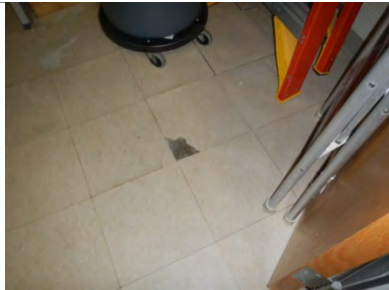
System	Subsystem	Condition and Deficiency Overview	System Condition Rating
	Interior Stairs	The interior stairs consist of painted metal staircases with a landing, wall-hung handrails, and vinyl non-slip surfaces on the tread. Interior wood stairs are present in this facility to access the school stage in the cafeteria. The interior stairs were reported and observed to be in good condition.	Good
Interior Finishes	Interior Wall Finishes	The school has painted and texturized finishes on gypsum board. The interior wall finishes were reported and observed to be in good condition. Minor wall scuffing was evident and consistent with the age and use of the facility.	Good
	Interior Floor Finishes	Vinyl composition tile flooring is present throughout the classrooms, janitorial closets, and cafeteria. Ceramic tile floor is present in the restrooms and kitchen area. Concrete flooring is present in the mechanical rooms. The music, library, and office spaces' flooring consists of carpeting. There is a wood stage located at the front of the cafeteria. It was observed that the flooring in all areas was in good condition with the exception of minor scuffing and one instance of chipped tile located in a janitorial closet.	Good

1. Repair any scuffed or chipped vinyl floor tile.
2. Identify the cause of wet ceiling tiles. Repair the leak and replace ceiling tiles.

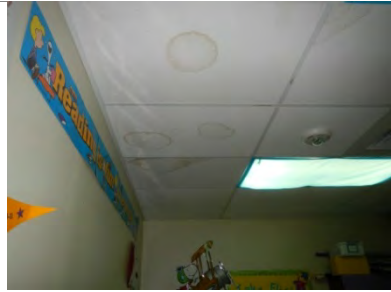
Interior Ceiling Finishes	The ceiling consists predominantly of acoustic ceiling tiles throughout the classrooms, office spaces, restroom, and kitchen. The common area corridors and stairwells contain open ceilings with exposed roofing and gypsum board. The ceiling finishes were observed to be in good condition. A few instances of wet ceiling tiles were observed from an unknown source.	Good
Conveying	The building is equipped with a hydraulic passenger elevator to service two levels. This elevator was reported and observed to be in good condition. A recent inspection certificate issued within the last year, as required, was visible, and no operational issues were reported by the facility staff.		Good
Plumbing	Plumbing Fixtures	The building has public restrooms for males, females, and students, and separate staff restrooms located throughout the facility. The classrooms typically contain a unisex restroom with a vitreous china and floor-mounted toilet with manual flushing mechanisms. Stainless steel, counter-mounted sinks are located within the classrooms and have institutional grade goose-neck faucets and drinking fountain bubblers. Multi-use restrooms in public areas typically have vitreous china wall-hung hand sinks with manual	Good

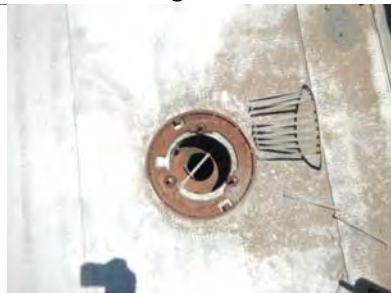
Other Plumbing

System	Subsystem	Condition and Deficiency Overview	System Condition Rating
		<p>faucets, along with vitreous china floor-mount toilets with manual flushing mechanisms, and vitreous china wall-hung urinals in the male restrooms with manual flushing mechanisms.</p> <p>The staff restrooms typically have vitreous china wall-hung hand sinks with automatic faucets and floor-mounted toilets with manual flushing mechanisms. There are floor drain service sinks in the janitorial closets. Water coolers are located throughout the facility, typically near the public restrooms. The building also includes other specialty locations with plumbing fixtures, including a kitchen for the school cafeteria and an arts room with counter-mounted stainless steel hand wash sinks and a floor-mounted service sink with a plaster trap.</p> <p>The plumbing staff reported that there is a sewer gas odor mostly occurring in the 200-wing in the winter months. It was reported that the pressure reducing valve and backflow preventer are experiencing high levels of calcification due to water hardness.</p> <p>The plumbing fixtures were in good condition.</p>

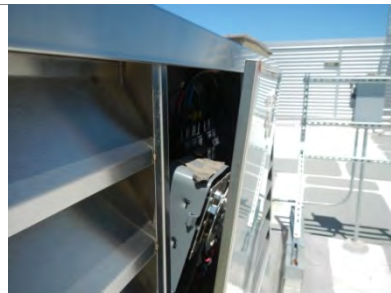
Mechanical/HVAC System Deficiency Examples

System	Subsystem	Condition and Deficiency Overview	System Condition Rating
		<p>primarily in closets in the corridors adjacent to every classroom.</p> <p>The mechanical/HVAC system was reported and observed to be in good condition. It was observed that the controls for RU-1 were exposed to the elements and required immediate maintenance.</p>	
Fire Protection	Fire Alarm	<p>The building has a fire alarm system that consists of alarm and signaling devices such as horns/annunciators, strobes, horn/strobe combinations, pull stations, and detectors. The fire alarm system is controlled by a control panel.</p> <p>The fire alarm system was reported and observed to be in good condition.</p>	Good
	Fire Protection/Suppression	<p>The building is equipped with a fire sprinkler system.</p> <p>The building has a series of fire extinguishers for fire protection.</p> <p>The fire extinguishers were reported and observed to be in good condition with inspection certifications issued within the last year.</p>	Good

1. Repair the exposed controls to RU-1.
