Barrington Elementary School Site Summary

Address	400 Cooper Drive Austin, TX 78753
Number of Permanent Campus Facilities	3
Original Year of Construction	1969
Total Campus Building Area (combined)	79,689 SF

Introduction

Main School Building – BLDG-149A

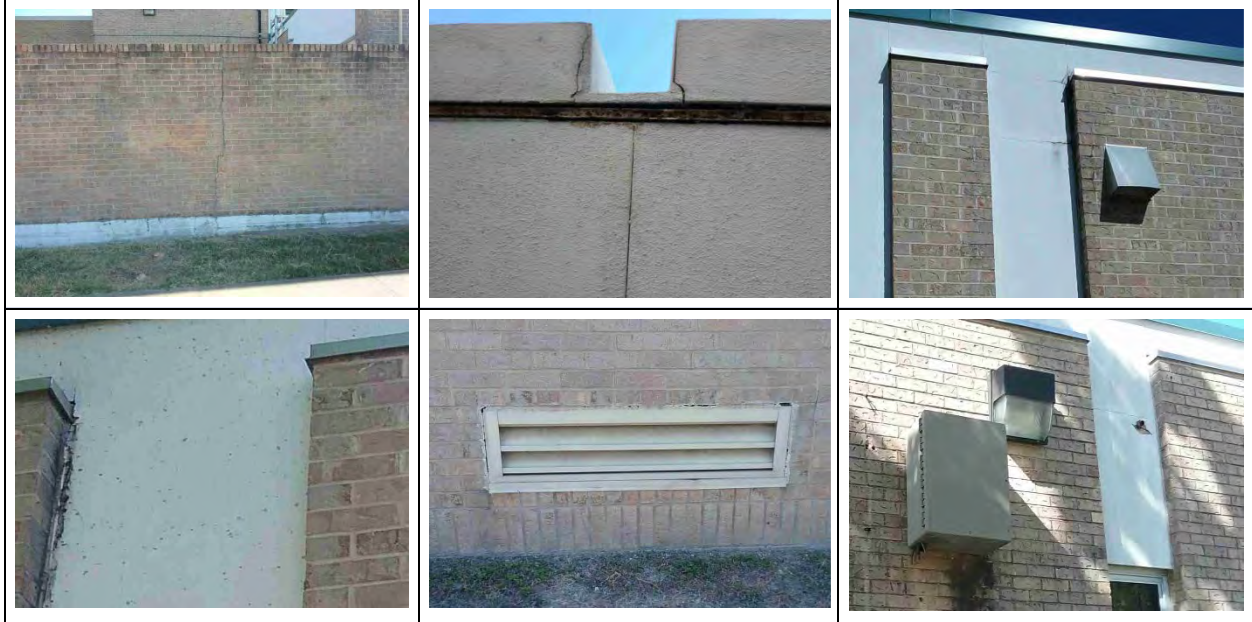
System	Subsystem	Condition and Deficiency Overview	System Condition Rating
Exterior	Exterior Walls	Exterior walls are primarily brick with a stucco accent band at the roof line, above the windows, and at the main entrance roof extension. The exterior walls were observed to be in average condition. Deficiencies noted in the brick included staining from uncontrolled water run-off from the roof areas, and cracked and aged sealant. Deficiencies observed on the stucco finish included cracking above the window heads at various locations, one instance of an unfinished electrical installation damaging the surface, and the appearance of organic growth on the surface.	Average
	Exterior Windows	The exterior windows consist of aluminum framed single pane glazing units with solid infill panels below the vision lites and tinted glass above the operable sash. The windows were observed to be in poor condition. The metal panels installed in the bottom portion of the frames were observed to be deteriorating or damaged. The sealant at the jambs, sills, and heads appeared aged and cracked. Corrosion on the window frames was observed.	Poor

1. Repair or replace sealants at the brickwork.
2. Repair stucco systems above window heads.
3. Repair stucco systems at exterior roof extensions or awnings. Replace rusted elements and review interior structure of system for rusting of support materials.
4. Survey and replace the windows.
5. Survey building and replace acrylic glazing with glass.
6. Replace rusted door at GYM.

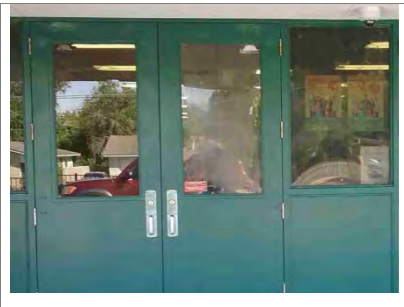
Exterior Doors	The exterior doors consist of hollow metal doors set in hollow metal frames. Typically, these units are partially glazed. Some mechanical room doors have louvers set in the metal doors or have louvered transoms. The doors were observed to be in average condition.	Average

System	Subsystem	Condition and Deficiency Overview	System Condition Rating
		Some units with acrylic glazing lites appeared to be damaged or aged. It was reported that the door from the gymnasium area was deteriorating and corroded.	
Roofing	<p>The roofing system is typically modified bitumen with a fluid applied top coating on the cap sheet. One small area of built up roofing is located at section A-13.</p> <p>The roofing system was observed to be in poor condition. This was determined from the deficiencies observed from the exterior and the visible signs of water damage observed to interior ceiling finish surfaces. The roof areas were observed to have blistering and loose cap sheets, aged areas and organic growth or deterioration on the cap sheet. At several locations on the roof surface, the runoff did not appear to be controlled and, as a result, stained the facade. Roof leaks were reported by the facility staff in the gymnasium storage closet.</p>		Poor

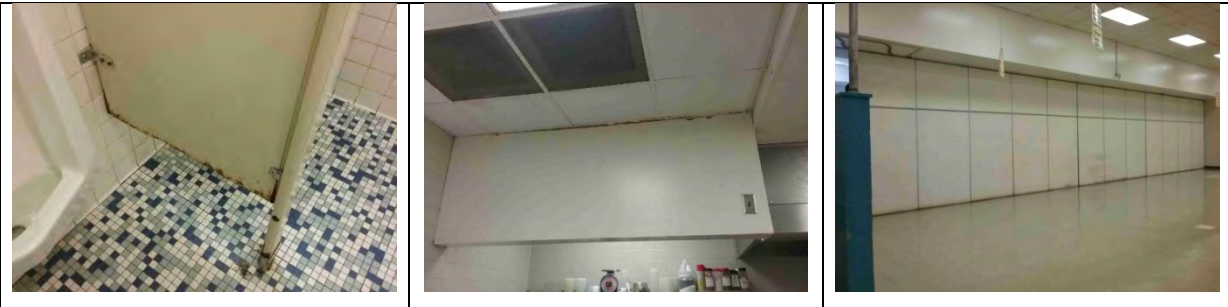
Interior Construction	Interior Walls	<p>Interior walls are stud construction with gypsum board finish or concrete masonry unit construction.</p> <p>The interior walls were observed to be in good condition. Observed deficiencies were limited to the kitchen area where partial height walls extended from the ceiling to capture humidity or fumes. This construction appeared to be separating from the ceiling grid. The toilet partitions in BRRGYM were noted as rusting. An accordion door was noted in room 108. The operable partition between the gymnasium and cafeteria was noted as having damage to the finishes and was requested to be replaced by the facility staff. At the time of the assessment the Café and associated hallways to the gym had received a fresh coat of wax making a closer review of the operable partition impossible.</p>	Good
	Interior Doors	<p>Interior doors are solid core wood veneer doors set in hollow metal frames. There are a limited number of hollow metal doors inside the facility.</p> <p>The frames and veneer of the interior doors were observed to be in average condition. Hardware appeared to be in good condition. Typically, frames had paint system condition issues resulting from wear and tear. The veneer on doors was observed as chipped, marred, and damaged. This appeared to be typical for all doors in the building. In one instance hardware at the door head appeared disconnected. It was reported by the CAC and Principal that some of the doors in the 100-wing did not lock properly.</p>	Average

1. Repair partitions at kitchen ceiling.
2. Review closure of accordion door closets at six locations.
3. Survey interior door systems replace or repair as necessary.
4. Reinstall hardware at 208RR's door head or remove if not required.
5. Investigate and repair non-locking doors within the 100-wing, as reported by the CAC and Principal.
6. Replace operable partition in GYM/CAFÉ.
7. Replace toilet partitions in BRRGYM.

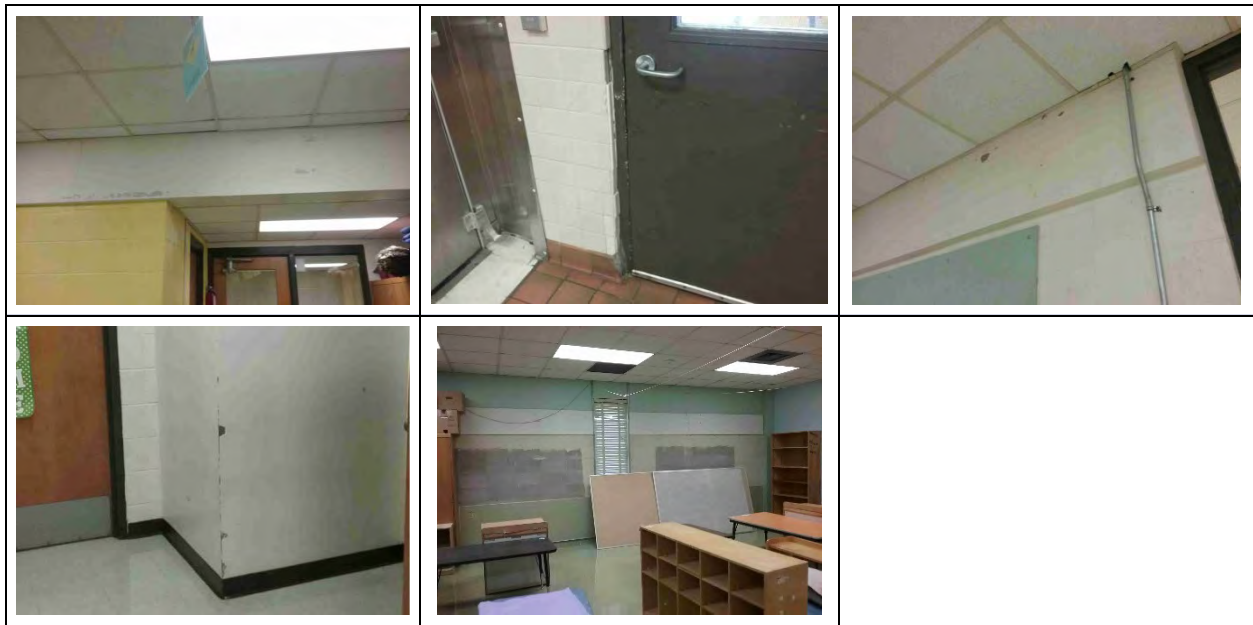
System	Subsystem	Condition and Deficiency Overview	System Condition Rating
Interior Finishes	Interior Wall Finishes	<p>Interior wall finishes consist of paint over gypsum board partitions or concrete masonry units. The restrooms include a combination of painted gypsum board and ceramic tile. Ceramic tile is also present in the kitchen.</p> <p>The interior wall finishes were observed to be in average condition. The deficiencies observed were chipped or peeling paint and a limited amount of damaged ceramic tile. Some portions of the building appeared to have older paint systems. Unfinished CMU (concrete masonry unit) was observed in several rooms creating a non-uniform aesthetic appearance. Damaged laminate was noted at several sink cabinets throughout the building.</p>	Average
	Interior Floor Finishes	<p>Interior floor finishes include VCT (vinyl composite tile), strip wood flooring at the stage, ceramic tile, quarry tile in the kitchen, carpet and an interlocking athletic flooring system in the gymnasium.</p> <p>The flooring finishes were observed to be in average condition. The quarry tile was observed to be aged and in poor condition. It was noted as chipped and patched, and delaminating from the substrate in many areas. Physical damage to the VCT was noted in several areas. The VCT in the cafeteria was reported as delaminating from the substrate. The exposed concrete floor in the kitchen janitorial closet was noted as damaged along with rust developing at the base of a structural column.</p>	Average

1. Repaint the portion of the 200 wing that includes rooms 201 thru 211.
2. Repaint the resource office area that includes RESCLO and RESOFC1
3. Review rooms for exposed CMU uncovered by the removal of black boards.
4. Replace the quarry tile in the kitchen.
5. Replace damaged VCT tiles. Where matching tiles are not available, replace the tile in the room.
6. Review VCT in cafeteria for adhesion issues.
7. Replace VCT in OFC200
8. Repair concrete flooring and structural column at KITCC. Install appropriate flooring to control wetting of this area.
9. Replace ceiling grid and tile; install appropriate tile system in KITCC.
10. Review humidity issues in MULTI200 and rooms 200, 202, 204, 206, 208, and 210.

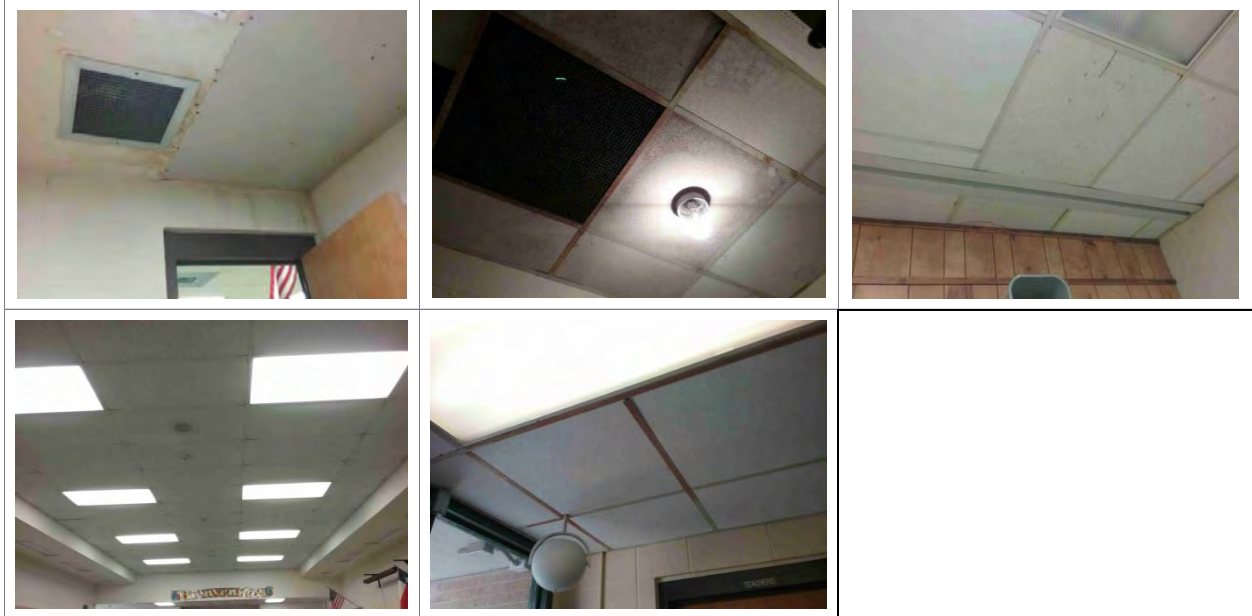
Interior Ceiling Finishes	<p>Ceiling systems were observed to be a 2'x4' and 2'x2' suspended ceiling system. Gypsum board ceilings were observed in restrooms, book rooms or as accents in several areas.</p> <p>The ceiling finishes were observed to be in poor condition. The ceiling grid had rust and corrosion noted in many locations. The ceiling tiles exhibited water damage, humidity damage and physical damage throughout the building.</p>	Poor
Conveying	System not present.		N/A

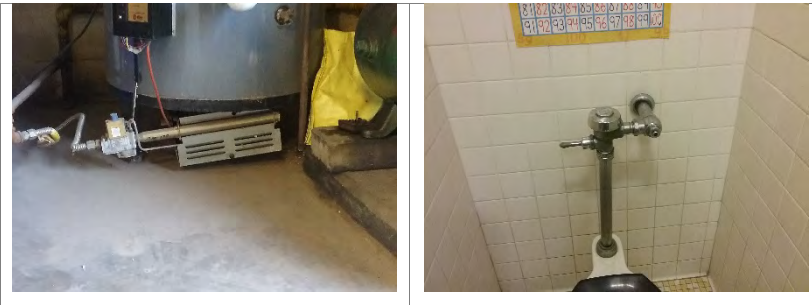
System	Subsystem	Condition and Deficiency Overview	System Condition Rating
Plumbing	Plumbing Fixtures	<p>The building has public restrooms for males and females, students, and separate staff restrooms located throughout the facility. These restrooms typically have vitreous china hand sinks in counters with manual faucets, along with vitreous china, floor-mount/wall toilets with manual flushing mechanisms, and vitreous china, wall-hung urinals in the male restrooms with manual flushing mechanisms. There are service sinks found in the janitorial closets, and water coolers located throughout the facility. It was reported by the CAC and Principal that some of the water fountains had issues with water pressure.</p> <p>The restroom plumbing fixtures were observed to be in good condition as the fixtures were typically aged but functional.</p>	Good
	Domestic Water Distribution	<p>All of the plumbing fixtures are serviced with domestic cold water. There is a GWH (gas water heater) in the main mechanical room that serves the kitchen.</p> <p>The domestic water distribution system was observed to be in average condition. The burner to the GWH was observed to not be installed correctly.</p>	Average

1. Repair burner installation on GWH.
2. Investigate water pressure issues, as reported by the CAC and Principal.

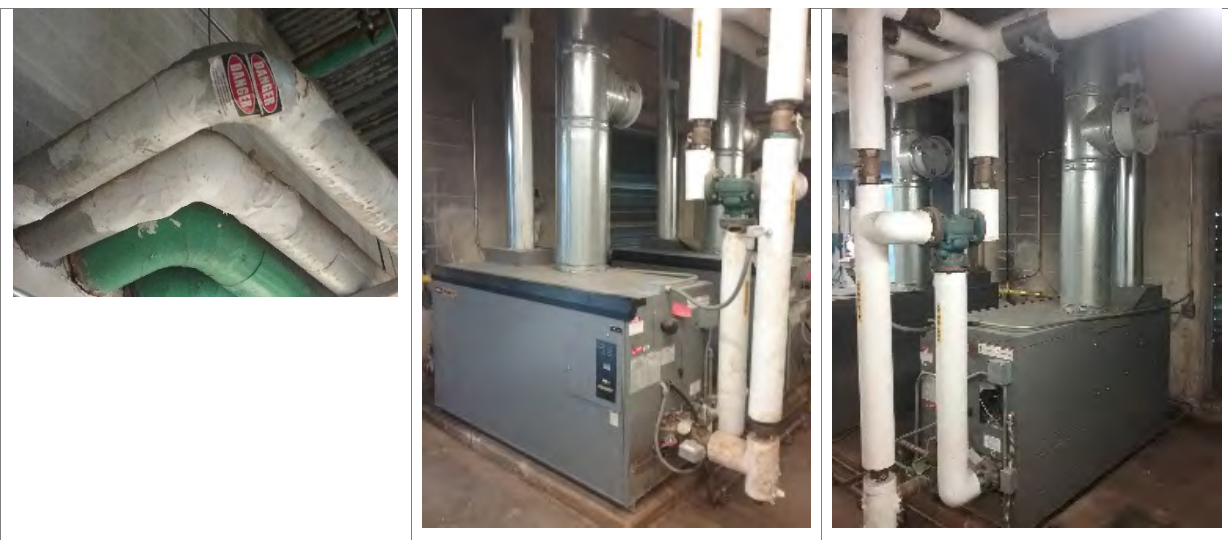
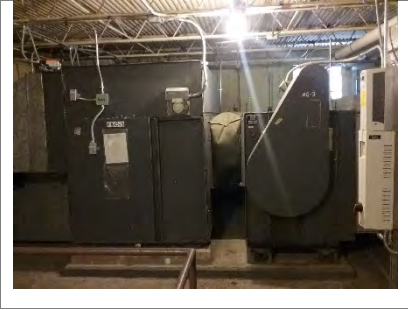
Mechanical/HVAC System Deficiency Examples

Other Plumbing	<p>The roof drains are equipped with metal grate covers to prevent debris from entering the drainage system.</p> <p>The roof drains were observed to be in good condition. The floor drain in the basement mechanical room was not draining at the time of observation.</p>	Average
Mechanical/ HVAC	<p>The major mechanical equipment consists of indoor chilled/hot water single zone and multiple zone AHUs (air handling units), an air cooled chiller and gas fired boilers. All AHUs are located in mechanical closets and mezzanines. The mechanical closets are located around the gymnasium and kitchen. There are other mezzanines located above the corridor of each group of classrooms. Several of the units are original to the building and have exceeded their service life by more than ten years. The remainder of the units were installed within the last ten years and were observed to be in good condition. Most of the newer AHUs appeared to be installed as outside air pre-treatment units and appeared to be in good condition.</p> <p>There is one air cooled chiller serving the main building. Its approximate age is ten years and it appeared to be in good condition.</p> <p>The boilers were reported by the facility staff to be aged. According to the nameplates on the boilers, they are less than ten years old. It was observed that the boilers were installed without a primary pump, which could lead to incorrect operation. The CAC and Principal reported that the HVAC (heating, ventilating, and air conditioning) is not working properly within the 100-wing and within the gymnasium.</p>		Average

1. Create a replacement plan for the AHUs that have exceeded their service dates.
2. Reinstall boiler piping to incorporate a primary pumping.
3. Investigate and repair issues with the HVAC system in the 100-wing and in the gymnasium, as reported by the CAC and Principal.

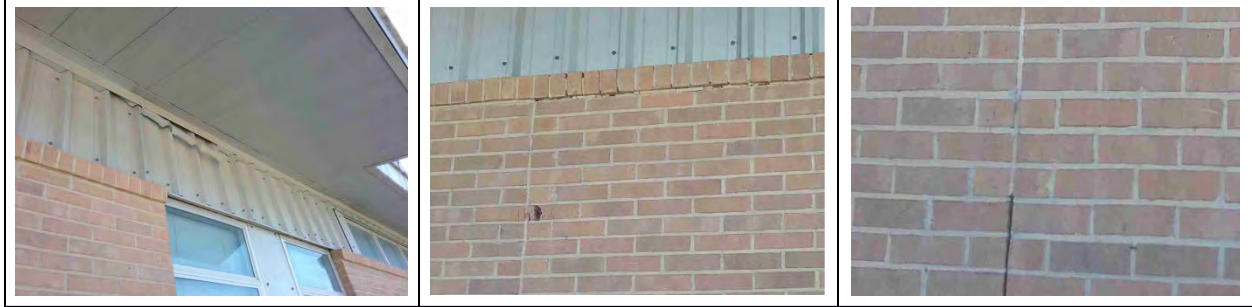
System	Subsystem	Condition and Deficiency Overview	System Condition Rating
Exterior	Exterior Walls	Exterior walls are primarily brick with mechanically fastened metal panels above and as infill panels at window units. The exterior walls were observed to be in good condition. Deficiencies noted for the brick work included missing or aged sealant at the control joints and cracking of brickwork or grout at the outside corner of room 307. The metal panel system had a loose trim piece in one location and the fasteners appeared to be loose and missing in a few locations.	Good
	Exterior Windows	Exterior windows are aluminum framed single pane glazing units in a single hung configuration. The exterior windows were observed to be in good condition. One window unit was observed with damaged glazing. On all units, the sealants were noted as aged and cracking.	Good
	Exterior Doors	The exterior doors consist of hollow metal doors set in hollow metal frames. Typically, these units contain glazed vision panels. Mechanical rooms have door leafs without windows. The exterior doors were observed to be in good condition. The only deficiency noted was the lack of lower glazing stops in three locations at the southern exit from corridor C1.	Good

1. Replace all exterior sealants at brick work and windows.
2. Repair damaged grout and brick work at the outside corner of room 307.
3. Tighten all fasteners in exterior metal panel system.
4. Replace damaged window glazing.
5. Install new glazing stops at exterior side lite configuration of the southern exit from corridor C1.

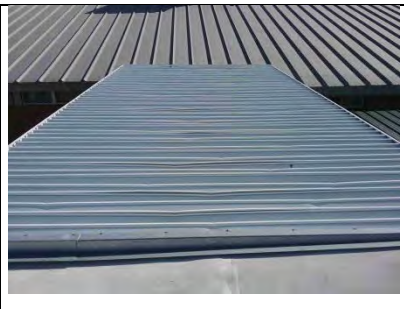
Roofing Deficiency Examples

Roofing	The roofing is a mechanically fastened metal panel system as observed from the adjacent building. This roof system was observed to be in poor condition. There		Poor

System	Subsystem	Condition and Deficiency Overview	System Condition Rating
		was evidence of consistent leaking and previous repairs to the roof surface. The staff report major and persistent roof leaks at the 300-wing.	
Interior Construction	Interior Walls	Interior wall systems are stud construction finished with gypsum board. The interior walls were observed to be in good condition. No deficiencies were noted.	Good
	Interior Doors	Interior doors are solid core wood veneer doors set in hollow metal frames. The door units include side lites. There are a limited number of hollow metal doors inside the facility and utility spaces. The interior doors were observed to be in good condition.	Good
	Interior Specialties	System not present.	N/A
Stairs	Exterior Stairs	System not present.	N/A
	Interior Stairs	System not present.	N/A
Interior Finishes	Interior Wall Finishes	Interior wall finishes consist primarily of paint over gypsum board, ceramic tile in the corridor, and ceramic tile in the restrooms. The interior wall finishes were observed to be in good condition. There was minor damage noted to ceramic tile in corridor C1.	Good

1. Replace roofing system with one that does not contain exposed fasteners.

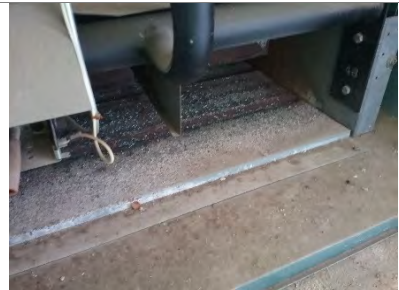
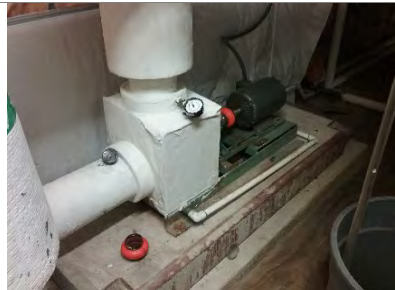
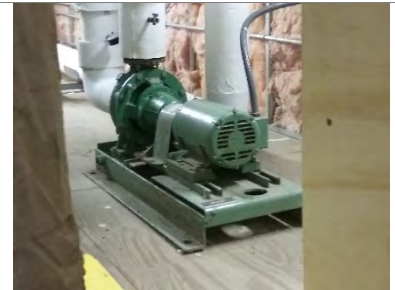
Mechanical/HVAC System Deficiency Examples

System	Subsystem	Condition and Deficiency Overview	System Condition Rating
		faucets, along with vitreous china, floor-mount/wall toilets with manual flushing mechanisms, and vitreous china, wall-hung urinals in the male restrooms with manual flushing mechanisms. There is a service sink in the janitorial closet, and a water cooler located near the library. The restroom plumbing fixtures were observed to be in good condition.	
	Domestic Water Distribution	The domestic water is served from the main building. There is an electric heater in the boiler room suspended above the boiler. The water heater was not accessible, but appeared to be in good condition.	Good
	Other Plumbing	There were no roof drains observed on the roof surface.	N/A
Mechanical/ HVAC	<p>The major mechanical equipment consists of several chilled water AHUs and fan coil units in addition to one boiler, one chiller and one pump per system.</p> <p>The boiler was observed to be in average condition as it is approaching the end of its useful life.</p> <p>The chilled water pump is installed on an inertia base on the mechanical mezzanine and exhibits vibration noises. These vibrations are highly apparent from the first level.</p> <p>The heating water pump is sitting directly on the floor and is not mounted on an inertia base nor is it secured in its location.</p> <p>The chiller appeared in excellent condition as it was installed within the last year.</p> <p>The AHUs appeared to be in good condition. The associated fan coil units appear to be in serviceable conditions. The condensate drain line is not secured in position to keep the line from moving or causing damage to the condensate drain pans. <i>It was reported by the CAC and Principal that the HVAC system was not working properly.</i></p>		Average

1. Create a plan to replace the boiler.
2. Create a plan to replace the heating and chilled water pumps, remove inertia bases and install inline pumps.
3. Install automatic purge for air separator.

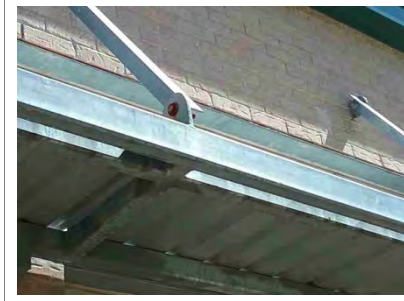
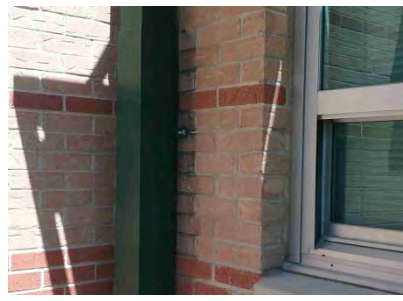
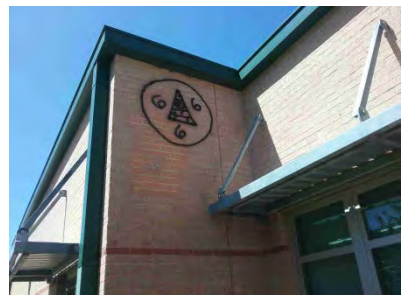
System	Subsystem	Condition and Deficiency Overview	System Condition Rating
Exterior	Exterior Walls	Exterior walls are brick with brick accents. The exterior walls were observed to be in good condition. Graffiti was noted on one wall and it appeared this was the location of previous applications of graffiti. The fastener at one of the awnings was noted as rusting and one downspout appeared to be clogged and staining the brick work.	Good
	Exterior Windows	Exterior windows are aluminum framed single pane glazing units in a single hung configuration. The exterior windows were observed to be in good condition. No deficiencies were noted.	Good
	Exterior Doors	Exterior doors consist of hollow metal doors set in hollow metal frames. Typically, these units contain glazed vision panels. The exterior doors were observed to be in good condition. One exterior door was noted as missing its sweep.	Good
Roofing	The roofing system appears to be modified bitumen with a cap sheet coated with plastic sheet. A metal panel system is found at covered walkways and awnings. The roofing system was observed to be in good condition with a few minor deficiencies noted. Ponding was noted in some areas on the modified bitumen. Physical damage was observed in one location of the metal panel roofing system. One awning was noted as having physical damage.		Good

1. Remove graffiti from exterior brick work outside of room 414.
2. Replace rusting fastener outside of room 403.
3. Clean stained brick work outside room 403 at the downspout.

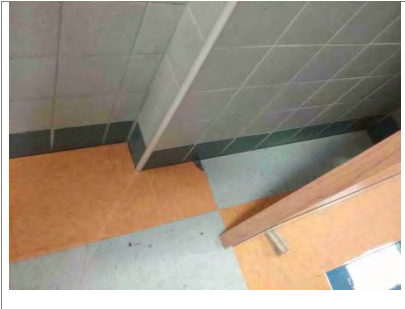
Interior Floor Finishes	Interior floor finishes include VCT, carpet, and ceramic tile. The floor finishes were observed to be in good condition. Minor damage was noted in corridor C2.	Good
	Interior Ceiling Finishes	Ceiling systems were observed to be a 2x4 suspended ceiling system with acoustical tile and gypsum board ceilings in the restrooms. The ceiling finishes were observed to be in good condition. On room was noted as having water damage tile.	Good
Conveying	System not present.		N/A
Plumbing	Plumbing Fixtures	The building has one restroom for male students and one restroom for female students per classroom pair and a staff restroom in the building. These restrooms typically have vitreous china hand sinks in counters with manual faucets, along with vitreous china, wall-mounted toilets with manual flushing mechanisms. There is a janitorial closet near the main entrance. The restroom plumbing fixtures were observed to be in good condition.	Good

1. Replace damaged tiles in corridor C2.
2. Diagnose source of water in room 414, repair and replace damaged ceiling tiles.
