Barton Hills Elementary School Site Summary

Introduction

Main School Building – BLDG-103A

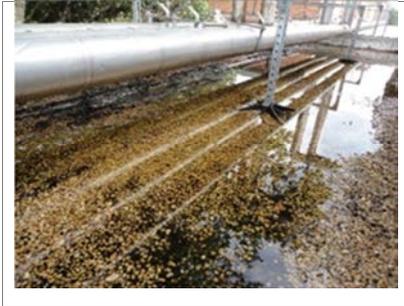
Roofing Deficiency Examples

| System | Subsystem | Condition and Deficiency Overview | System Condition Rating |
|---|--|--|---|
| Roofing | The roof is part modified bitumen and part built-up roof covering with roof gravel. A pre-finished metal walkway cover leads from the southwest exterior doors from corridor C4. Facility staff reported the roofing was replaced five years ago. The roof covering appeared to be in average condition with two areas that required attention. There were areas of ponding water on the built-up roof covering at A-02, A-04, A-05, and A19. The ponding water over A19 had overflowed previously, causing discoloration to the exterior brick where BLDG-103A joins BLDG-103C. The ponding water on A-05 overflowed onto the front walkway and deteriorated the pre-finished fascia and stucco below. | | Average |

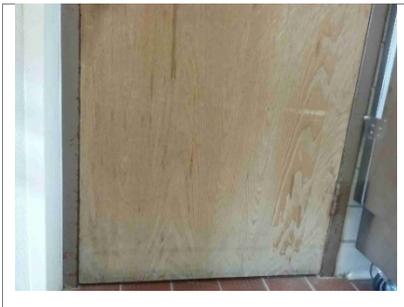
| System | Subsystem | Condition and Deficiency Overview | System Condition Rating |
|---|---|---|---|
| | Interior Doors | <p>The administration suite entry doors are stained, solid-core wood doors set in a stained wood frame. Most other doors are stained solid-core wood doors set in painted, hollow metal frames. Two painted steel, accordion gates are installed in the corridors.</p> <p>The door assemblies and hardware appeared to be in good condition except for the scuffed and worn door face finishes. Both gates appeared to be in average, operational condition, but staff said that they were never used.</p> | Average |

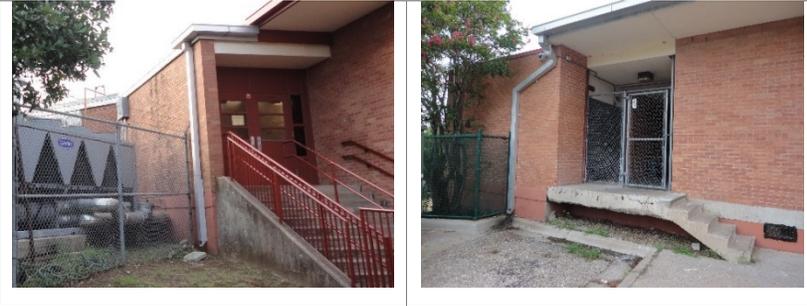
Exterior stairs

| System | Subsystem | Condition and Deficiency Overview | System Condition Rating |
|---|---|---|---|
| Stairs | Exterior Stairs | <p>There are exterior concrete stairs with painted metal railings on the north ends of corridors C2 and C3, the south end of corridor C4, and the south side of room 104. There are also exterior concrete stairs with painted metal railings at the exterior of the kitchen and cafeteria.</p> <p>The exterior concrete stairs were observed to be in average condition due to age yet fully functional, except the painted railings were starting to peel off of corridor C3. The stairs at KITMOPRM did not have any railing.</p> | Average |

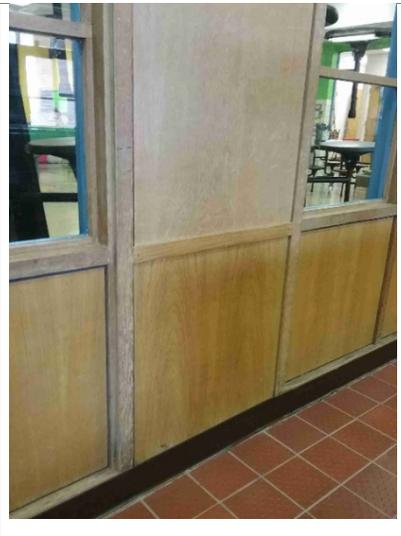
| System | Subsystem | Condition and Deficiency Overview | System Condition Rating |
|---|---|---|---|
| Interior Finishes | Interior Wall Finishes | <p>Stained paneling is in the corridors surrounding the administration suite and inside of the administration reception area. Stained paneling is installed on the kitchen side of the wood panel wall between the</p> | Good |

| System | Subsystem | Condition and Deficiency Overview | System Condition Rating |
|---|---|---|---|
| | | <p>cafeteria and kitchen. A paint finish is on the cafeteria side of the panel wall. There are also stained panels below the stairwell windows at the intermediate landings. The vice-principal's suite, parts of the administration suite and library office wall finishes are paint on gypsum wallboard. The finish is paint on CMU in the classroom suites, including the interior faces of the exterior walls. There is full-height ceramic tile finish in the nurse's toilet room, and ceramic tile is installed in some areas of walls in the classrooms. In the corridors and classroom toilets, structural glazed tile is the finish up to 5'-4" above the floor and painted CMU above this to the ceiling. The upper portions of the cafeteria walls are painted CMU. A mural is painted on CMU in the library.</p> <p>The stained panel finish in the kitchen and below the stair landing windows was old and required a new stain finish. All other finishes appeared to be in good condition.</p> | |

1. Refinish the stained wood frames and panels on the kitchen side of the cafeteria wall and under windows in corridor stairwells.
2. Investigate if resilient floor tile and floor glue in the cafeteria and cafeteria toilet rooms contain asbestos. Once determined, proceed as required to refinish or install new tile in these areas.
3. Refinish resilient floor tile in rooms 102, 103, and 104.
4. Replace ceiling tiles in the cafeteria toilet rooms.

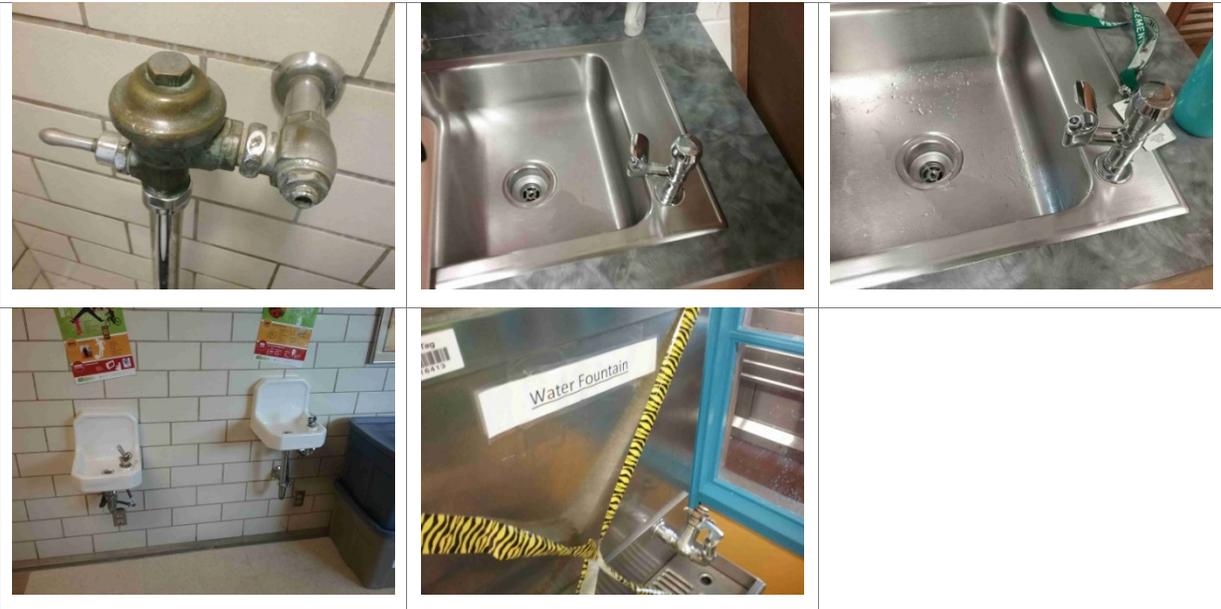
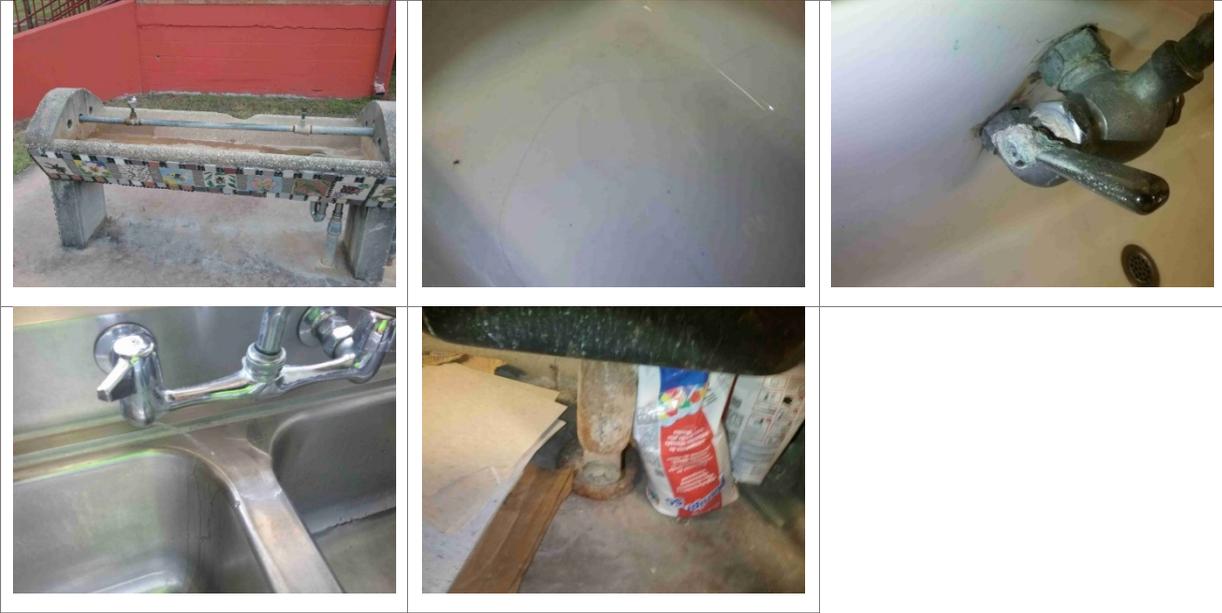
| System | Subsystem | Condition and Deficiency Overview | System Condition Rating |
|---|---|--|---|
| Plumbing | Plumbing Fixtures | <p>The building contains predominantly single-use restrooms throughout the facility. Typical restrooms have floor-mounted vitreous china water closets with manual flush valves. Each pair of classrooms contains two shared water closets between the rooms. Typical classrooms contain a single-basin stainless steel sink with a drinking fountain attached. Vitreous china drinking fountains can be found in the corridor outside of the cafeteria.</p> <p>A commercial kitchen is located in the school's cafeteria. The kitchen contains stainless steel kitchen equipment, including a triple-basin prep sink. It also has various wall-mounted vitreous china and stainless steel sinks for personal use. A porcelain enamel metal trough hand washing sink with two faucets is located outside of the kitchen. The building has service sinks located in various janitorial closets. Various other rooms, such as the library, have stainless steel basin sinks for personal use.</p> <p>The majority of plumbing fixtures were observed to be in average working condition but were aged and showed minor signs of deterioration. The drinking fountain in room 103 had low flow going to it. The drinking fountain in room 201 was observed to stick in the on position. One of the two drinking fountains outside of the cafeteria was not functioning. There was a drinking fountain/water station in the cafeteria that appeared to be working but was taped off. A cement exterior drinking fountain sprayed unevenly and sporadically, and one nozzle was capped off.</p> <p>No hot water was observed to the personal sinks in the kitchen and the kitchen restroom. The triple-basin prep sink had a leak at one of the faucet handles. No hot water was observed to the triple-basin prep sink. There was a basin hand washing sink outside of the kitchen</p> | Average |

| System | Subsystem | Condition and Deficiency Overview | System Condition Rating |
|---|---|---|---|
| | | that had corroded faucet handles and the hot water knobs did not turn. The sink was worn and had cracks. Some fixtures had corrosion and rust at the base and on the connections. | |

1. Repair or replace drinking fountains that observed to be broken or not functioning properly.
2. Repair faucets observed to be leaking.
3. Repair or replace the hand washing sink outside of the cafeteria that is cracked and has corroded handles.
4. Address any rust or corrosion observed on the equipment, its associated piping, or any other sub-asset by cleaning, repainting, or repairing to prevent further deterioration.
5. Verify the functionality of the GWH in AHUCAFE, and repair or replace as necessary.
6. Repair the sink in room 104 that has evidence of leaks underneath it.
7. Inspect, clean and repair plumbing in multiple restrooms that are emitting an unpleasant odor.
8. Replace plumbing fixtures that are beyond their expected design life need before failure occurs.

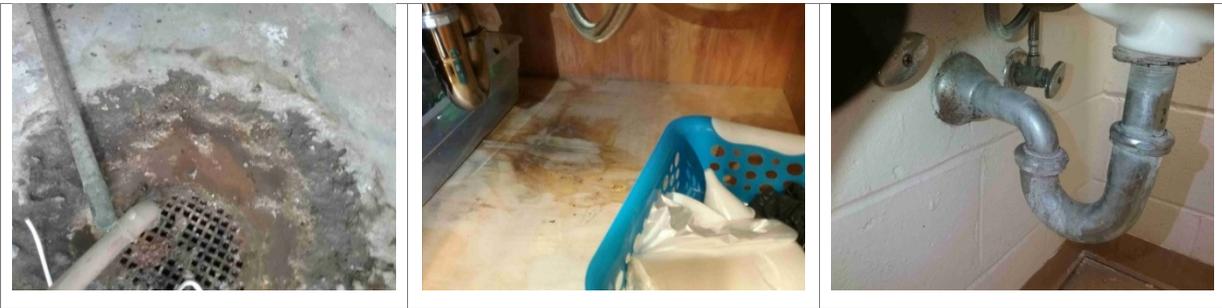
| System | Subsystem | Condition and Deficiency Overview | System Condition Rating |
|---|---|---|---|
| | Domestic Water Distribution | <p>Domestic hot water to the kitchen is provided by a 30-gallon GWH (gas water heater) found in AHUCAFE and a 100-gallon GWH stored in the mechanical room (KITMECH). Various smaller electric hot water heaters are located throughout the building to provide heated domestic water to specific locations in the school (i.e., nurse and administration). Domestic hot water is not supplied to the classroom plumbing fixtures.</p> <p>The GWHs feeding the cafeteria were aged and observed to be in average condition. The unit in AHUCAFE had signs of corrosion and rust. This unit also showed signs of leakage. The unit in KITMECH was aged and out of date and was turned off at the time of assessment. The majority of the smaller units installed for hot water use to a specific location were newer and appeared to be in good condition.</p> <p>The plumbing distribution equipment appeared to be in average condition with damaged insulation and corrosion and rust observed on piping throughout the building. The cabinet underneath the sink in room 104 showed evidence of leaks.</p> | Average |

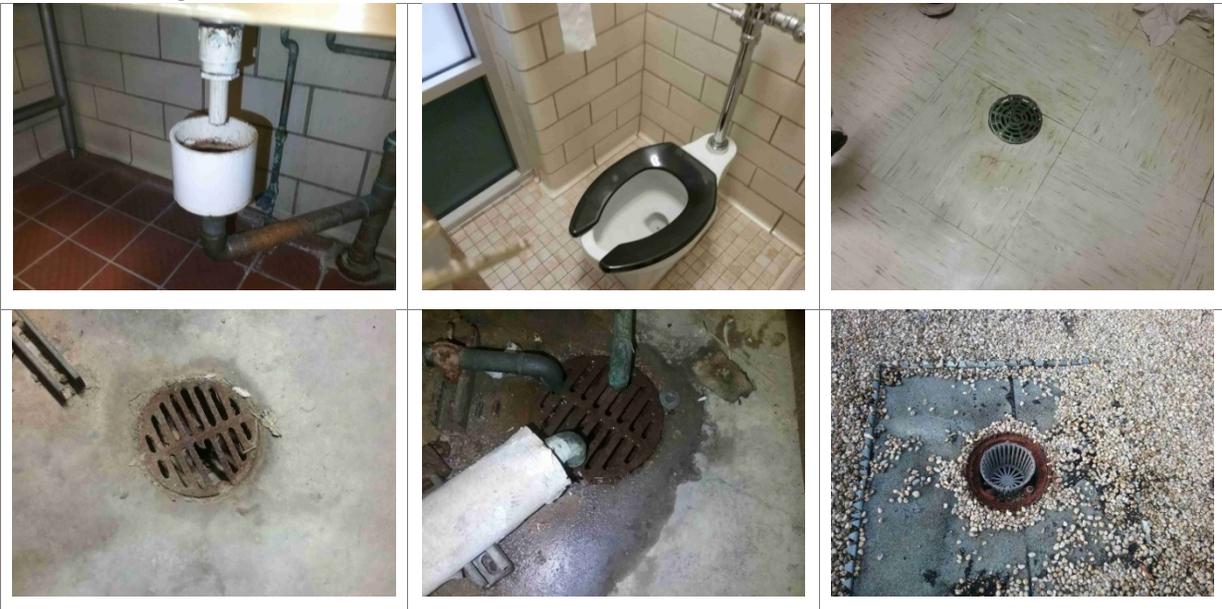
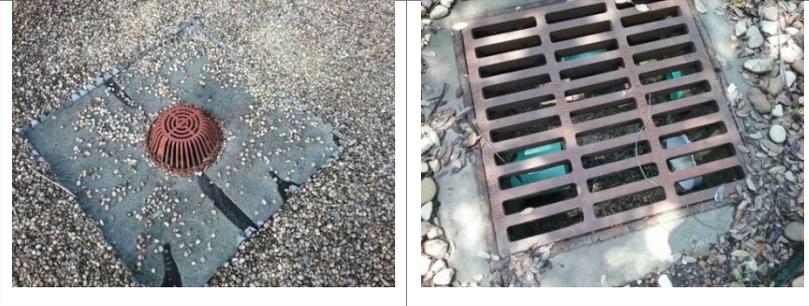
| System | Subsystem | Condition and Deficiency Overview | System Condition Rating |
|---|---|---|---|
| | Other Plumbing | Associated other plumbing appeared to be in average condition. The kitchen drain pipes had corrosion and rust. The male restrooms in room 103 and handicap cafeteria were emitting a foul odor. Some floor drains were damaged and aged and had signs of corrosion. Some roof drains had rocks around the grates, which could cause plugging. Some roof drains had rust on the grates. Additionally, one was observed to have the grate not properly sitting over the drain. Storm drain covers were rusted. | Average |

9. Clean and flush out all floor drains to ensure adequate drainage. It was reported these are not draining properly.
10. Remove debris from around roof drains that could cause clogging.

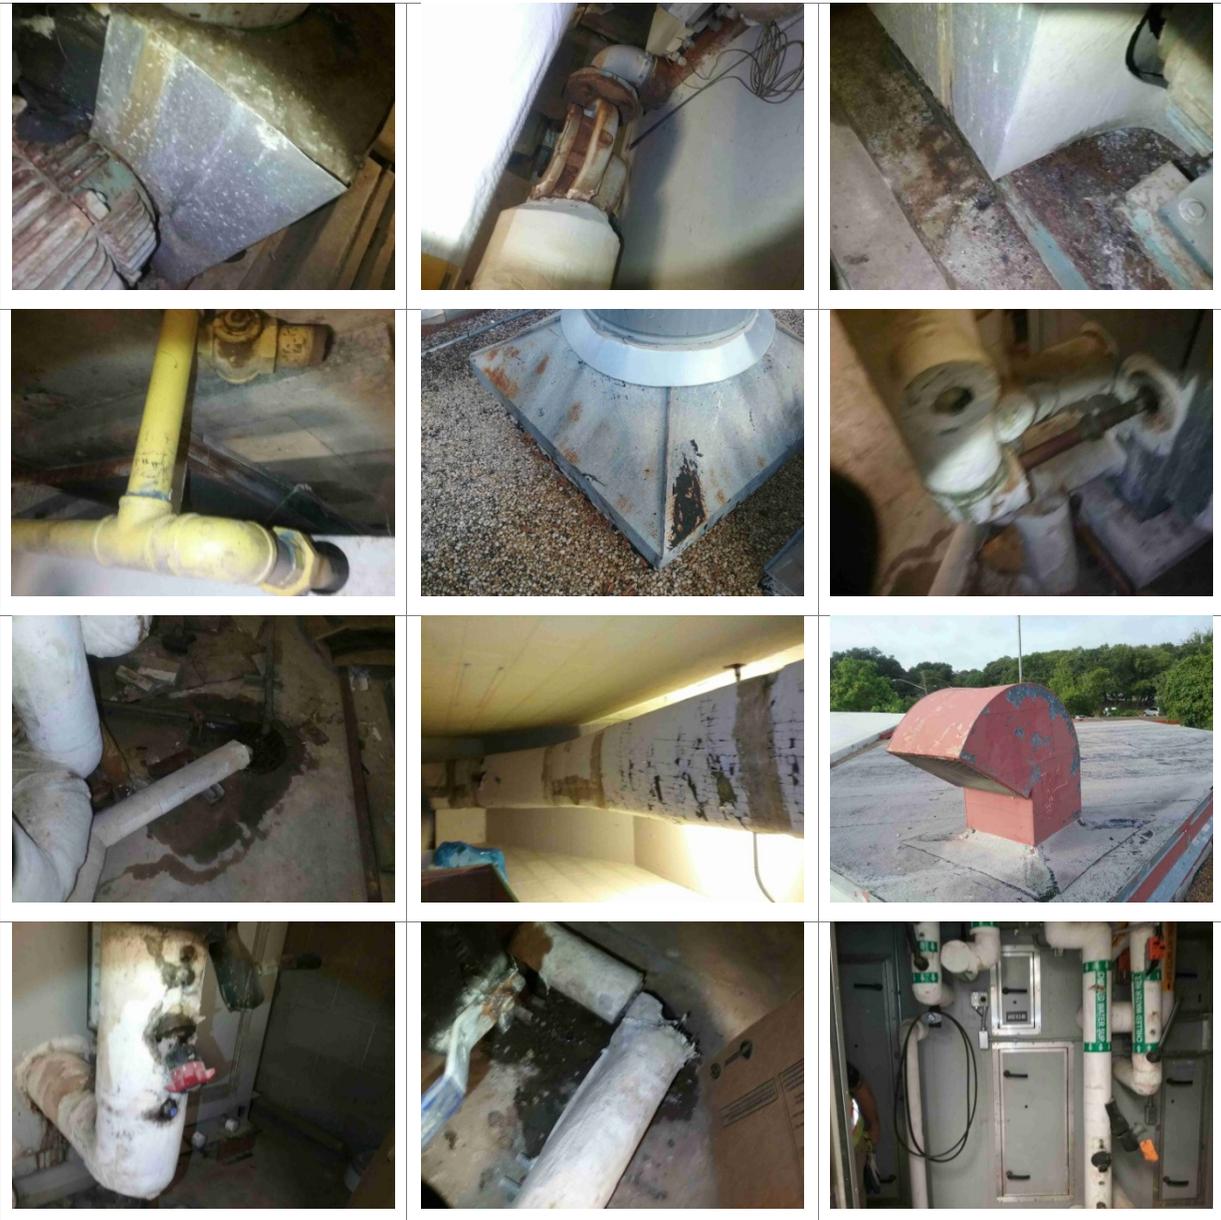
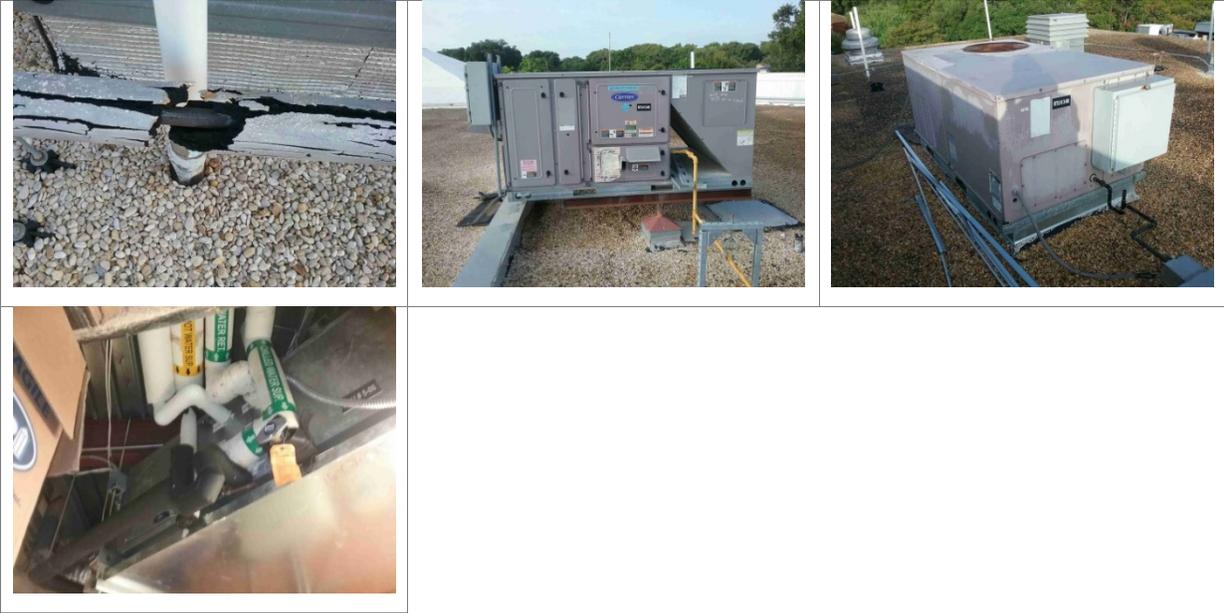
Mechanical/HVAC System Deficiency Examples

| System | Subsystem | Condition and Deficiency Overview | System Condition Rating |
|---|---|---|---|
| Mechanical/ HVAC | | <p>The building's HVAC (heating, ventilating, and air conditioning) system is primarily composed of a chiller and boiler system supported by chilled water pumps, heated water pumps, and AHUs (air handling units). Additionally, RTUs (roof top units) feed the library and kitchen. Various-sized EFs (exhaust fans) feed the building.</p> <p>Chilled water pumps found in the MAINMECH room showed signs of corrosion and leakage. The chiller unit outside of the MAINMECH room was newer and appeared to be in good condition. MAINMECH also contained two gas water boilers (B-1 and HWB 2-06). B-1 was aged and out of date. The unit also had signs of corrosion and rust. HWB 2-06 was newer and appeared to be in good</p> | Average |

| System | Subsystem | Condition and Deficiency Overview | System Condition Rating |
|---|---|---|---|
| | | <p>condition. The MAINMECH room also contained a blower coil unit that had signs of leakage and excessive wear and tear on the insulation.</p> <p>AHUs were newer but showed signs of wear and tear. AHU 1-06 and AHU 2-06 showed signs of wear on the connection and insulation. Additionally, multiple AHUs were making whirring or vibrating noises and had signs of leakage around the floor drain.</p> <p>RTUs showed signs of weather wear and were observed to be in average condition. RTU 1-06 had insulation missing from the connection lines on the back of the unit. RTU 2-06 was making a buzzing noise when operating. RTU 3-06 was significantly older than other RTUs and showed signs of corrosion and rust. The janitorial closets CC11 and CC21 had aged and worn ductwork. The counselors' area and administrative conference rooms were very warm, indicating the corresponding HVAC unit (BCU 5-06) was potentially not functioning properly.</p> <p>The HVAC system appeared to be in average condition with wear associated with the age of the units. Roof top vents and EFs showed signs of age and deterioration. Multiple HVAC units were using R-22 refrigerant, which is outdated and being phased out of use.</p> | |

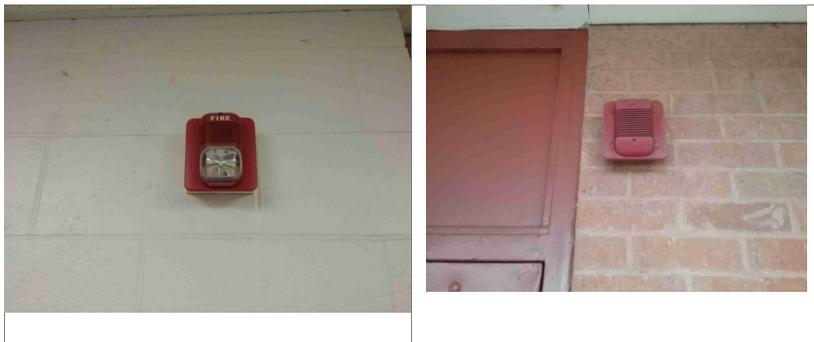
| System | Subsystem | Condition and Deficiency Overview | System Condition Rating |
|---|---|---|---|
| Fire Protection | Fire Alarm | <p>The building has a fire alarm system that consists of alarm and signaling devices such as strobes, horn/strobe combinations, pull stations, and detectors.</p> <p>The fire alarm system appeared to be in good condition. Many of the interior end devices appeared dated and were approaching the end of their service life. One exterior-mounted end device at the stage egress was extremely worn and dated past service life expectancy.</p> | Good |

1. Investigate the operation of existing interior fire alarm end devices and replace as needed.
2. Replace the worn fire alarm exterior end device at the stage egress.

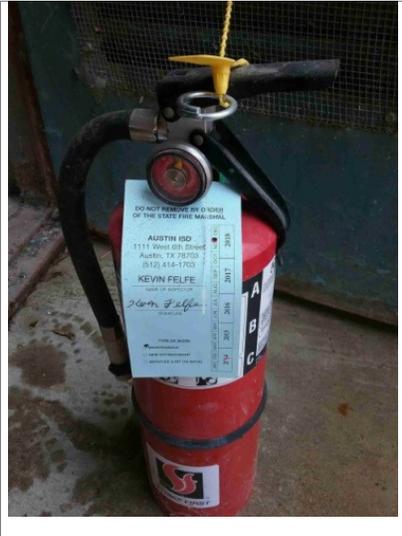
| System | Subsystem | Condition and Deficiency Overview | System Condition Rating |
|---|---|---|---|
| | Fire Protection/Suppression | <p>A fire suppression system is present for the range hood in the kitchen with a tank mounted to the wall at the ceiling. The remaining fire suppression system consists of fire extinguishers throughout the building.</p> <p>Visual inspection showed these were observed to be in average condition. The majority of the extinguishers were observed to be up to date with their inspections. The fire extinguisher in room KITMECH was out of date on its annual inspection.</p> | Average |

1. Inspect fire extinguishers that are out of date on annual inspections, and replace if necessary.

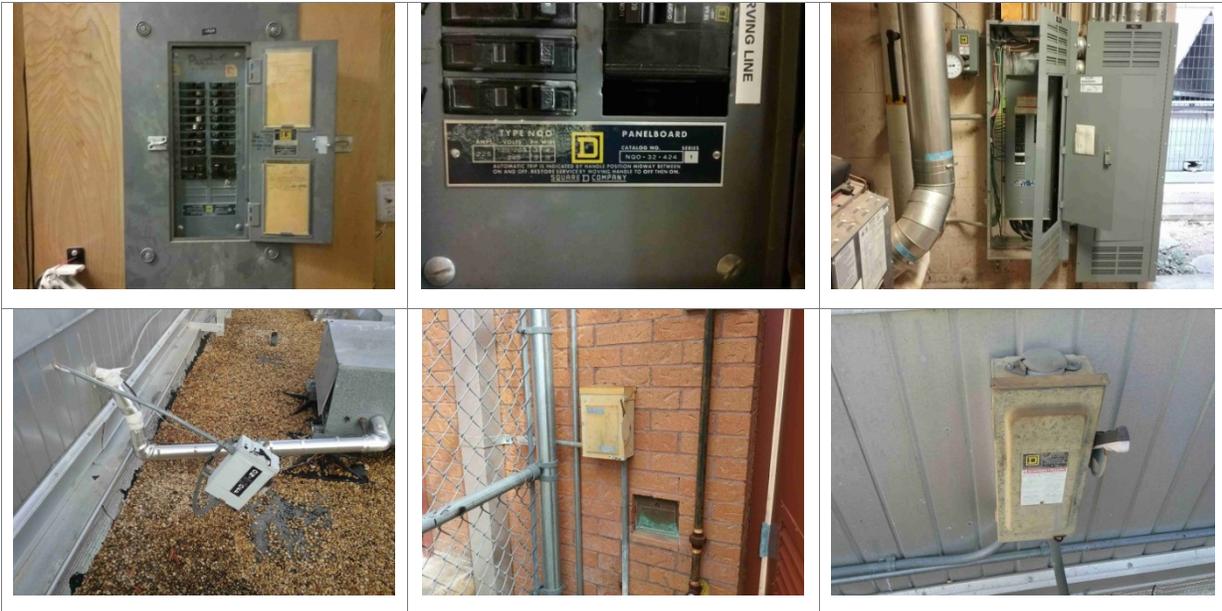
| System | Subsystem | Condition and Deficiency Overview | System Condition Rating |
|---|---|---|---|
| Electrical | Electrical Distribution | <p>The electrical service enters the building at the 120/208Y-volt, 1600-amp main switchboard located in room MAINMECH on the north end of the building. The building does not have a lightning protection system.</p> <p>The electrical distribution equipment appeared to be in average condition. Several electrical panelboards throughout the building were original to construction and past their service life expectancy. Panel K in the kitchen was found with a missing breaker cover, which should be considered a life safety issue. Panel 1PJZ SEC 2 in</p> | Average |

| System | Subsystem | Condition and Deficiency Overview | System Condition Rating |
|---|---|---|---|
| | | <p>the MAINMECH room was observed with an open front cover due to missing screws, allowing access to the live electrical components, and should be considered a life safety issue. The building had a number of dated or damaged shutoff switches for mechanical and HVAC equipment. One roof top safety switch was hanging by the connected conduit without a mount.</p> <p>School faculty have expressed concern over the age of the original panelboards and requested replacements. Faculty reported that many panelboards were at full capacity and caused frequent circuit trips.</p> | |

1. Replace the exterior luminaires that are damaged or have exceeded their service life expectancy with LED luminaires.
2. Replace original (1964) panelboards throughout the facility.
3. Replace burned-out lamps and missing lens covers for luminaires throughout the facility.
4. Install surveillance cameras to overlook the north-end parking lot.

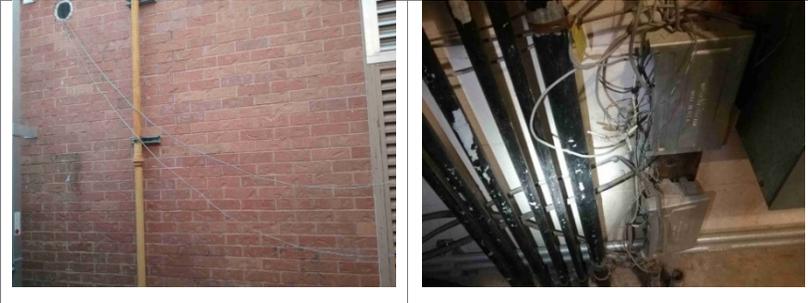
Communications & Security

| System | Subsystem | Condition and Deficiency Overview | System Condition Rating |
|---|---|--|---|
| | | <p>Exterior surveillance cameras overlook the parking lot/drop off area, the main entrance, and the building entrance on the north-end (gymnasium area). Interior surveillance cameras are located within corridors overlooking entrances, the administrative area, and within the kitchen. Motion detectors are located throughout the building.</p> <p>The communications and security system appeared to be in good condition. Telecommunications/cabling systems were damaged and improperly mounted on the exterior of the building. Some storage rooms had poorly routed or damaged telecommunications/cabling systems.</p> <p>Faculty reported that the building had inadequate surveillance coverage and requested cameras for the cafeteria and the north-end parking lot. Faculty reported that the main entrance exterior surveillance camera had very poor visibility.</p> | |

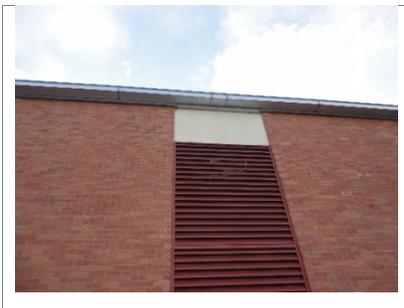
| System | Subsystem | Condition and Deficiency Overview | System Condition Rating |
|---|---|---|---|
| Exterior | Exterior Walls | The exterior walls are a brick facade and painted stucco above full-height painted louvers on the west side. There is an exterior covered walkway along the east side of the building. The exterior brick and stucco appeared to be in good condition. There was a pest issue in the louvers on the west side. | Good |

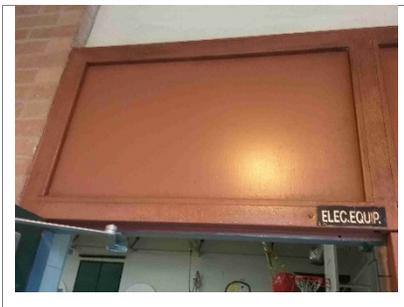
| System | Subsystem | Condition and Deficiency Overview | System Condition Rating |
|---|---|---|---|
| | Exterior Doors | The exterior doors are painted metal with painted metal frames. The doors have half vision lites. The exterior doors on the gymnasium appeared to be in average condition. The doors and frames were serviceable but required a new paint finish. | Average |

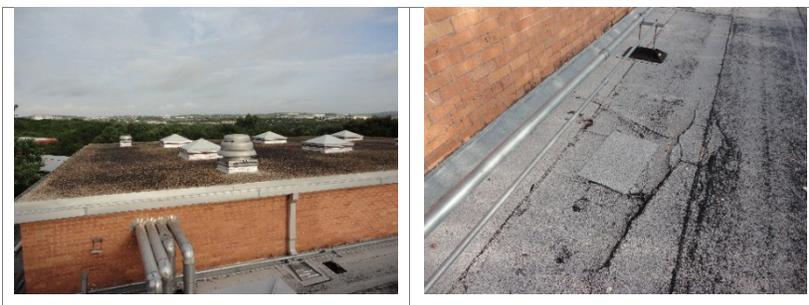
Roofing Deficiency Examples

| System | Subsystem | Condition and Deficiency Overview | System Condition Rating |
|---|---|---|---|
| Roofing | The roof covering is a built-up roof membrane with roof gravel. There are six skylights on the gymnasium roof. There is a covered walkway on the east side of the gymnasium that has modified bitumen roofing. The gymnasium restrooms, storage rooms, and office roofs are lower than the gymnasium itself and have modified bitumen roof covering. Facility staff reported the roof coverings on campus were replaced five years ago. The roof covering appeared to be in good condition with some discolored areas on the south portion of the built-up roof, likely due to previous standing water. There was a bubble in the modified bitumen roof covering near the north end of the exterior covered walkway. | | Good |

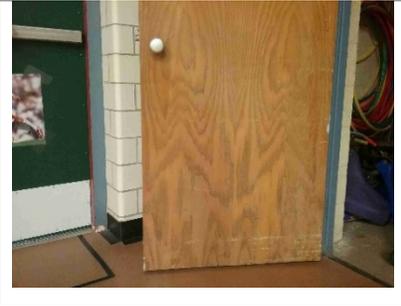
| System | Subsystem | Condition and Deficiency Overview | System Condition Rating |
|---|---|---|---|
| | Interior Doors | The interior doors are stained solid-core wood set in painted hollow metal frames. These assemblies appeared to be in good serviceable condition, but an average rating was given due to the marring and scratches that were present. | Average |

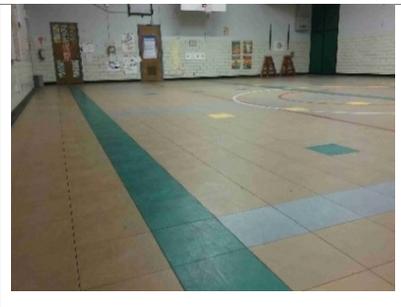
| System | Subsystem | Condition and Deficiency Overview | System Condition Rating |
|---|---|---|---|
| | Interior Floor Finishes | Athletic floor tile is installed on the floor. The tile floor appeared to be in good condition though cleaning was required. | Good |

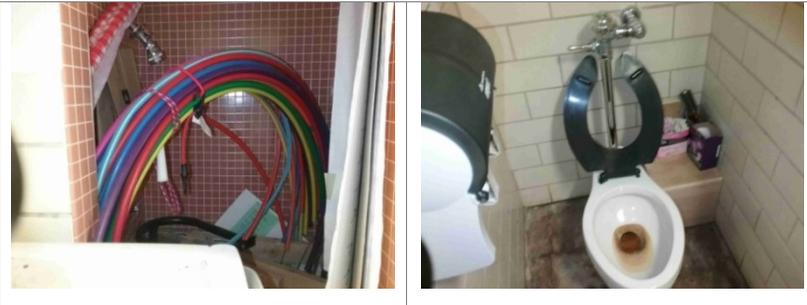
| System | Subsystem | Condition and Deficiency Overview | System Condition Rating |
|---|---|---|---|
| Plumbing | Plumbing Fixtures | The building contains a single-use personal restroom with a shower. The restroom contains a floor-mounted vitreous china water closet and wall-mounted vitreous china hand washing sink. The gymnasium restroom also contains a single-use shower. The majority of plumbing fixtures were observed to be in average working condition. The shower located inside of the gymnasium office had items stored in it and was unable to be assessed for operation. Visual inspection showed it to be in average condition. The water closet in the gymnasium office had signs of build-up on the inside. | Average |

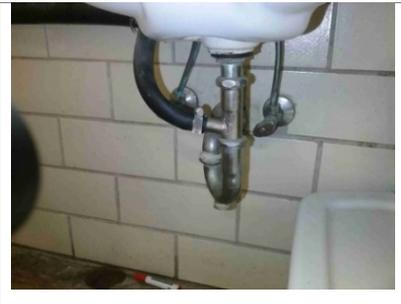
| System | Subsystem | Condition and Deficiency Overview | System Condition Rating |
|---|---|---|---|
| | Domestic Water Distribution | No water heaters were observed in the building. The plumbing distribution appeared to be in average | Average |

| System | Subsystem | Condition and Deficiency Overview | System Condition Rating |
|---|---|--|---|
| | | condition with evidence of corrosion visible. It was reported that the shower in the gymnasium office did not have hot water flowing to it, making it unusable. The domestic water system appeared to be in average condition with typical wear and tear associated with the system's age and general daily use. | |

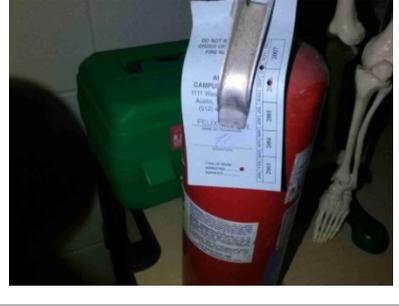
Fire Protection/Suppression

| System | Subsystem | Condition and Deficiency Overview | System Condition Rating |
|---|---|--|---|
| | Fire Protection/ Suppression | The building does not contain a fire suppression system. There is one fire extinguisher. The fire extinguisher in room GYMOFC was observed to be out of date on its annual inspection. | N/A |

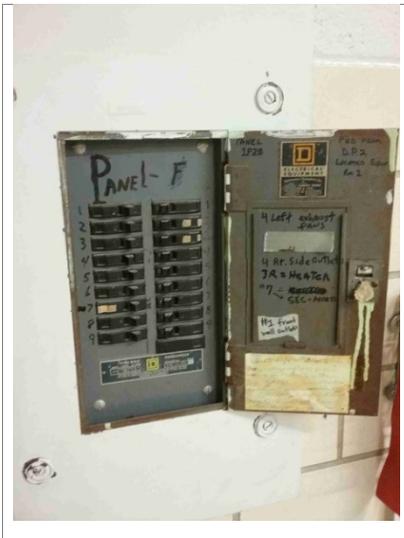
| System | Subsystem | Condition and Deficiency Overview | System Condition Rating |
|---|---|--|---|
| Electrical | Electrical Distribution | The main electrical distribution for the building is a single 100-amp panelboard. The electrical distribution system appeared to be in average condition. The single panelboard appeared to be original to the building's construction and was past its service life expectancy. Faculty reported that the panelboard was at full capacity and caused frequent circuit trips. | Average |

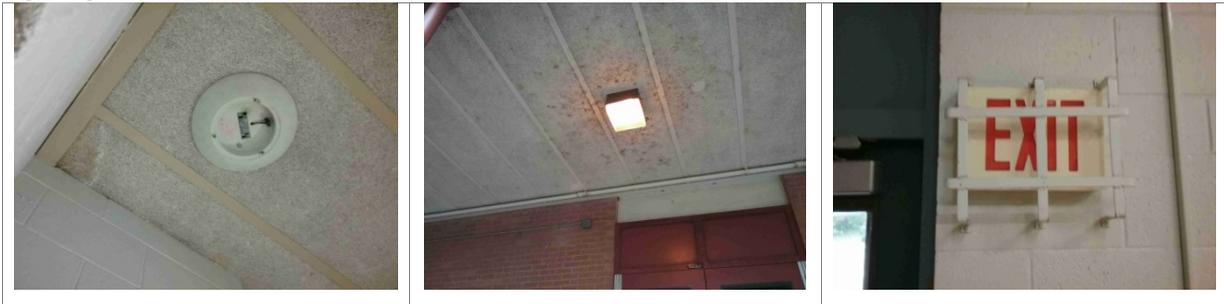
| System | Subsystem | Condition and Deficiency Overview | System Condition Rating |
|---|---|--|---|
| | Lighting | The building's exterior lighting consists predominantly of canopy-style metal-halide luminaires on the exterior covered walkway. Interior lighting is predominantly suspended strip light and downlight fluorescent luminaires. Emergency lighting luminaires were present within the gymnasium and the exterior connected corridor. The lighting for the building appeared to be in average condition. One restroom had a missing lamp and luminaire cover. Exterior metal-halide canopy luminaires were worn and discolored. The exit sign luminaires did not function. | Average |

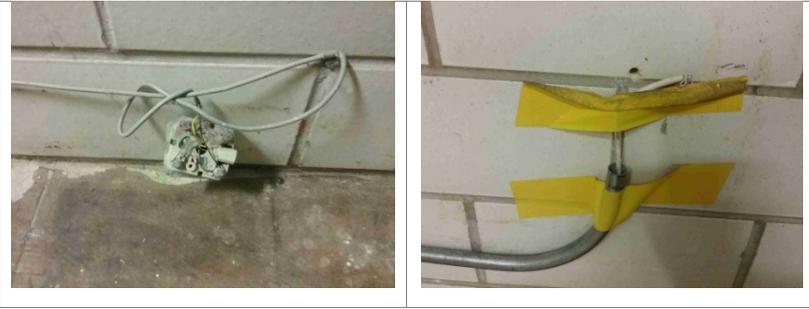
Communications & Security

| System | Subsystem | Condition and Deficiency Overview | System Condition Rating |
|---|---|---|---|
| | | <p>single exterior surveillance camera overlooking the portable building area. No interior surveillance cameras were observed. Motion detection sensors are present within the gymnasium.</p> <p>The building communications and security systems were observed to be in average condition. Telecommunications and cabling systems were damaged in several areas of the building.</p> | |

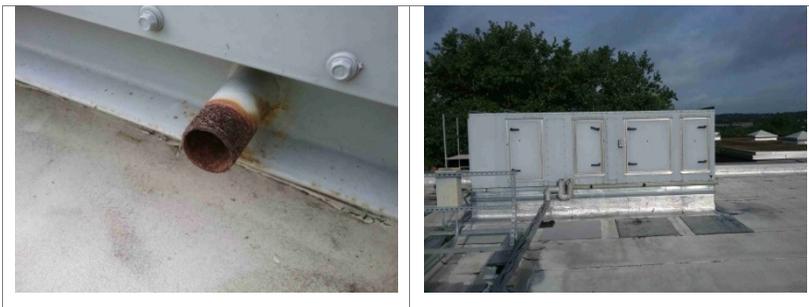
Mechanical/HVAC System Deficiency Examples

| System | Subsystem | Condition and Deficiency Overview | System Condition Rating |
|---|---|---|---|
| Mechanical/ HVAC | The HVAC system is composed of a roof top AHU and various sized EFs for the restrooms and kiln room. The roof top AHU had signs of weathering, corrosion, and rust. The building's HVAC system appeared to be in average condition. | | Average |

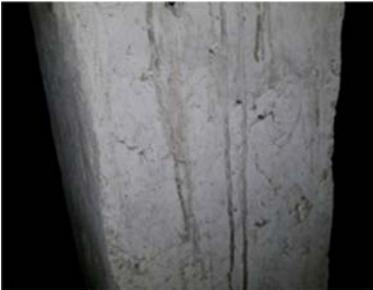
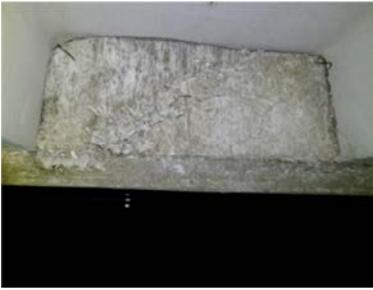
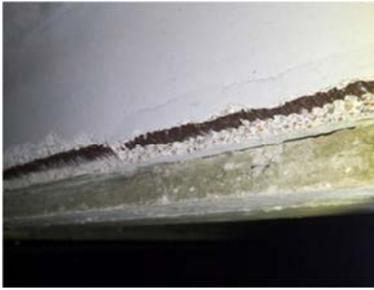
| <p>Minor honeycombing at column</p> | <p>Moderate honeycombing at interior beam</p> | <p>Significant spalling at pan joist web with significantly corroded longitudinal reinforcement</p> |

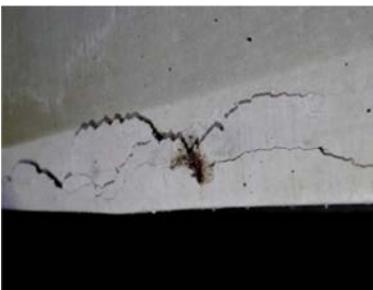
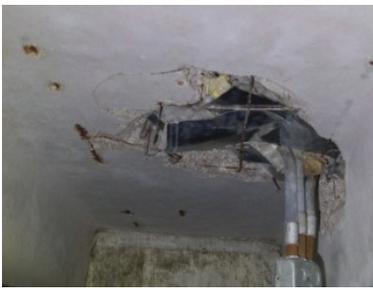
| <p>Cracking/spalling in pan joist web</p> | <p>Exposed reinforcement in underside of slab and at pipe penetration</p> | |

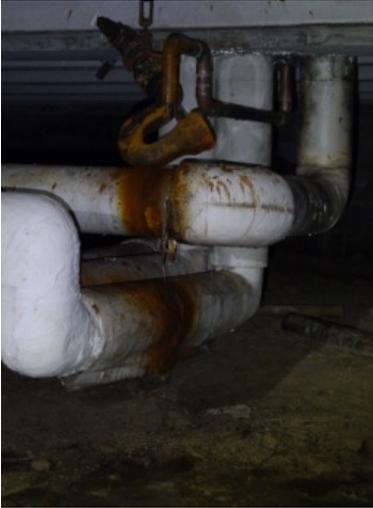
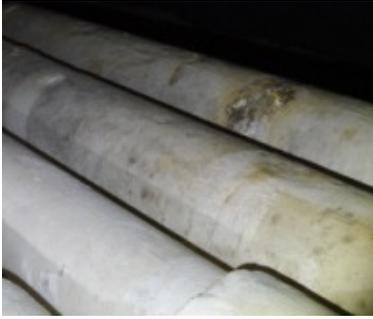
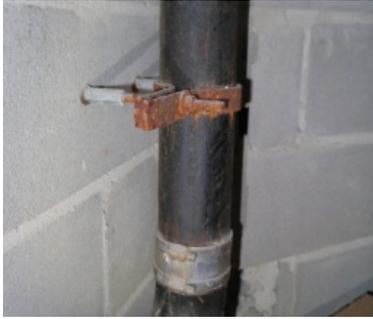
| <p>Leaking pipe & pipe corrosion</p> | <p>Moldy pipe insulation</p> | <p>Corroded pipe support</p> |

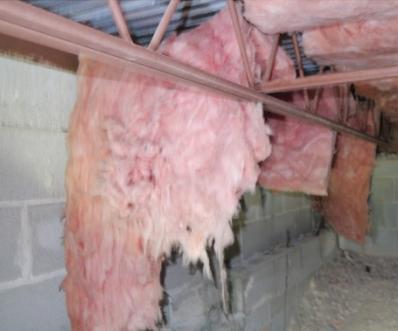
| <p>Detached slab insulation</p> | | |

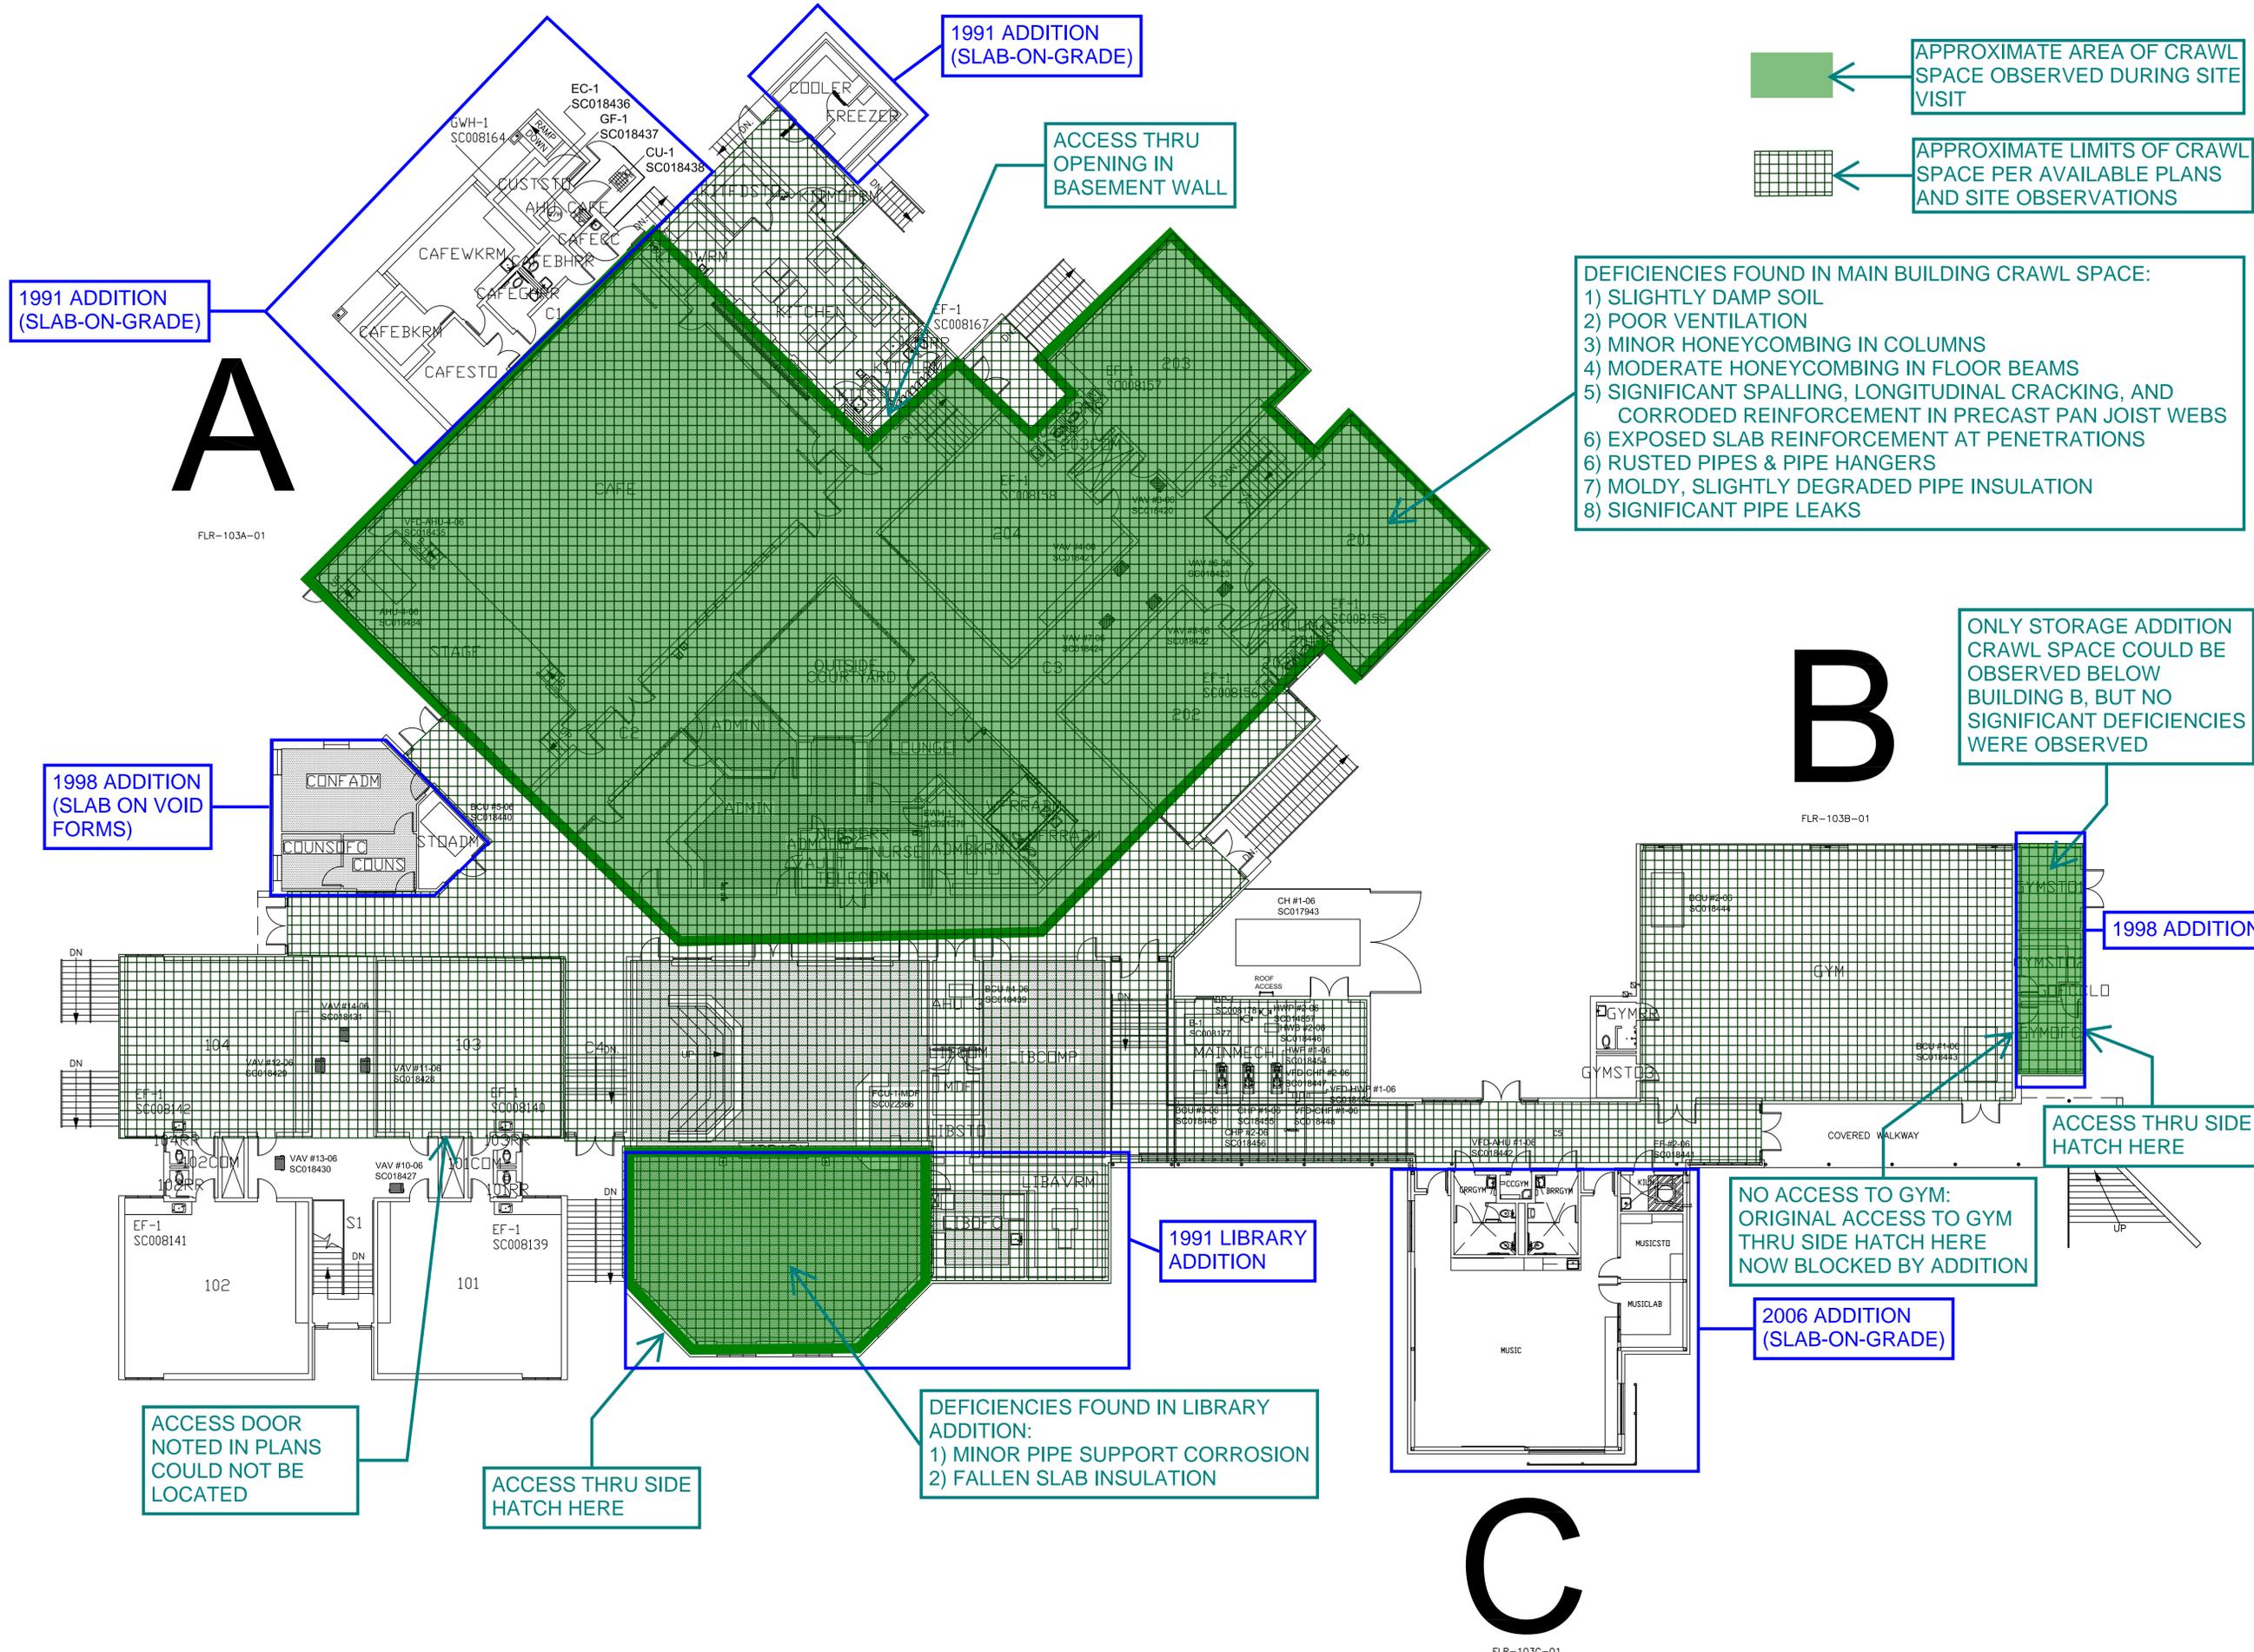
- DEFICIENCIES FOUND IN MAIN BUILDING CRAWL SPACE:
- 1) SLIGHTLY DAMP SOIL
 - 2) POOR VENTILATION
 - 3) MINOR HONEYCOMBING IN COLUMNS
 - 4) MODERATE HONEYCOMBING IN FLOOR BEAMS
 - 5) SIGNIFICANT SPALLING, LONGITUDINAL CRACKING, AND CORRODED REINFORCEMENT IN PRECAST PAN JOIST WEBS
 - 6) EXPOSED SLAB REINFORCEMENT AT PENETRATIONS
 - 7) RUSTED PIPES & PIPE HANGERS
 - 8) MOLDY, SLIGHTLY DEGRADED PIPE INSULATION

ONLY STORAGE ADDITION CRAWL SPACE COULD BE OBSERVED BELOW BUILDING B, BUT NO SIGNIFICANT DEFICIENCIES WERE OBSERVED
