Becker Elementary School Site Summary

Address	906 W. Milton Street Austin, TX 78704
Number of Permanent Campus Facilities	4
Original Year of Construction	1936
Total Campus Building Area (combined)	59,669 SF

Main School Building – BLDG-104A

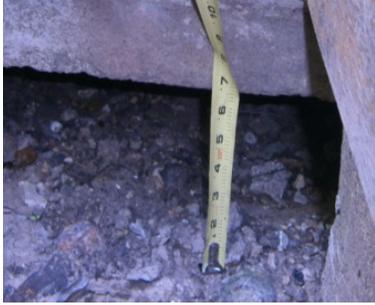
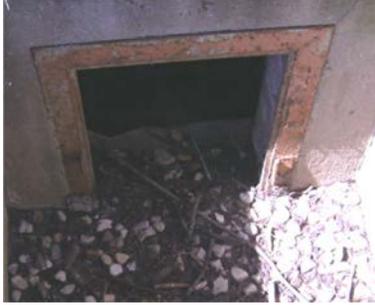
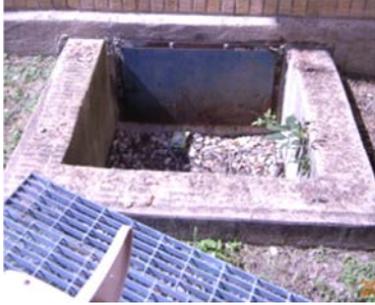
Soil, Drainage, Ventilation & Access

<p>East Areaway below original construction had approximately 6 inches of clearance (not accessible)</p>	<p>Rust on frame and missing door at wall hatch in middle areaway</p>	<p>Rust on door at west areaway access hatch</p>

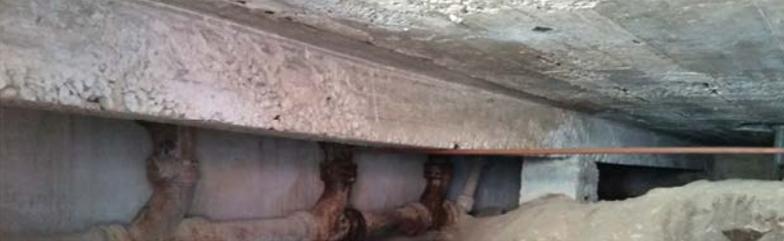
Exposed Structure

<p>Honeycombing in interior beams, columns, and the underside of the slab</p>	<p>Formwork nails in suspended beam</p>

3. Patch and repair beams and slabs with honeycombing and exposed rebar

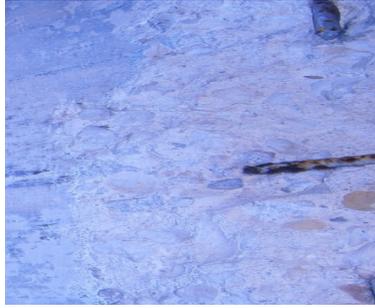
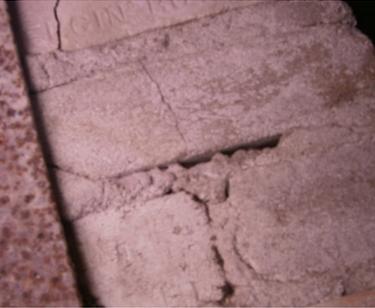
<p>Exposed reinforcing in slab where concrete has spalled</p>	<p>Cracking in masonry exterior wall at access hatch</p>	<p>Beam is honeycombing, exposed/corroded reinforcing</p>

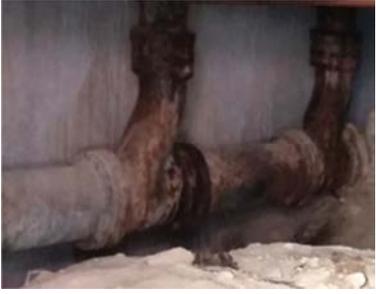
Pipes, Ducts, Equipment & Fireproofing

Rust on cast iron pipes
