## Blanton Elementary School Site Summary

## Main School Building – BLDG-106A

Building Purpose	Administrative, Classrooms, Library, and Cafeteria
Inspection Date	August 11, 2016 (Morning)
Inspection Conditions	85° - Sunny and Dry

**CRAWL SPACE – Blanton ES – Stand-Alone Classroom Building (BLDG-106C)**

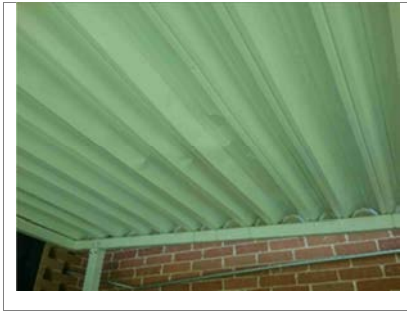
Exterior Doors	<p>Exterior doors are steel with hollow metal frames with wire glass vision panels. Doors appear to be original and in average condition and are currently being painted.</p>	Average
<b>Roofing</b>	<p>The roof appears to have been recoated in 1999, according to warranty signage on building facade. Roof is both low slope and steep slope (saw-tooth) over the building. The flashing system and gutters at the perimeter appear to have been recently installed.</p> <p>The building's roof was observed to be in poor condition. The roofing showed</p>		Poor

System	Subsystem	Condition and Deficiency Overview	System Condition Rating
		significant bubbles forming under the membrane. Ponding has occurred near the mechanical equipment and the roofing seams have begun to split. Evidence of roof leaking is minimal inside; however, roof has exceeded 80% of life and is showing signs of deterioration. The flashing and gutters are in generally good condition with a few exceptions where rusting was visible. Organic growth on the north wall is indicative of some water infiltration through the roof or at the perimeter flashing. The aluminum walkway canopy showed damage to the roof panels.	
<b>Interior Construction</b>	Interior Walls	The interior walls are double wythe brick, exposed on both sides.  The interior walls are original and in good condition.	Good
	Interior Doors	Interior doors are painted steel with hollow metal frames.  Doors and frames appeared to be original and in good condition relative to age.	Good

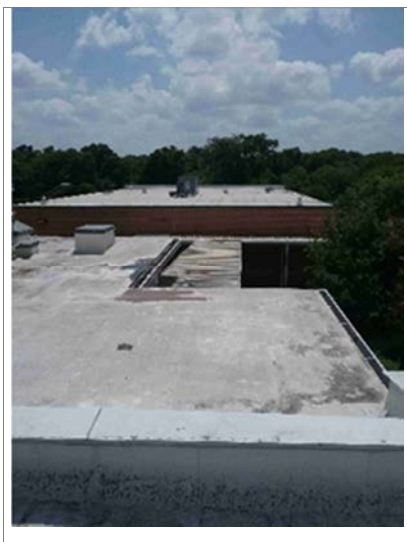
Roofing	<p>The roof appears to be original to the building constructed in 2000. Roof is low slope with continuous gutter system along the north and south walls.</p> <p>The roof was observed to be in poor condition. The roofing showed significant bubbles forming under the membrane over large expanses of the roof area. Evidence of roof leaking is minimal inside; however, the roof has exceeded 80% of life and showed signs of deterioration. Flashing and gutters are in generally good condition.</p>		Poor

1. Roofing is nearing end of life expectancy. Patching may temporarily extend roof; however, replacement should be expected within the next five years.

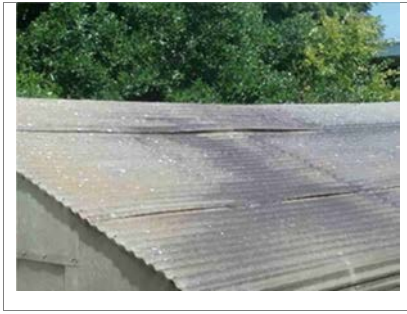
System	Subsystem	Condition and Deficiency Overview	System Condition Rating
<b>Exterior</b>	Exterior Walls	The Greenhouse is a pre-manufactured type aluminum frame with both flat and corrugated fiberglass panels.  The structural frame appeared to be in good condition; however, fiberglass panels are aged and showing significant deterioration from ultra violet exposure. Panels are brittle and some seams do not seal properly.	Poor
	Exterior Windows	System not present.	N/A
	Exterior Doors	There is one exterior aluminum door.  The door is a residential type storm door and appeared to be functioning except the screen is damaged allowing intrusion of pests.	Poor
<b>Roofing</b>	The roof of greenhouse is corrugated fiberglass panel similar to the exterior walls. The fiberglass roof panels were visibly aged and showing significant deterioration from ultra violet exposure. The roof panels are brittle and some seams do not seal properly. The greenhouse roof was observed to be in poor condition.		Poor

1. Exterior translucent fiberglass panels are becoming brittle and will be more prone to breakage. Replacement of wall and roof panels will likely be needed within the next ten years.

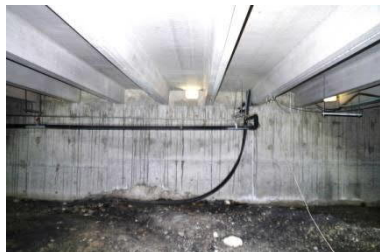
#### Soil & Drainage

Damp soil adjacent to perimeter beams

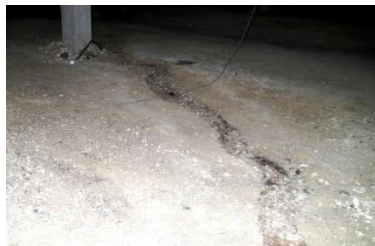
Water trails in soil indicate running surface water in crawl space

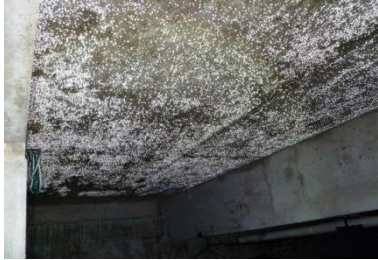
Condensation on underside of floor structure

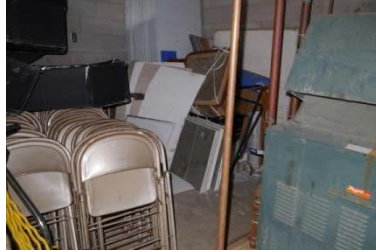
West wing crawl space inaccessible due to equipment covering floor hatch

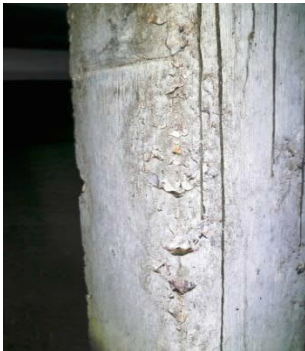
Honeycombing at column

1. Where reinforcement is exposed, remove rust from reinforcement and repair spalled concrete.
2. Where reinforcement is exposed due to inadequate clear cover, remove rust from reinforcement and coat with a rust-inhibitive coating.

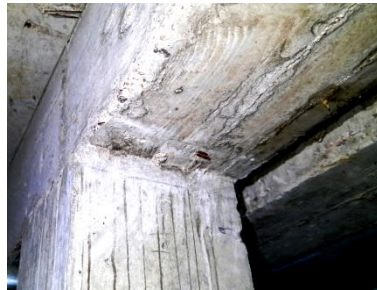
Minor beam spalling & corroded reinforcement

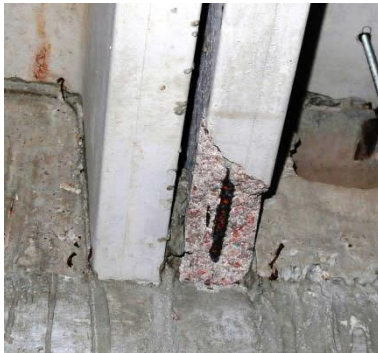
Pan joist web spalling at beam support

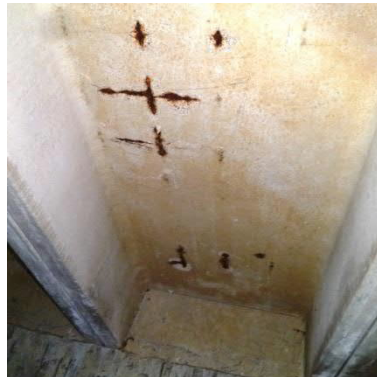
Exposed pan joist flange reinforcement

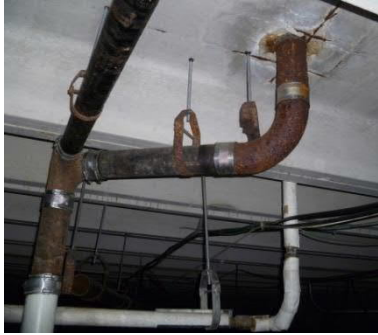
Corroded pipes

1. Replace highly corroded pipes and hangers
2. Replace failed hanger rods

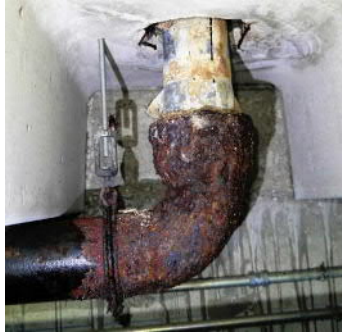
Corroded pipes

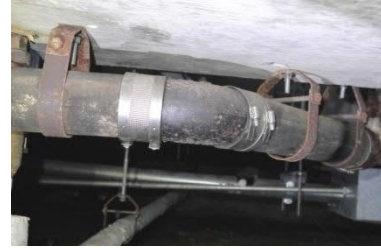
Corroded hangers

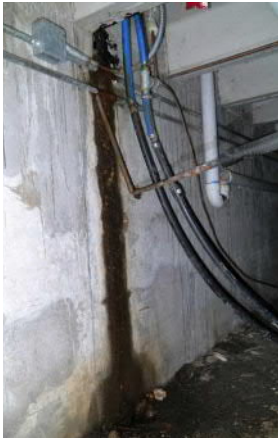
Leaking pipe

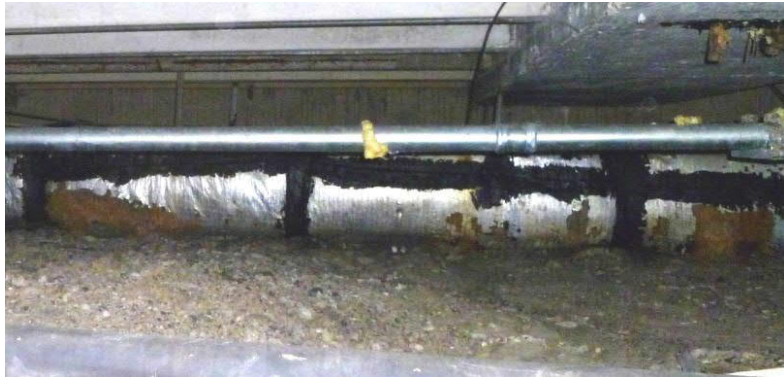
Duct is torn & losing insulation

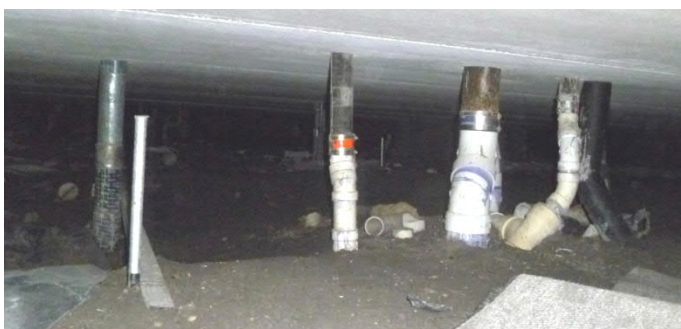
#### Pipes, Ducts, Equipment & Fireproofing

Minor corrosion on observed pipes
