Blazier Elementary School Site Summary

Main School Building – 185A

Building Purpose	Administrative, Classrooms, Library, Cafeteria, and Gymnasium
Building Area	82,897 SF
Inspection Date	July 28, 2016
Inspection Conditions	97°F - Sunny
Facility Condition Index

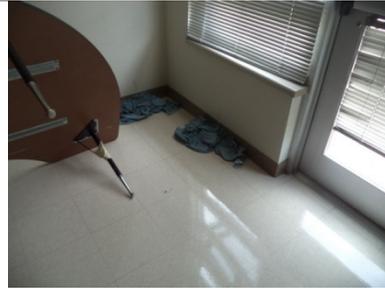
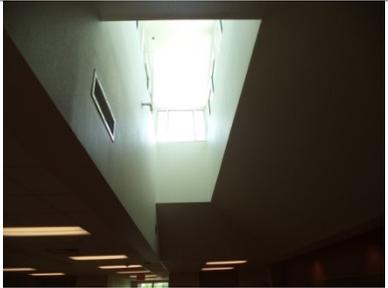
System	Subsystem	Condition and Deficiency Overview	System Condition Rating
Exterior	Exterior Walls	<p>The exterior façade of this facility is constructed of three colors of common brick.</p> <p>There is a canopy at the front entrance that is constructed of tube steel columns, metal framing, and a metal roof. The tube steel columns are enclosed with brick half columns. The canopy extends out from the entrance doors, and then follows the sidewalk in both directions with four bays.</p> <p>It was reported by District staff and observed the building façade was in good condition with no breaks or cracks in the block.</p>	Good
	Exterior Windows	<p>The exterior windows consist of single-pane glazing units with aluminum frames. There is a clerestory above the gymnasium with aluminum frames and glazing.</p> <p>It was reported the aluminum clerestory windows leaked badly.</p> <p>It was reported and observed there were leaks around the window frames. Staff reported this was not a caulking issue, but rather a defective product. This occurred on all sides of the building.</p>	Poor

1. Remove and replace aluminum window/door units at classrooms with hollow metal units because the aluminum frames have a quality issue and cannot be repaired.
2. Consult an architect for solutions to replace the clerestory windows with appropriate windows for the application. Replace the windows as directed.
3. Survey the site to determine the extent of the drainage problem as it affects the exterior exits and windows. Regrade the affected part of the site and/or install a storm sewer line to take water away from the building.

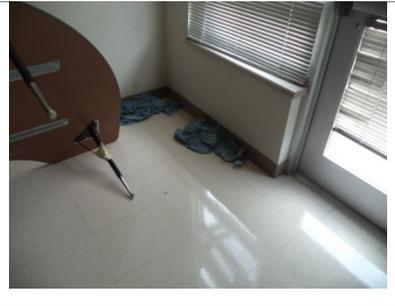
Exterior Doors	<p>There is one public entryway located at the south side of the building. There are one pair and two single-leaf metal doors in a metal frame with half lites in each door and four panels of glazing above the doors. On the east side of the building, there is a public entrance into the gymnasium area. This entrance consists of a pair of</p>	Poor

System	Subsystem	Condition and Deficiency Overview	System Condition Rating
		<p>metal doors in a metal frame with half lites. There are glazed side lites and glazing above the doors.</p> <p>The remaining exterior doors around the facility are metal with metal frames. The doors used for egress by students and faculty have various sizes of lites. The doors to mechanical and electrical rooms have no lites. There is a roll up door into the gymnasium area.</p> <p>At the classrooms, there are aluminum frames with aluminum doors. There are side lites in the frames.</p> <p>It was reported the classroom doors leaked at the frames due to poor quality frames.</p> <p>It was reported and observed that there was leaking under the majority of the doors due to poor site drainage.</p> <p>It was observed that the doors were in poor condition.</p>	
Roofing		<p>The roof system for this facility is modified bitumen, which is original to construction. This is common to the building and the canopies.</p> <p>Ponding was reported to occur on the main roof.</p> <p>It was also reported that the roof leaked throughout the building. The leaks occurred in the entry foyer and the entire length of the main corridor. Leaks were also reported to occur in the library and the equipment storage room connected to the gymnasium.</p> <p>The roof was observed to be in average condition; however, the leakage caused it to be rated in poor condition.</p>	Poor

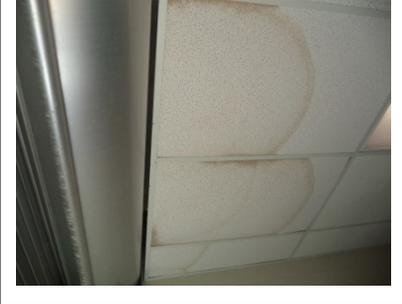
System	Subsystem	Condition and Deficiency Overview	System Condition Rating
Interior Finishes	Interior Wall Finishes	<p>The interior partitions in this facility are a painted drywall system or CMU. The kitchen is painted CMU with full-height ceramic tile in the serving area. The restrooms have ceramic tile wainscoting on some walls.</p> <p>It was observed the walls were in average condition with normal wear and tear.</p>	Average
	Interior Floor Finishes	<p>The interior floor finishes in the building consist of vinyl tile in the classrooms, corridors, and cafeteria. There is carpet in the administration office and the library, and ceramic tile flooring in the kitchen, serving area and restrooms.</p> <p>It was observed that the interior floors were in good condition.</p>	Good
	Interior Ceiling Finishes	<p>The ceilings throughout this building are a 2x4 suspended acoustical system.</p> <p>It was reported and observed there were no issues with the ceiling system itself. However, there were damaged ceiling tiles throughout the building due to roof leakage.</p>	Average

1. Continue replacement of damaged ceiling tiles as needed until a permanent solution is developed and implemented to resolve the roof leaks.

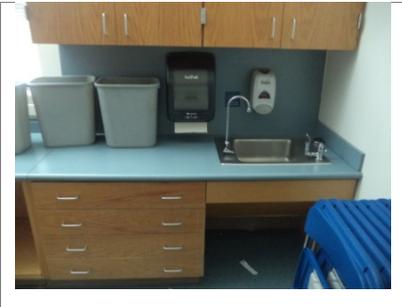
Conveying	System not present.		N/A
Plumbing	Plumbing Fixtures	<p>The building has one set of public restrooms for men and women located near the cafeteria. There are separate staff restrooms located throughout the facility. These restrooms typically have vitreous china hand sinks with manual faucets, along with vitreous china toilets with manual flushing mechanisms, and vitreous china wall-hung urinals in the male restrooms with manual flushing mechanisms. There are floor sinks in the janitorial closets, and water coolers located throughout the facility. Each suite of classrooms has two restrooms with a floor-mounted toilet in each. Each classroom has a stainless steel sink with a gooseneck faucet and a water fountain.</p> <p>The building also includes plumbing fixtures in the kitchen.</p> <p>It was reported the gooseneck faucets were too fragile in their construction and require frequent replacement.</p> <p>It was reported the angle stops leaked when the key was inserted.</p> <p>A sewage smell was reported in corridors 2 and 5 and the restrooms off the gymnasium.</p> <p>The plumbing fixtures were observed to be in average condition.</p>	Average

1. Remove and replace all gooseneck faucets with a more substantial model appropriate for the application.
2. Replace angle stops as needed.
3. Investigate the source of the sewage smell. Repair as needed to alleviate the smell.

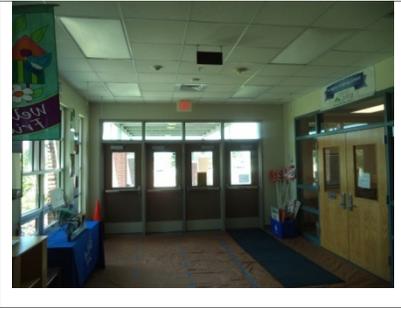
Communications & Security

<p>Communications & Security</p>	<p>This facility has a Wi-Fi system, card readers, a public address system, and CCTV (closed circuit television).</p> <p>It was reported the Wi-Fi system had connection problems throughout the building. It was reported the card readers were working properly, and there were a sufficient number of card readers in the facility.</p> <p>It was reported there were issues with the cameras. The</p>	<p>Average</p>

System	Subsystem	Condition and Deficiency Overview	System Condition Rating
		<p>cameras were original and had poor resolution. There was a need for additional cameras in the main corridor and in the area of the cafeteria. There was also a need for a dedicated monitor for viewing the various cameras.</p> <p>It was reported there was no way to prevent visitors from entering the school building without prior screening through the administration offices.</p> <p>It was observed the communications and security systems were in average condition based upon the age of the equipment and the state of current technology.</p>

9. Consult with a professional architect to determine how to change the entry foyer into an airlock that will force visitors to enter through the administration office.
10. Add one camera in the main corridor and one camera in the cafeteria.
11. Consider replacing the camera system with newer technology and adding a dedicated monitor to view the cameras in real time.
