Boone Elementary School Site Summary

Address	8101 Croftwood Drive Austin, TX 78749
Number of Permanent Campus Facilities	2
Original Year of Construction	1986
Total Campus Building Area (combined)	73,690 SF

Main Classroom Building – BLDG-170A

CRAWL SPACE – Boone ES – Main School Building (BLDG-170A)

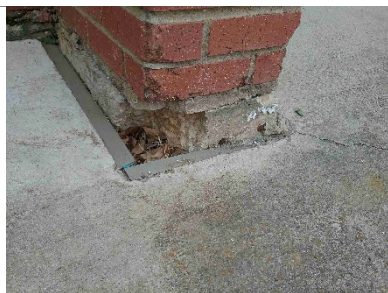
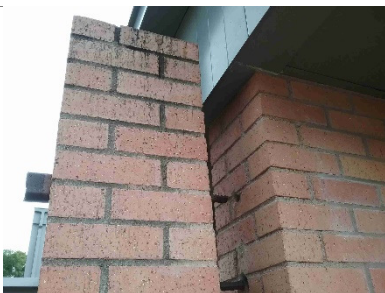
System	Subsystem	Condition and Deficiency Overview	System Condition Rating
Exterior	Exterior Walls	The exterior walls of the building are finished in brick with a flat metal panel fascia. They were observed to be in good condition with a few isolated and minor deficiencies. Small areas of brick were observed to be chipped or missing. One decorative brick column had unconnected anchors and was leaning away from the wall.	Good
	Exterior Windows	The exterior windows are comprised of single pane systems set in metal frames. Some are part of a storefront system and have painted frames. The painted window frames were observed to have peeling paint on the exterior. Many window frames were observed to be unclean on the exterior as well.	Good
	Exterior Doors	There are two main entry doors to BLDG-170A located on the west side of the building. They are metal doors set in metal storefront systems. The remaining exterior doors are metal in metal frames with a fixed transom window. The exterior doors were observed to be in good condition with isolated areas of worn paint.	Good

1. Patch and repair all areas of damaged brick.
2. Secure decorative brick column to wall.
3. Refinish and clean exterior window frames.

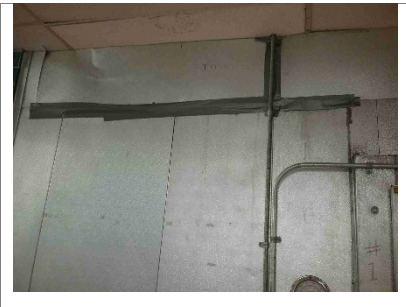
Interior Walls

System	Subsystem	Condition and Deficiency Overview	System Condition Rating
		windows are prevalent throughout the building. Some rooms, like the cafeteria, are divided by foldable partitions. The interior walls were observed to be in good condition with very few signs of damage. Cracks in the freezer wall in the kitchen were observed to be covered with duct tape.	
	Interior Doors	The interior doors are wood and metal, both in metal frames. Most wood doors have narrow lites in metal frames. There is one small roll-up door providing dish access from the cafeteria to the kitchen. It measures approximately 4'-0" wide and 5'-0" tall. The doors were observed to be in average condition due to age and use. The wood was observed to be splitting on many of the doors. The doors in the kitchen, including the freezer door, were observed to have corroded frames and deteriorated door finishes. The roll-up door to the kitchen was observed to be in good condition.	Average

1. Repair the damaged refrigerator walls in the kitchen.
2. Replace the corroded doors and frames in the kitchen.
3. Recondition the wood doors.

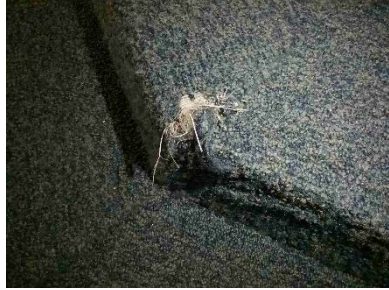
Interior Specialties	System not present.	N/A
Stairs	Exterior Stairs	System not present.	N/A
	Interior Stairs	There are three stairs leading to the stage level of the cafeteria. Two are small wood stairs, and the third is a low monument stair covered in carpet. The stairs were observed to be in good condition, only showing a few spots of damage to the carpet of the monument stairs. The corners of the stairs were observed to have pulled tufts of carpet.	Good
Interior Finishes	Interior Wall Finishes	The walls of the school are finished with painted drywall, painted CMU, and varnished wood paneling. The restrooms and kitchen have FRP (fiber-reinforced plastic) panels on the walls as well. The wall finishes appeared to be in good condition, showing signs of wear lighter than expected for the school's age. Some of the wood paneling was observed to be faded at the base, and one location exhibited signs of water damage. The corners of the drywall in the classrooms were observed to have chipped paint, and a few wall penetrations were unsealed. The FRP by the kitchen sinks was observed to be unclean and aged.	Good

1. Patch the carpet on the stairs leading to the cafeteria stage.
2. Recondition faded or water-damaged wood paneling.
3. Repair and repaint corners of classroom walls.
4. Seal any penetrations through the walls.
5. Replace FRP in kitchen.
6. Clean and repair the damaged kitchen floor tiles, or replace them as necessary.
7. Further investigate the slope of the kitchen floor to ensure it properly slopes to drainage points.
8. Replace all of the cracked linoleum tiles.
9. Install ceiling tiles where they are currently missing.
10. Replace all damaged ceiling tiles.

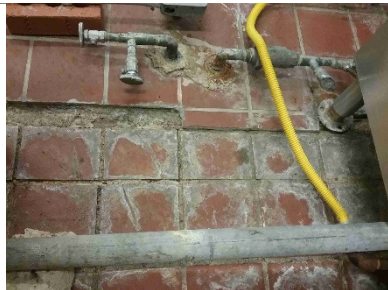
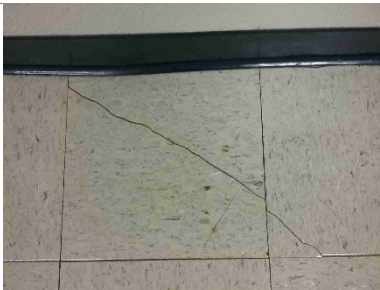
Interior Floor Finishes

System	Subsystem	Condition and Deficiency Overview	System Condition Rating
		<p>stage floor is wood.</p> <p>The kitchen floor appeared to be in good condition except for isolated spots of calcium staining and tile corrosion. These spots were near the freezer door and under the heating equipment. The linoleum tile was observed to be in good condition throughout the school with only a few cracked tiles. The stage floor, administration carpet, and restroom tile floors were likewise observed to be in good condition.</p>	
	Interior Ceiling Finishes	<p>There is ACT (acoustical ceiling tile) in the majority of the school. There is drywall ceiling in the restrooms. There is wood wool ceiling in the gymnasium. The cafeteria ceiling is finished with lay-in FRP panels.</p> <p>The ceilings in the administration wing and faculty areas were missing tiles or cracked. Very few tiles showed signs of water damage except in the kitchen. The kitchen ceiling showed signs of water damage and rust on the tiles and tees.</p>	Good

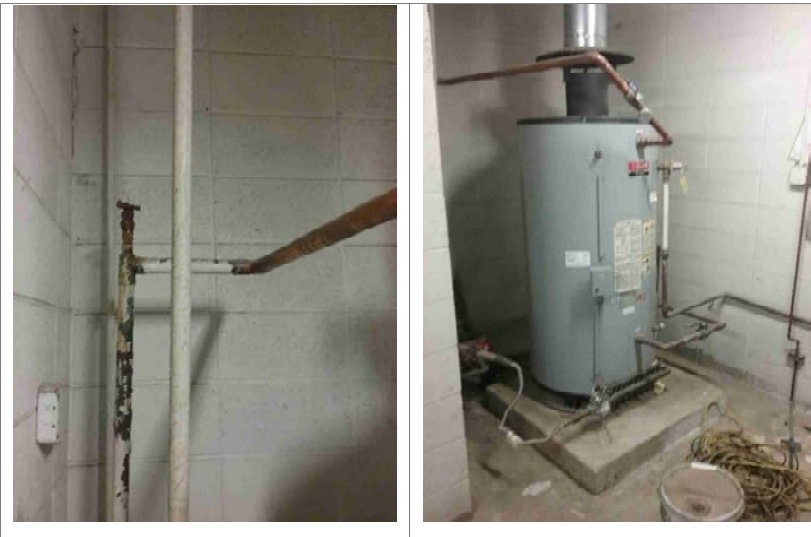
Conveying	System not present.		N/A
Plumbing	Plumbing Fixtures	<p>The building has public restrooms for males and females located throughout the facility with separate restrooms for the staff.</p> <p>The restrooms in the administrative area were observed to be in good condition. The hot water lines for the A1 and A2 faucets remained cold. The A6 faucet was only slightly warm. The flush valve for room C1 would continue to flush for a long period of time when activated. The urinals in the BHRGYM restroom did not flush properly.</p>	Average
	Domestic Water Distribution	<p>There are several sinks in the A-wing classrooms that have hot water lines. One sink in the B-wing classrooms has a hot water line as well. The faucets that have hot water are directly connected to a small water heater located underneath the sink. The restrooms in the administrative offices had faucets that were directly connected to small water heaters underneath the sink as well.</p> <p>The gas water heater located in the main mechanical room was observed to be in poor condition. Part of the distribution piping for this unit was extremely corroded. The nameplate showed that the manufacturing date was 1992 and water heaters should be replaced every 15 to 20 years.</p>	Average

1. Repair crawl space hangers. It was reported that the crawl space is always wet and the space hangers are deteriorating.
2. Secure the cast iron waste water line and the copper domestic water line in the crawl space. It was reported that these water lines are falling.
3. Replace Boiler 1 in the main mechanical room. It was reported to be aged and a persistent maintenance issue.

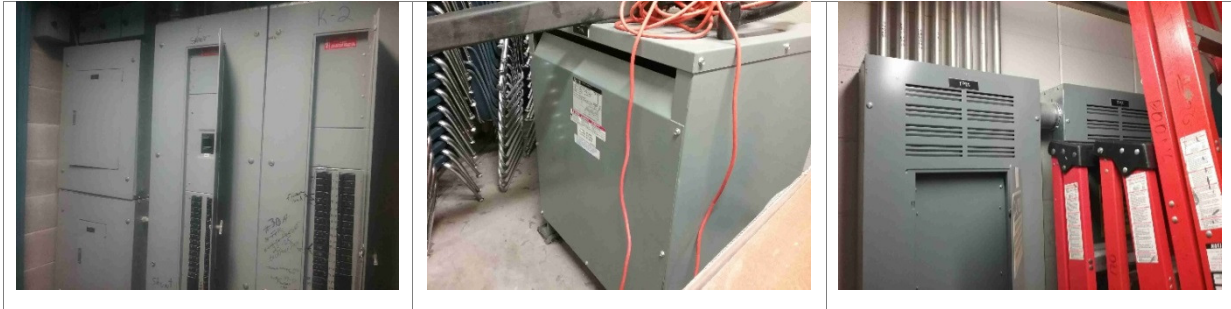
System	Subsystem	Condition and Deficiency Overview	System Condition Rating
Electrical	Electrical Distribution	<p>A pad-mounted transformer serves a 1200A 480/277V main switchboard MSB. MSB was installed in 2002. There were also additions to the electrical system in 1998, which included the addition of a 100kVAR power factor correction capacitor bank. The remaining equipment is original from 1986. The building does not have a lightning protection system.</p> <p>The electrical distribution equipment was observed to be in average condition. Approximately 40% of the distribution equipment appeared to be in good condition and the remaining 60% appeared to be from the original 1986 construction and was showing signs of wear and tear and corrosion/rust. One panelboard was observed with missing circuit breaker covers and the bussing was exposed behind the breaker board. This condition could be considered a life safety hazard and breaker covers should be installed immediately. One transformer was observed to be humming very loudly. The kitchen area janitorial storage room that contains the power factor correction bank felt hotter than normal.</p>	Average

1. Immediately provide missing break cover plates for all electrical equipment that were noted, as these instances should be considered life safety hazards.

2. Repair or replace all electrical equipment affected by corrosion or rust. If the corrosion/rust is beyond the enclosure then replacement is suggested.

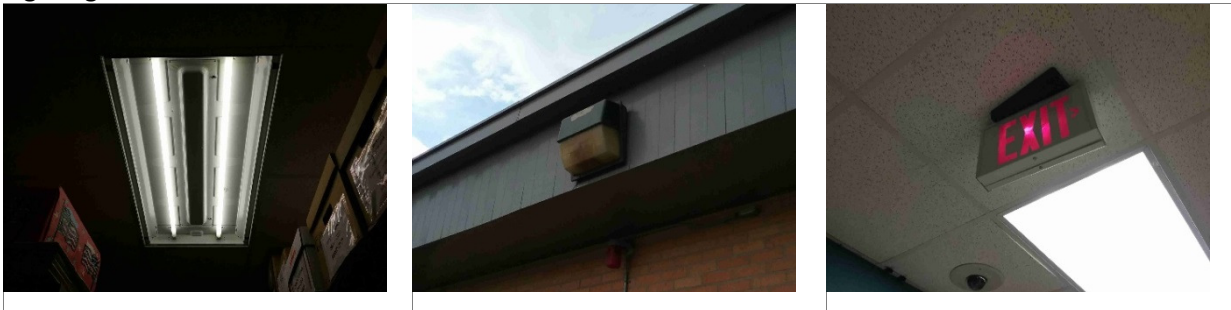
Lighting	<p>Approximately 95% of the facility consists of 2x4 fluorescent recessed light fixtures which appear to be in good condition. Approximately 40% of the exit signs appear to be LED (light-emitting diode) type with LED emergency heads, which appear to be in good condition. However, 60% of the exit signs are worn out or non-functional. All lighting controls in the facility are manual.</p> <p>The gymnasium has HID (high-intensity discharge) low bay fixtures that appeared to be in good condition. There are LED exit signs with integral emergency heads that appear to be recently installed.</p> <p>The cafeteria has 2x4 fluorescent recessed light fixtures and the stage area has fluorescent strip lights for house lighting. There are also theatrical lights for the stage. All lights in the cafeteria appeared to be in good condition. The exit signs are LED with integral emergency heads and appear to be recently installed.</p> <p>Exterior lighting at the facility consists of HID building-mounted light fixtures.</p> <p>The interior lighting for the building was observed to be in good condition. In the book room, a 2x4 light fixture was observed missing a lens. The exterior lighting appeared to be aged past their design life, but it was</p>	Good

3. Remove any floor receptacles as they are being phased out of use district-wide.
4. Replace all outdated interior light fixtures with LED light fixtures with dimming capabilities.

5. Replace all outdated existing incandescent exit signs with LED fixtures. Provide additional LED exit signs where required for all buildings.
6. Provide additional security cameras in interior corridor areas and at exterior of all buildings to obtain adequate coverage.

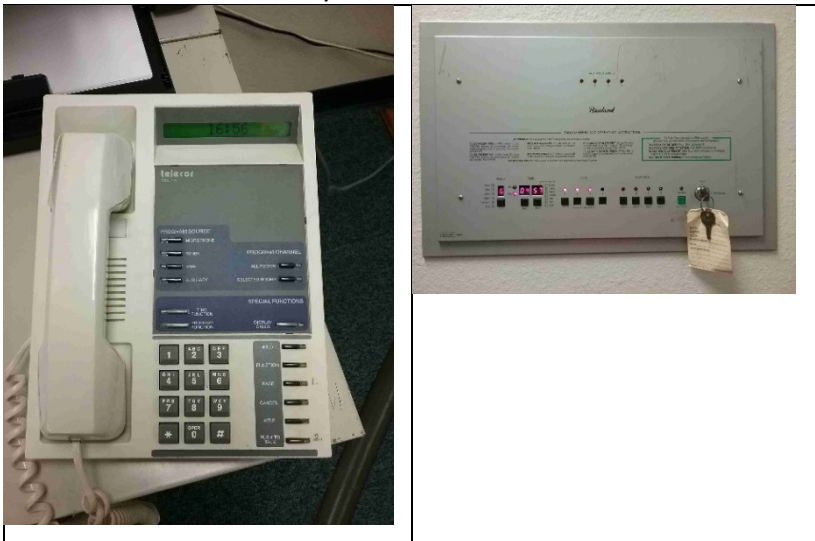
System	Subsystem	Condition and Deficiency Overview	System Condition Rating
		reported that all exterior lighting is being replaced with LEDs.	
	Communications & Security	<p>There is a Gemini security system including surveillance cameras in the building.</p> <p>According to facility staff, the system is in good condition with no reported deficiencies.</p> <p>There is public address system in the building.</p> <p>The PA system is in poor condition as it was reportedly not functional in the corridor areas.</p> <p>The building is equipped with telecommunications systems, but the main backbone equipment is located in an inaccessible room. Wi-Fi hubs are present throughout the facility and appeared to be in good condition.</p> <p>The telephone system is in average condition as it was reported that the telephone system is traditional and does not have VOIP (Voice Over Internet Protocol) capabilities.</p> <p>The school bell system is controlled by the District through a Telcor MCC-4 phone controller.</p> <p>The bell system is in average condition as it is functional, but was reported very cumbersome to use/program.</p> <p>The school clock system is digital appears to be original to the 1986 construction.</p> <p>The clock system is in poor condition as it was reported that it requires all manual controls/user inputs and very cumbersome and difficult for the staff to program each year.</p>	Average

9. Repair/upgrade existing PA system to provide coverage in corridor areas.
10. Upgrade school bell system to a new easy-to-use digital type system per staff reports of struggle with current system.

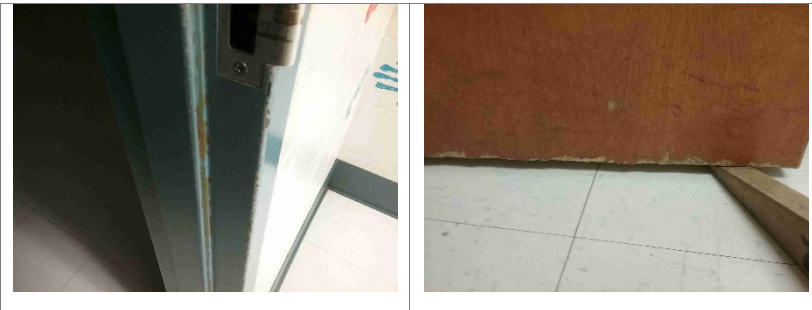
System	Subsystem	Condition and Deficiency Overview	System Condition Rating
	Interior Doors	The interior doors are wood with metal frames. The interior doors were observed to be in good condition with slight damage to the door frames and bases. Many door frames were observed to have worn paint, and many doors were observed to have worn wood bases.	Good
	Interior Specialties	System not present.	N/A
Stairs	Exterior Stairs	System not present.	N/A
	Interior Stairs	System not present.	N/A
Interior Finishes	Interior Wall Finishes	The wall finishes consist of painted dry wall and CMU with FRP panels in the restrooms. The wall finishes were observed to be in good condition with isolated moments of deficiency. The restroom wall finish is damaged where a toilet paper dispenser was removed from the wall, and the wall behind one light switch was observed to be poorly finished. The wall corners were observed to be damaged from typical wear and tear.	Good

1. Recondition the bases of the wood doors.
2. Repaint the metal door frames.

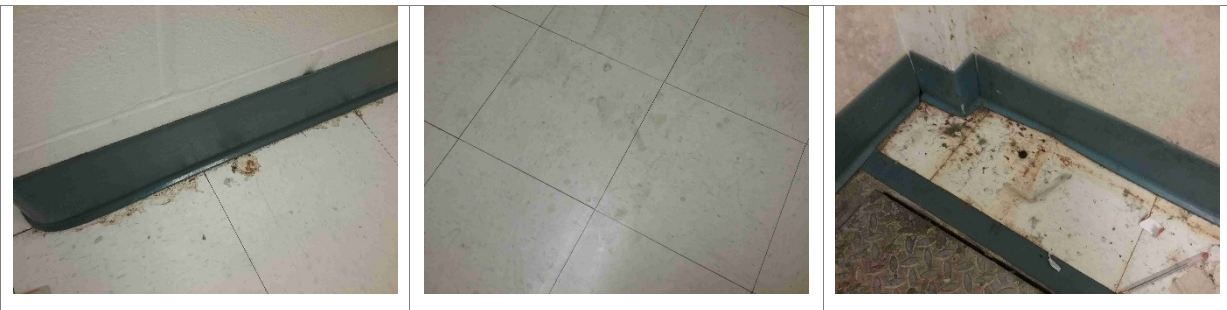
Interior Floor Finishes	The floor is finished with linoleum tiling and rubber wall base throughout. The floor was observed to be in average condition due to areas of stained and uneven linoleum. The janitorial closet was observed to have a particularly stained floor.	Average
	Interior Ceiling Finishes	The building is ceiled with 2x4 lay in ACT throughout. The ceiling was observed to be in average condition due to the prevalence of damaged tiles. Water damage was observed in many areas of the ceiling. Some ceiling tiles were observed to be bowing out of their support tees, and the tees were observed to be significantly bent.	Average
Conveying	System not present.		N/A
Plumbing	Plumbing Fixtures	The building has a restroom with a toilet and sink in each classroom. These restrooms have vitreous china hand sinks and toilets. The toilets have manual flush valves and the sinks have manual faucets. There was a faucet located in room E6 that did not have water flow. A toilet in E3HRR does not flush. The faucet in E3 has very low water pressure and is loose. There was one mop sink in the building that was observed to be in good condition.	Average

1. Install metal corner guards to all the classroom wall corners.
2. Repair all damaged wall finishes.
3. Clean linoleum flooring.
4. Replace all damaged ceiling tiles.

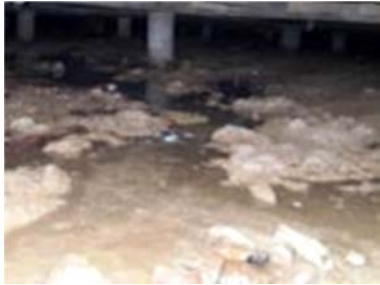
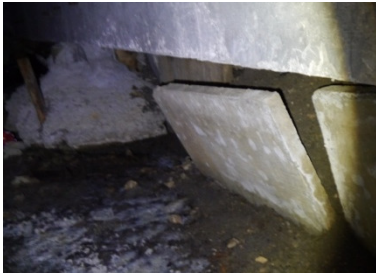
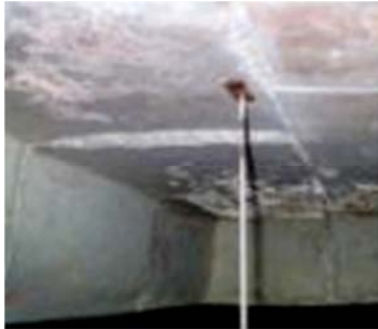
System	Subsystem	Condition and Deficiency Overview	System Condition Rating
Soil, Drainage, Ventilation & Access	Soil Below Building, Site Drainage in Crawl Space	Soil beneath building was saturated. Standing water was observed at all access hatches. Channels for drainage exist, but appear ineffective. Source of water is unknown, but given heavy amounts of rainfall recently, likely source is runoff infiltration. Soil/Drainage deficiencies: <ul style="list-style-type: none"> Saturated soil / Standing water / Poor drainage Potentially poor site drainage (if standing water is due to infiltration of rain water from outside of building) 	Poor
	Soil Retainers	A combination of concrete and plastic soil retainers were observed around the building. Overturned/caved concrete and plastic retainers were observed on the southwest and north sides of the building. Describe any soil retainer deficiencies. <ul style="list-style-type: none"> Overturned/caved plastic & concrete soil retainers 	Average

Areaways/Ventilation	Ventilation appeared inadequate. Condensation was observed on underside of slab and on pipes. Areaways were located around the building and appeared generally in good condition. Areaway/ventilation deficiencies: <ul style="list-style-type: none"> Poor ventilation Condensation under slab 	Poor
	Access Hatches	Three access hatches are located in the main building. Access hatches were located in the floors of custodial closets	Average

Standing water	Overturned plastic soil retainers	Condensation under slab

1. Improve drainage in crawl space
2. Investigate need for improved site drainage around perimeter of building
3. Replace failed soil retainers
4. Provide adequate ventilation
5. Replace or repair access hatch steel framing

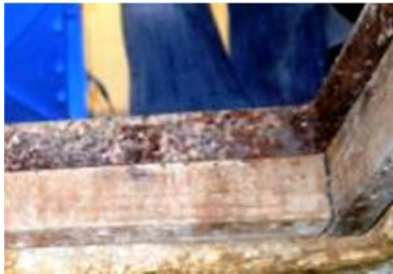
Rusted access hatch steel frame & inadequate connection to floor slab

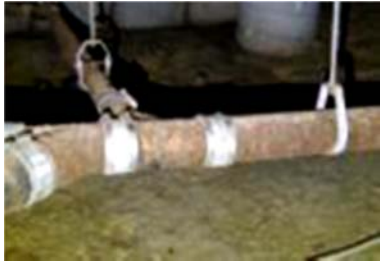
Rusted cast iron pipes

1. Replace failed/rusted hangers
2. Repair fallen pipe

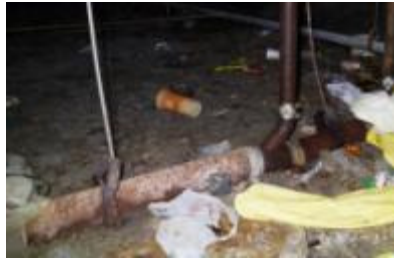
Pipe on the ground, failed hangers

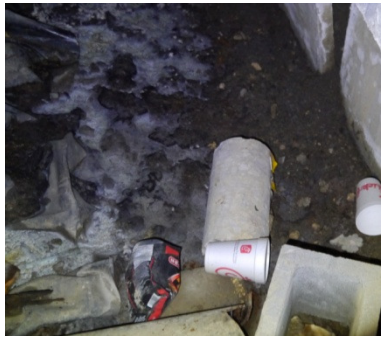
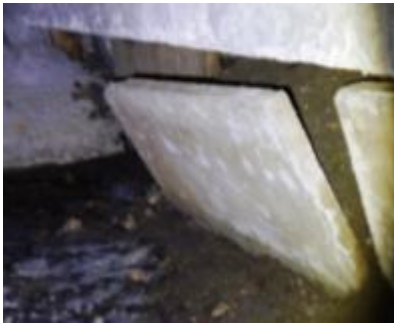
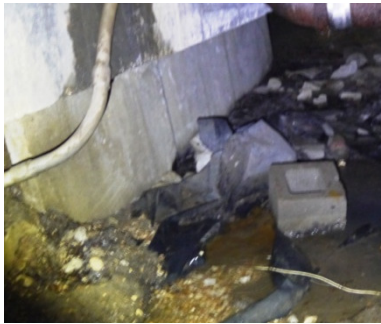
System	Subsystem	Condition and Deficiency Overview	System Condition Rating
Soil, Drainage, Ventilation & Access	Soil Below Building, Site Drainage in Crawl Space	Soil below building was saturated and held standing water. Soil/Drainage deficiencies: <ul style="list-style-type: none"> • Saturated soil / Poor drainage • Potentially poor site drainage (if standing water is due to infiltration of rain water from outside of building) 	Poor
	Soil Retainers	Building contained concrete soil retainers. Overturned and/or collapsed soil retainers were observed along the north wall. Others had slid or rotated inward at the bottom. Describe any soil retainer deficiencies. <ul style="list-style-type: none"> • Overturned/rotated/undermined soil retainers 	Average
	Areaways/Ventilation	Areaways are located all around the building. Poor ventilation was observed in crawl space. Areaway/ventilation deficiencies: <ul style="list-style-type: none"> • Poor ventilation 	Poor

Staging, stagnant soil	Overturned soil retainer	Soil retainers rotated inwards at base

1. Improve drainage in crawl space
2. Investigate need for improved site drainage around perimeter of building
3. Replace failed soil retainers
4. Provide adequate ventilation
5. Replace or repair steel framing at access hatch

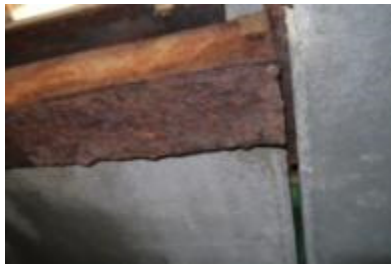
Access Hatches	Access hatch was located on the floor of the custodian closet on the north side of the building. An exterior access door is located on the east wall of the building but could not be opened. Steel framing on floor access hatch was very rusted. Access hatch deficiencies: <ul style="list-style-type: none"> • Rusty steel framing (see additional commentary in floor slab section below) 	Average

Rusted access hatch steel frame

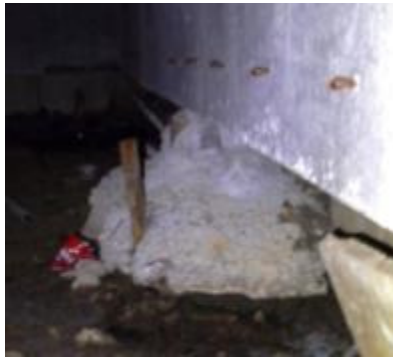
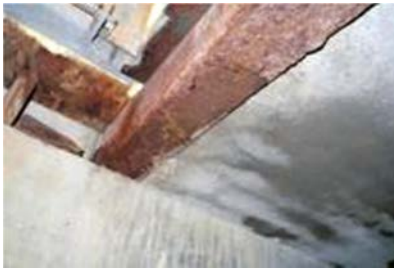
<ul style="list-style-type: none"> Exterior access door not operable 	
Exposed Structure	Exposed Columns & Tops of Foundations	<p>Building contained a badly over-poured pier; the top of the pier mushrooms.</p> <p>Column/Foundation deficiencies:</p> <ul style="list-style-type: none"> Over-poured pier with mushroom top 	Average
	Exposed Faces of Perimeter Walls / Beams	Perimeter beams were in good condition. No perimeter beam deficiencies were observed.	Good
	Exposed Portions of Interior Floor Beams Above	Interior suspended beams ran between columns. Beams were in good condition. No beam deficiencies were observed.	Good
	Underside of Suspended Floor Slabs Above	<p>The floor system consisted of hollow core panels spanning between beams. The floor system was typically in good condition. The steel framing for the hatch opening supports one end of a panel and is rusted badly.</p> <p>Slab deficiencies:</p> <ul style="list-style-type: none"> Transfer framing surrounding hatch opening is badly rusted. 	Average

Over-poured pier ("mushroom" top)	Transfer framing surrounding hatch opening is badly rusted

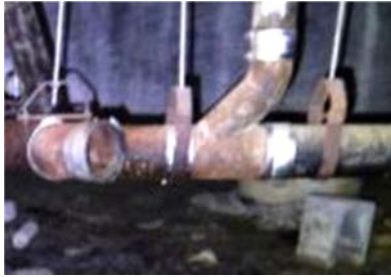
Pipes, Ducts, Equipment & Fireproofing	Suspended Pipes & Hangers	<p>Cast iron pipes were present in the crawl space with moderate rusting. All pipes were suspended. One broken drain pipe was continuously spilling water on an electrical outlet. A drain from the custodial room above was poorly sealed and leaking continuously into the crawlspace, presumably from a condensate line.</p> <p>Pipe deficiencies:</p> <ul style="list-style-type: none"> Broken pipe leaking into crawl space (and on electrical outlet) Leaking drain Rusted pipes & hangers 	Average
	Exposed Ductwork	N/A – Building does not contain exposed ductwork.	N/A
	MEP Equipment	N/A – Building does not contain MEP equipment.	N/A
	Spray Fireproofing/ Insulation	N/A – Building does not contain spray fireproofing or insulation.	N/A

Broken pipe and rusted hangers

1. Repair broken pipe
2. Repair leaking pipe
3. Replace rusted hangers
4. clean rusted pipes and protect from further corrosion
5. Seal drain in custodial room

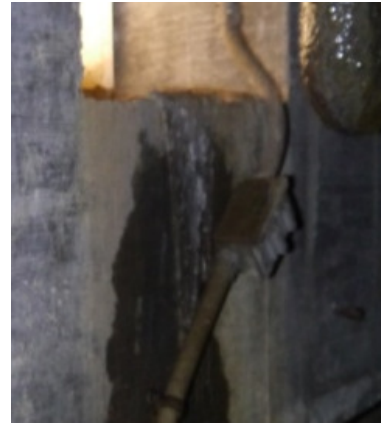
Water flowing over electrical outlet
