Brentwood Elementary School Site Summary

Address	6700 Arroyo Seco Austin, TX 78757
Number of Permanent Campus Facilities	2
Original Year of Construction	1951
Total Campus Building Area (combined)	62,890 SF

CRAWL SPACE – Brentwood ES – Main School Building (BLDG-107A)

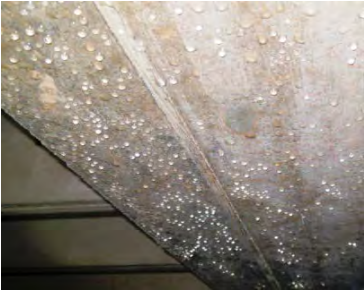
Condensation under beam indicates poor ventilation

1. Investigate need for improved ventilation at all crawl spaces.
2. Provide access to B Wing crawl space (may have hatch in janitor's closet or new access point may need to be provided).
3. Clean corrosion from floor hatch frames and paint to prevent further corrosion.

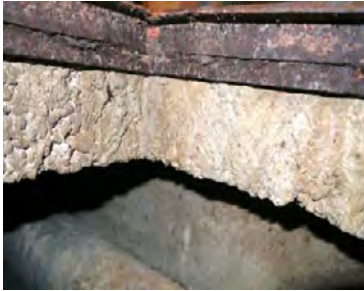
Slab honeycombing and corroded steel frame at C Wing floor hatch

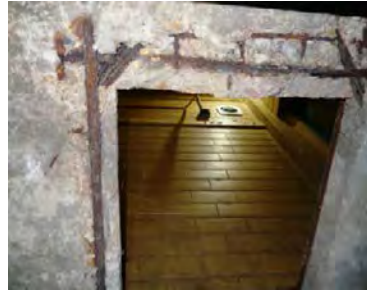
Exposed/corroded reinforcement at C Wing floor hatch

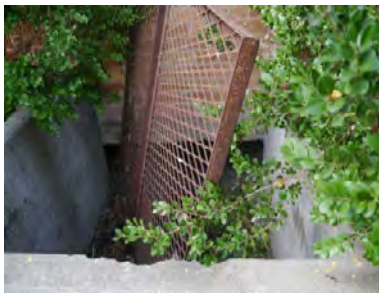
Kitchen crawl space areaway opening too small to access

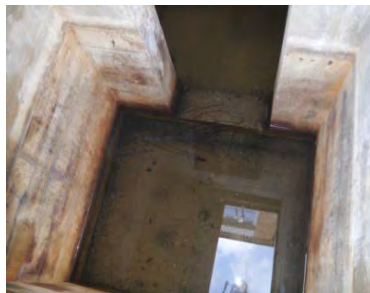
Standing water in vault access on November 2, 2016.

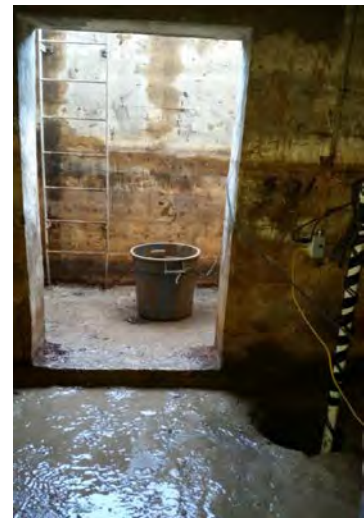
Mud at bottom of vault under gym and sump pit observed November 14, 2016 (after standing water removed).

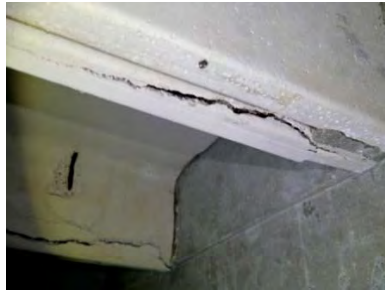
Longitudinal cracks along bottoms of precast channel legs

1. Clean corrosion from exposed reinforcement and remove unsound concrete along bottoms of channel legs. Patch damaged areas with a repair mortar. Enlarge leg section as needed to establish adequate clear cover to the rebar. Note that approximately one-half of the channel legs below the C Wing will require repair, and the B Wing floor framing may be in similar condition.
2. Clean corrosion from exposed slab reinforcement and channel lifting bars and paint with a rust-inhibitive coating to protect from further corrosion

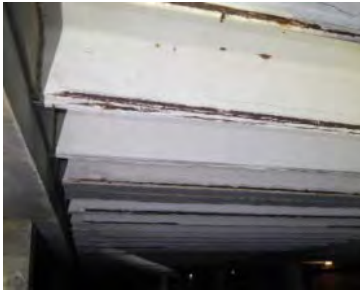
Longitudinal spalling & corroded/scaling reinforcement along bottoms of precast channel legs

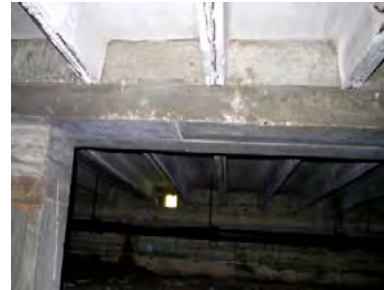
Channel leg spalling & corroded metal lifting inserts

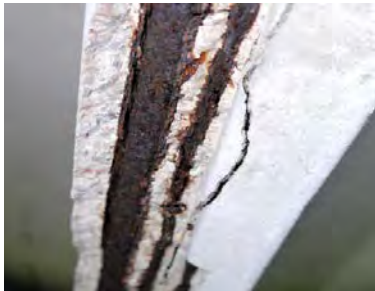
Advanced corrosion & scaling on channel leg longitudinal reinforcing

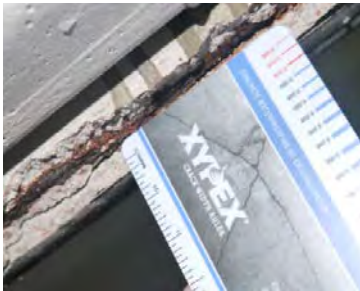
Channel leg exposed longitudinal bar has less than 1/2in of clear cover to outside face of concrete

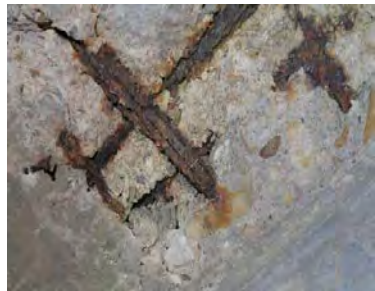
Slab spalling & corroded rebar

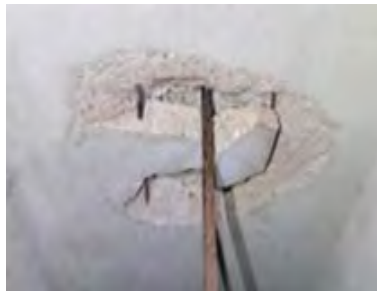
Slab spalling at pipe hanger connection

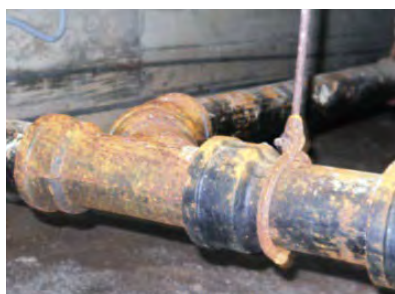
Rusted cast iron pipes and pipe hangers

1. Clean corrosion from pipes and paint to prevent further corrosion.
2. Replace heavily corroded pipe hangers.
3. Replaced degraded/missing pipe insulation.

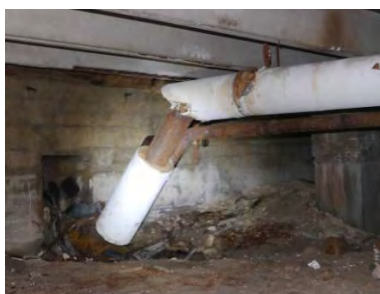
Degraded pipe insulation
