Brooke Elementary School Site Summary

Main School Building – BLDG-108A

CRAWL SPACE – Brooke ES – Main Building (BLDG No. 108A)

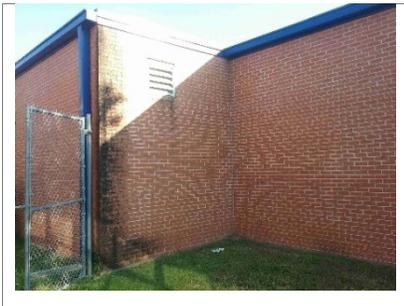
System	Subsystem	Condition and Deficiency Overview	System Condition Rating
Exterior	Exterior Walls	<p>The exterior walls are brick throughout the school with cast in place concrete above doors and windows. There are concrete sills below the windows. There is glass block and a painted strip of stucco above the covered walkways with painted steel supports periodically on the east classrooms wings. The west side of the school has brick sills at the windows. The main entrance at the front has cast in place concrete panels at the door and a cast in place concrete wing wall that supports the concrete walkway cover above.</p> <p>The exterior walls appear in good condition and are well maintained with good shade provided by overhangs and trees. There are limited areas that require cleaning due to buildup of organic material.</p>	Good
	Exterior Windows	<p>A majority of the exterior windows are updated anodized aluminum frames with single-pane glazing. The remaining windows on the south side of the classroom wings and in the kitchen appear to be original.</p> <p>The windows as a system are in average condition, considering the majority of the aluminum framed windows are in good condition and the older or original windows are in poor condition due to age and sealant failing.</p>	Average

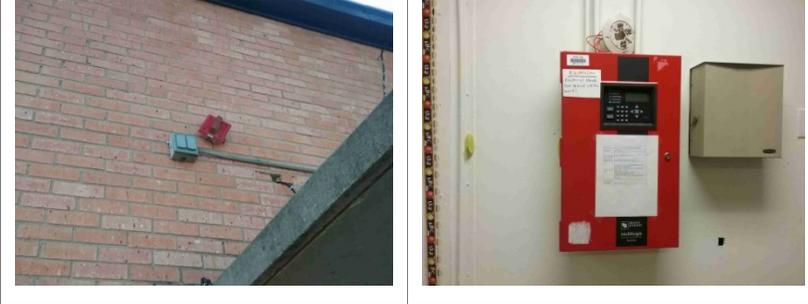
Fire Protection	Fire Alarm	<p>The building has a fire alarm system that consists of alarm and signaling devices such as strobes, horn/strobe combos, pull stations, and detectors. The fire alarm system is controlled by a Silent Knight control panel.</p> <p>The fire alarm system was observed to be in average condition due to some of the end devices being aged or worn from outdoor exposure. One heat indication end device was found to be hanging on the exterior wall at the west-side entrance, just south of the cafeteria. Room Admin 5 was also found to have an end device receptacle lying on a fire alarm control panel. The gymnasium has no fire detection end devices, only indication.</p>	Average
	Fire Protection/ Suppression	<p>A fire suppression system is present for the range hood in the kitchen with a tank mounted to the wall at ceiling height. The remaining fire suppression system consists of fire extinguishers throughout the building.</p> <p>Visual inspection showed these are in average condition.</p>	Average

1. Repair or replace loose fire indication end device on exterior wall at west-side entrance, just south of the cafeteria.

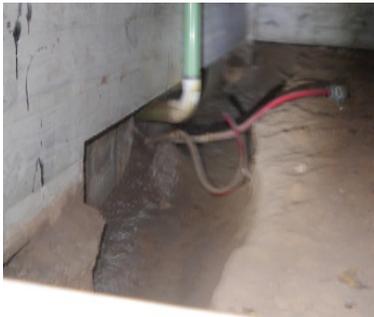
<p>Soil Damp at exterior of crawl space</p>

1. Investigate need for improved drainage.
2. Repair light switches at areaway entrances.
3. Clean out areaways of vegetation, conduit, bee hives, etc. so all areaways provide access to crawl space.

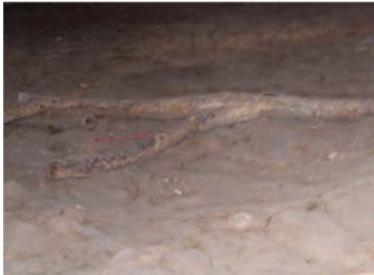
<p>Roots found in crawl space</p>

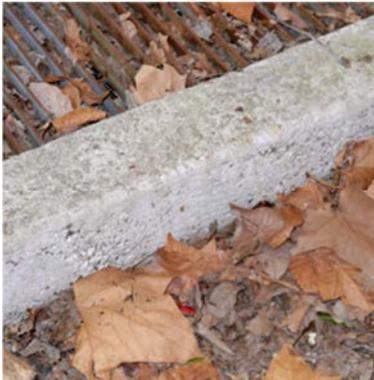
<p>Honeycombing in areaway</p>
---	---	--

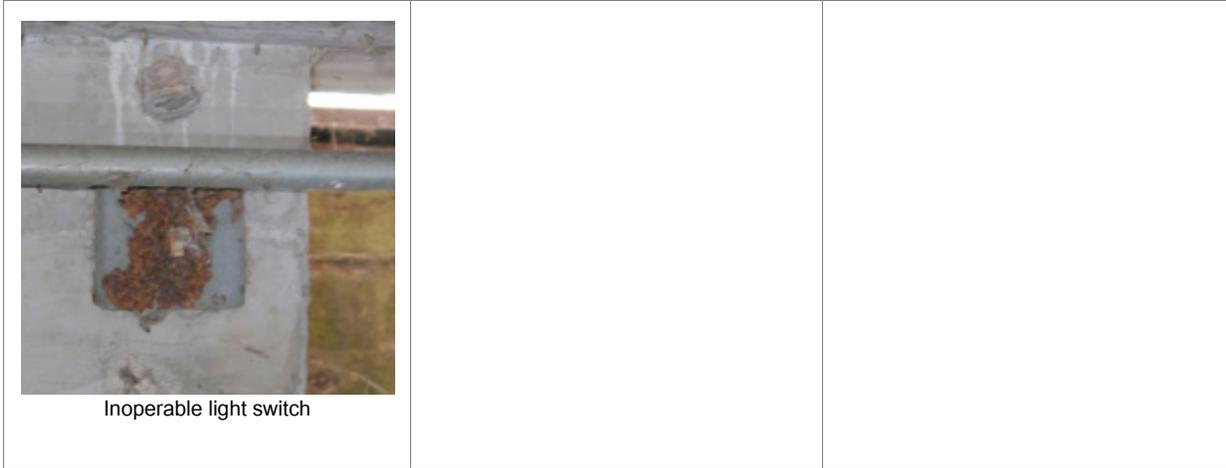
Inoperable light switch

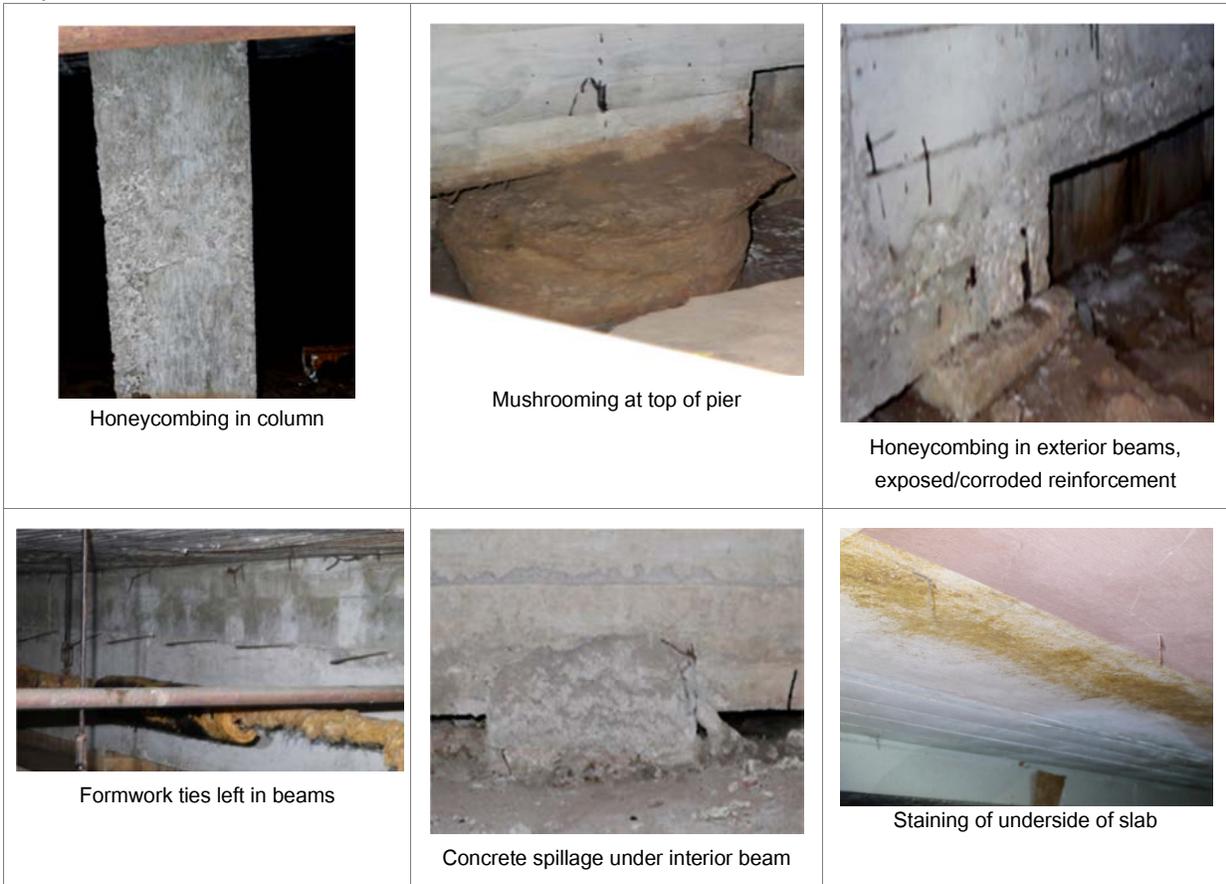
Honeycombing in column

Mushrooming at top of pier

Honeycombing in exterior beams,
exposed/corroded reinforcement

Formwork ties left in beams

Concrete spillage under interior beam

Staining of underside of slab

1. Repair and clean underside of slab.
2. Investigate source of slab stains & repair any leaks, etc. as needed
3. Repair honeycombed piers and beams.

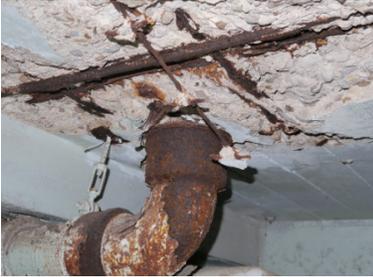
<p>Exposed reinforcing at rusted pipe</p>

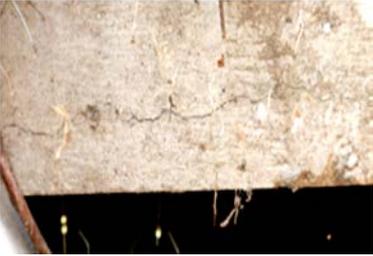
<p>Crack in slab at areaway entrance</p>

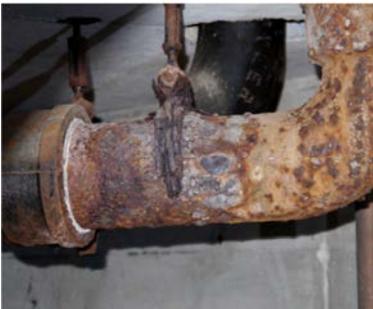
<p>Pipe & hanger significantly corroded</p>

1. Repair leaking pipes.
2. Replace rusted/damaged pipes and hangers.
3. Investigate pipes resting on ground and suspend from slab as needed.
4. Repair damaged/degraded pipe insulation.
5. Ensure proper drainage of condensate lines.

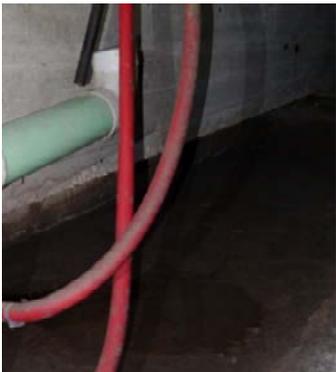
<p>Condensate line leaking onto soil</p>

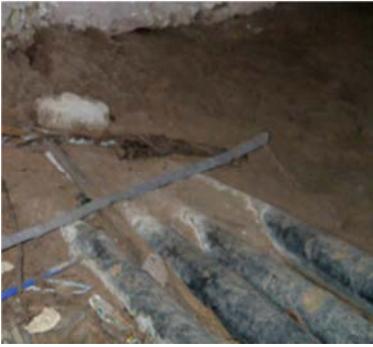
<p>Pipes running on the ground</p>

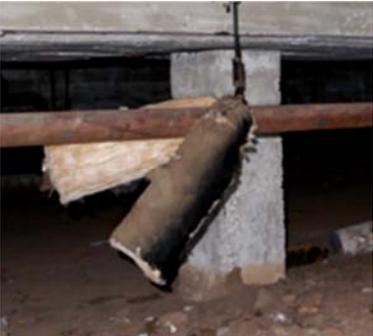
<p>Insulation stripped off cast iron pipe</p>

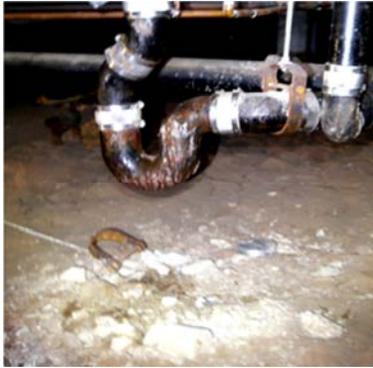
<p>Leaking cast iron pipe</p>

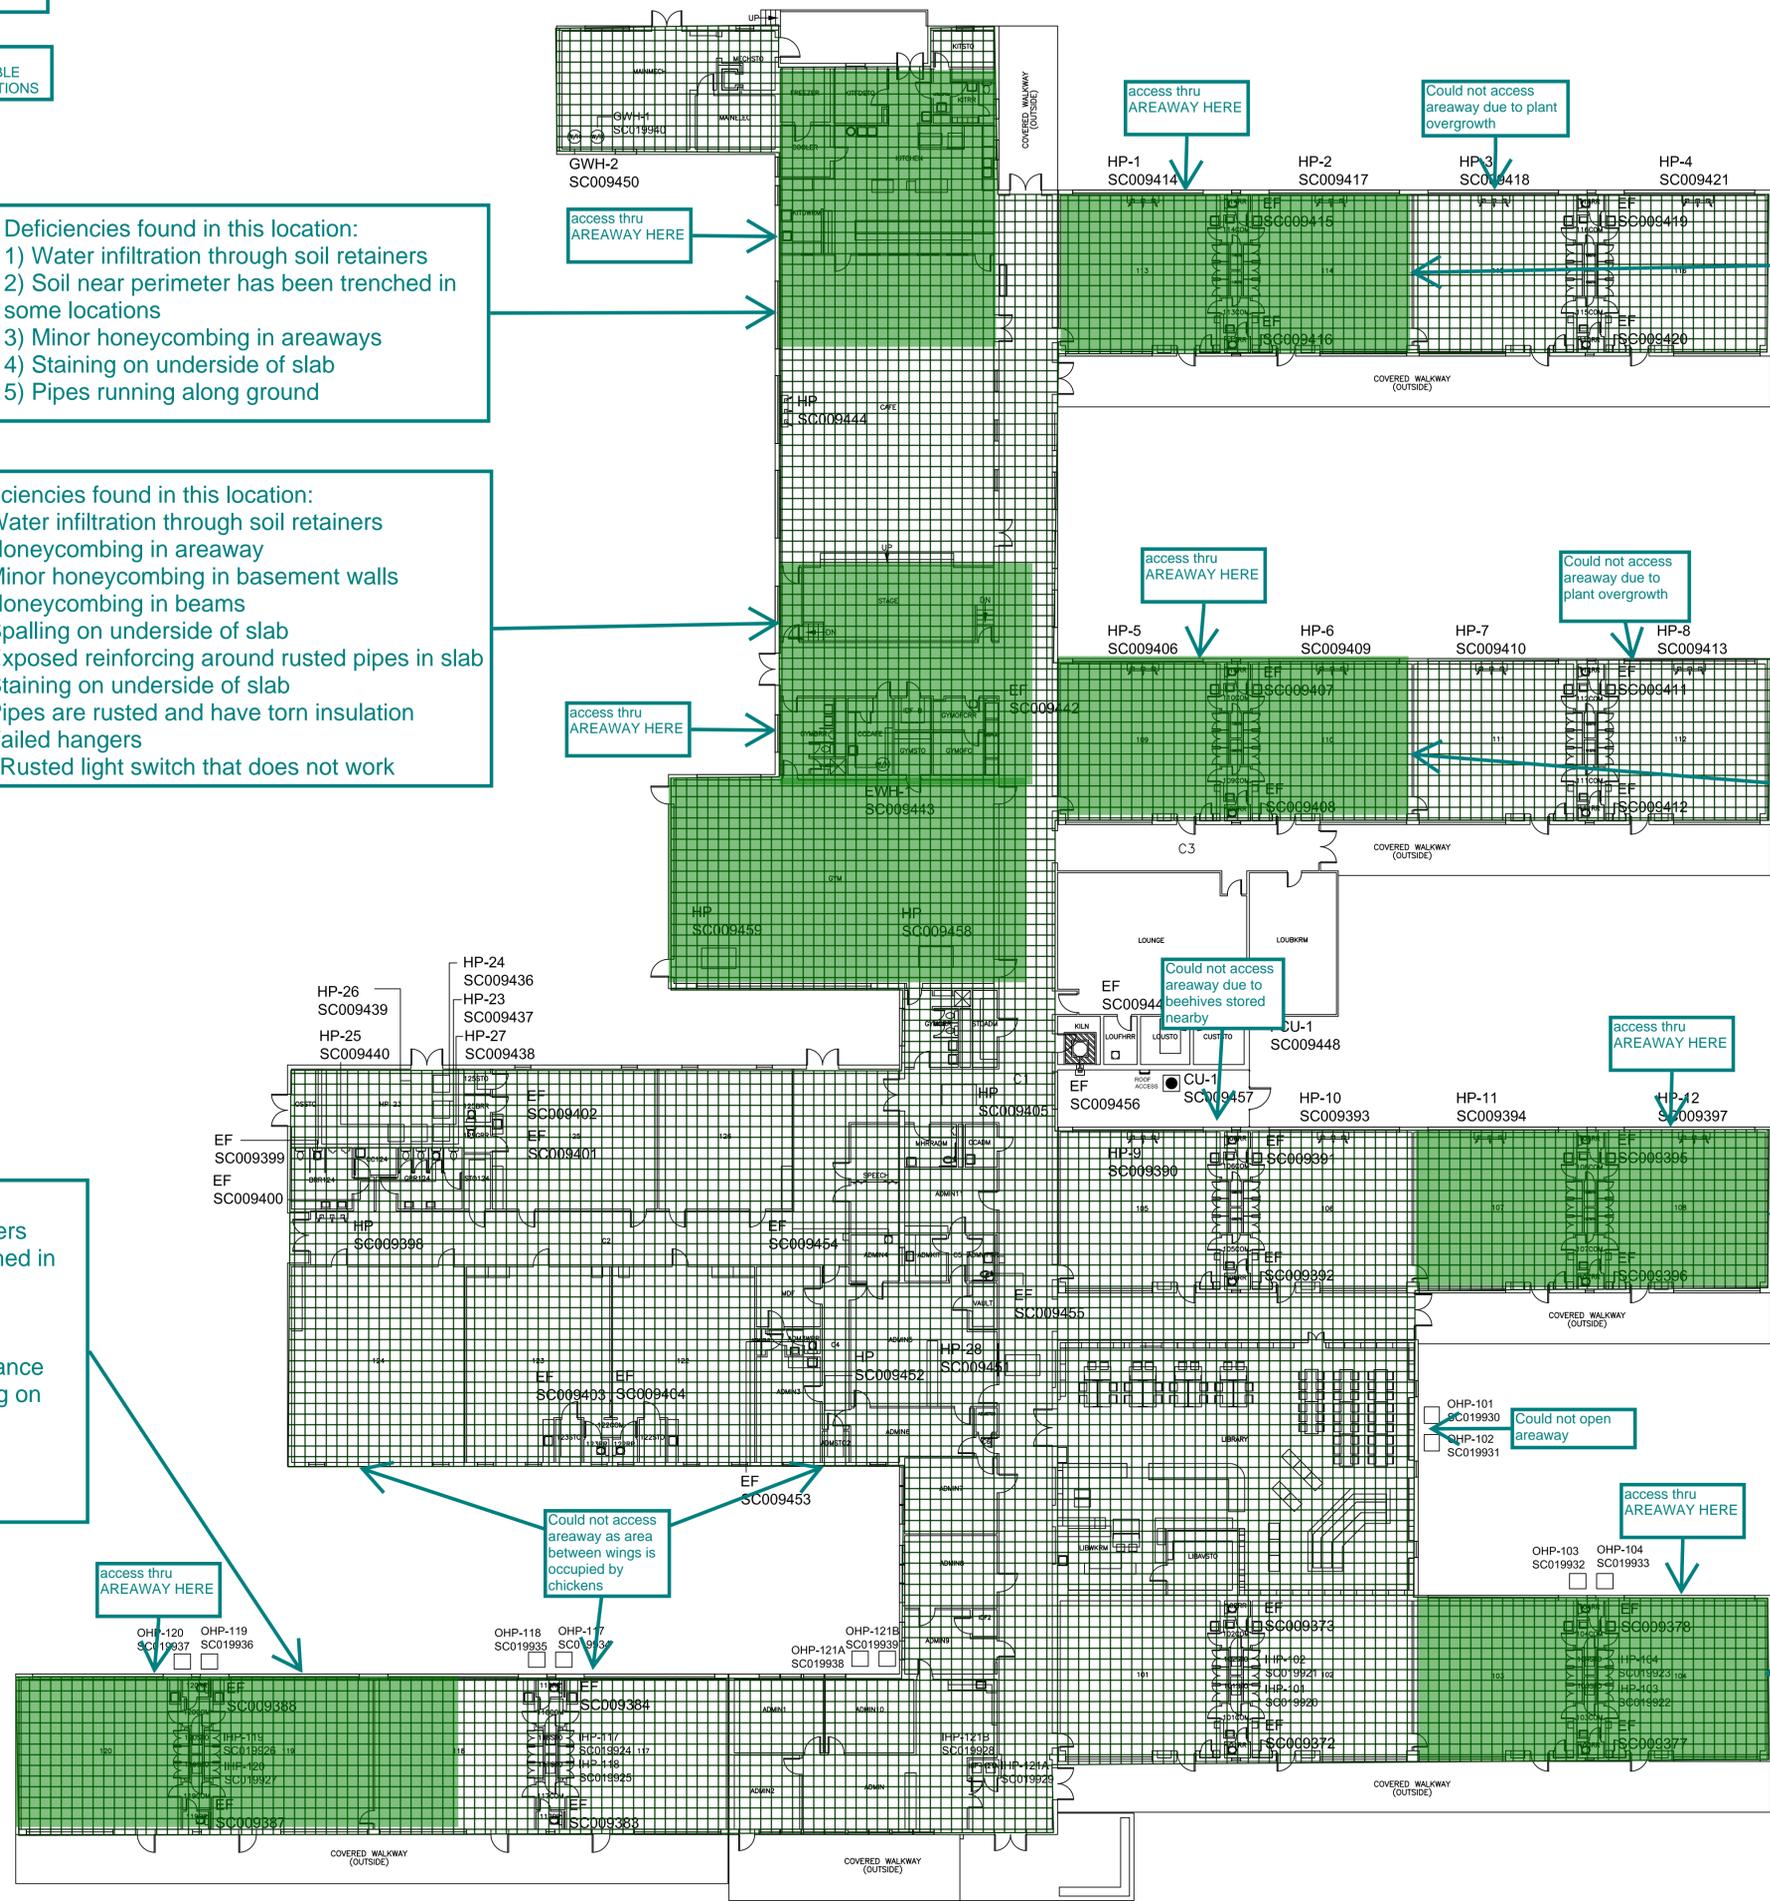
- 1) Water infiltration through soil retainers
- 2) Soil near perimeter has been trenched in some locations
- 3) Minor honeycombing in areaways
- 4) Staining on underside of slab
- 5) Pipes running along ground

- 1) Water infiltration through soil retainers
- 2) Honeycombing in areaway
- 3) Minor honeycombing in basement walls
- 4) Honeycombing in beams
- 5) Spalling on underside of slab
- 6) Exposed reinforcing around rusted pipes in slab
- 7) Staining on underside of slab
- 8) Pipes are rusted and have torn insulation
- 9) Failed hangers
- 10) Rusted light switch that does not work

- 1) Water infiltration through soil retainers
- 2) Soil near perimeter has been trenched in some locations
- 3) Piers are badly honeycombed
- 4) Form ties remain in basement walls
- 5) Cracking in slab over areaway entrance
- 6) Formed corrugated deck has rusting on underside of ribs
- 7) Insulation missing from pipes
- 8) Minor rusting in pipes
- 9) Light switch inoperable

- 1) Water infiltration through soil retainers
- 2) Soil near perimeter has been trenched in some locations
- 3) Soil was more saturated toward the main building
- 4) Minor concrete spillage under exterior beam
- 5) Rusted pipes

- 1) Water infiltration through soil retainers
- 2) Soil near perimeter has been trenched in some locations
- 3) Failed pipe hangers
- 4) Rusted and abandoned pipes
- 5) Water dripping from black hose from AC unit above. Water is dripping on soil, in other places this water drips into a PVC pipe.

- 1) Water infiltration through soil retainers
- 2) Soil near perimeter has been trenched in some locations
- 3) Mushrooming at top of piers
- 4) Failed pipe hangers
- 5) Rusted and abandoned pipes

- 1) Water infiltration through soil retainers
- 2) Soil near perimeter has been trenched in some locations
- 3) Mushrooming at top of piers
- 4) Failed pipe hangers
- 5) Rusted and abandoned pipes
- 6) Light switch was rusted and inoperable
