Campbell Elementary School Site Summary

Address	2613 Rogers Avenue Austin, TX 78722
Number of Permanent Campus Facilities	1
Original Year of Construction	1992
Total Campus Building Area (combined)	61,793 SF

Main School Building – BLDG-111A

Building Purpose	Administration, Classrooms
Building Area	61,793 SF
Inspection Date	June 29, 2016
Inspection Conditions	Sunny and Humid
Facility Condition Index

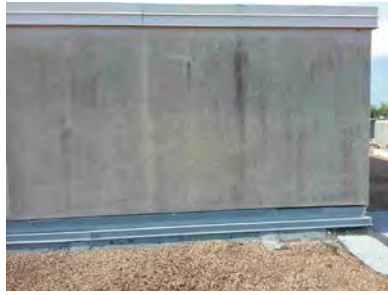
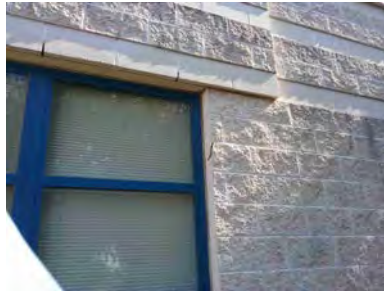
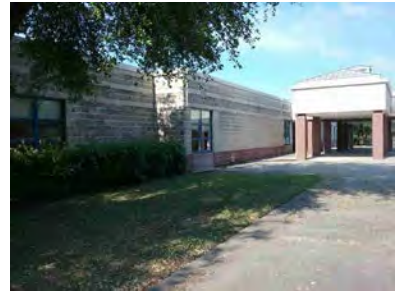
System	Subsystem	Condition and Deficiency Overview	System Condition Rating
Exterior	Exterior Walls	<p>The exterior walls are comprised of rusticated and smooth concrete masonry unit (CMU) with inset windows and doors. The walls above the first floor roof areas for the cafeteria and the gymnasium are exterior insulated finish system (EIFS) construction.</p> <p>The exterior walls were observed to be in average condition. Discoloration and staining was observed at the northeast corner among other locations of the CMU. The EIFS shows discoloration consistent with water behind the exterior surface along with rusting of the sill condition of the system. At two locations, cracks were noted at a doorway and windows.</p>	Average
	Exterior Windows	<p>The window system is a metal frame system with single pane glazing. The existing sealants and system are in good condition, but there are a number of units where the center mullion is askew at the bottom of the unit. As a result, the window unit is not air or weather tight. Several units had Plexiglas installed and one window pane was noted as broken.</p>	Average

1. Clean exterior CMU and monitor for water infiltration of wall system.
2. Extend roof drains such that the exterior CMU is not wetted continuously.
3. Provide drainage at EIFS wall systems or replace with metal wall panel system over continuous air and moisture barrier.
4. Investigate exterior wall systems that show clear signs of water retention.
5. Replace or repair window systems that are not plumb at the center mullion.
6. Replace Plexiglas window panes with glass.
7. Replace broken window pane.
8. Install continuous hinges at main entry doors.
9. Repair or replace roof hatch such that it can be operated normally.
10. Investigate potential foundation or structural issues at cracked CMU.
11. Repair cracked CMU.
12. Clean and coat rusting window sills.

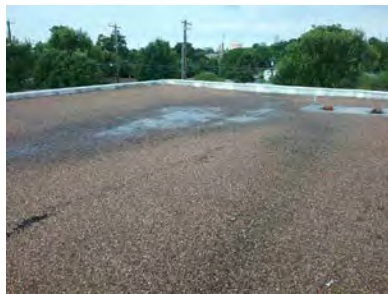
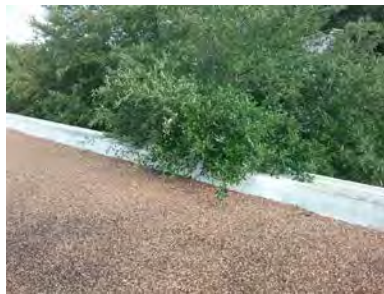
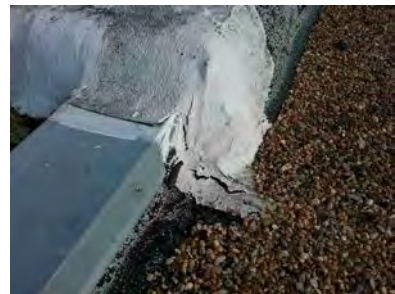
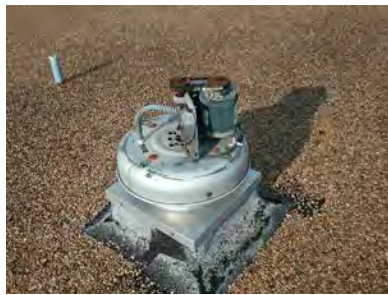
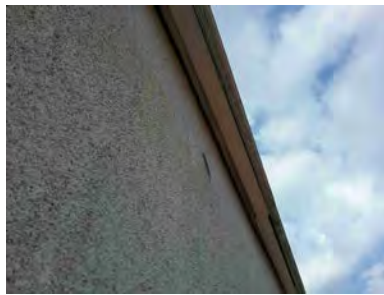
Roofing Deficiency Examples

System	Subsystem	Condition and Deficiency Overview	System Condition Rating
Roofing		The roof is primarily built-up with canopies, and the library has standing seam metal roofs . All of the roofing appears to be original construction to the building. The roofing appeared to be in poor condition. It was reported that there are leaks all along north side of building. Observations confirmed that the individual bathrooms in the classrooms and administration area showed signs of water infiltration from the roof along with fresh roof leaks in areas like the gymnasium storage. Ponding was observed at the southwest corner of the building. In addition, sealant failures, blisters, and exposed fibers in cap sheets were observed. Tree limbs were hanging over the roof, which over time will cause damage and provide a path for pests to make their way into the building. It was observed that the roof edge blocking was exposed in areas connected to the EIFS wall system. Walk pads were deteriorated or nonexistent.	Poor

1. Investigate and repair roof areas above known leaks.
2. Install continuous moisture and air barrier between EIFS and roofing systems at cafeteria and gymnasium.
3. Provide positive drainage such that areas do not pond or retain water and the exterior walls are not wetted by runoff.
4. Install walkpads.

5. Repair sealant between parapet and roof systems as well as at expansion joint covers and parapet.

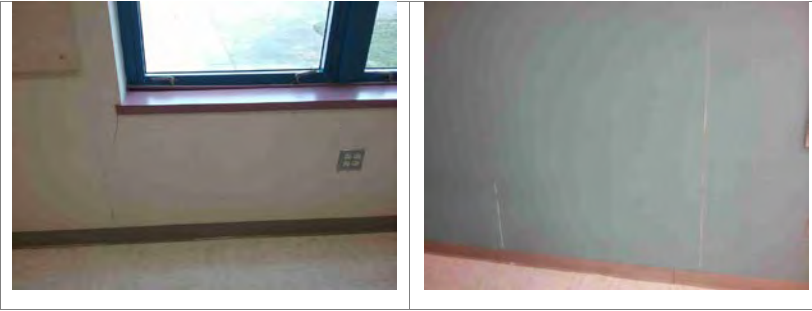
Interior Construction	Interior Walls	The interior wall construction is either CMU or gypsum board wall systems. There is an accordion door and an operable wall in the cafeteria. The interior wall construction appeared to be in average condition.	Average
	Interior Doors	There are solid core wood veneer doors with glazing at most spaces. Doors without glazing were present at the bathrooms and storage. In the corridors, there are rated doors that have hold opens connected to the fire alarm. The interior doors appeared to be in good condition.	Good
	Interior Specialties	Subsystem not present.	N/A
Stairs	Exterior Stairs	The facility only has concrete stairs at loading dock. The stairs appeared to be in good condition.	Good
	Interior Stairs	Subsystem not present.	N/A
Interior Finishes	Interior Wall Finishes	Wall finishes include paint on drywall, exposed masonry, and vinyl wall covering. The wall finishes appeared to be in good condition. Consistent with building movement, some rooms have cracking at the sill condition of the windows. In other areas, the vinyl wall covering has started to delaminate from the drywall system or shows damage.	Good

1. Repair or replace vinyl wall covering where delaminated or damaged.
2. Repair drywall systems at window sills where cracking has occurred.
3. Replace VCT where damaged.
4. Replace ceiling tiles or drywall systems damaged from leaks once leaks have been repaired.

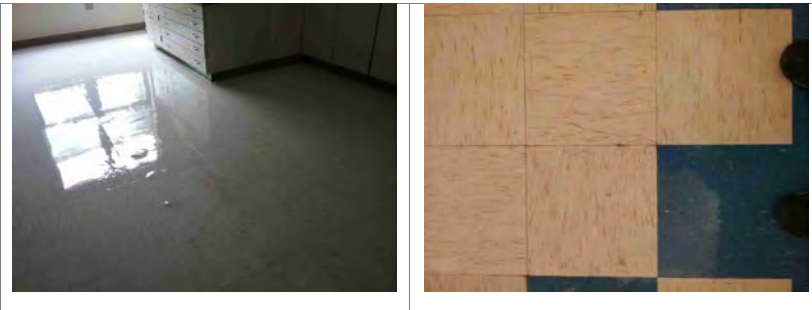
Interior Floor Finishes	The floor finish systems are comprised of vinyl composite tile (VCT), carpet tile, broadloom carpet, and ceramic tile. These floor finishes appeared to be in good condition. There appeared to be minor issues in the VCT; which have manifested into cracked or bubbled tiles.	Good

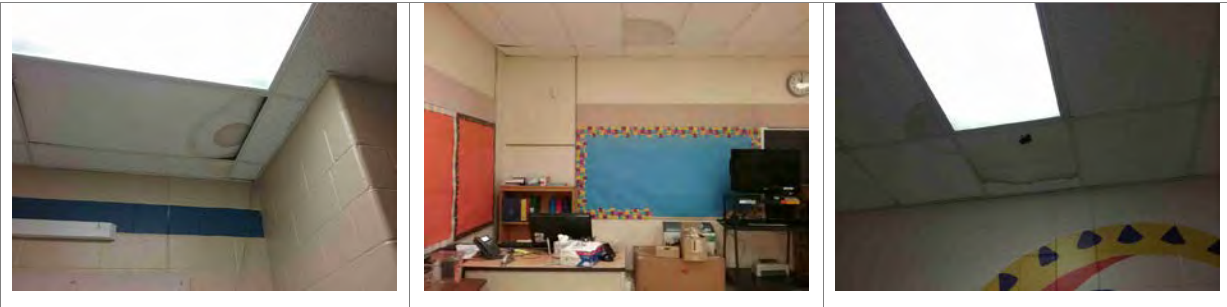
System	Subsystem	Condition and Deficiency Overview	System Condition Rating
	Interior Ceiling Finishes	<p>The ceiling finish systems are comprised of two by four foot acoustic ceiling tiles with drywall in the bathrooms or as accents in the corridors.</p> <p>The interior ceiling finishes appeared to be in good condition. Damage was observed to the ceiling tiles as a result of water from the roof or possibly overhead plumbing.</p>	Good
Conveying	System not present.		N/A
Plumbing	Plumbing Fixtures	<p>The building has public restrooms for males, females, and students, with separate staff restrooms located throughout the facility. These restrooms have vitreous china hand sinks in counters with manual faucets, along with vitreous china, floor-mount/wall toilets with manual flushing mechanisms, and vitreous china, wall-hung urinals in the male restrooms with manual flushing mechanisms. There are service sinks found in the janitor closets, and water coolers located throughout the facility, typically near the public restrooms.</p> <p>The restroom plumbing fixtures were observed to be in good condition as the fixtures were typically aged but still operational. The building included other specialty locations with plumbing fixtures, including a kitchen for the school cafeteria. These plumbing fixtures were observed to be in good condition. A deficiency observed was rusted floor drain grates throughout the kitchen floor.</p>	Good

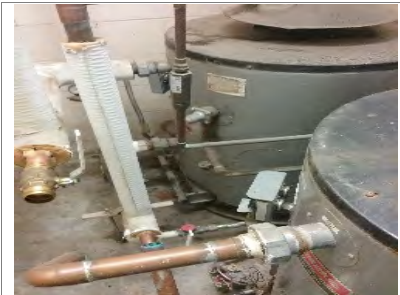
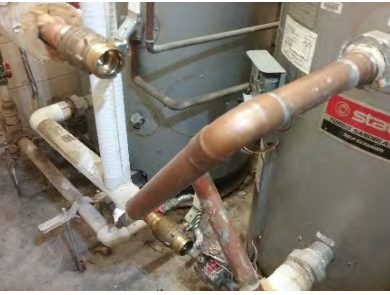
Domestic Water Distribution	<p>Plumbing fixtures are serviced with cold water from the facility. The only fixtures that have hot water service are in the staff restrooms, break rooms, etc. These fixtures are served by local electric water heaters (EWHs). The kitchen hot water is generated by a gas water heater (GWH) in the kitchen mechanical room. GWH-2 was disconnected at the time of assessment. It was reported from the staff that the grease waste lines from the kitchen were in need of immediate attention. The domestic water distribution system was observed to be in average condition.</p>	Average
	Other Plumbing	<p>The roof drains are equipped with metal grate covers to prevent debris from entering the drainage system. The roof drains are in good condition.</p>	Good

1. Reconnect or replace GWH-2 to kitchen hot water loop.
2. Inspect/clean or replace grease waste lines.
3. Inspect grease trap.

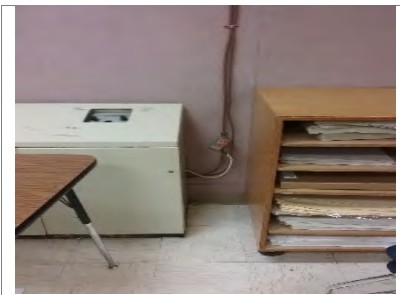
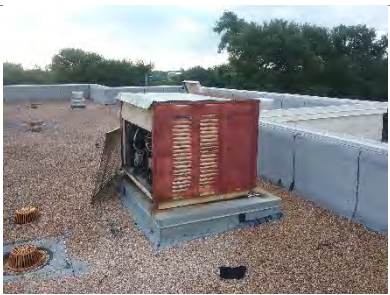
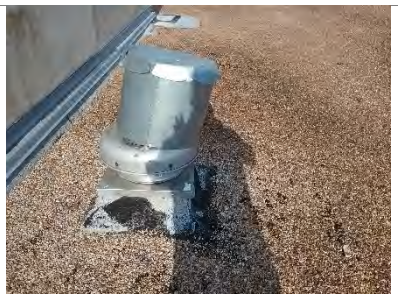
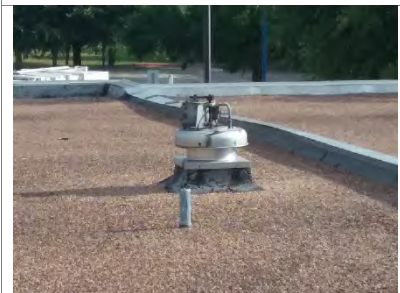
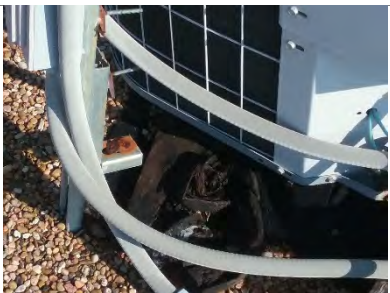
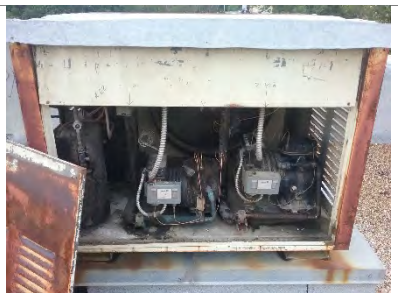
Mechanical/HVAC System Deficiency Examples

System	Subsystem	Condition and Deficiency Overview	System Condition Rating
Mechanical/ HVAC	<p>The main mechanical system consists of a distributed water source heat pump system. Each classroom is serviced by geothermal wells. Several classrooms are also supported by individual floor mounted units. These units are past their recommended service date. The unit in the art classroom has been disconnected from the water source loop and is now cooled with the domestic water loop. No mechanical separation such as backflow prevention or reduced pressure zone is observed to be present, which is a code violation and presents a possible health hazard.</p> <p>Each wing of the school including the administration areas was observed to be supported by a roof mounted air cooled make up air unit. These units from the outside appeared to be in aged condition. As observed from the inside, they are in good condition and appeared to have little runtime. These units are the only source of ventilation for the above listed areas.</p> <p>The cafeteria appeared to be serviced by two air cooled split system units with air handler units (AHUs) mounted in the mezzanines in the stage area. The AHUs appeared to be in good condition and in no need of service. The condensing units appeared weathered and aged but operating well.</p> <p>The facility mechanical staff notified assessors of the geothermal units are aged and leaking. This has effected all classrooms.</p> <p>The library, kitchen, and computer room appeared to be served by air cooled roof top units (RTUs). The kitchen RTU was recently replaced. The other two RTUs will be approaching the end of their useful life within the next five years.</p> <p>The building appeared to be serviced by numerous exhaust fans. Many exhaust fans appeared to have hand fabricated covers that do not meet the manufacturers' requirements nor the NEMA (National Electrical Manufacturers Association) 3R rating as required for exterior roof mounted equipment. These covers are a hazard and the fans are aged and beyond service.</p> <p>IDF (intermediate distribution frame) rooms were observed to be hot and lacked in mechanical ventilation.</p> <p>Due to the extensive repairs and age of the existing mechanical equipment, specifically the WSHP (water source heat pump) systems in the classrooms, the lack of a backflow prevention system, reduced pressure zone and the exhaust fan systems, the system rating is in poor condition.</p>		Poor

1. Repair correctly or replace exhaust fans throughout the facility that have non-OEM (original equipment manufacturer) fabricated coverings to avoid hazards.
2. Replace existing WSHPs in classrooms with new horizontal WSHPs.
3. Repair condensing unit roof mounts for MDF (main distribution frame) condensing unit.
4. Add centralized controls and monitoring for all equipment as well as geothermal well monitoring.
5. Install backflow prevention and/or reduced pressure zone(s) to meet code and avoid a possible health hazard.

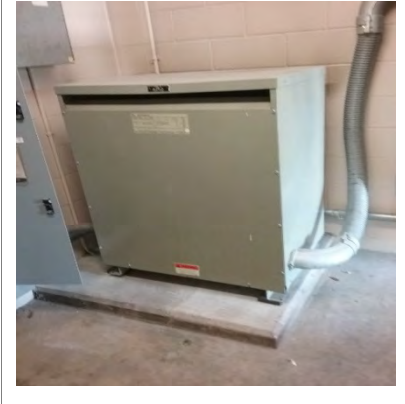
System	Subsystem	Condition and Deficiency Overview	System Condition Rating
Electrical	Electrical Distribution	The electrical service enters the building at the 277/480-volt 1200-amp main switchboard located in the electrical room, MAINELEC RM. The main switchboard appears to be original and in good condition. Transformer K in the MAINELEC RM is making excessive noise for its age, which earned an average rating. There are multiple branch panel boards and step-down transformers, which are located in various electrical rooms throughout the building. The branch panel boards and transformers appear to be in good condition. The electrical system appears to be in averageoperable condition. The building is not equipped with a lightning protection system.	Average
	Lighting	The building's exterior lighting consists of HID (high-intensity discharge) luminaires that are located along the perimeter. The majority of the building structure lighting in the corridors and classrooms consist of two-lamp fluorescent 2' x 4' recessed troffer fixtures. The lighting for the interior and exterior of the building appears to be in good condition. Sufficient exit lighting throughout the building appears to be in good operating condition.	Good

1. Inspect or service transformer "K" to insure it is still within its electrical capabilities and correct operational condition.
