Casey Elementary School Site Summary

Main School Building – BLDG-173A

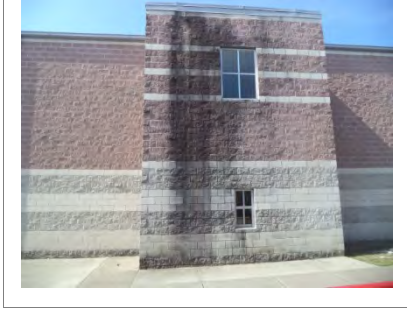
Exterior Walls

System	Subsystem	Condition and Deficiency Overview	System Condition Rating
		<p>properly. The active leaf was hitting on the inactive leaf. It was also reported the pair of doors on the south face of the building did not close properly. It was observed the closer was not working.</p> <p>The exterior doors were observed to be in average condition.</p> <p>It was observed and reported that there was a painting project being performed on the exterior doors.</p>	
Roofing		<p>The roof system used for this facility is modified bitumen. This is common to the building, the portico, and the canopy.</p> <p>The roof was observed and reported to be in poor condition.</p> <p>It was reported that ponding occurred on the main roof. It was also reported that a roof leak existed at the wall transition in room 116. The drywall was damaged, and an organic substance that has the appearance of mold was inside the wall. It was observed that areas of ponding occurred as well as areas with large bubbles under the bituminous material.</p> <p>The roof drainage system was observed to be in average condition.</p> <p>The roof drains are a system of gutters and downspouts that drain into an underground system. In areas with concrete paving or sidewalks, the downspouts are day lighted onto the concrete.</p> <p>It was reported the roof drainage system was in average condition.</p> <p>It was observed that there is an exception where that the gutter and downspout system on the canopy was badly damaged. Some of the downspouts were missing. Instances of an organic substance that has the appearance of mold were observed on the exterior block walls, which may be caused by either leaking or overflow of the gutter system.</p>	Poor

1. Identify the source of the gutter leak that is causing the [organic substance that has the appearance of mold](#). Perform repairs to stop leaking, which should include gutter cleaning and a gutter cleaning maintenance plan. Pressure wash the entire exterior of the building to remove [the organic substance that has the appearance of mold](#).
2. Adjust exterior door hardware and evaluate closers. Replace nonfunctioning closers.

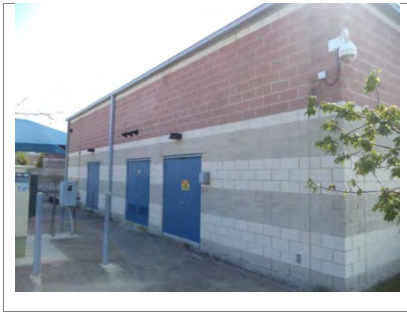
Exterior Doors	<p>There is one public entryway located at the east side of the building; there are one pair and two single leaf metal doors with a metal frame and half lites in each door. The remaining service doors around the facility are metal.</p> <p>The doors used for egress by students and faculty have various sizes of lites. The doors to mechanical and electrical rooms have no lites.</p> <p>The doors at the main mechanical room did not close</p>	Average

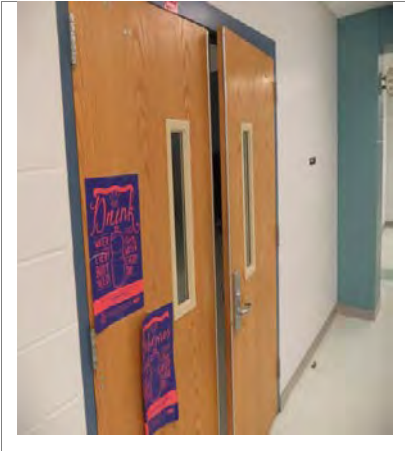
System	Subsystem	Condition and Deficiency Overview	System Condition Rating
	Interior Doors	<p>The interior doors in this facility are stained wood with hollow metal frames. These doors contain small lites with wire glass.</p> <p>It was observed that the doors were in average condition.</p> <p>It was observed that the doors from the cafeteria and the main corridor would stick in the open position. It was also observed that the door between the cafeteria and the kitchen did not close</p>	Average
	Interior Specialties	System not present.	N/A
Stairs	Exterior Stairs	<p>The exterior stairs in the facility are poured-in-place concrete with metal hand rails.</p> <p>It was observed that the stairs were in good condition.</p>	Good
	Interior Stairs	<p>This facility has two sets of interior stairs that are poured-in-place concrete and metal pan construction.</p> <p>It was observed that the stairs were in good condition.</p>	Good

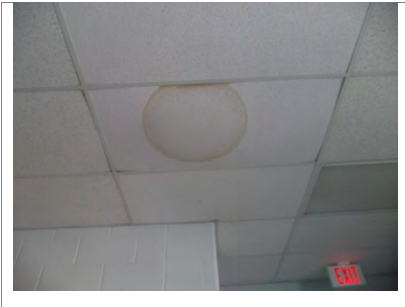
System	Subsystem	Condition and Deficiency Overview	System Condition Rating
	Interior Ceiling Finishes	<p>The ceilings throughout this building are a 2x4 suspended acoustical system.</p> <p>The ceiling tile was observed to be in poor condition.</p> <p>It was reported that in some places where wires suspend the ceiling, the wires have been cut by people who were working on the mechanical system.</p> <p>Water stained and damaged ceiling tile was observed throughout the building.</p>	Poor
Conveying	<p>The building is equipped with a hydraulic passenger elevator to service two levels. The elevator was noted as having a maximum weight capacity of 2,100-pounds.</p> <p>The elevator was observed to be in good condition and had a recent inspection certificate issued, which will expire in October 2016.</p>		Good
Plumbing	Plumbing Fixtures	<p>The building has one set of public restrooms for males and females located near the cafeteria. There are separate staff restrooms located throughout the facility. These restrooms typically have vitreous china hand sinks with manual faucets, along with vitreous china, floor-mount/wall toilets with manual flushing mechanisms, and vitreous china, wall-hung urinals in the male restrooms with manual flushing mechanisms. There are floor sinks found in the janitorial closets, and water coolers located throughout the facility. Each suite of classrooms has two restrooms with a floor-mounted toilet in each. Each classroom has a stainless steel sink with a goose-neck faucet and a water fountain. The building also includes plumbing fixtures in the kitchen.</p> <p>The plumbing fixtures were observed to be in average condition.</p> <p>It was reported that sewer gas problems caused by vent stacks that are too short and have caused the air conditioner to draw the sewage smell into the building.</p> <p>It was observed that a toilet in GHRR 100 was removed and replaced in a different place, leaving a dirty floor condition.</p>	Average

1. Replace broken ceramic bases as needed.
2. Remove carpet at steps to the stage. Determine if the floor under the carpet is the same hardwood as the stage and evaluate its condition. If it is hardwood and in acceptable condition; choose between refinishing the hardwood or replacing the carpet.
3. Replace damaged ceiling tile.

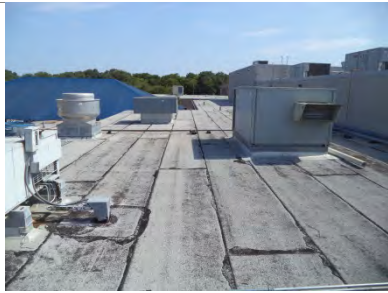
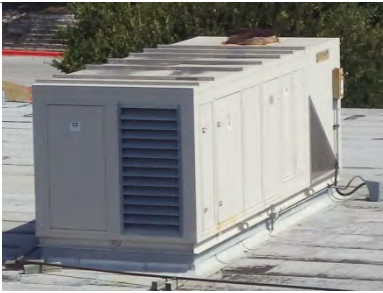
Mechanical/HVAC

System	Subsystem	Condition and Deficiency Overview	System Condition Rating
		the sanitary sewer system in the area of the kitchen due to corrosion.	
	Other Plumbing	System not present.	N/A
Mechanical/ HVAC	<p>The mechanical system has heating and cooling provided by ground source heat pumps, which serve the classrooms, the common areas, and the corridors. There are five package units located on the roof of the gymnasium, kitchen, and cafeteria. The library has a split system. There are also four fresh air units on the roof.</p> <p>It was in poor condition given the age of the equipment.</p> <p>It was reported the package units were original and were at the end of their design life.</p> <p>The MDF (main distribution frame) room is cooled by the split unit. It was reported that the compressor on this unit had been repeatedly replaced. This unit was at the end of its design life.</p> <p>It was observed that the mechanical system was reaching the end of its design life.</p>		Poor

1. Plan to replace aged HVAC equipment prior to failure.
2. Replace cooling equipment that serves the MDF room.

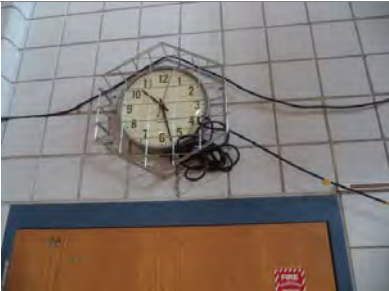
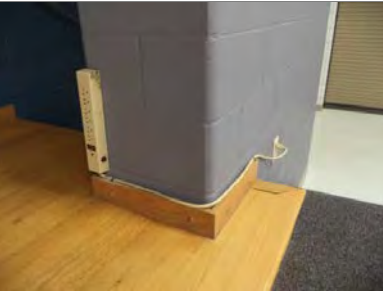
Electrical Distribution

System	Subsystem	Condition and Deficiency Overview	System Condition Rating
		<p>It was reported the Panel 3 BL surge protector had shorted out and needs to be replaced. It was reported that outlets were not properly anchored in the CMU wall and were falling out of the wall. It was reported that refrigeration unit C frequently tripped the breaker following an outage on the city side of the electrical system.</p> <p>It was observed that places in the gymnasium and cafeteria had power provided by surface-run extension cords rather than standard outlets.</p>	
	Lighting	<p>The interior lighting systems consist of 2x4 troffer fixtures in the suspended ceiling system. There is architectural wall-mounted lighting in the main entry. The lighting system was observed to be in poor condition because much of the equipment was out dated and spare parts were unavailable.</p> <p>It was reported that staff cannot turn on wall-mounted lights in the main entrance. It was reported there is insufficient lighting in corridor B. It was reported that some corridor lighting was controlled by remote ballasts. These ballasts were no longer available.</p> <p>The exterior lighting systems consist of a drum-type surface-mounted fixture in the portico; square surface-mounted fixtures are used in the canopy walkways. There is an assortment of wall packs used around the exterior of the building.</p> <p>It was reported the walkway's light fixture lenses were melting due to overheating by the bulbs.</p> <p>It was reported that lighting was insufficient in the parking lots and in the vicinity of the kitchen entrance.</p> <p>It was reported the emergency lighting system was dated and needs to be replaced with newer technology.</p>	Poor

1. Replace the panel surge protector in Panel 3 BL.
2. Anchor and reinstall all receptacle boxes in the CMU wall.
