Clayton Elementary School Site Summary

Address	7525 La Cross Avenue Austin, TX 78739
Number of Permanent Campus Facilities	1
Original Year of Construction	2006
Total Campus Building Area (combined)	102,295 SF

Main School Building – BLDG-184A

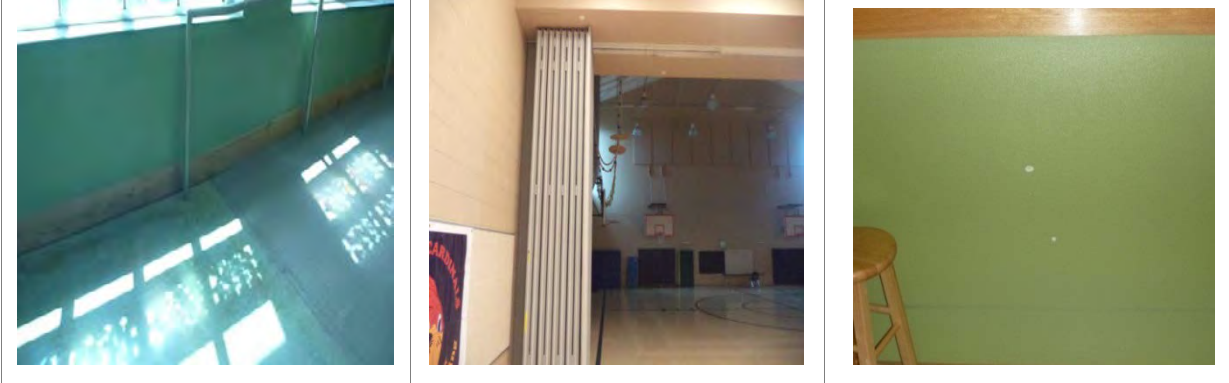
Interior Walls

Interior Doors	<p>The interior doors are wood with hollow metal frames as well as hollow metal framed interior windows.</p> <p>The interior doors and frames appeared to be in average condition, given their age of and typical wear and tear. No deficiencies were reported by facility staff.</p>	Average
	Interior Specialties	This system is not present.	
Stairs	Exterior Stairs	This system is not present.	N/A
	Interior Stairs	<p>The interior stairs are concrete and steel.</p> <p>The stairs appeared to be in average condition. It was reported there are no problems with the stairs.</p>	Average
Interior Finishes	Interior Wall Finishes	<p>The interior wall finishes consist of paint on drywall. There is ceramic tile wainscoting in the cafeteria at the hand sinks. The kitchen is constructed of CMU (concrete masonry unit) that is painted.</p> <p>The finishes were in average condition based on the age of the building. No problems were reported with the finishes. Water damage was observed on the wall and baseboards in corridor 6, caused by water intrusion during major storm events.</p>	Average

1. Contract a qualified technician to investigate and service the motorized partition, as reported by AISD Project Management.

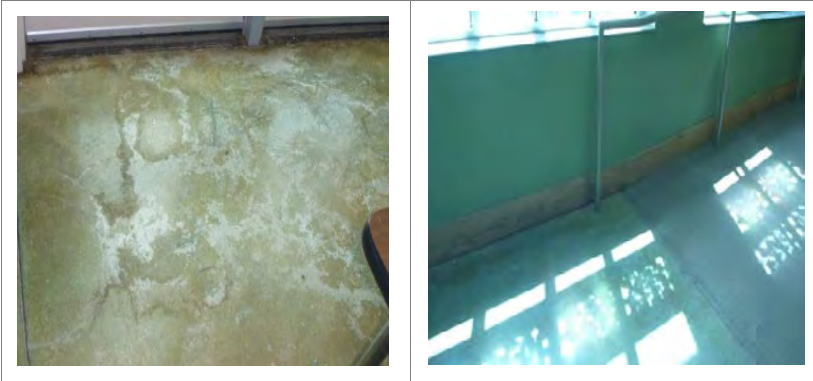
System	Subsystem	Condition and Deficiency Overview	System Condition Rating
	Interior Floor Finishes	<p>The interior flooring consists of stained concrete in the corridors and classrooms and carpet in the administration office and library. The flooring in the kitchen is ceramic tile.</p> <p>The flooring was in good condition. However, it was reported and observed that there is damage at the double doors in corridor 6 where water has leaked in from the courtyard during major storm events. The damages occurred to the floor finish and the baseboard.</p>	Good
	Interior Ceiling Finishes	<p>The ceiling systems consist of a 2x2 suspended acoustical ceiling system.</p> <p>The ceiling system was observed to be in average condition. However, it was reported and observed that there was ceiling damage in the art room from leaking during major storm events. AISD Project Management reported that the ceiling tiles are composed of perlite and are capable of becoming wet.</p>	Average

1. Repair damaged ceiling tiles. Monitor and repair roof leaks as needed.
2. Repair and repaint areas in corridor damaged by courtyard flooding.
3. When courtyard flooding issue is solved, replace baseboard and refinish concrete corridor floor damaged by water intrusion from courtyard.

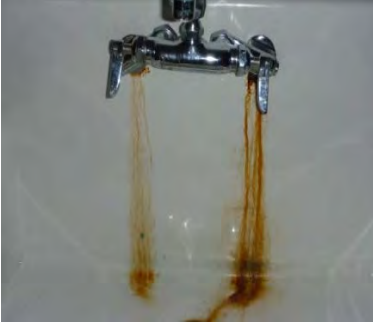
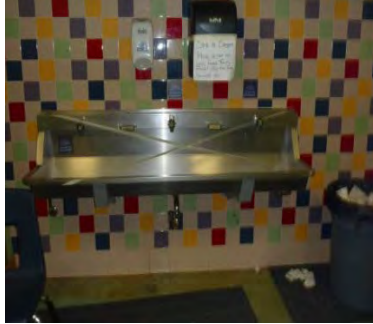
Plumbing Fixtures

System	Subsystem	Condition and Deficiency Overview	System Condition Rating
		<p>The building also includes plumbing fixtures in the kitchen for the school cafeteria and stainless steel hand sinks for the students.</p> <p>These plumbing fixtures were observed to be in average condition.</p> <p>It was reported that one of the hand sinks outside the cafeteria was inoperable because it was clogged. The drain was manufactured as part of the sink and may not be replaceable, which would make the sink unusable. These sinks do not have isolation valves so they have to be shut off at the mezzanine level in an emergency, which is not convenient.</p> <p>It was reported that there are no cleanouts for the grease traps for maintenance.</p> <p>A sewage smell was observed in the area of the gymnasium restrooms.</p>	
	Domestic Water Distribution	<p>The kitchen and administration areas are serviced with hot water from gas water heaters. There is a new water heater for the kitchen as well as two new instant water heaters. The janitorial closets have electric water heaters that are original.</p> <p>The domestic water distribution system was observed to be generally in poor condition due to hard water corrosion.</p> <p>The electric water heaters in the janitorial closets were observed to be nearing the end of their typical design service lives and were in need replacement. It was reported that gate valves in the classrooms need to be replaced with ball valves. The plumbing distribution equipment was reported and observed to be in poor condition based upon the damage from corroded piping.</p>	Poor

1. Explore the possibility of repairing the existing water softener. If it cannot be repaired, then a replacement should be considered.
2. Perform a water analysis to determine the iron concentration. If excessively high, an iron filter should be installed.
3. Replace plumbing faucets that are damaged by hard water corrosion.
4. Replace the drain on the hand sink if possible. If it cannot be replaced, then another sink will be required. At the time of the repair, add a shut-off valve at the sink.
5. Install grease trap outside the kitchen to solve grease accumulation in plumbing piping.
6. Replace aging water heater in custodial closets.

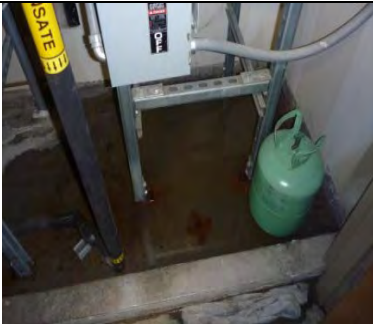
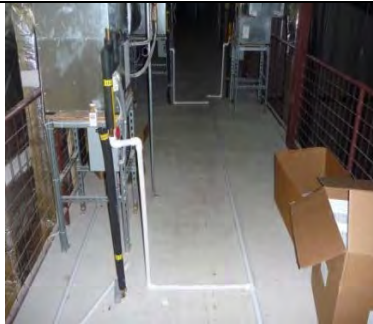
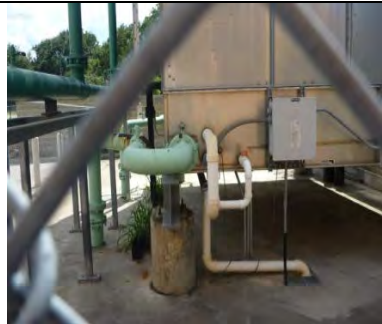
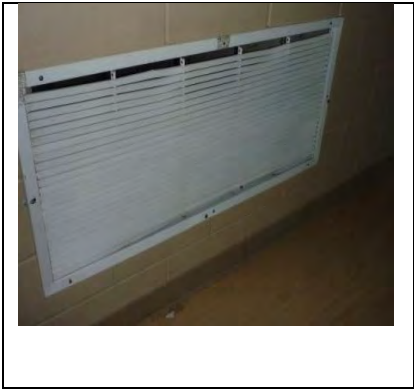
Mechanical/HVAC System Deficiency Examples

Other Plumbing	System not present.	N/A
Mechanical/ HVAC	<p>The HVAC (heating, ventilating, and air conditioning) system consists of heat pumps that service the classrooms and are located in the mechanical closets on the first floor and the mezzanines. There is one ducted unit on the roof of the cafeteria as well as two package units. There is one ducted unit in the main mechanical room. There are three package units for the library that are located in the second floor mechanical room. There are three fresh air units on the second floor, which are not operable and are LOTO (locked out and tagged out). There are 12 VAVs (variable air volume units) and four VFDs (variable frequency drives) utilized on the first floor. There are two gas-fired boilers in the main mechanical room and a cooling tower outside the kitchen dock.</p> <p>The HVAC system was observed to be in average condition. It was reported that the cooling tower was showing signs of age, as well as damage from hard water</p>		Average

System	Subsystem	Condition and Deficiency Overview	System Condition Rating
		<p>corrosion, including the box at the top, which needed replacement; the screen was also missing. There was an 8-inch pipe on the unit that was about 20% blocked by rust.</p> <p>It was reported and observed that the drainage in the mezzanine for the condensate did not work. It was reported the drains were blocked by construction debris from the original building construction or may be undersized.</p> <p>It was reported and observed that the mezzanine condensate drains were being drained by temporary PVC (polyvinyl chloride) piping that was running across floors to 3-inch drains.</p> <p>It was reported and observed that the VAVs in the corridors drained into a 2-inch drain that was blocked and did not function.</p> <p>It was observed that condensate was leaking on the floor of the HVAC 2 mechanical closet. A damaged cold air return louver was observed in the gymnasium.</p>

1. Unclog drains for condensate lines if possible. If not possible to unclog the drain, then the drains should be replaced, and the temporary piping removed.
2. Determine the source of the clog and repair the drain on the air conditioning unit in HVAC 2.
3. Replace the chiller's corroded piping and missing screen at the top of the unit.
4. Replace the return air grill in the gymnasium.

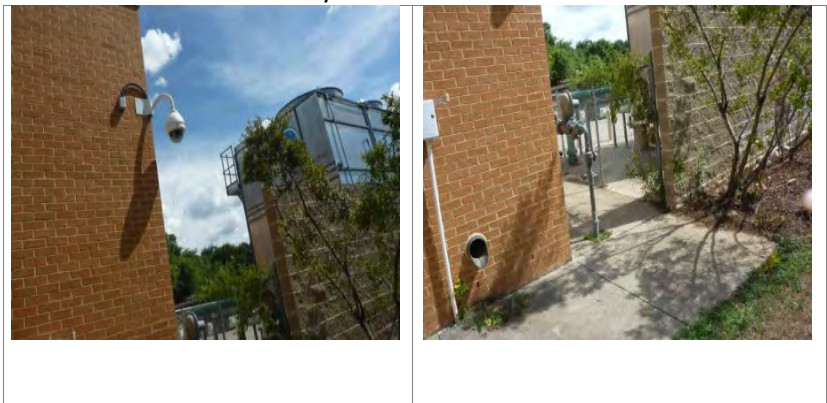
System	Subsystem	Condition and Deficiency Overview	System Condition Rating
		<p>average condition.</p> <p>It was reported that interior lighting was in good condition due to the ongoing maintenance program.</p> <p>It was reported that lighting in the stairwells was not sufficient. It was also reported the stairway light was difficult to access to change bulbs, and staff would prefer wall-mounted fixtures.</p> <p>It was reported that the interior exit lighting has a back-up battery system that has a very short life, causing frequent replacement.</p>	
	Communications & Security	<p>This facility has a building-wide Wi-Fi system, public address system, card readers, and security cameras.</p> <p>It was observed that the building system is in average working order.</p> <p>The Wi-Fi system was reported and observed to function well.</p> <p>The card readers were reported and observed to work well. However, there is a need for card readers at the exterior double doors that access the rear of the stage at Corridor 7 and the exterior double doors between the library and the music room in Corridor 8.</p> <p>It was reported and observed that the camera system is controlled by two different operating systems. A portion of the cameras are controlled by one system, and the rest are controlled by the other system, making it impossible to toggle between cameras to watch someone moving through the school. Additional problems with the camera system were reported and observed, including the camera outside the main mechanical room was not working and that two additional cameras were needed, one in the cafeteria near the serving line and one in the vestibule leading into the gymnasium.</p> <p>It was reported there is a need for a fence with a gate between the corner of the building near the main mechanical room and the wall around the chiller to prevent students from accessing the dock area.</p> <p>It was reported there is a serious vandalism problem that would be improved by putting a fence around the exterior of the school property.</p>	Average

1. Add cameras in the areas where there is insufficient coverage.
2. Provide a gate at the chiller wall to limit access into the dock for life safety reasons.
3. Add card readers at two exterior doors to improve school security.
4. Provide three new cameras outside the mechanical room and doc area.
5. Provide software for the CCTV system that utilizes one system and has a dedicated monitor.
6. Install a gate with a keypad between the chiller and the main mechanical room.
