## Cook Elementary School Site Summary

## Main School Building – BLDG-161A

## Stand-Alone Classroom Building – BLDG-161B

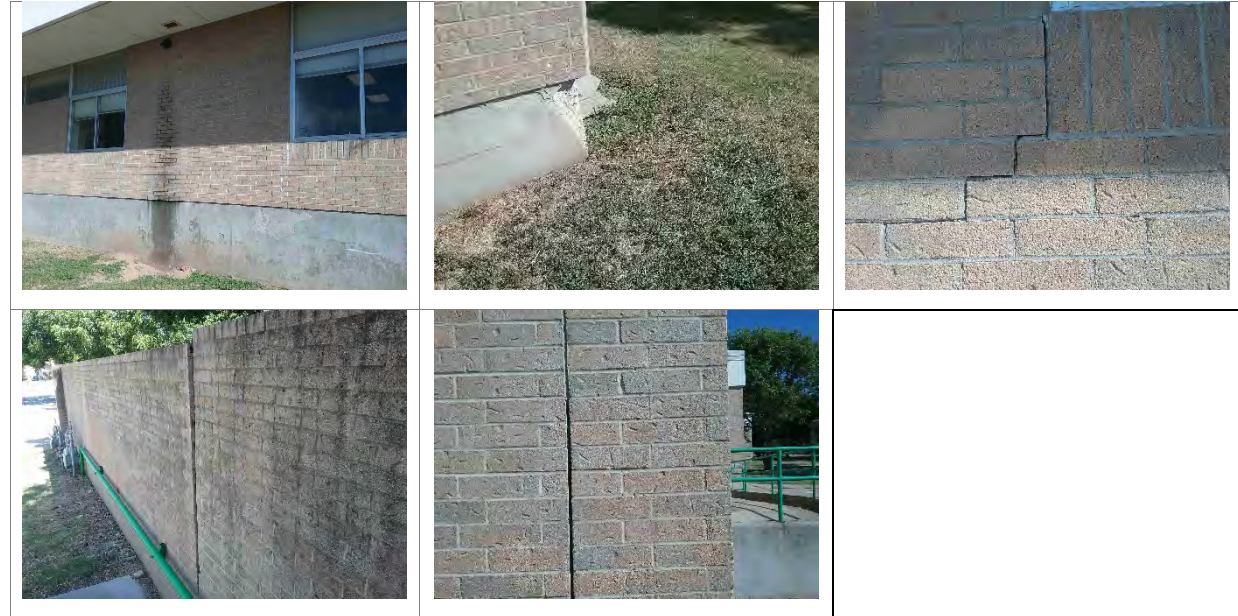
### Exterior Walls

System	Subsystem	Condition and Deficiency Overview	System Condition Rating
Exterior	Exterior Walls	<p>The exterior walls are brick veneer and plaster fascia over CMU (concrete masonry unit) backup. The cafeteria/gymnasium walls above the roof have a synthetic plaster finish over EFIS (exterior insulated finish system).</p> <p>The main building exterior walls were observed to be in average condition. The exterior walls of the newer classroom addition on the south and east elevations were observed to be in poor condition. Multiple large cracks were visible in the brick veneer and were likely related to reported foundation problems. There were broken corners visible at the foundation corners. Sealants on the main building appeared to be in average condition, but sealants on the south classroom addition were visibly deteriorated or missing. Organic growth was visible on the south classroom addition brick facade where roof drains discharged or gutters appeared to be leaking. The brick screen wall at the loading dock area was out of alignment with adjacent surfaces.</p>	Average

1. Further study the cause of cracks in the brick facade at the south addition and repair.
2. Repair spalled concrete corners and surfaces at the foundation on the south addition
3. Replace sealants at exterior walls where needed.
4. Replace or repair horizontal sliding exterior windows where operation is desired.
5. Ensure all glazing at building entrances is laminated glass, not acrylic.
6. Replace exterior doors and frames that have corrosion present.
7. Replace hardware at doors identified to have problems latching.
8. Repaint spandrel panels at exterior windows on the original part of the building.
9. Repair or replace the steel handrail at the loading dock.
10. Further study the cause of misalignment of the masonry screen wall at the loading dock and repair.

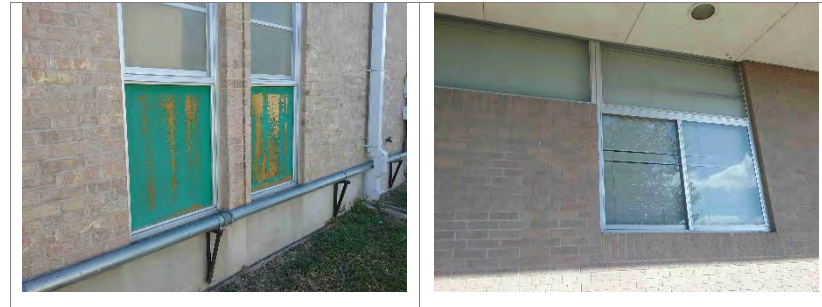
### Exterior Windows

Exterior Windows	<p>The exterior windows are metal-framed with single-pane glazing and are original to the building's and classroom additions' dates of construction. Most windows have an operable sash, and in the main building, have lower spandrel panels. Some of the windows in the south classroom addition have large horizontal sliding sashes.</p>	Average

System	Subsystem	Condition and Deficiency Overview	System Condition Rating
		The exterior windows were observed to be in average condition. The larger horizontal sliding windows were reported to be difficult to operate due to their size and age. The spandrel panels had visibly deteriorated painted surfaces. Sealants around the exterior windows were dry and visibly deteriorated.	
	Exterior Doors	The exterior doors are steel with metal frames. Building entry doors have side-lites and transoms. Doors to electrical and mechanical rooms have metal louvers.  The majority of the exterior doors frames and hardware were observed to be in average condition. Door frames near the kitchen and gymnasium had visible corrosion at the bottom. Some of the utility doors had corrosion and deteriorated paint surfaces. The exterior entry doors were reported to have problems latching. Some exterior entry doors and side-lites had acrylic glazing.	Average

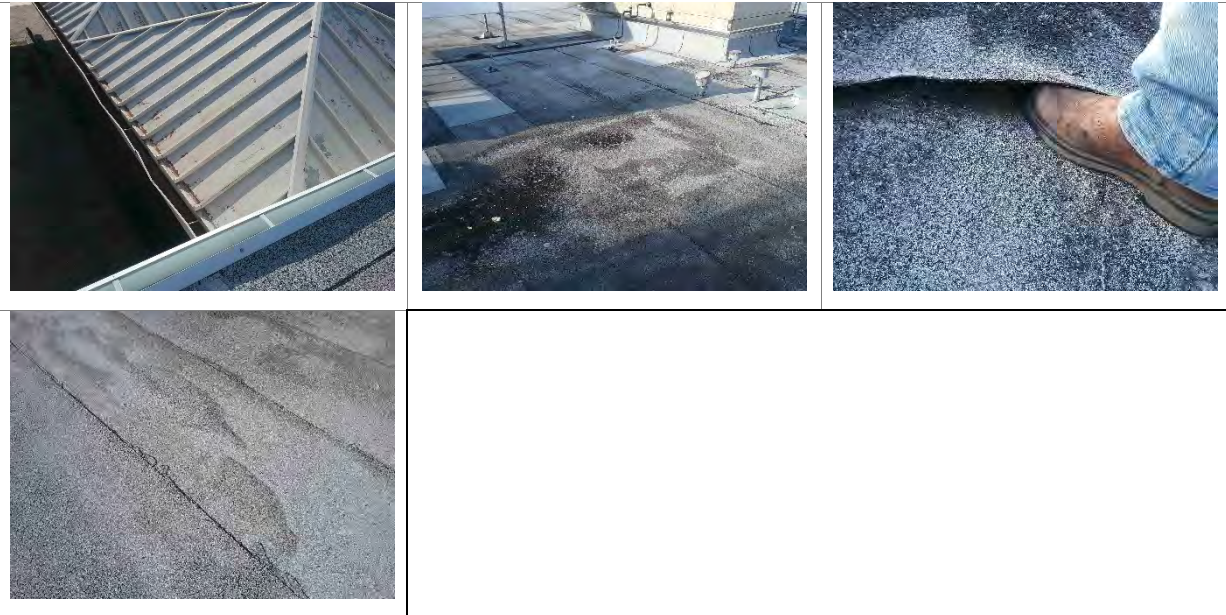
### Roofing Deficiency Examples

Roofing	<p>The main building's roof is a modified bitumen membrane. There is a small amount of standing seam metal roof at the clerestory above the south classroom addition. There are nine small hipped metal roofs with internal gutters that form the main building entry canopy. The original portion of the main building has continuous gutters and downspouts.</p> <p>The main building roofing had been replaced in sections at various times within the last 25 years. Warranty signage mounted on the roof indicated about 36% of the roof membrane would expire in 2026; this area was observed to be in good condition. The remaining modified bitumen roofing was visually aged out of service (estimated 1990) and observed to be in poor condition. Roof scuppers and internal drains were original, but gutters and downspouts appeared to be installed recently. The building roof membrane was in good to poor condition relative to its age. Some ponding was evident, regardless of roof age. Deteriorated surface membrane and cracking were visible at older roof areas. Older roof areas also had large blisters. Separation of end laps was observed at more recently installed areas. The perimeter gutter system appeared to be in good condition. Two internal roof drains were missing their strainers. The metal entry canopies had severe corrosion and 30% of their surface coating was gone. The metal canopy internal gutters were severely corroded and were filled with leaves.</p>		Average

1. Replace the modified bitumen roof membrane over about 64% of the building where aged and in poor condition within the next five years.

2. Replace the standing seam metal hipped roof panels and gutter system on the entrance canopies within the next five years.
3. Consider alternatives to the roof drain discharge points high on masonry exterior walls to eliminate rainwater from saturating the masonry and contributing to organic growth on the exterior walls.

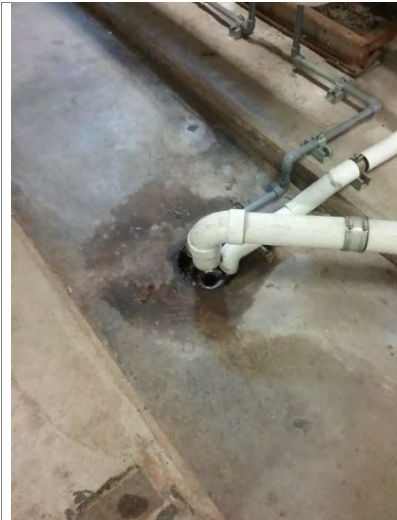
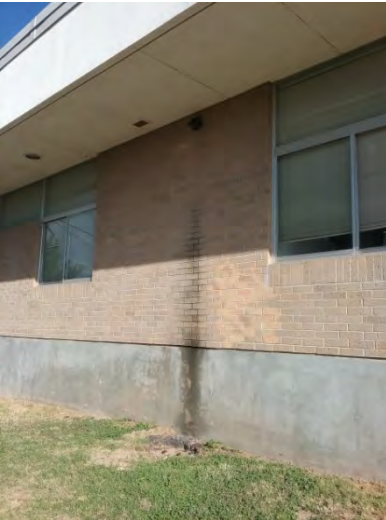
### Other Plumbing

Other Plumbing	<p>The roof was equipped with roof drains. The roof drains are equipped with metal grate covers to prevent debris from entering the drainage system.</p> <p>The roof drains were corroded. A roof drain cover was missing as well. Roof drains discharged water from the top of the wall, causing water ponding on the ground below and staining on the wall. Floor drains in the main mechanical room were missing covers. The plumbing system was equipped with a backflow preventer.</p> <p>The plumbing equipment serving the facility was observed to be in poor condition, primarily due to the age of the equipment and the deficiencies mentioned above.</p>	Poor
<b>Mechanical/ HVAC</b>	<p>The major mechanical equipment consists of plenum-mounted water-source FCUs (fan coil units), chilled water central station AHUs (air handling units), scroll chillers, an associated cooling tower, and RTUs (roof top units). An abandoned fan motor was observed on the exterior of the building near the south exterior mechanical room. These serve the HVAC (heating, ventilating, and air conditioning) system along with roof-mounted EFs (exhaust fans).</p>		Poor

1. Replace fixtures where corrosion or rust exists.
2. Repair or replace loose faucets.
3. Replace water coolers that are not cooling properly.
4. Repair or replace drain covers that are damaged or missing.
5. Reroute roof drains that discharge water from the top of the exterior wall.

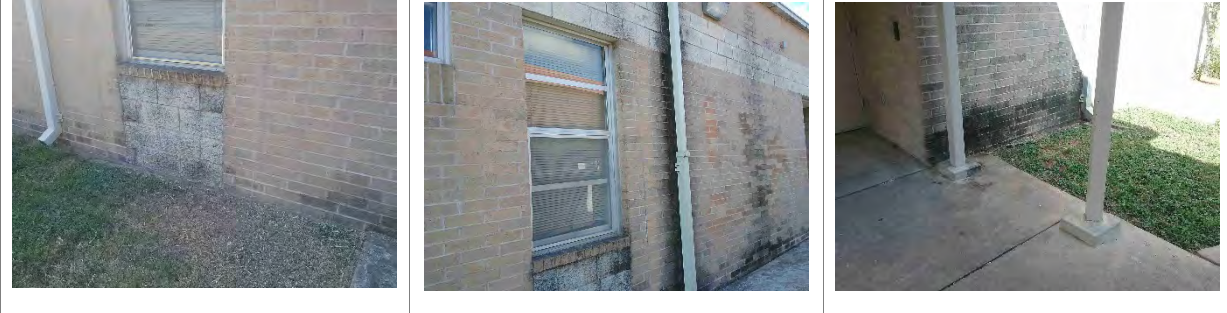
### Exterior Walls

System	Subsystem	Condition and Deficiency Overview	System Condition Rating
Exterior	Exterior Walls	<p>The exterior building facade is brick with a decorative CMU band and a CMU panel below the exterior windows.</p> <p>The brick and CMU facade appeared to be in average condition. Organic growth was visible on masonry surfaces around the building, especially on the CMU panels below windows, suggesting water may be entering at the sealant joint around windows. Other areas of organic growth were observed near downspouts and at the base of walls.</p>	Average
	Exterior Windows	<p>The exterior windows are metal-framed single-pane glazed with an operable sash. There are also horizontally oriented, fixed sash, metal-framed windows positioned high on classroom walls.</p> <p>The exterior windows were observed to be in average condition. The sealant around the windows was dry, hard, and cracked. Water infiltration was evident from the organic growth on the CMU surfaces below windows.</p>	Average

1. Replace sealant at masonry joints and around exterior windows and doors.
2. Clean masonry surfaces of organic growth. Identify the source of moisture intrusion that facilitates growth and repair.
3. Repair or replace the steel entry door on the building's west side.

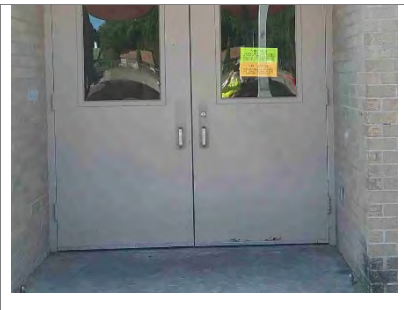
### Exterior Doors

Exterior Doors	<p>There are two pairs of steel entry doors with vision panels and transoms with hollow-metal frames. There is one pair of steel utility doors with hollow-metal frames at the mechanical room.</p> <p>The exterior doors, frames, and hardware were in good to average condition. Corrosion was visible on the west side building entry doors.</p>	Average

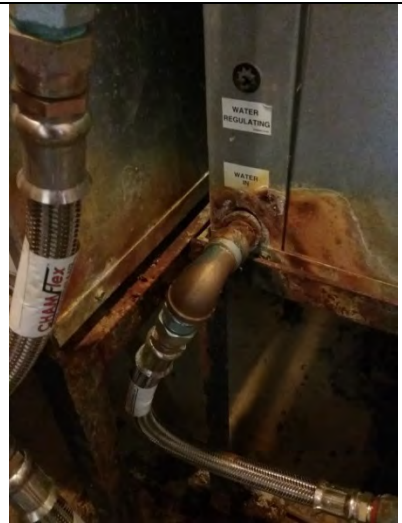
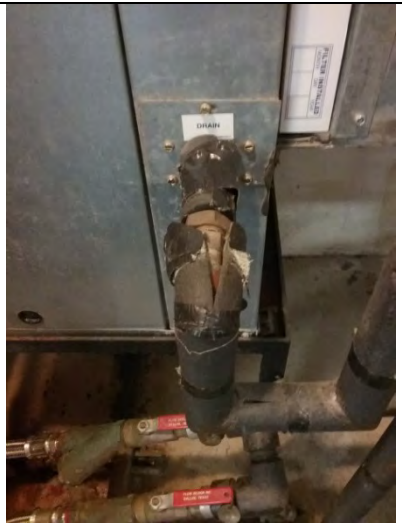
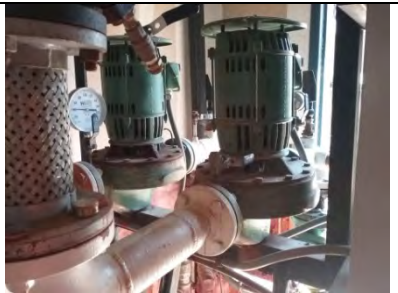
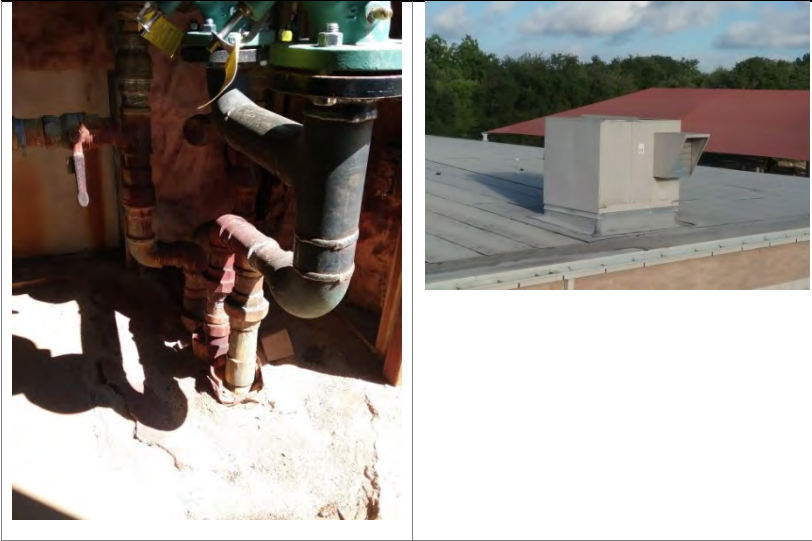
### Mechanical/HVAC System Deficiency Examples

<b>Mechanical/ HVAC</b>	<p>The major mechanical equipment consists of floor-mounted WSHPs (water source heat pumps), associated distribution pumps, and a roof-mounted heat recovery unit. These serve the HVAC system along with plenum-mounted restroom EFs.</p> <p>The HVAC system was in poor condition. The WSHPs were aged and near the end of their design service life. Several units were corroded at the piping connections. Condensate drain piping insulation associated with several units was missing or damaged. Building staff reported that WHP-1 had to be filled with water constantly and frequently experienced flooding issues in the mechanical room and adjacent classrooms. It was also reported that all heat pumps were off line because the well was dry. The units appeared to be operating at the time of assessment. The distribution pumps appeared to be aged and needed replacement in the near future. The associated distribution pump piping was rusted and corroded. The heat recovery unit was located on the roof and was inaccessible at the time of assessment. From inspection from the main building's roof, the unit appeared to be aged and near the end of its useful life.</p> <p>Supplemental mechanical equipment for the HVAC system included ceiling-mounted restroom EFs. The fans appeared aged and in poor condition.</p>		Poor

1. Plan for replacement of the WSHPs as they appeared to be past or near the end of their design service life.
2. Plan for replacement of the distribution pumps as they appeared to be past or near the end of their design service life.
3. Plan for replacement of the EFs as they appeared to be past or near the end of their design service life.
4. Plan for replacement of the energy recovery unit as it appeared to be past or near the end of its design service life.
