## Cowan Elementary School Site Summary

The Cowan Elementary School campus is located at 2817 Kentish Drive in Austin, Texas. Cowan Elementary School was established in 1999, and consists of the primary school building, referred to as the Main School Building (BLDG-183A).

**Main School Building – BLDG-183A**

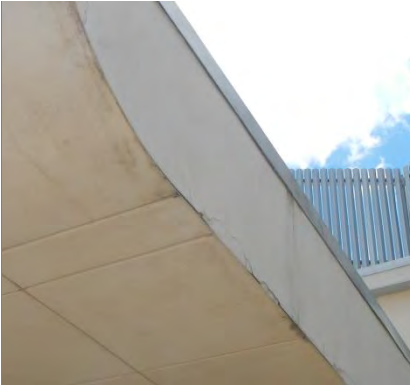
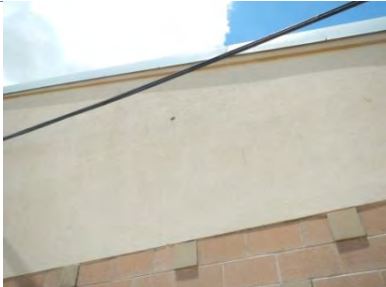
System	Subsystem	Condition and Deficiency Overview	System Condition Rating
<b>Exterior</b>	Exterior Walls	<p>The exterior of the building consists of a split-faced block made from CMU (concrete masonry unit) and shotcrete façade.</p> <p>The exterior walls were in average condition, with isolated areas where staining was present from a lack of downspouts and gutters causing rain splash back on the exterior CMU and shotcrete. Minor cracks and small penetrations were observed around the exterior of the facility. Divots were present in the shotcrete siding of the southeast side of the facility. Cracks were apparent in the southeast side of the school entry awning.</p>	Average
	Exterior Windows	<p>The exterior windows consist of single-pane glazing units with metal frames. The windows are original to the facility's construction.</p> <p>There were no reported deficiencies with the exterior windows. It was observed that the windows were in good condition.</p>	Good

1. Clean the stained brick façade where splash back stain is present. Install gutters and downspouts to collect and discharge rain runoff away from the base of the facility walls.
2. Repair cracks located in the entryway awning.
3. Repair divots in the shotcrete.
4. Repair all exterior doorway mullions that exhibit corrosion.

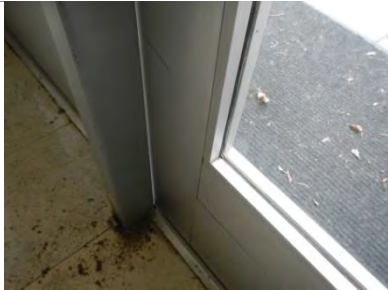
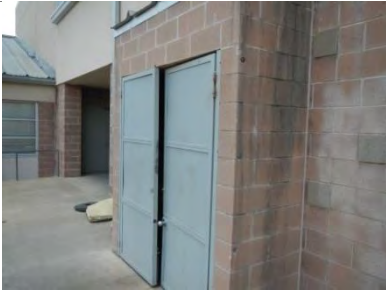
Exterior Doors	<p>There is one main public entryway located at the northwest side of the building. This consists of a pair of double doors that are metal with interior glazing and a metal frame. The remaining service doors around the facility are metal double doors with interior glazing and metal frames.</p> <p>It was observed that the mullion located at the northeast end of corridor N is corroded along the base. It was observed that the exterior doors to the kitchen storage room had no mullion and did not close properly. The</p>	Average

System	Subsystem	Condition and Deficiency Overview	System Condition Rating
		exterior doors were in average condition due to age, high usage, and minor rusting of the metal frames.	
<b>Roofing</b>	<p>The material covering the roofing of the building consists entirely of a standing seam metal roof. There is a covered walkway for access to the roof top mechanical equipment over the kitchen and library.</p> <p>The roof surfaces were in average condition. It was reported that the facility was experiencing multiple roof leaks along corridor N, the southeast end of corridor W, the library, the teachers' lounge, room S1, and corridor E adjacent to room E1. Most of these roof leaks were reported as having unknown origins. The exception was the leak in corridor W adjacent to room N1 which was reported and observed to be caused by a gap in the roof construction.</p>		Poor
<b>Interior Construction</b>	Interior Walls	<p>The interior partitions original to the building are predominantly constructed of painted CMU. The administrative offices and the library have painted gypsum board construction.</p> <p>The interior partitions appeared to be in average condition. At the intersection of corridor E and corridor 7, a minor crack was observed along the ceiling and cascading down corridor E. Based on these observations, the interior walls were rated as having an average condition.</p>	Average

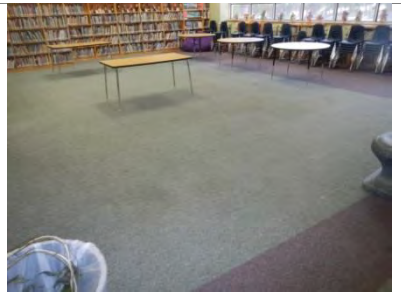
### Interior Floor Finishes

Interior Floor Finishes	Vinyl composition floor tile is found throughout the building and is original to construction. Ceramic tile floor is present in the restrooms. The administrative offices,	Average

System	Subsystem	Condition and Deficiency Overview	System Condition Rating
		<p>music room, and library are finished with carpet. The flooring appeared to be in average condition as minor scuffing was observed throughout the vinyl tile flooring system. Roof leaking was reported and observed throughout the library as damaging the carpeting.</p> <p>It was reported that rooms N11 and N12 experienced water intrusion along the base of the floors during high-intensity rain events, causing minor flooding and damage in the rooms.</p> <p>The flooring was in average condition.</p>	
	Interior Ceiling Finishes	<p>The interior ceiling consists of standard 2x4 acoustical fiberglass ceiling panels located throughout the facility and painted gypsum board in the classroom restrooms and mechanical and janitorial closets.</p> <p>The interior ceiling tiles were observed to have water damage on 5% of the tiles from potential roof leaks. The staff had been replacing the tiles as they were damaged. The ceiling was reported and observed to be in average condition, based on the aforementioned deficiency.</p>	Average

1. Repair and seal roof leaks, and replace damaged ceiling tiles with new matching ceiling tiles and replace impacted carpeting.

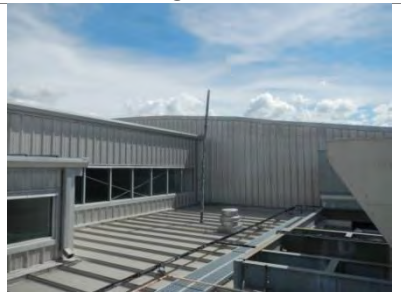
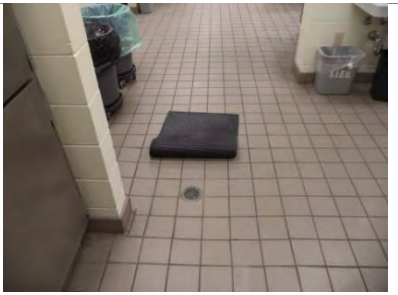
### Other Plumbing

System	Subsystem	Condition and Deficiency Overview	System Condition Rating
		cafeteria kitchen. The plumbing distribution equipment was reported and observed to be in average condition.	
	Other Plumbing	The school utilizes cast iron piping in the walls to discharge sewer gases and PVC (polyvinyl chloride) piping on the roof to move the gases away from HVAC air intake vents. It was reported that the cast iron ventilation piping in the facility walls had experienced corrosion, causing sewer gas to emanate throughout the facility. It was observed that the PVC piping was corroding on the roof. The floor drains in the kitchen were reported as having nonfunctional p-traps, allowing sewer gas to emanate into the kitchen. The kitchen staff have to cover the floor drains to contain the gas odors. Based on these reports, other piping was in average condition.	Average
<b>Mechanical/ HVAC</b>	The major mechanical equipment consists of classroom console units and AHUs (air handling units) located primarily on the roof of the school. There is a cooling tower to service the AHUs located on the southeast side of the facility. These serve the HVAC (heating, ventilating, and air conditioning) system. The school boilers that service the kitchen are gas fired. There are six RTUs (roof top units) and two ERUs (energy recovery units) are located on the roof of the facility. Supplemental mechanical equipment for the HVAC system includes exhaust fans. These units are original to the facility and were reported to reach the end of their useful life within the next ten years. It was observed that insulation on the HVAC ductwork of RTU4 was peeling from the HVAC conduit. The HVAC system was reported and observed to be in average condition.		Average

1. Replace toilet wax rings and reset toilets to seat properly.
2. Test the sewer gas discharge system to locate pipe leaks and replace piping as needed to contain and discharge sewer gases properly.
3. Replace the PVC piping for roof sewer gas discharge so as not to discharge gas adjacent to an HVAC intake.
4. Repair or replace the kitchen floor drain traps that are not functional.

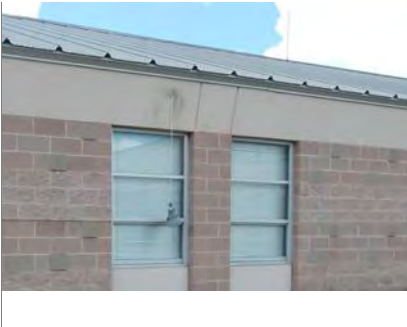
#### Communications & Security

Communications & Security	There is a security system including surveillance cameras in the building. There is a communications system for the school that consists of an intercom system. The building is equipped with telecommunications systems with the main backbone equipment located in an inaccessible room. It was reported that there were no noticeable problems with the telecommunications systems. It was observed that an outside intercom speaker was dislodged from its mount and hanging by electrical wiring. The communications and security system was reported and observed to be in average condition.	Average

1. Provide additional panels for additional electrical capacity.
2. Provide additional low-voltage panels throughout the facility.
3. Repair and remount exterior intercom speakers to a secure foundation against the exterior of the facility.
