## Cunningham Elementary School Site Summary

## Main School Building – BLDG-113A

Building Purpose	Administration Offices, Classrooms, Cafeteria, and Gymnasium
Building Area	51,844 SF
Inspection Date	July 27, 2016
Inspection Conditions	Rain, then sunny and hot
Facility Condition Index

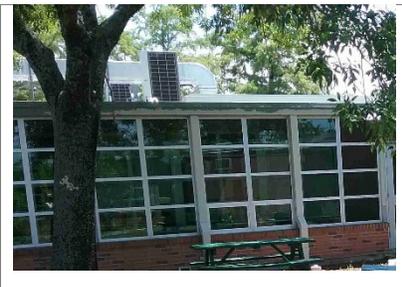
System	Subsystem	Condition and Deficiency Overview	System Condition Rating
Exterior	Exterior Walls	<p>The main building's exterior walls are brick veneer. The taller exterior walls that project above the single-story roofline have a painted stucco finish (at gymnasium) or are pre-finished metal siding (at library).</p> <p>The exterior walls were observed to be in good condition. The paint on the exposed steel structure of cantilevered roof sections appeared to be aging with oxidation and fading. Paint on the gutters in the courtyard was peeling. Sealants were showing age but appeared to be in average condition.</p>	Good
	Exterior Windows	<p>The exterior windows are metal-framed with single-pane glazing. Most windows are original to the building except at corridor C5 surrounding the courtyard. These windows were installed most likely when the newer library addition was constructed and walkways enclosed.</p> <p>The windows were observed to be in average condition. Windows in the 300-wing and along corridor C5 at the courtyard were reported to leak during rain events. Sealant around windows was dry and cracked.</p>	Average

1. Repair leaking exterior windows and resolve water intrusion at corridor C5 on the west side of the 300-wing. Replace sealants around windows as needed.
2. Paint gutters in the perimeter of the courtyard.

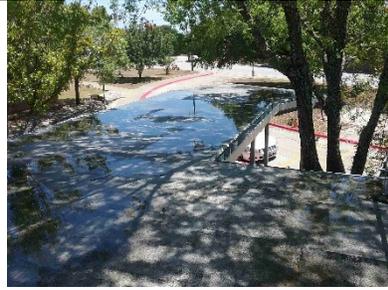
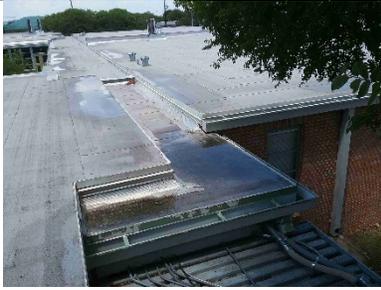
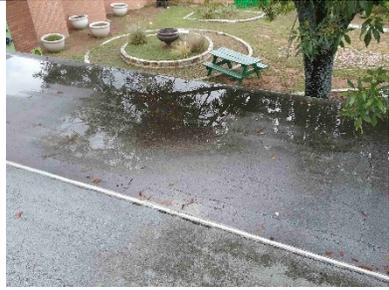
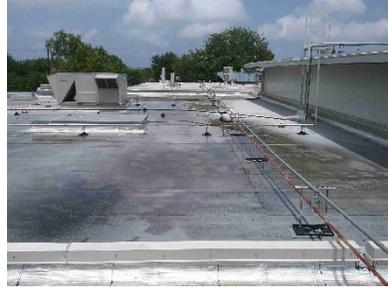
**Roofing Deficiency Examples**

System	Subsystem	Condition and Deficiency Overview	System Condition Rating
<b>Roofing</b>		<p>The roof is predominantly modified bitumen with a small section of steep sloped metal roof over the gymnasium office and storage. There is a gutter and downspout system at the roof perimeter.</p> <p>The building roof was observed to be in average to poor condition. The modified bitumen roof membrane is near end of life with cracks showing in the granular surface. Significant ponding was observed over much of the building roof and specifically over the main entrance and administrative areas. Ponding was commonly found at the edge of the roof where water was retained by the edge flashing.</p>	Poor
<b>Interior Construction</b>	Interior Walls	<p>The interior walls are constructed of CMU (concrete masonry unit), framed gypsum board panels, brick, and glazed masonry units. Corridor C5, surrounding the courtyard, has been converted from an exterior covered walkway to an enclosed corridor with the original brick walls and metal windows exposed. The newer library addition has framed gypsum board walls. The recently renovated 100-wing has glazed masonry unit and CMU walls creating a restroom core. Classrooms in all three wings have framed gypsum walls.</p> <p>The interior walls were observed to be in good condition relative to their age. General scuffing and wear was visible in high traffic areas.</p>	Good

1. Replace areas of roofing that are aged out of service and areas where ponding is occurring. Slope roof appropriately to remove rainwater and eliminate ponding at roof edge.

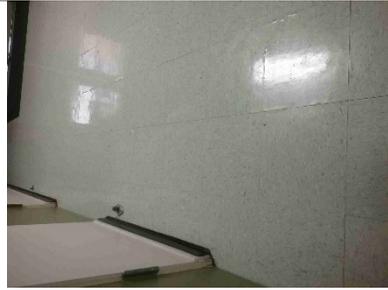
**Interior Floor Finishes**

System	Subsystem	Condition and Deficiency Overview	System Condition Rating
<b>Interior Finishes</b>	Interior Wall Finishes	<p>The CMU and gypsum board interior wall finishes are painted. There is ceramic wall tile in restrooms. Glazed masonry units are found in the kitchen. The cafeteria and gymnasium walls are both glazed masonry below and painted CMU on the upper half. There is a moveable wall system separating the cafeteria and gymnasium. Many of the corridor walls between classroom wings are the exposed brick of the original building exterior.</p> <p>Interior walls were observed to be in good condition relative to their age. Wall finishes had general scuffs and wear.</p>	Average
	Interior Floor Finishes	<p>The interior floors throughout the building are primarily vinyl tile. The library has carpet, quarry tile is found in the kitchen areas and the gymnasium has athletic flooring.</p> <p>The vinyl flooring in the 200- and 300-wings and in corridors was in average to poor condition. The vinyl tile in administration and the 100-wing had been recently replaced. The carpet in the library appeared relatively new and in good condition. It was reported that the floor in the library workroom had been damaged by flooding. The kitchen quarry tile appeared to be in good condition. There was reported damage to flooring in the 300-wing due to water from various causes; roof leaks, window leaks, or seepage from exterior. This damage was not observed but could have been obscured by furniture.</p>	Average

1. Repair vinyl flooring where damaged from water intrusion.
2. Replace stained and damaged ceiling tiles once roof leaks are resolved.

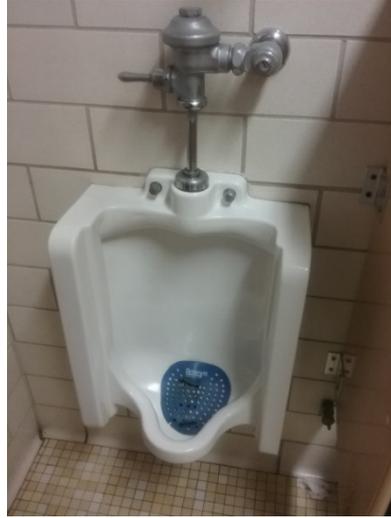
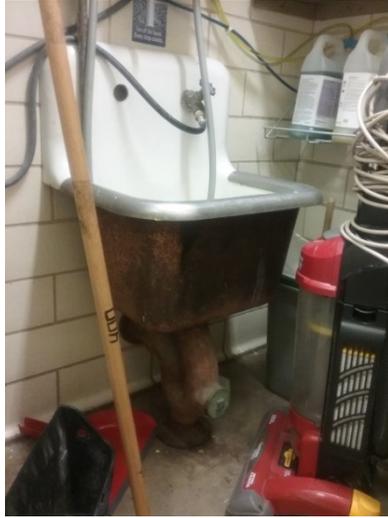
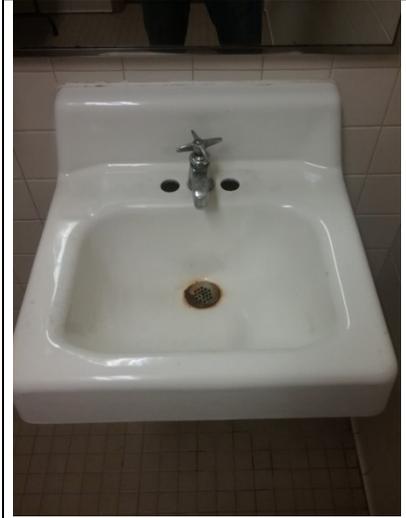
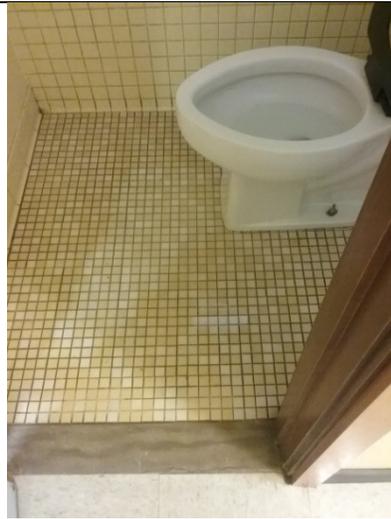
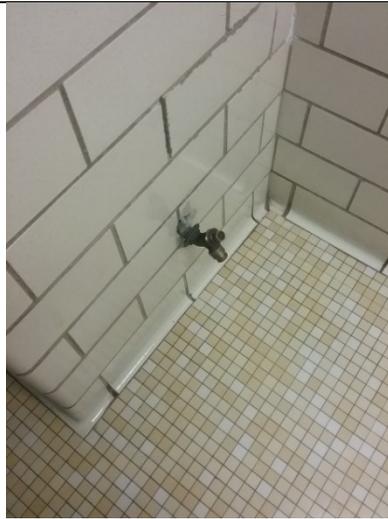
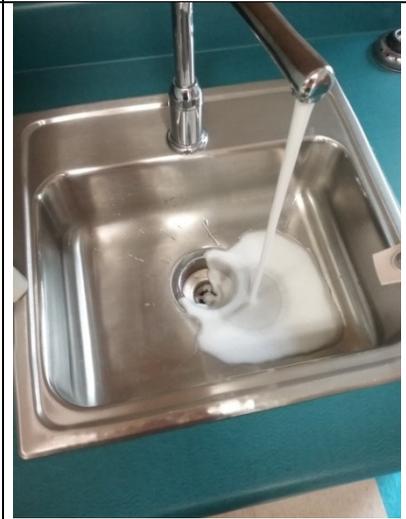
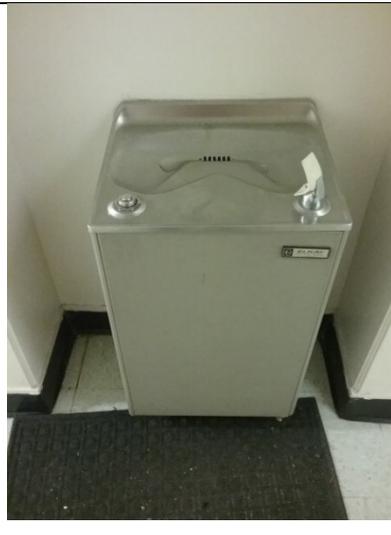
**Plumbing Fixtures**

Interior Ceiling Finishes	<p>The interior ceilings are a mix of exposed structure and roof deck and suspended lay-in acoustical tile. The gymnasium and corridor C5 have exposed structure as do classrooms in the newly renovated 100-wing. The cafeteria, library, administration, and 200- and 300-wings are mostly suspended acoustical tile.</p> <p>The interior ceilings were observed to be in good condition. There were many newly replaced ceiling tiles observed, possibly due to staining caused by roof leaks.</p>	Good
<b>Conveying</b>	<p>The building is equipped with an ADA (Americans with Disabilities Act) chair lift, located in the cafeteria that was installed less than a year ago. This ADA lift appears to be in excellent condition, and no operational issues were reported by the facility staff.</p>		Excellent
<b>Plumbing</b>	Plumbing Fixtures	<p>The building has shared public restrooms for students and separate staff restrooms located throughout. The classrooms are equipped with sinks mounted in</p>	Poor

System	Subsystem	Condition and Deficiency Overview	System Condition Rating
		<p>laminated counters with faucets and bubblers. The restrooms have vitreous china hand sinks with manual faucets, along with vitreous china toilets with manual flushing mechanisms. There is a staff and handicap accessible unisex restroom with a vitreous china sink, toilet, and wall-mounted urinal. There are service sinks found in the janitorial closets and water coolers located throughout the facility, typically near the public restrooms. The kitchen includes additional plumbing fixtures: stainless steel wash sinks and a vitreous china floor-mounted toilet and sink in a small restroom.</p> <p>The restroom plumbing fixtures were observed to be in average condition as the fixtures were aged but still operational with noticeable wear. Corrosion was observed on the associated sink drain piping throughout the building. Several sink drains were rusted. Select classroom restrooms in the 200-wing had standing water in them. It was unclear if the recent rain or a plumbing leak was responsible. The restrooms in the 100-wing had hose bibs present. The faucets located in classrooms 405 and 406 discharge white milky water. Rust was observed on several service sinks in the janitorial closets. Numerous water coolers were not cooling properly. It was reported by building staff that numerous toilets continued to flush longer than necessary. Building staff reported that select toilets throughout the facility continued to flush after pressing the handle.</p> <p>The plumbing fixtures were observed to be in poor condition due to the age of the fixtures and the deficiencies mentioned above.</p>

1. Continue preventive maintenance on aged plumbing fixtures and plan for replacement in the future, as fixtures continue to age.
2. Replace rusted and broken fixtures as needed.
3. Replace rusted roof drains as needed.

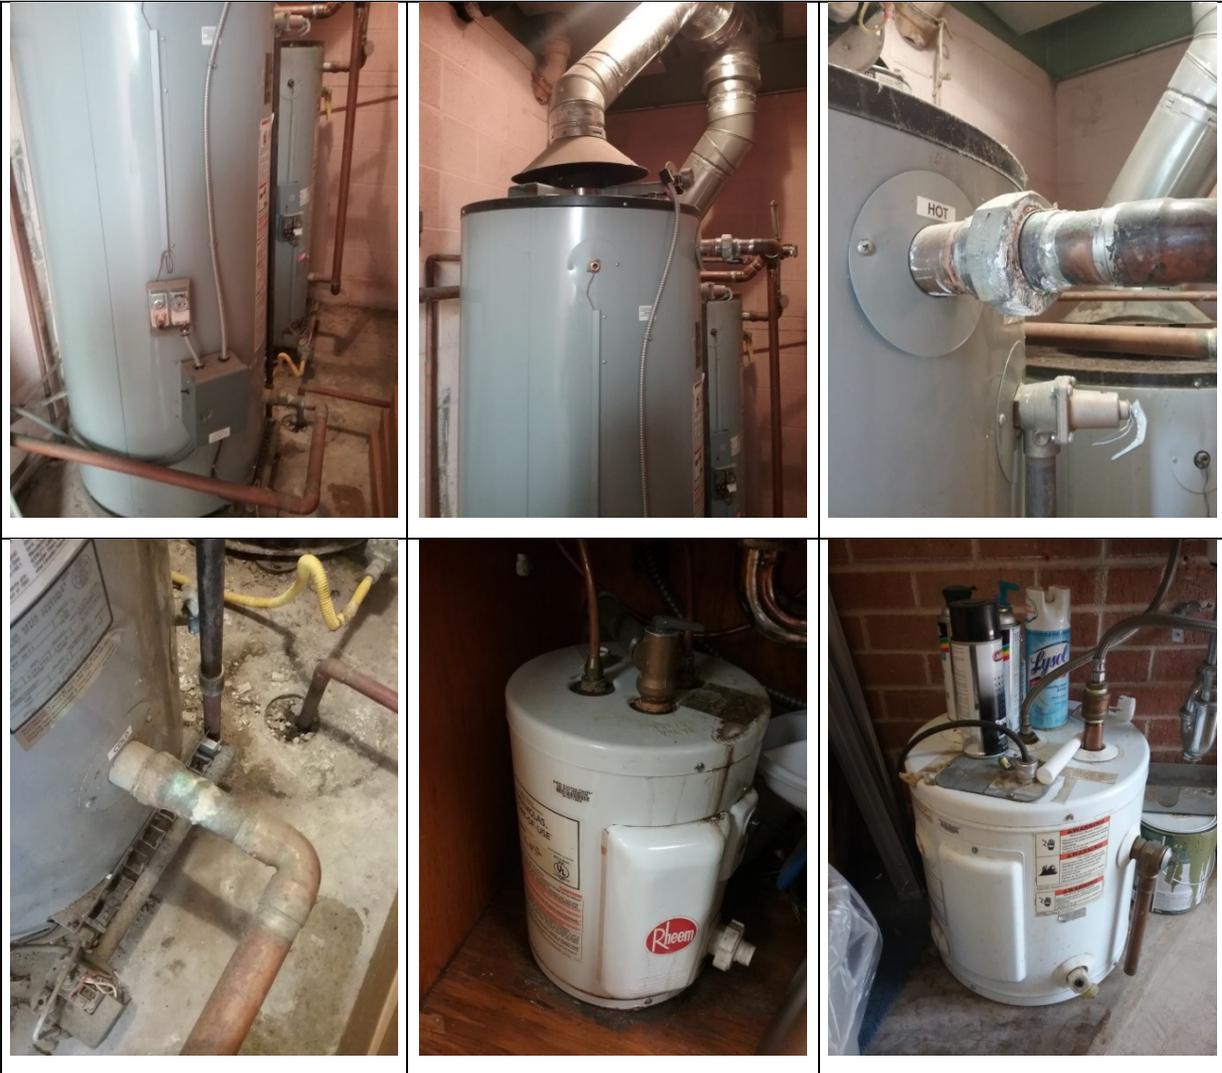
Domestic Water Distribution	<p>Hot water is provided to multiple areas by a series of water heaters. Gas water heaters GWH-1 and GWH-2, located in the kitchen mechanical room; provide the kitchen hot water service. The hot water to the lounge, gymnasium office, janitorial office, art room, and science classroom is provided by a series of localized small EWHs (electric water heaters).</p> <p>The kitchen water heaters were functioning, but nearing the end of their useful lives. Leakage and corrosion was observed at the hot water piping connections to the water heaters. The small EWHs were functional but appeared to be near the end of their useful lives. The building staff reported that the art classroom did not receive sufficient hot water. It was also reported that the</p>	Poor

System	Subsystem	Condition and Deficiency Overview	System Condition Rating
		<p>kitchen water pressure was insufficient.</p> <p>The plumbing distribution equipment was observed to be in poor condition based upon the deficiencies of the water heaters mentioned above.</p>	
	Other Plumbing	<p>Roof drains are present with condensate piping draining into them.</p> <p>The roof drains were rusted and need replacement. Building staff reported that the kitchen grease trap drain clogged approximately eight to ten times per year and that a portion of the drain line had collapsed. It was reported that the 100- and 400-wings' plumbing systems lack water shut-off valves, which requires that the school's water supply be shut off when work occurs in those areas.</p> <p>These systems appeared to be in poor condition due to their age and the deficiencies mentioned above.</p>	Poor
<b>Mechanical/ HVAC</b>		<p>The major mechanical equipment consists of package RTUs (roof top units) located on the roof and serving the non-classroom areas of the building, two outside AHUs (air handling units) providing outside airflow throughout the entire building, ceiling-mounted split system AHUs providing cooling in the classrooms, and ground-mounted ground source heat pumps providing cooling in the classrooms. These serve the HVAC (heating, ventilating, and air conditioning) system along with roof-mounted (EFs) exhaust fans.</p> <p>Eight RTUs, ranging in capacity from an estimated 10- to 25-TON, are located on the roof. Eight floor-mounted, ground source heat pump units were located in the classrooms and select other areas. The RTUs and floor-mounted units appeared to be aged and need replacing. The RTUs had damaged or missing insulation on condensate piping, rusting on the gas piping, and rusting on the unit housing. The disconnects also appeared to be rusted and aged. The RTU condenser coils appeared to be damaged. Nineteen split-system AHUs are located in classrooms throughout the building and range from an estimated 3- to 5-TON in capacity. They were in good condition as they appeared to be installed within the last five years. The MDF (main distribution frame) room was inaccessible for assessment but appeared to be served by a wall unit. The condensing unit was visible from the exterior of the building in the courtyard and appeared to be damaged and aged. Abandoned compressors were observed near the kitchen RTU. The wall air conditioning unit serving the janitorial office was reportedly no functioning and needs replacement. It was reported that the RTUs are aged, undersized and need replacement.</p> <p>Supplemental mechanical equipment for the HVAC system also includes roof-mounted restroom and kitchen EFs. The fans appeared to be outdated.</p> <p>The HVAC system was observed to be in poor condition based on the prior mentioned deficiencies.</p>	Poor

1. Track the installation year of water heaters and plan for replacement as the typical design service life for a water heater is 10 to 15 years.
2. Repair or replace any damaged or missing piping insulation as needed.
3. Remove rust and paint/protect gas lines from further rusting as needed.
4. Investigate the white milky discharge from faucets in rooms 405 and 406, and correct as needed.
5. Replace rusted service sinks.
6. Replace or repair nonfunctioning water coolers.
7. Replace or repair toilet fixtures that were reported to continuously flush.

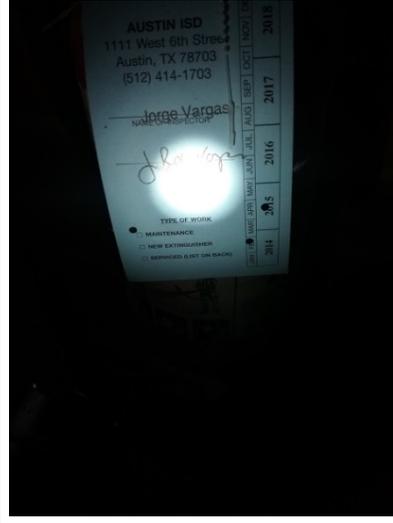
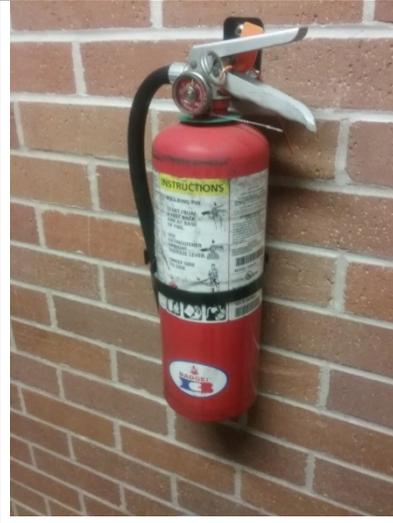
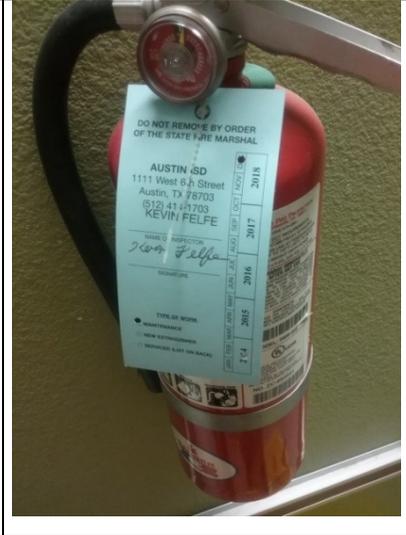
#### Fire Protection/Suppression

System	Subsystem	Condition and Deficiency Overview	System Condition Rating
		<p>which appeared to be in average condition.</p> <p>The system consists of alarm and signaling devices such as strobes, horn and strobe combination devices, pull stations, and detectors that appeared to be in good condition.</p>	
	Fire Protection/Suppression	<p>There are no fire sprinkler systems installed in the building. Fire extinguishers are located throughout the building and were observed to have been inspected within the last year for most of the building. Fire extinguishers which not been inspected within the last year were located in the main mechanical room and the 300-wing corridor. The fire extinguisher located in the 200-wing corridor did not have an inspection tag. There is a fire suppression system present in the kitchen, which is incorporated into the range hood.</p> <p>The fire protection system appeared to be in average condition.</p>	Average

1. Inspect fire extinguishers to bring them up-to-date and replace aged fire extinguishers.
2. Continue annual inspections of the Fire Alarm System and replace any aged fire alarm devices throughout the building.

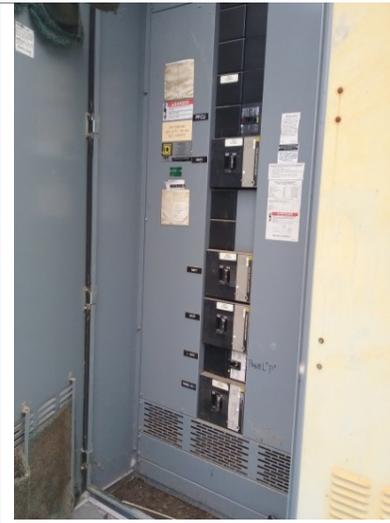
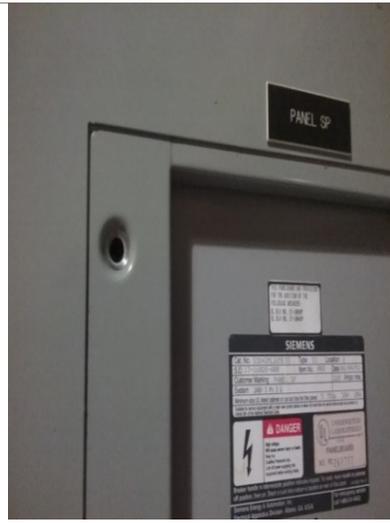
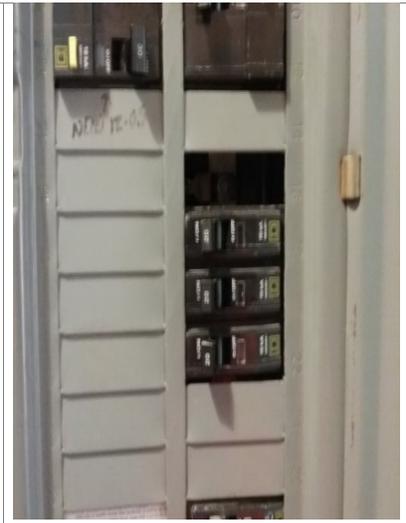
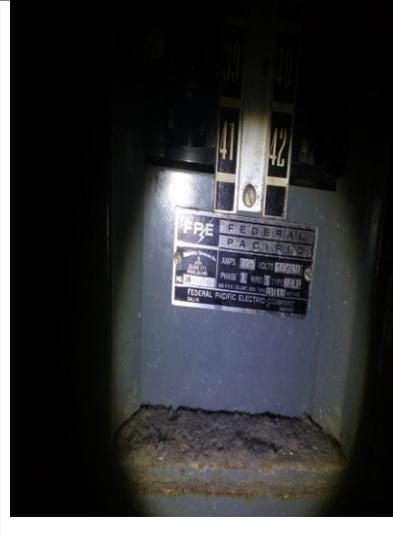
#### Electrical Distribution

Electrical	Electrical Distribution	<p>The electrical service enters the building at the 277/480 volt, 1600-amp main switchboard PFCU located in the electrical courtyard, and then enters into the main electrical room near the gymnasium. The service feeds six transformers and 480-volt panelboards located in various electrical rooms throughout the building.</p> <p>The electrical distribution equipment appeared to be in average condition. The main switchboard PFCU located in the electrical courtyard needs dirt and debris removed from the inside of the enclosure and the exterior housing repainted.</p> <p>Several panelboards in the 100-wing, 200-wing, C6 corridor, and C7 corridor are original to the building. These panelboards are aged and are at their full capacity. Panel SP has a missing screw in its cover. Panel K2 in the kitchen has a missing circuit breaker cover; this condition poses a hazard to personnel life and safety.</p> <p>In the 300-wing electrical equipment room, Panel A is a Federal Pacific panelboard and is identified as a life safety hazard because the company is no longer in business and historically the circuit breakers have failed causing major fires..</p> <p>The building does not have a lightning protection system.</p>	Poor

1. Per the interview notes, the kitchen panel is original construction and needs to be replaced along with other panels in the wings that are noted in the document.
2. Per the interview notes, in the Teacher's lounge, the microwave ovens frequently cause circuit breakers to trip. Remove circuit to microwave and install a new circuit breaker in the next available spare in the panel serving the microwave.
3. Per the interview notes, the kitchen steam tables and ovens trip circuit breakers. Remove circuit to steam tables and ovens and install a new circuit breaker in the next available spare in the panel serving the kitchen steam tables and oven.
4. Provide additional exterior lighting at the playground area.

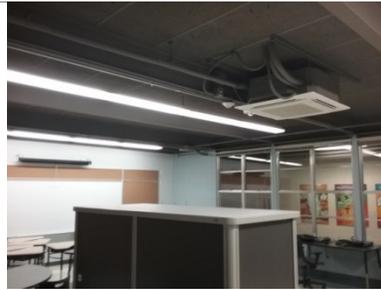
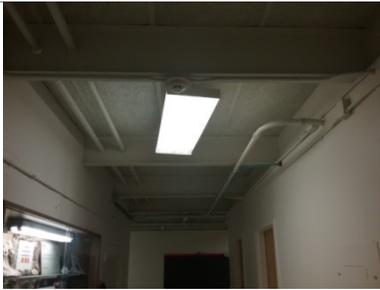
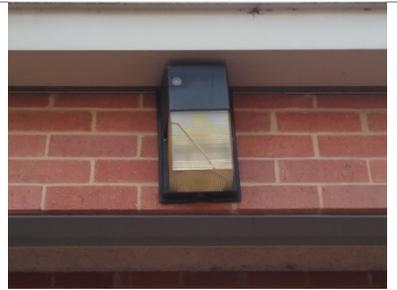
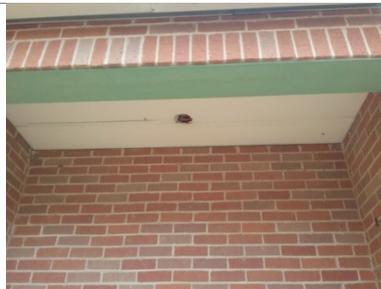
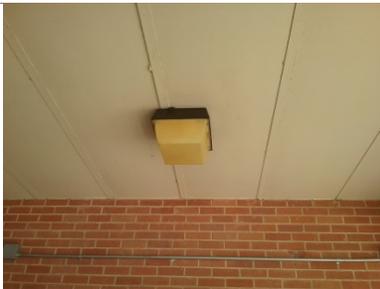
Lighting	<p>The building's exterior lighting consists of downlights, wall mounted HID (high-intensity discharge), and wall</p>	Poor

System	Subsystem	Condition and Deficiency Overview	System Condition Rating
		<p>mounted LED (light-emitting diode) fixtures that are located along the entire perimeter. The interior lighting primarily consists of T8 light fixtures that are either surface mounted or pendant type.</p> <p>The lighting for the building appeared to be in poor condition. Approximately 30% of the interior and exterior light fixtures appeared to have aged past their design life. Observed deficiencies included broken lenses, inconsistent color temperatures, and non-functional fixtures.</p> <p>Per the interview notes, the existing exterior lighting is insufficient at the playground area. Additional exterior lighting is requested to prevent the frequent vandalism. There are exit signs present in the building, and they appeared to be functioning at the time of assessment.</p>	
	Communications & Security	<p>There is a Gemini security system including surveillance cameras in the building. According to facility staff, the system erroneously triggers at least twice a week.</p> <p>There is a public address system in the building, and it appeared to be in average condition with no reported deficiencies.</p> <p>The building is equipped with VOIP telecommunications system and Wi-Fi. It was reported by facility staff that the telecommunications system is not communicating with the new phone system correctly.</p>	Average

1. Replace all light fixtures with LED fixtures with dimming capabilities.
2. Replace all exit signs with LED fixtures.
3. Per the interview notes, the kitchen panel is original construction and needs to be replaced along with other panels in the wings that are noted in the document.

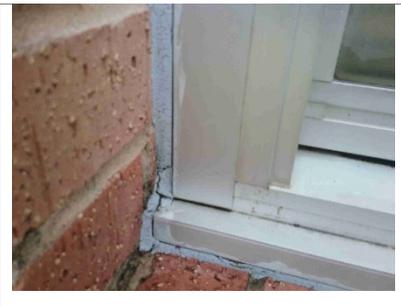
System	Subsystem	Condition and Deficiency Overview	System Condition Rating
<b>Exterior</b>	Exterior Walls	The building's facade is brick veneer. There are gutters and downspouts at the building perimeter.  The stand-alone building exterior walls were observed to be in good condition. Sealants have begun to show age and will likely need to be replaced within the next five years. Gutters and downspouts appeared to be in good condition.	Good
	Exterior Windows	The stand-alone classroom building has metal framed windows with single-pane glazing and operable sashes.  The exterior windows appeared to be functionally good, but sealants around the windows were deteriorated.	Average
	Exterior Doors	The exterior steel doors have hollow metal frames. The exterior entrance doors have vision panels.  The exterior doors were observed to be in good condition.	Good
<b>Roofing</b>	The stand-alone classroom building's built-up roof is most likely original and is 26 years into a 20-year service life.  The roof was not accessible for assessment but ponding at building corners was observed from an adjacent building. The roof has exceeded its service life and is presumably in poor condition.		Average

1. Replace sealant around windows.

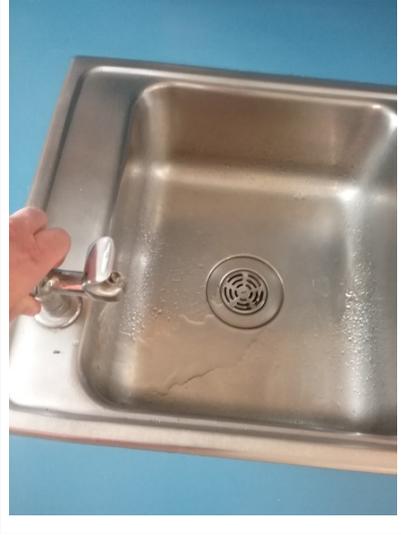
Interior Ceiling Finishes	The interior ceilings are suspended lay-in acoustical tile throughout the building's corridor and classrooms. The restroom ceilings are gypsum board. The interior ceilings were in good condition.	Good
<b>Conveying</b>	System not present.		N/A
<b>Plumbing</b>	Plumbing Fixtures	The building has separate male and female restrooms for students shared between classrooms and a separate unisex restroom located adjacent to the lounge. The male and female restrooms have vitreous china hand sinks with manual faucets, which do not have hot water service. These restrooms also have vitreous china toilets with manual flushing mechanisms. There are sinks with faucets and bubblers located in each classroom. There is a water cooler in the corridor. One bubbler was observed to lack sufficient flow. The plumbing fixtures were in average condition as the fixtures were typically aged but still operational with noticeable wear due to their age.	Average

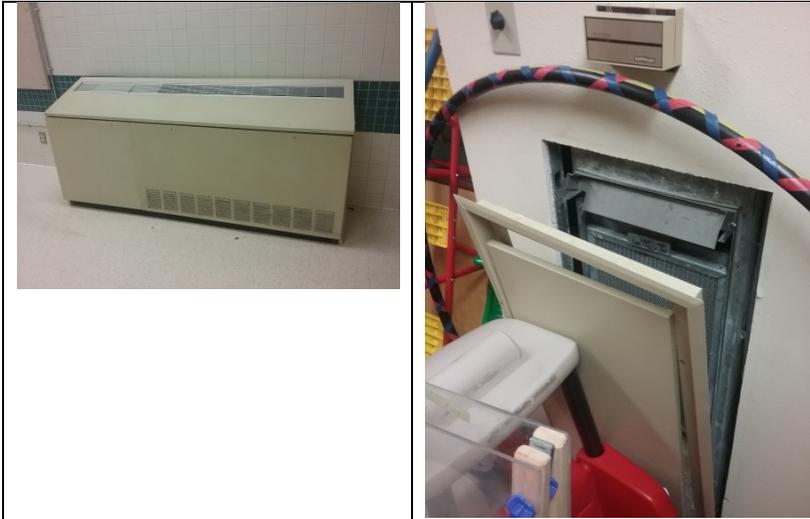
**Mechanical/HVAC System Deficiency Examples**

System	Subsystem	Condition and Deficiency Overview	System Condition Rating
	Other Plumbing	Floor drains are located in the janitorial closet and male and female restrooms.  The floor drains were aged but operational and appeared to be in average condition.	Average
<b>Mechanical/ HVAC</b>		The major mechanical equipment consists of floor-mounted ground source heat pump AHUs providing cooling to the classrooms and corridor. These serve the HVAC system along with a roof-mounted EF.  The AHUs were observed to be aged and in poor condition. The roof-mounted EF appeared to be in average condition. The heat pump located in workroom 400 appeared to be aged and in need of replacement.  The HVAC system was observed to be in poor condition, primarily due to its age.	Poor
<b>Fire Protection</b>	Fire Alarm	The building has a Silent Knight fire alarm control panel, which appeared to be in good condition.  The system consists of alarm and signaling devices such as, horn and strobe combination devices, pull stations and detectors that appeared to be in good condition.	Good

1. Replace the aged heat pump in Workroom 400.
