Davis Elementary School Site Summary

Main School Building – BLDG-179A

Stand-Alone Classroom Building – BLDG-179B

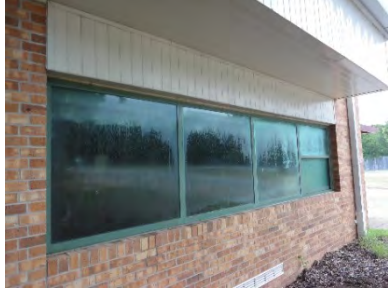
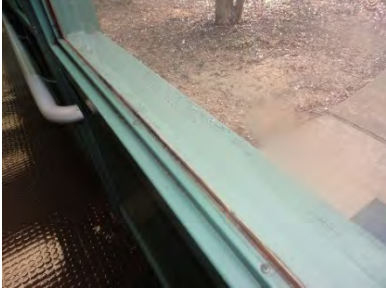
System	Subsystem	Condition and Deficiency Overview	System Condition Rating
Exterior	Exterior Walls	<p>The exterior walls are brick facade with pre-finished metal panels above doors and windows and at the upper half of the gymnasium and cafeteria. There is a pre-finished metal siding at the main entrance with a combination stucco and metal panel soffit. The majority of the school is framed with metal studs. The gymnasium and cafeteria enclosure is CMU (concrete masonry unit).</p> <p>The exterior walls were observed to be in good condition. Facility staff reported pest control as an ongoing issue.</p>	Good
	Exterior Windows	<p>The exterior windows are painted metal frames with single-pane glazing. There is a painted hollow metal framed, full-height window system in corridor C6 along the ramp.</p> <p>The exterior windows were observed to be in good condition. There was condensation on the south facing windows on the classroom wings at the time of the assessment. This may impact the useful life of the painted finish. The paint was beginning to peel on the window system at corridor C6. PM Chris Lewis reported leaking windows within the 100- and 200- wings.</p>	Good

1. Replace door weather-stripping/door sweep on the south doors of corridor C6.
2. Investigate and repair leaking windows within the 100- and 200-wings (requested by PM Chris Lewis).

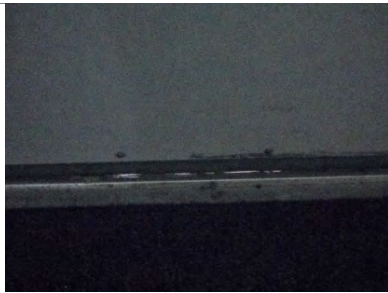
System	Subsystem	Condition and Deficiency Overview	System Condition Rating
	Exterior Doors	<p>The exterior doors are painted metal with painted hollow metal frames. The exterior doors have half lite glazing, and the main entrances have integral painted hollow metal framed glazing above and on either side.</p> <p>The exterior doors were observed to be in good condition with a minor issue being the weather stripping on the south doors of corridor C6.</p>	Good
Roofing	<p>The building has a built-up roof covering with gutters and downspouts routed underground to a storm drain system. There is one interior roof drain at the ramped portion of corridor C6. There are pre-finished metal standing seam walkway covers on the east side of the building.</p> <p>The roof covering appeared to be in good condition with minor leaks reported over the gymnasium and cafeteria. There was minor blistering around the mechanical units on the gymnasium roof and the northwest corner of the kitchen roof. There was a downspout near room B201 that appeared to be leaking on its adjacent brick wall, possibly due to a clog.</p>		Good

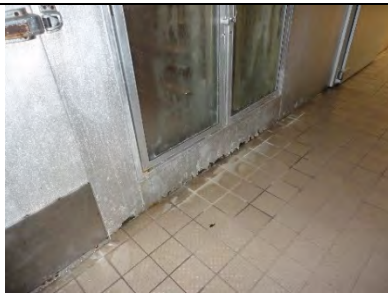
Interior Construction	Interior Walls	<p>The interior walls consist of gypsum board on metal studs with control joints at interior door corners. The gymnasium and cafeteria interior is painted CMU. There is a fabric-covered movable partition between the cafeteria and gymnasium. The bookroom area was being remodeled at the time of the assessment.</p> <p>The interior wall construction appeared to be in good condition with typical wear and tear. The kitchen cooler walls on the inside of the kitchen were deteriorating at the floor due to moisture.</p>	Good
	Interior Doors	<p>The interior doors are wood veneer in painted metal frames with wire glass vision panels. There are metal kick plates on the doors to the cafeteria and gymnasium. There is a manual roll-up counter door between the cafeteria and kitchen.</p> <p>The interior doors were observed to be in good condition.</p>	Good
	Interior Specialties	System not present.	N/A

1. Repair the kitchen cooler walls at the floor to ensure the cooler envelope is intact.

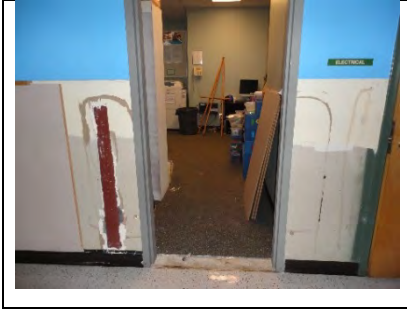
Interior Wall Finishes

System	Subsystem	Condition and Deficiency Overview	System Condition Rating
Finishes		restrooms have ceramic tile on the lower portion and paint above. The cafeteria has acoustic wall panels mounted at an angle on the upper portion of wall. The interior wall finishes were observed to be in good condition. There were a few minor stains on the acoustic panels in the cafeteria. There was a portion of the plastic laminate wainscot missing in the corridor adjacent to the library storage where work appeared to be ongoing.	
	Interior Floor Finishes	The interior floor finish is VCT (vinyl composition tile) in the classrooms and corridors. There is carpet in the administration areas, library, and main entrance foyer. The interior floor finish appeared to be in average condition due to cracking and bubbling issues with the VCT throughout the school. This is typically due to moisture from the foundation interacting with the adhesive, creating organic matter build-up. The carpet in the foyer was installed to remedy the cracking tile. The VCT will need to be replaced more frequently than its expected useful life. The rubber flooring in the ramp portion of corridor C6 was coming off at the transition to the wall.	Average

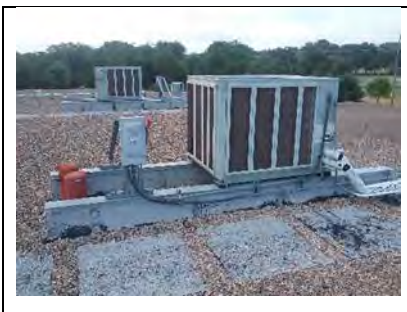
Mechanical/HVAC System Deficiency Examples

System	Subsystem	Condition and Deficiency Overview	System Condition Rating
	Distribution	<p>mechanical room adjacent the kitchen that serves the kitchen fixtures.</p> <p>There is an additional EWH (electric water heater) in the gymnasium storage that was not accessible.</p> <p>The GWH serving the kitchen appeared to be in good condition.</p>	
	Other Plumbing	<p>The roof drains are equipped with metal grate covers to prevent debris from entering the drainage system.</p> <p>The roof drains appeared to be in average condition.</p>	Average
Mechanical/ HVAC	<p>The major mechanical equipment for this building is a distributed GSHP (ground source heat pump) system. There are several CUs (condensing units) on the roof of the kitchen and cafeteria that serve DX AHUs (air handling units). The outside air for the cafeteria and gymnasium is served through individual ERUs (energy recovery units) for each AHU.</p> <p>CU-C1, which serves the cafeteria's AHU-C1, was making a loud noise. This loud noise is directly associated with the compressor and indicates an internal issue with the compressor. The remaining units on the roof were observed to be in good condition.</p> <p>The classrooms are each served through floor-mounted GSHP console units. These GSHP units were all in average condition.</p> <p>The AHUs serving the gymnasium were inaccessible. The AHUs serving the cafeteria and kitchen were in good condition. PM Chris Lewis reported two HVAC units at the stage and one at the gymnasium constantly shut down and have been an ongoing maintenance issue.</p>		Average

1. Create a two year replacement plan for CU-C1.
2. Create a replacement plan for the console GSHP units.
3. Repair or replace HVAC units at the stage and gymnasium that constantly shutdown. Consider contacting the manufacturer for additional troubleshooting (requested by PM Chris Lewis).

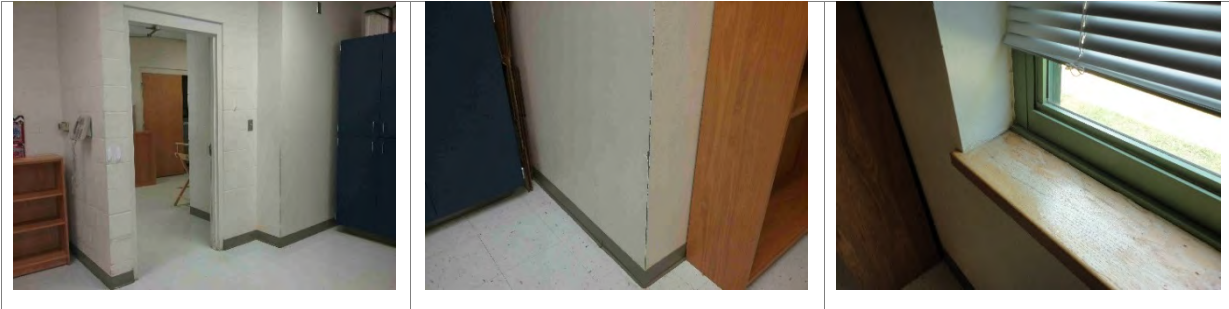
Interior Construction	Interior Walls	The interior walls are mostly CMU with metal stud and gypsum board walls between classrooms. The interior walls were in good condition.	Good

1. Paint room 404.
2. Provide corner guards.

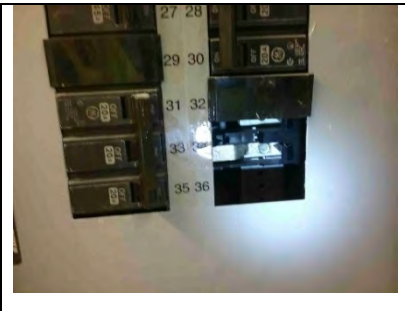
System	Subsystem	Condition and Deficiency Overview	System Condition Rating
Mechanical/ HVAC	<p>The major mechanical equipment consists of packaged GSHPs. The outside air is served through an ERU located in a mechanical room on the north side of the building.</p> <p>These units were original to the building and were in average condition.</p>		Average
Fire Protection	Fire Alarm	<p>The building has a fire alarm system that consists of alarm and signaling devices such as horn/strobe combinations, pull station, and smoke detectors.</p> <p>The fire alarm system appeared to be in good condition.</p>	Good
	Fire Protection/ Suppression	<p>The building is protected by portable fire extinguishers placed throughout the facility. The observed inspection tags were current.</p>	Good
Electrical	Electrical Distribution	<p>The electrical service enters the building through an 800-amp disconnect switch located on the exterior near the service transformer. Three 120/208-volt branch panelboards are located in the mechanical room "HP9."</p> <p>The electrical distribution equipment appeared to be in good condition, although panelboard "L2" in mechanical room "HP9" had open breaker spaces.</p> <p>The building does not have a lightning protection system.</p>	Good

1. Provide two circuit breaker covers for the open spaces in panelboard "L2" in mechanical room "HP9."
