Dawson Elementary School Site Summary

Main School Building – BLDG-114A

Storage Building – BLDG-114B

Stand-Alone Classroom Building– BLDG-114C

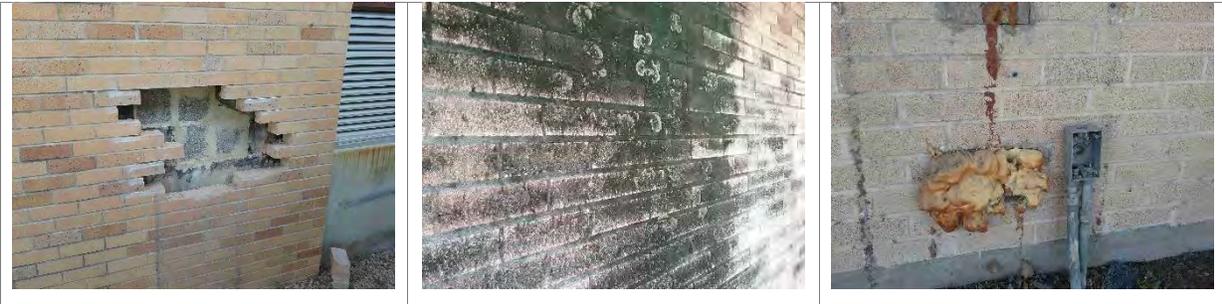
System	Subsystem	Condition and Deficiency Overview	System Condition Rating
Exterior	Exterior Walls	<p>The exterior walls are composed of double-width brick with pebble inlay. The walls are about 8'-6" high.</p> <p>Renovation construction was occurring on the days of assessment. There were significant holes observed in the exterior walls of the classrooms and construction-related debris scattered around the campus. A penetration in the exterior brick wall in the 400-wing was noted; the penetration may be temporary and related to construction activities. Discoloration was observed on multiple exterior walls of the 400-wing, which could create an environment for organic growth. Spray foam insulation was observed to have been placed in a ventilation opening in the wall and was over-filling the opening.</p>	Good
	Exterior Windows	<p>The exterior window system is comprised of single pane vision glazing in aluminum frames. There is a clerestory band facing the courtyard in most classrooms. The windows seem to be recently installed across the building.</p> <p>The window system appeared to be in good condition, except for the lintels above the 400-wing double-hung windows. The lintel was observed to be rusting. One piece of the exterior soffit was also observed to be damaged. Leaks were reported at windows in the 200-wing, but none were observed.</p>	Good

1. Repair all elements of buildings affected by construction.
2. Remove patchy paint from exterior concrete walkways.
3. Clean all windows of debris.
4. Remove discoloration from exterior walls.

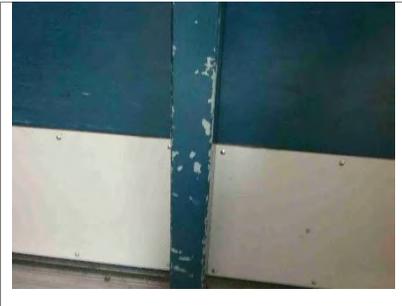
Exterior Doors	<p>The exterior doors consist of painted metal double doors set in a metal frame window system. The doors</p>	Good

System	Subsystem	Condition and Deficiency Overview	System Condition Rating
		<p>are half glazed with panic hardware.</p> <p>The exterior doors were observed to be in good condition with normal scratches and scuffs observed on the doors and frames. Small dents were seen on some of the hardware release levers.</p>	
Roofing		<p>The roof is composed of many roofing materials including; built-up asphalt with granular topping, modified bitumen and corrugated metal. There are six skylights above the gymnasium which are 4'-0" square. There is also an extensive metal canopy system on the exterior of the 400-wing with metal posts and corrugated metal covering. Neither the walkway covers nor canopy have downspout systems.</p> <p>The roof as a whole was observed to be in average condition with a few deficiencies. It appeared mostly watertight except for the area above the stage. The roof above the stage was inaccessible to observe the relationship to the evidence of leaks below. From a nearby vantage point, deficiencies were observed; at two roof penetrations near the location of the leaks below, the gravel and roofing were sunken in, providing an area for ponding water. Also, there were observed small areas of disturbed granular topping and areas of damp or discolored material. The frames of the skylights were observed to be very rusted and aged. The metal canopy was observed to be in poor condition with extensive dents and leaks. A portion of the roof was being used as a staging area for construction and was not assessed.</p>	Average

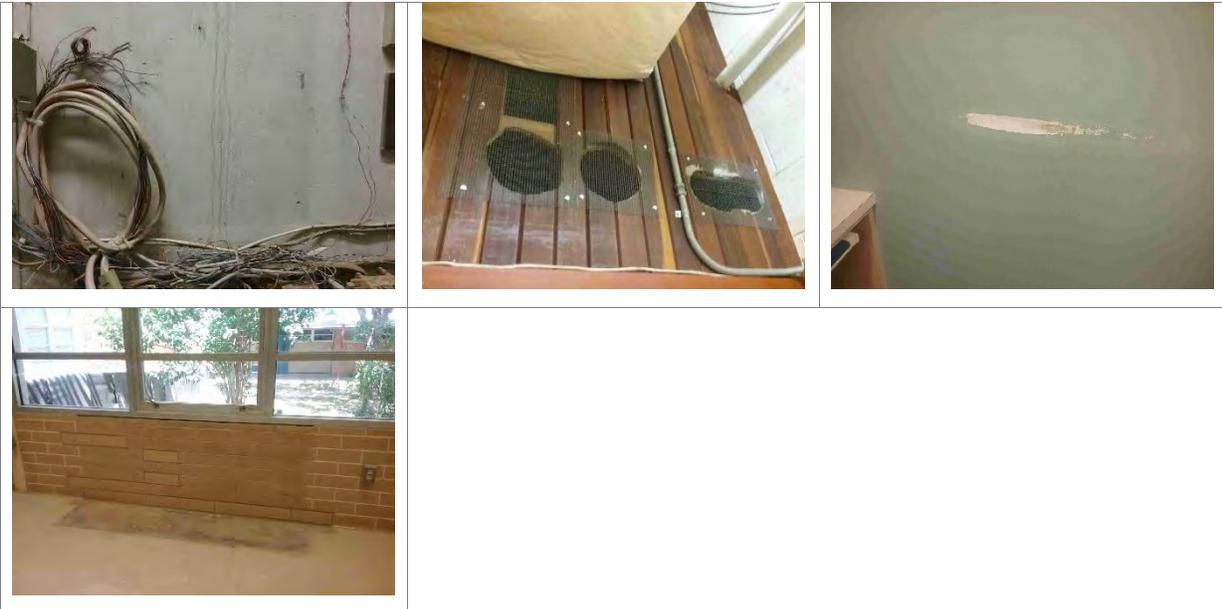
System	Subsystem	Condition and Deficiency Overview	System Condition Rating
		The stairs and finishes appeared to be in good condition and showed only minimal expected signs of wear.	
Interior Finishes	Interior Wall Finishes	<p>The majority of the walls are exposed, unpainted brick with ceramic-faced masonry units as a wainscot. There are portions of painted CMU (concrete masonry unit). Some wood paneling exists around specialty doors, for example the cafeteria, but it is minimal.</p> <p>Interior wall finishes were dingy. One wall of the stage exhibited streaks in the paint from water coming from the AHU (air handling unit) pipe penetrations. The wood panel wall finish on stage was observed to have large unpatched holes. In the classroom wings, no signs of damage were observed on the wall finishes of the classrooms assessed.. A mildew odor was noticed in two classrooms in the 200-wing, rooms 202 and 204. There was a small tear observed in the wall finish in the librarian's office.</p> <p>One patched wall in a classroom was observed to have been patched with slightly discolored ceramic-faced masonry where the FCU (fan coil unit) had once been.</p>	Average

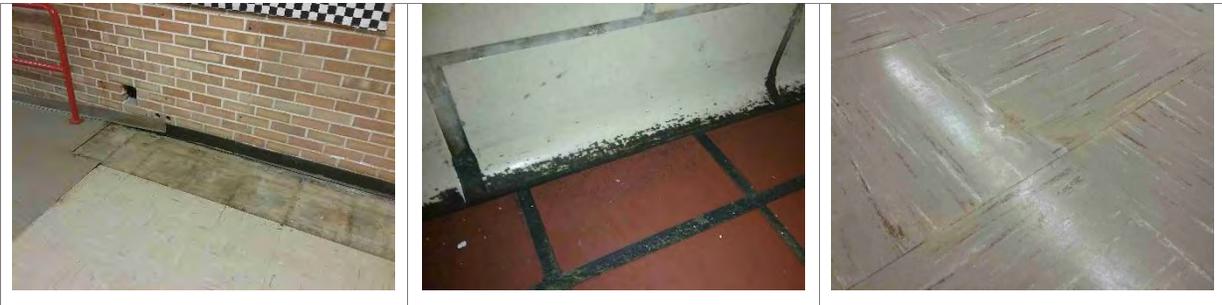
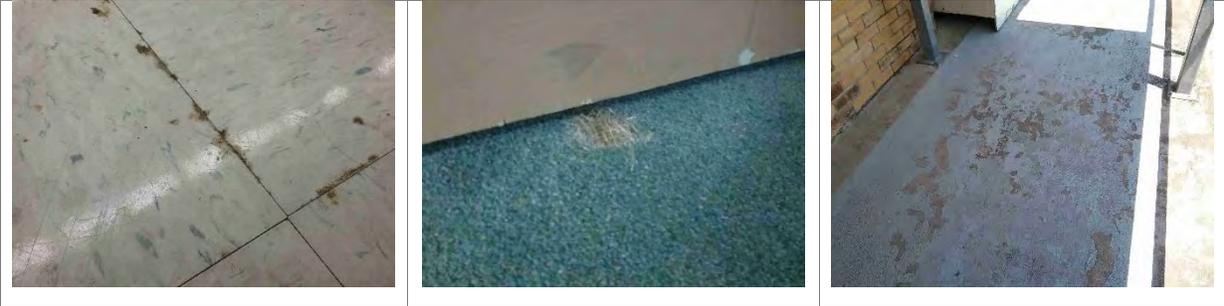
Interior Floor Finishes	<p>The interior floor finishes are linoleum tiling, rubber tiles for the gymnasium and sloped areas of the corridor, ceramic tile in the kitchen and carpet in the administration offices. The classrooms are finished with linoleum tile.</p> <p>The floor finishes appeared dingy and aged in the main building corridor. A portion of linoleum tile was observed to be missing in the corridor near the cafeteria. The floor in the kitchen was observed to be in good condition. No cracking nor excessive debris were observed. The ceramic-faced masonry units, acting as the wall base, appeared discolored. In the classroom wing, some of the linoleum floors were observed to be dimpled and bubbling. Room 204 was observed to have very damaged floor tile at the joints, possibly from repeated flooding.</p> <p>The carpet in the administration offices was observed to be worn and aged with small tears. Bubbling of the carpet was observed in a few places.</p> <p>The paint on the concrete exterior walkways was observed to be inconsistent.</p>	Average

1. Replace the area carpet in the administration wing with carpet tiles.
2. Repair all damaged ceiling tiles observed and properly seal ceiling penetrations.
3. Replace bubbling or damaged linoleum tiles.
4. Remove textured plaster ceiling finish.

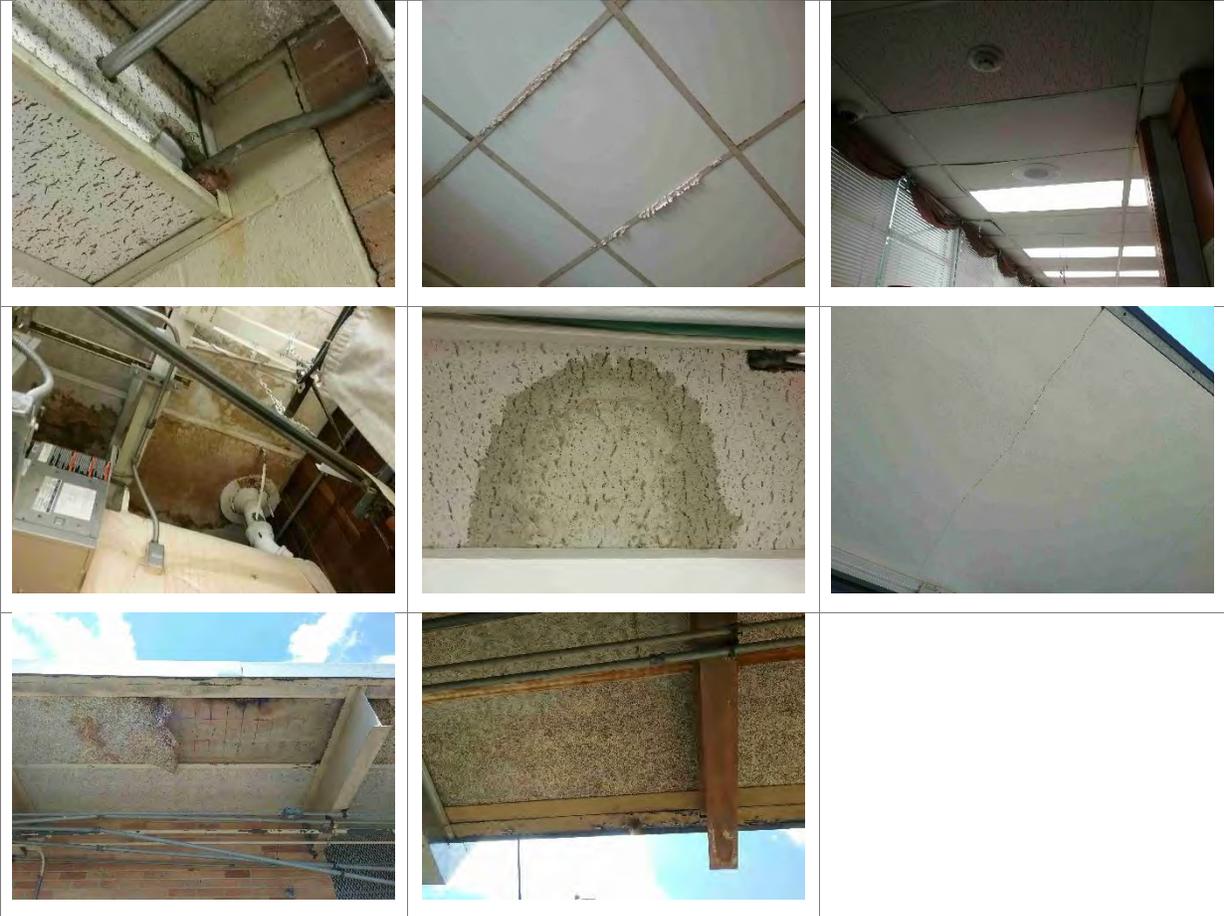
Interior Ceiling Finishes	<i>The majority of the ceiling areas in the administrative offices, library and cafeteria are finished with acoustic ceiling tile (ACT.) The corridor is finished with textured</i>	Average

System	Subsystem	Condition and Deficiency Overview	System Condition Rating
		<p><i>plaster and ACT. The kitchen is finished with lay-in water-resistant ceiling tiles. The majority of the building, including all classrooms, is accessed from covered exterior walkways. The walkway canopies are extensions of the roof, and the underside is clad with painted wood wool composite panels. The classroom areas have lay-in ACT ceilings, which follow the slope of the roof. The multiple-person restrooms, entered from the courtyard, have gypsum board ceilings.</i></p> <p><i>The administration ceiling tiles were observed to be out of place.</i></p> <p><i>The library ceiling appeared to be newly installed with no visible deficiencies.</i></p> <p><i>Two significantly water-damaged areas were observed at the AHU piping penetration above the stage. It was reported that leaking over the stage area occurs consistently. In the corridors adjacent to the cafeteria, the textured plaster ceiling was observed to be in average condition, showing damage near piping support connections. The material also looked aged beyond the expected design service life.</i></p> <p><i>Half of the kitchen ceiling area was observed to be aged and discolored. Many of the tees were found to be peeling, which could pose a danger of shedding into the food. The dishwashing area was observed to have intact ceiling tiles, possibly installed more recently.</i></p> <p><i>The ACT ceiling tiles in the corridors were observed to be bowing and mismatched.</i></p> <p><i>Hairline cracks in the walkway canopy material were observed every three to four feet.</i></p> <p><i>Though many classroom ceilings appeared to be newly installed, a few ceiling tiles were observed to be damaged from water, especially in the restrooms adjoining classrooms.</i></p> <p><i>Many of the classroom ceiling panels in the 100-wing and 300-wing had been removed for construction access and were not assessed. Some exterior walkway covering wood wool panels were frayed or extremely damaged. No signs of water damage were observed on the 200-wing ceiling. In the 200-wing exterior walkway, the panel tees showed signs of rust.</i></p>

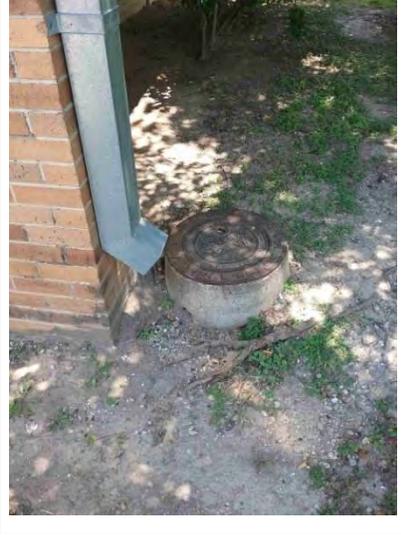
Domestic Water Distribution	<p>Plumbing fixtures in the cafeteria kitchen are serviced by a 100-gallon, 200-MBH gas domestic hot water heater unit, which was installed in the last year and observed to be in excellent condition. No other plumbing fixtures in the building at the time of inspection are believed to be serviced with hot water.</p> <p>Domestic water service piping was not observable, as it was buried or located above suspended ceiling, between walls, or in crawl spaces. Staff has reported problems with the water supply shut-off valve(s). Visual assessment only indicated that the apparent primary, 2-inch metered service line from South First Street had dual isolation with readily accessible actuators.</p> <p>Staff interviews identified the concern that domestic water piping is deteriorated and failing.</p> <p>Different wings of the building appeared to be sub-metered. One of these meters, adjacent-south of the Principal's office, had a surface monument with slight damage and positioned directly below a roof leader downspout.</p>	Average

1. Reposition the roof leader downspout adjacent to the exterior of the Principal's office that is discharging onto the water meter monument. Repair and seal the water meter monument.
2. Conduct evaluations of roof drainage shortly following rain events, carefully following active interior leaks and noting areas of pooled water and shingling gaps on the roof top. Consider re-coating corroded natural gas piping (such as outside the kitchen).

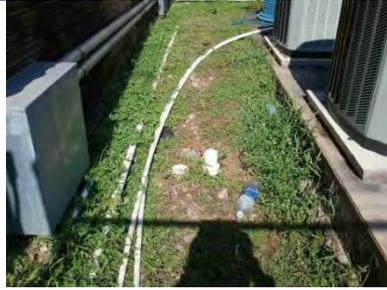
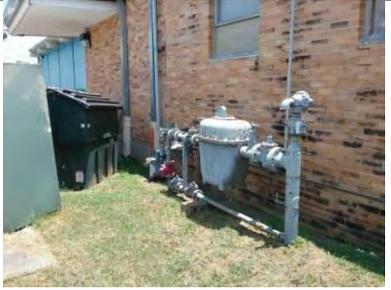
Other Plumbing	Centralized (piped) roof drainage systems in conjunction with simple sloped roof and	Average

System	Subsystem	Condition and Deficiency Overview	System Condition Rating
		<p>gutter/downspout systems were present.</p> <p>Most roof drains appeared to be in place and free of debris. Staff interviews have indicated there are leakage issues with the roof drain(s) located over the kitchen and stage (i.e., roof sections A-20, A-15, and A-02); visual inspection in dry weather did not reveal any apparent deficiencies.</p> <p>Gutters and downspouts appeared to be in good condition; however, the roof leaders on the kitchen exterior exhibited corrosion.</p> <p>It should be noted that two vertical cylindrical polyethylene tanks were staged adjacent to the BLDG 114B; possibly a rainwater harvesting system is planned. Staff interviews have identified the desire to improve building and site drainage.</p> <p>Natural gas piping observed at the exterior of the kitchen area appeared corroded, although valve actuators and other appurtenances appeared in accessible, functional condition.</p> <p>An assumed sanitary sewer 2-way cleanout near the gymnasium male restroom's northern exterior wall was observed without covers.</p> <p>Staff interviews identified the concern that sanitary sewer piping is deteriorated and failing.</p>

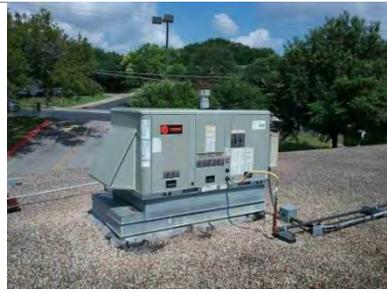
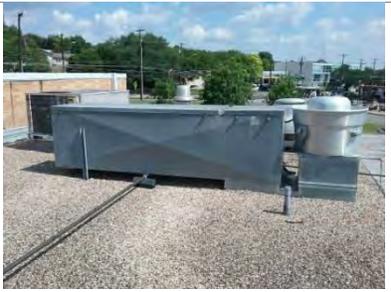
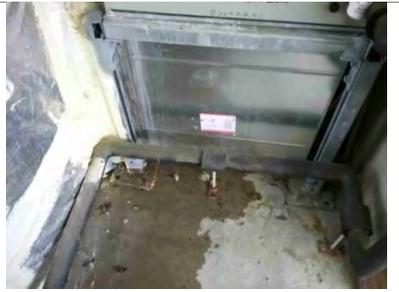
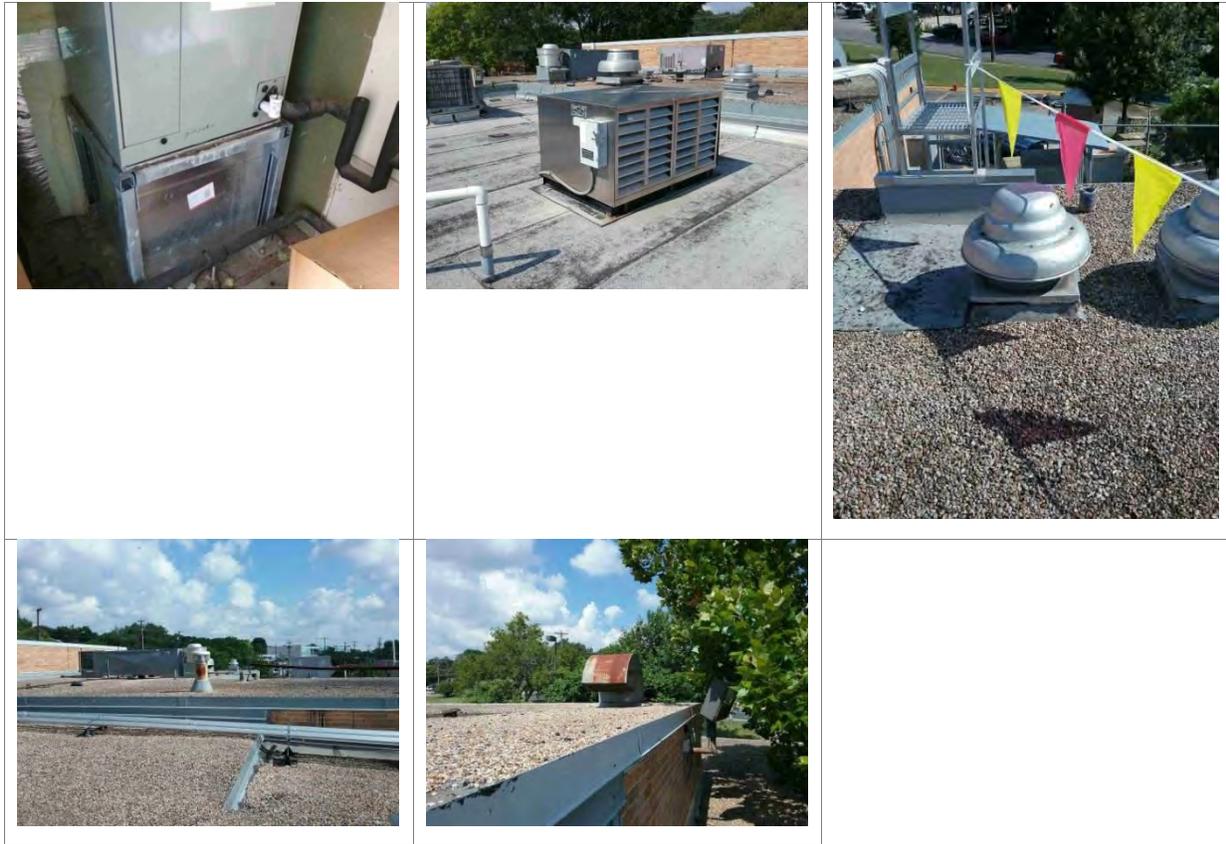
<p>Mechanical/ HVAC</p>		<p>At the time of assessment, full-scale renovation of the building's mechanical/HVAC (heating, ventilating, and air conditioning) systems was in progress; most of the old equipment had been removed, and the new equipment had not yet been installed.</p> <p>The old system consisted mostly of geothermal and water source fan coil console- or ceiling-mounted heat pumps, which provided heating and cooling for classrooms, offices, and restrooms. Each of these units, with the exception of units in the 200-wing and the book room, have been removed. A series of larger RTUs (roof top units) and centralized ducting is planned to provide HVAC for these areas.</p> <p>Major existing mechanical equipment consisted of three 5- to 6--TON air-cooled, gas-heat RTUs (-1, -2, and -3) and were observed to be in average condition with each exhibiting exterior corrosion. The newest unit (RTU-3, installed in 2015) also exhibited condensate leaks and a slightly erratic noise during operation. Staff interviews indicated that RTUs-1 and -2 have approached the end of their expected design service life, although with a generally accepted service life of 20 years and a manufacture date of 2000, about 20 percent of service life remains.</p> <p>A roof top HVAC unit labeled SF-1 on furnished roof plans (roof section A-15) was not in operation, appeared mostly gutted, and overall status and function was unclear. It is possible this unit was abandoned in place.</p>	<p>Good</p>

System	Subsystem	Condition and Deficiency Overview	System Condition Rating
		<p>The remainder of the mechanical equipment consisted of smaller packaged split systems, with exterior air-cooled 2- to 10-TON condenser units and nearby 5- to 10-TON indoor modular air handlers or fan coil console units. One 3-TON split system heat pump, which was not identified on furnished roof plans, was located in the southwest quadrant of roof section A-06 and connected to the fan coil console unit in room 404. Most of these units were in good condition, with smooth-sounding operation and a significant portion of service life remaining. A few units exhibited minor deficiencies such as small condensate leaks, slight rattles during operation, or localized corrosion.</p> <p>Staff have expressed concerns with the operation of classroom AC units in the 200-wing. Fan coil console units UV-1 through -4 (located in even-numbered rooms, and supplied by outdoor split system condenser units CU-1 through -4) indicated strong and rapid cold air generation and no major deficiencies. Water source heat pumps in odd numbered 200-wing rooms are to remain.</p> <p>Staff has also reported a condensate leak in the MDF (main distribution frame) room and ductwork issues in the offices, book room, and cafeteria. Due to security constraints, MDF rooms were not accessible, and equipment located above suspended ceilings was not assessed or verified. The ducting visible near the cafeteria (i.e., connected to AHUs-3 and -4) did not present any major deficiencies. No boilers or other heat-generating equipment were observed at the building.</p> <p>One estimated 2.5-TON packaged direct expansion, air-cooled refrigerant system (RU-1) was located above the kitchen, likely providing refrigeration for the kitchen freezer and cooler. It was observed to be in average condition, as it was past its estimated service life of 15 years and exhibited a slight rattle during operation.</p> <p>Roof top EFs (exhaust fans) were from 2006 or 2015 and were observed to be in good condition.</p> <p>On a system level, EFs and venting were found to be in average condition. EF-4 in roof section A-04 exhibited a rattle during operation, and two vents with significant corrosion were observed in roof sections A-14 and A-15, respectively.</p>

1. Remove or properly abandon-in-place all out-of-service HVAC units, such as unit SF-1 located on roof section A-15.
2. Perform a comprehensive examination of heating/cooling issues thought to be originating with existing packaged air conditioning systems, heat pumps, and ducting to remain (i.e., RTUs-1 and -2, water source heat pump console units in odd-numbered 200-wing classrooms, and ducting to remain for the offices, book room, and cafeteria), including ducting inspection and evaluation of operating parameters such as discharge air temperature, fan speed, chilled water supply/return temperature differentials, refrigerant pressure (if applicable), and controls for all related equipment, including air handlers.

3. Consider periodic inspection of EFs and vents for noise/vibration, rainwater leakage, and general condition. Two vents were observed with significant rust and are recommended for re-coating or replacement, and EF-4 (roof section A-04) should be evaluated for motor issues, as it exhibited a rattle during operation.

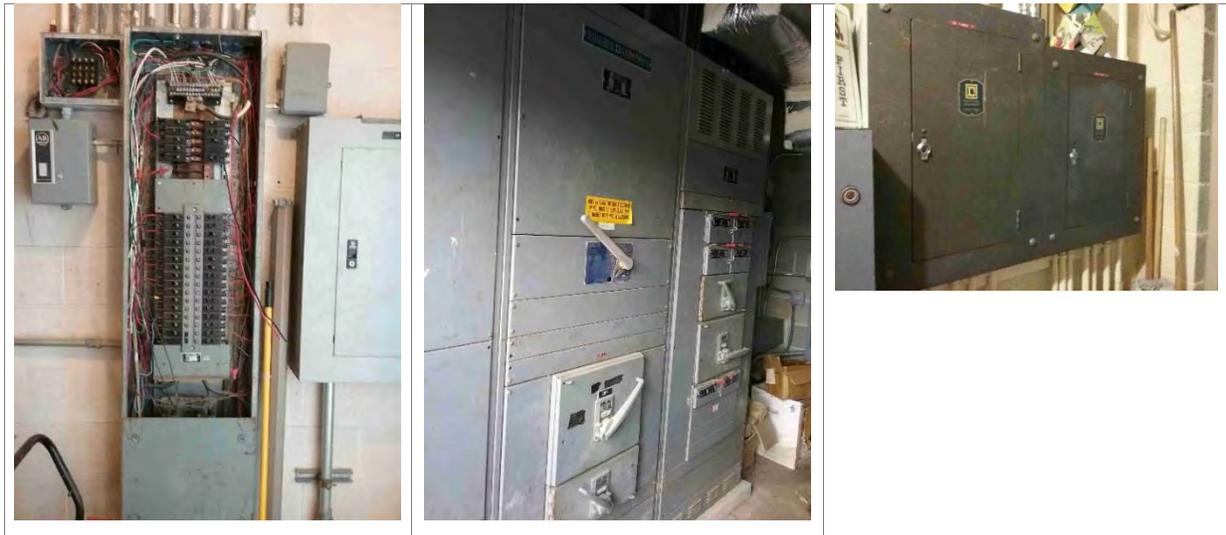
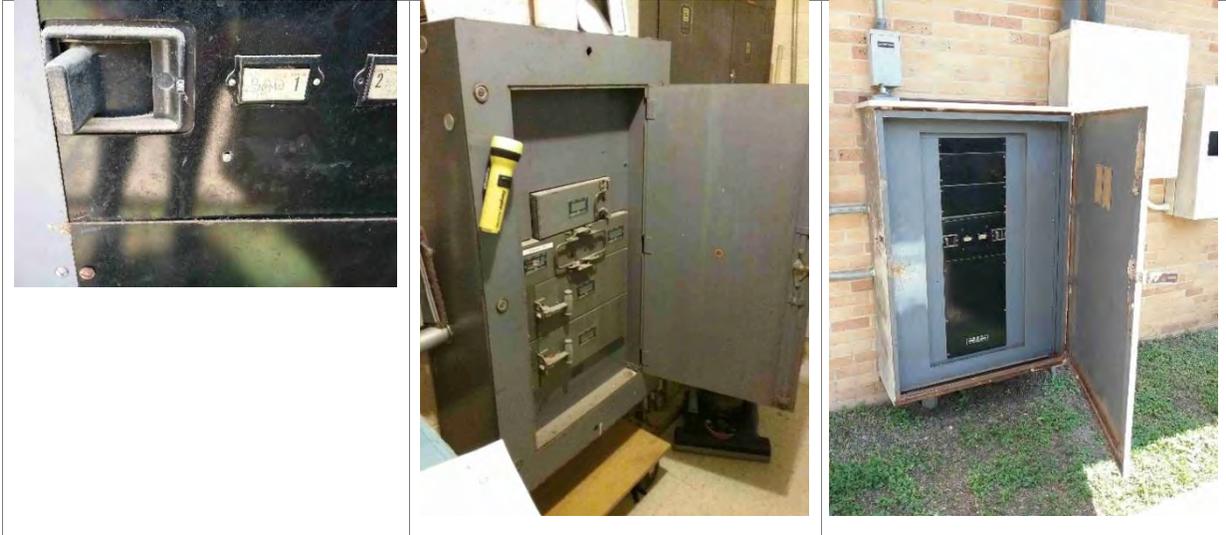
Electrical Distribution

System	Subsystem	Condition and Deficiency Overview	System Condition Rating
<p>Electrical</p>	<p>Electrical Distribution</p>	<p>There are two electrical services to this building. The first service is at the south side of the building. It is overhead via a 175kva overhead utility company transformer and is 120/240-volt 3-phase 4-wire delta 1200-amp, terminating on a service entrance distribution panelboard. The second service is at the north side of the building and is underground via a pad-mounted utility company transformer and is 120/240-volt 3-phase 4-wire delta 1600-amp, terminating on a 1600A 120/240-volt MDP (main distribution panel) located in a mechanical room. The north service feeds a single 150kva distribution transformer located outside the facility, and it steps the voltage down from 240-volt to 120/208-volt. This distribution transformer serves a 400-amp 120/208-volt distribution panelboard that distributes 120/208-volt throughout the building. There is a 50kvar 120/240-volt power factor correction capacitor bank installed at the facility, and it is in good condition. The building does not have a lightning protection system.</p> <p>The electrical distribution equipment is observed to be in poor condition. A majority of the assets were observed with corrosion. Three panelboards were observed as missing breaker covers, and the bussing is exposed behind the breaker board. This condition could be considered a life safety hazard, and breaker covers should be installed immediately.</p> <p>We observed one Federal Pacific panelboard installed in an electrical room. At the time of our visit, there was active construction work occurring on site. The Contractor informed us that part of the scope of the construction work required them to add new breakers and circuits to this Federal Pacific panelboard. Federal Pacific panelboards are known to fail catastrophically, overheat, and cause fires and are a considerable life safety hazard and should be replaced immediately.</p>	<p>Poor</p>

1. Replace all panelboards and switchboards from the original construction as they are severely aged past typical design life.
2. Provide additional electrical receptacles where needed, particularly in classrooms.
3. Verify the condition of telecommunications systems/equipment, as it was inaccessible. Add additional data drops in classrooms and additional Wi-Fi access points as requested by the facility staff.

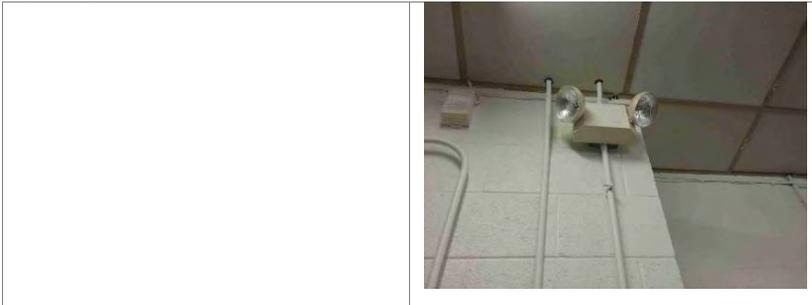
Lighting

<p>Lighting</p>	<p>The building's exterior lighting mostly consists of HID (high-intensity discharge) building-mounted luminaires. There is only one two-headed pole-mounted HID fixture in the staff parking lot and only one two-headed pole-mounted HID fixture in the bus/parent drop off area. There are also surface-mounted CFL (compact fluorescent) bowl fixtures mounted to the underside of the exterior canopies.</p> <p>At the time of our visit, there was construction work on-going to upgrade to LED lighting and add occupancy</p>	<p>Average</p>

System	Subsystem	Condition and Deficiency Overview	System Condition Rating
		<p>sensor controls in classroom wings 300 and 400. The interior lighting primarily consists of T8 fluorescent luminaires, some of which are direct-indirect.</p> <p>The lighting for the remainder of the building was observed to be in average condition. Many interior and exterior luminaires appeared to be aged past their expected design service life. Observed deficiencies included broken lenses, inconsistent color temperatures, and non-functional fixtures. There are exit signs present in the building, but they appear to be aged past their expected design service life. In general, there appears to be inadequate emergency egress lighting throughout the building. The cafeteria stage lights are simple track lights.</p>	
	<p>Communications & Security</p>	<p>There is a Gemini security system including surveillance cameras in the building. According to facility staff, there are areas of the building that do not have card access. Assessors observed that there are several new exterior cameras installed at the building.</p> <p>There is a Telcor MCC-4 public address/timeclock/bell system in the building, and it was observed to be in poor condition.</p> <p>The building is equipped with telecommunications systems, but the main backbone equipment is located in an inaccessible MDF room and could not be assessed. There is Wi-Fi throughout the facility. However, the facility staff reported that the Wi-Fi connection was very poor in the front office administration areas.</p>	<p>Poor</p>

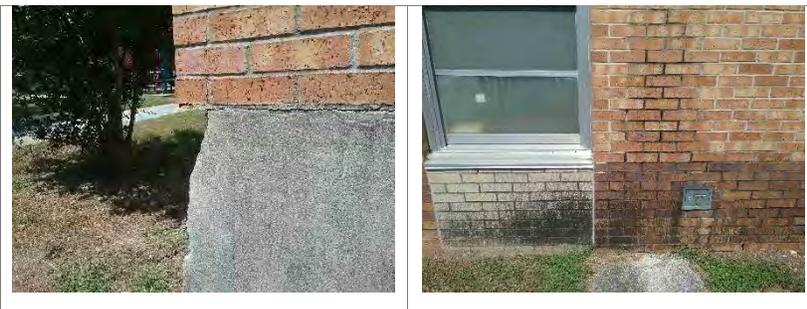
System	Subsystem	Condition and Deficiency Overview	System Condition Rating
Exterior	Exterior Walls	The building was erected in 1991 and is constructed of brick walls. It is connected to the main building by exterior walkways. The walls appeared to be in good condition except for one damaged corner with a broken foundation wall and a large area of discoloration.	Good
	Exterior Windows	The exterior window system is comprised of single-pane, double-hung windows in metal frames with a translucent film. The windows and frames appeared to be in good condition, showing only signs of debris and cobwebs.	Good
	Exterior Doors	There is one main entry into the building, through a set of metal double doors in metal frame. The doors are half-glazed. The doors appeared to be in good condition with no signs of wear or damage.	Good
Roofing	The roof is comprised of built up asphalt with granular topping. The roof appeared to be in good condition, except for one large area of discoloration.		Good

1. Repair broken wall corner.

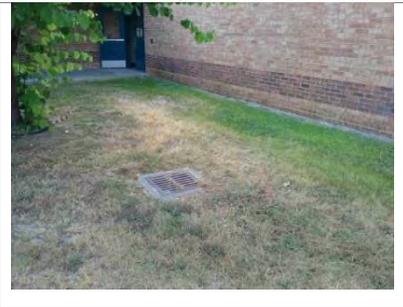
Other Plumbing	Centralized (piped) roof drainage systems in conjunction with simple sloped roof and gutter/downspout systems were present.	Average

System	Subsystem	Condition and Deficiency Overview	System Condition Rating
		<p>Most roof drains appeared to be in place and free of debris. Gutters and downspouts appeared to be in good condition.</p> <p>Area drainage catch basins were located around the exterior of the building. Three catch basins located around the building were filled with grass and dirt.</p> <p>It should be noted that two vertical cylindrical polyethylene tanks were staged adjacent to BLDG-114B; it is likely that a rainwater harvesting system is planned. Staff interviews have identified the desire to improve building and site drainage.</p> <p>Staff interviews identified the concern that sanitary sewer piping is deteriorated and failing.</p>	
Mechanical/ HVAC		<p>As with the Main School Building (BLDG-114A), at the time of inspection, full-scale renovation of the building's mechanical/HVAC systems was in progress. Most of the old equipment had been removed, and the new equipment had not yet been installed.</p> <p>The old system consisted mostly of geothermal and water source fan coil console- or ceiling-mounted heat pumps, which provided heating and cooling for classrooms, offices, and restrooms. Each of these units has been removed. A series of larger RTUs and centralized ducting is planned to provide HVAC for these areas.</p> <p>No existing mechanical equipment was present at the time of the assessment.</p>	N/A
