Doss Elementary School Site Summary

Address	7005 Northledge Drive Austin, TX 78731
Number of Permanent Campus Facilities	2
Original Year of Construction	1970 and 2010
Total Campus Building Area (combined)	61,102 SF

Main School Building – BLDG-154A

Stand-Alone Gymnasium – BLDG-154B

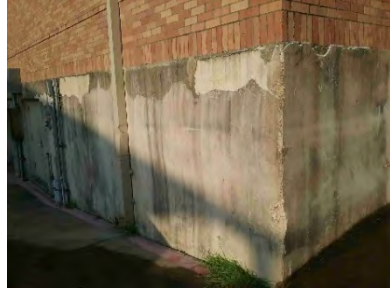
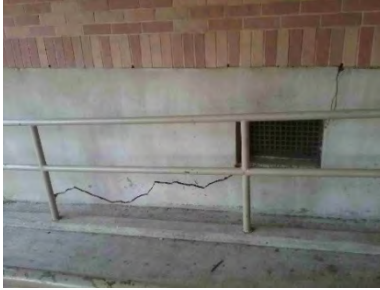
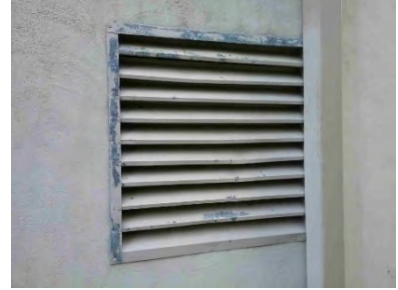
System	Subsystem	Condition and Deficiency Overview	System Condition Rating
Exterior	Exterior Walls	<p>The exterior wall is composed of a veneer brick exposed to the exterior with a CMU (concrete masonry unit) backer wall that is typically exposed and painted on the interior. Plaster soffits are installed over the exterior entries. Roof access is made possible with wall-mounted aluminum access ladders. Louvers are installed below the brick in the foundation walls.</p> <p>Isolated areas of the concrete foundation appeared to show surface spalling. It was reported by the school staff that the foundation wall was cracked outside the cafeteria doors that lead outside to the playground. This crack was observed below the exterior wall of room 105. It was also reported that there was a rodent and pest infestation problem. This crack could serve as a point of entry. Plans do not indicate a concrete ramp that was added against this wall and which could be a factor in the failure.</p> <p>Louvers were observed to be in good condition but require paint. The exterior otherwise appeared to be in good condition, and ladders appeared to be new.</p>	Good

1. Investigate the foundation wall cracked below room 105 for structural damage. Current floor plans do not indicate the newer concrete ramp construction that is installed adjacent to the crack. The ramp was installed directly against this wall and possible lateral pressure from the ramp could be a factor in the failure of the original foundation wall.
2. Refinish areas below the brick façade with cementitious finish where spalling has occurred. This operation is only required for aesthetic purpose.
3. Repaint wall-mounted metal louvers. The metal is not degraded so this operation is only required for aesthetic purpose.
4. Straighten and refinish stair rails.
5. Investigate the possibility of weather stripping the operable, single-hung portion of the exterior window units.

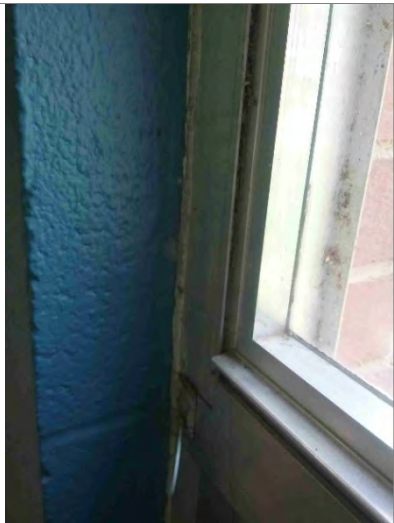
Exterior Windows	<p>Windows are aluminum, single-hung units with single glazed sashes. The taller units include an opaque, bottom panel.</p> <p>The operable sashes were loose in their tracks, allowing air infiltration.</p>	Average

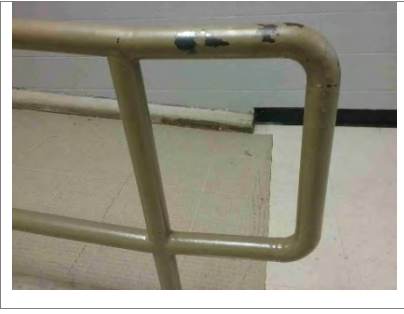
Interior Stairs	There are five similarly constructed stairs in the building. These cast-in-place concrete stairs have cast abrasive nosings and stained wood handrails. One stair is side-by-side with a ramp transitioning levels between corridors C1 to C6. A non-slip resilient surface and painted, metal handrails are installed at the concrete ramp. There are additional wood stairs leading up to the cafeteria stage with no handrails. All stairs appeared to be in good condition except that the paint finish on the ramp handrail was peeling.	Good
Interior Finishes	Interior Wall Finishes	Stained wood paneling is installed in the multi-purpose rooms, life skills room, the administration suite, and cafeteria. Ceramic tile is installed at sink areas and in toilet rooms. CMU and painted plaster are installed in toilet rooms 122 and 123. Paneling, cabinets and painted gypsum wallboard are installed at the classroom pods with paint applied to the inside faces of exterior CMU walls. A monolithic mural is painted on gypsum board in the library. All finishes appeared to be in good condition.	Good

1. Repaint the corridor ramp metal pipe guard/handrails.

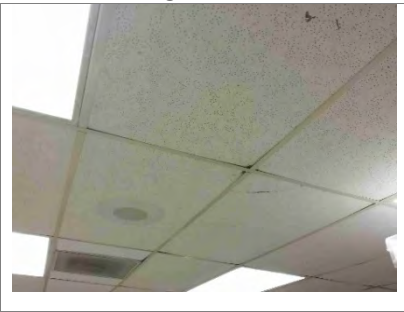
System	Subsystem	Condition and Deficiency Overview	System Condition Rating
		<p>Porcelain tile is installed in the toilet rooms and kitchen. A wood plank floor is installed in the cafeteria on the stage. Carpet tile is installed in the library.</p> <p>All floors appeared to be in good condition; however, staff reported that they required replacement. The resilient surfaces were being refinished during the time of the assessment. Vinyl-insert expansion joint covers also appeared to be in good condition.</p>	
	Interior Ceiling Finishes	<p>A 2'x4' acoustic tile in a suspended grid ceiling system is predominantly installed throughout. Ceilings are painted gypsum board in the toilet rooms and the back rooms of the administration suite.</p> <p>Some stained tiles were observed in the part-time music room. Tile ceilings in the classrooms, as well as in some of the corridors, appeared discolored and were beginning to show wear. These ceilings appeared to be the poorest of the main school building interior finishes. Staff reported that new ceilings were desired in the cafeteria and kitchen. The kitchen 2'x2' lay-in vinyl-faced tile was observed to be in good condition. The 2'x2' acoustic tile and grid in the library and library storage rooms appeared to be in good condition. The painted ceilings appeared to be in good condition.</p>	Average

1. Prioritize areas for suspended lay-in tile system replacement.

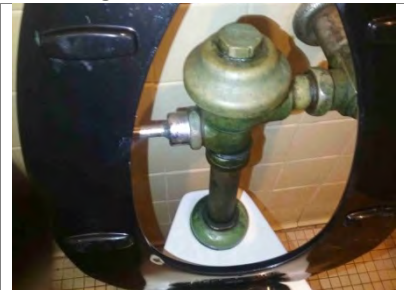
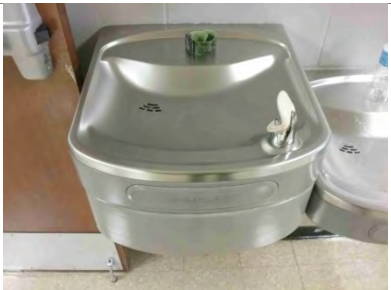
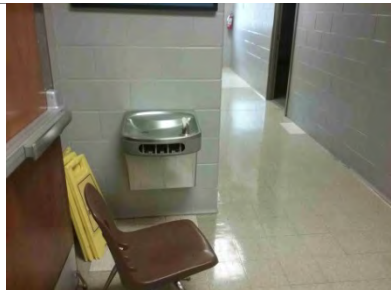
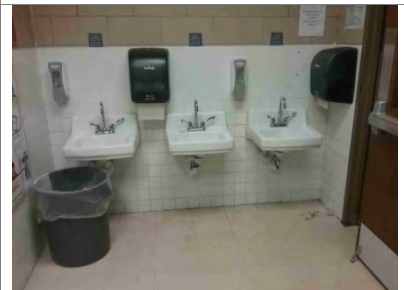
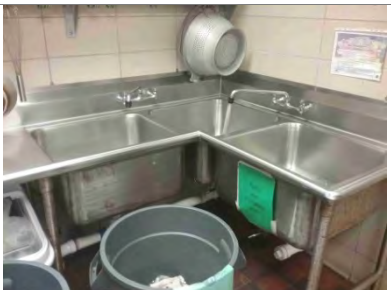
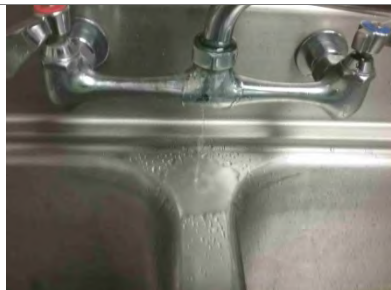
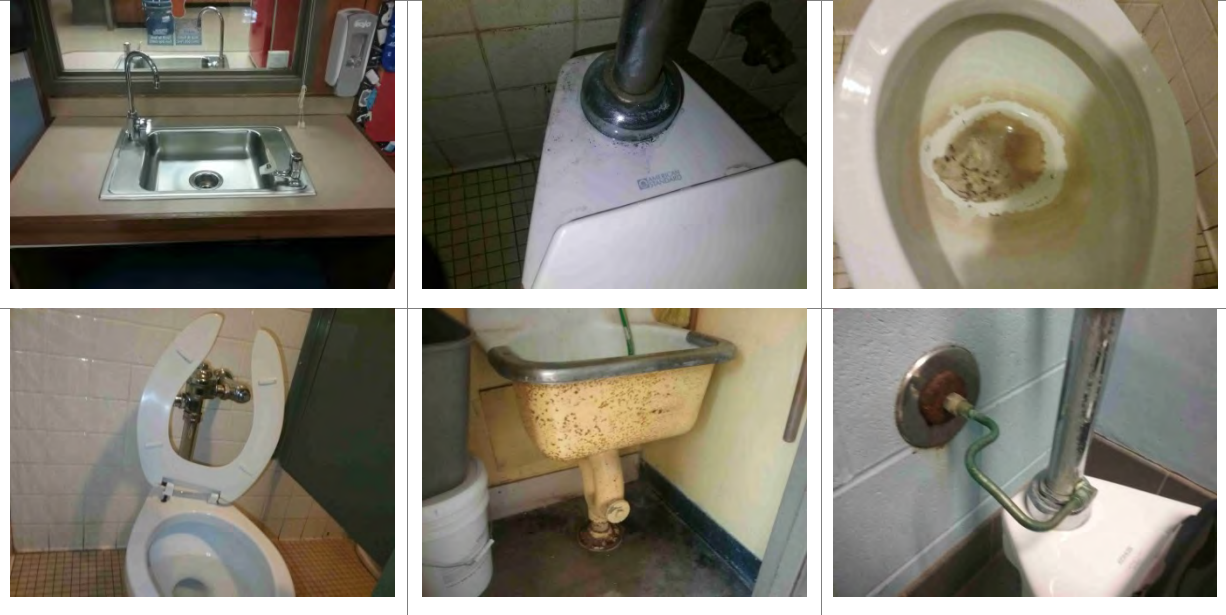
Conveying	<p>The building is equipped with a 750lb wheelchair lift for accessibility needs, located in the C4 corridor.</p> <p>The conveying system was observed to be in good condition.</p>		Good
Plumbing	Plumbing Fixtures	<p>The building contains predominantly multi-use restrooms throughout the facility, for each pod of classrooms. Additionally, multi-use restrooms are found outside of the cafeteria, and single-use restrooms in the administration, library, kitchen, and Parent/Teacher Association areas. Typical restrooms have floor-mounted vitreous china water closets with manual flush valves. Additionally, wall-hung vitreous china urinals with manual flush valves are located in the dedicated male restrooms. Typical classrooms contain a single-basin stainless steel sink with a drinking fountain attached. There is a community single-basin stainless steel sink with a drinking fountain attached in the multi-purpose area outside each pod of classrooms. Stainless steel drinking fountains can be found in the corridors of the building.</p> <p>A commercial kitchen is located in the school's cafeteria. The kitchen contains stainless steel kitchen</p>	Average

System	Subsystem	Condition and Deficiency Overview	System Condition Rating
		<p>equipment, including two triple-basin prep sinks. It also has various wall-mounted vitreous china sinks for personal use. Three vitreous china handwashing sinks are located outside the cafeteria. The art room contains three stainless steel basin sinks, two with a drinking fountain attached. Additionally, a vitreous china sink with two faucets is located inside the kiln room. The building also has service sinks located in various janitorial closets. Various other rooms, such as the parent teacher association (PTA) office, have stainless steel basin sinks for personal use.</p> <p>The majority of plumbing fixtures were observed to be in average working condition, but were aged and showed minor signs of deterioration. The drinking fountain in the corridor outside room 301 had no flow. One of the drinking fountains in the cafeteria was observed to not work. The drinking fountain outside the cafeteria was observed to be missing one of the pushbuttons.</p> <p>No flow was observed to the hot water handles on the handwashing sinks outside the cafeteria. The handwashing sink in the center was observed to stick on. One of the personal sinks in the kitchen did not work. One of the triple-basin prep sinks in the kitchen did not have hot water flowing to it. One of the faucets on a prep sink faucet was leaking. Some of the in-classroom sinks were observed to have loose faucets. The sink in the female administration restroom WRRADMIN leaked.</p> <p>Female restrooms 201 and 202 were both observed to have a leaking toilet. Both toilets in female restroom GRR101 leaked. One of the water closets in female restroom GRR310 had live pests in it. One of the toilet seats in female restroom GRR302 had a seat that was not adequately attached. Some fixtures were observed to have corrosion and rust at the base and on the connections. The janitorial mop sinks were observed to be in average to poor condition, with some showing signs of leaks and corrosion around the bases.</p>

1. Inspect, clean and repair plumbing in multiple restrooms that were emitting an unpleasant odor.
2. Replace plumbing fixtures that were beyond their expected design life before failure occurs.

3. Repair or replace drinking fountains that were broken or not functioning properly.
4. Repair water closets that were leaking.
5. Clean and flush all plumbing fixtures to remove and prevent odors and pests.

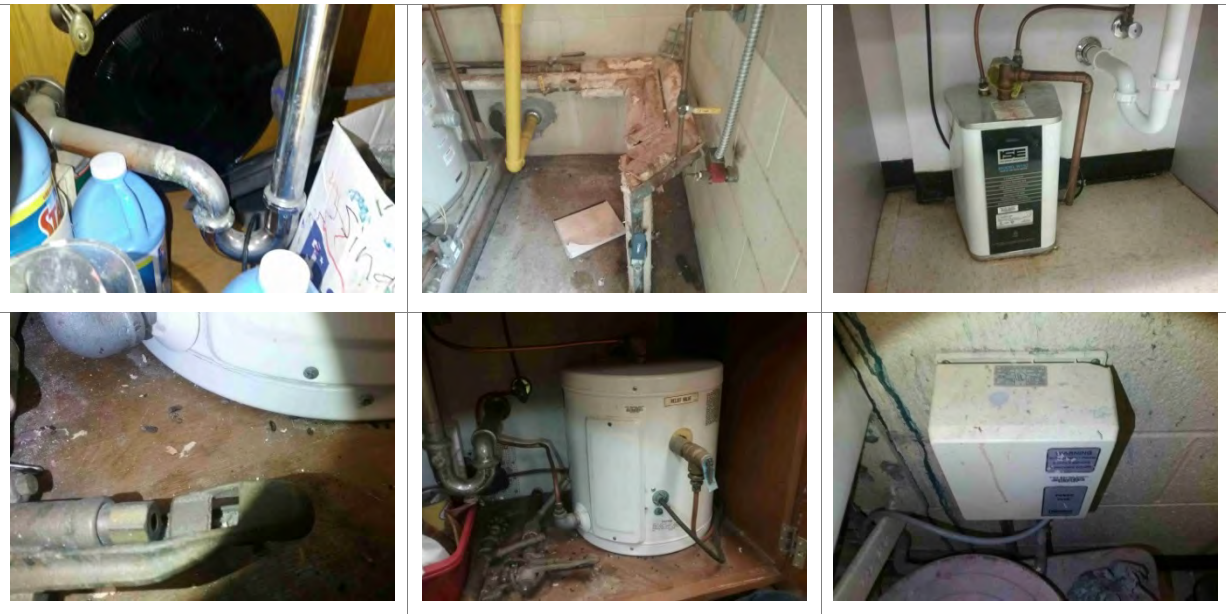
Domestic Water Distribution	Domestic hot water to the kitchen is provided by two 99-gallon, 0.199-MBH GWHs (gas water heaters) stored in the kitchen mechanical room (KITMECH). Various smaller electric and GWHs are located throughout the building to provide heated domestic water to specific locations (i.e., library and PTA office PTAOFC). Domestic hot water is not supplied to the classroom	Average

System	Subsystem	Condition and Deficiency Overview	System Condition Rating
		<p>plumbing fixtures.</p> <p>The GWHS feeding the cafeteria were in newer, good condition. The smaller units installed for hot water use to a specific location were in good to average condition, with some showing signs of age and deterioration. The water heater in the PTA office (PTAOFC) had signs of pests around the unit.</p> <p>The plumbing distribution equipment appeared to be in average condition with damaged insulation and corrosion and rust observed on piping throughout the building. Plumbing in the KITMECH room was aged and had damaged insulation, showing signs of excessive wear and tear.</p>	
	Other Plumbing	<p>There is a storm sump in the basement MAINMECH room. The MAINMECH room appeared to flood during rain events. Some roof drains were observed to have rocks around the grate, which could cause plugging. Some roof drains had rust on them. Storm drain covers were rusted. There was an exterior spicket leaking onto the ground.</p> <p>Associated other plumbing appears to be in average condition. The kitchen drain pipes had corrosion and rust. Male restrooms 505, 302, 307, 123, and 101, male administration restroom MFHRRADM, and janitorial closet CC300 had a foul odor. Some restroom floor drains were observed to be damaged, aged and have signs of corrosion.</p>	Average

7. Replace water heaters that were showing signs of deterioration and beyond their expected design life before failure occurs.
8. Clean and flush out all floor drains to ensure adequate drainage; it was reported these were not draining properly.

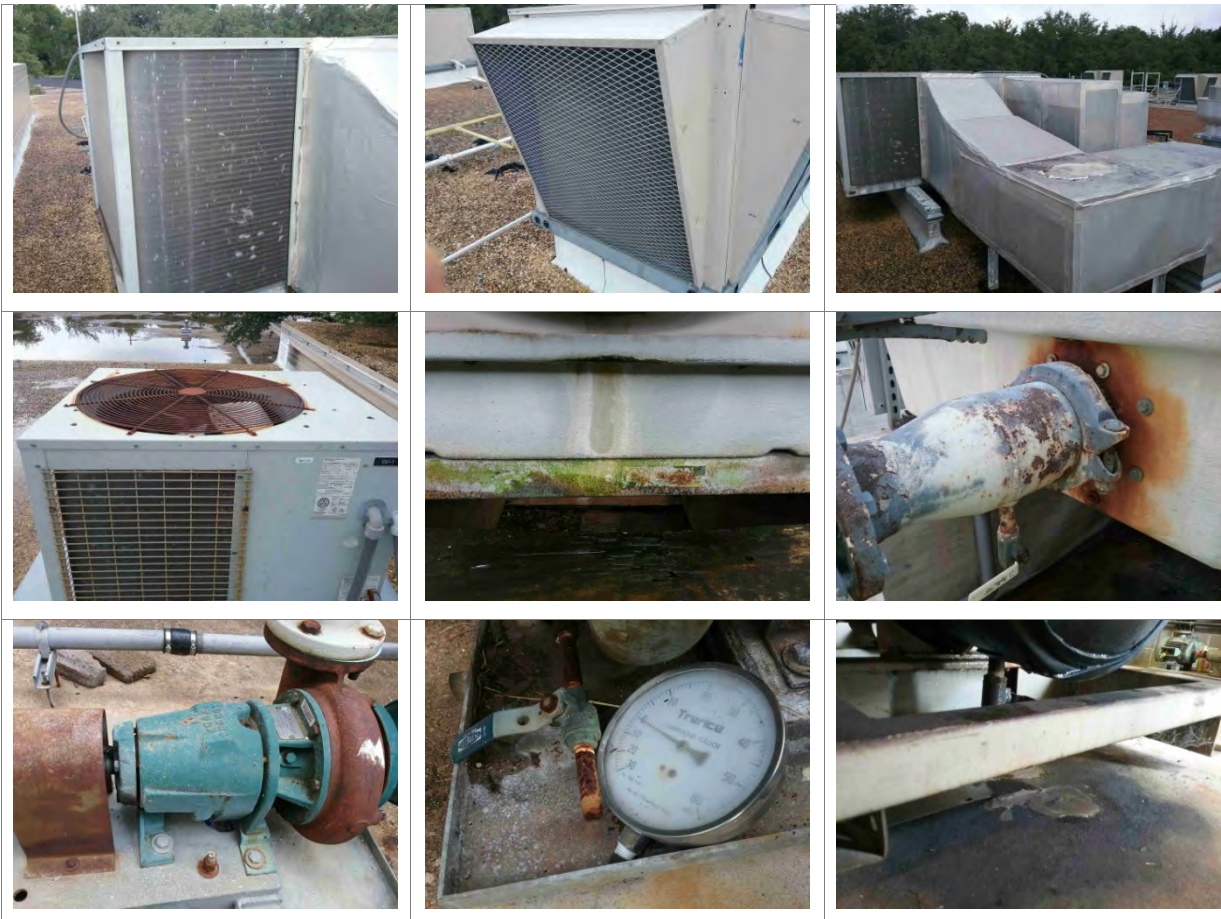
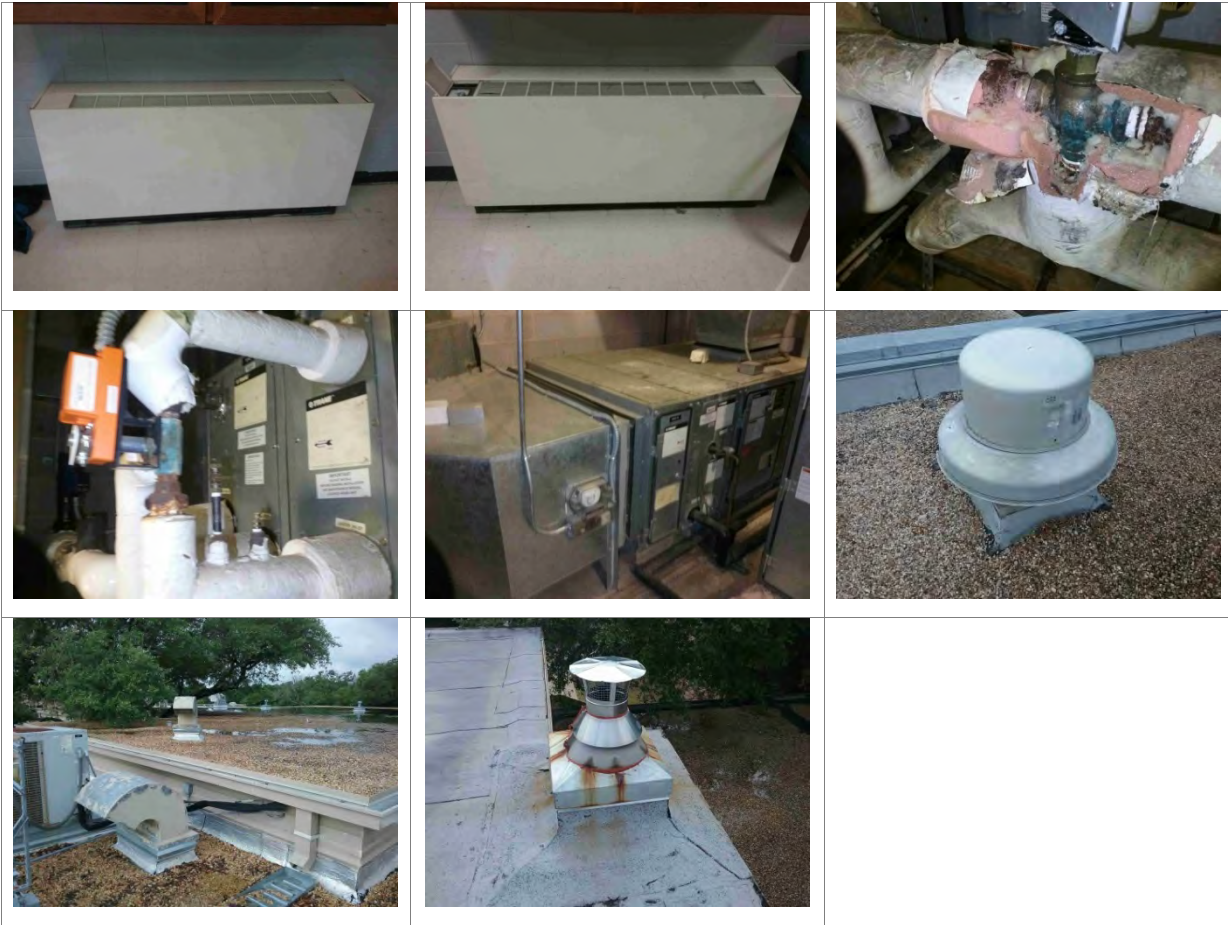
Mechanical/HVAC System Deficiency Examples

Mechanical/ HVAC		<p>The building's HVAC (heating, ventilation, and air conditioning) system is primarily composed of two cooling towers, two chillers and a boiler system supported by chilled water pumps, heated water pumps, and AHUs (air handling units). Additionally, RTUs (roof top units) feed the library, cafeteria, art and music areas of the building. Various sized EFs (exhaust fans) vent the building.</p> <p>Multiple RTUs were making vibrating noises. Older units had signs of corrosion and rust. The cooling tower units were aged and reaching the end of their expected operational life with signs of corrosion and leakage. CT-1 was in better condition than CT-2. The associated chilled water pumps were observed to be in average condition with signs of wear and rust. One of the pumps (CWP-2) had its pressure gauge unattached and on the ground next to the pump. The chiller in the MAINMECH room (CHLR1) was leaking. There is a boiler unit in the MAINMECH room that was installed in 2012 and appeared to be in good condition.</p> <p>The majority of the AHUs throughout the building were aged and making churning and whistling noises. There are two packaged systems in the corridor outside the cafeteria (FCU-1 and FCU-2). One unit did not turn on; the other made flapping noise, gave off a smell when on, and did not appear to be cooling properly. Both</p>	Average

System	Subsystem	Condition and Deficiency Overview	System Condition Rating
		<p>units were assumed to be no longer in use and abandoned in place.</p> <p>The HVAC system appeared to be in average condition with wear associated with the age of the units. Roof top vents and EFs showed signs of age and deterioration. The EF-1A on the roof was making a vibrating noise. Multiple HVAC units were using R-22 refrigerant, which is an outdated refrigerant that is being phased out of use.</p>	
Fire Protection	Fire Alarm	<p>The building has a fire alarm system that consists of alarm and signaling devices such as strobes, horn/strobe combos, pull stations, and detectors. The fire alarm system is controlled by a Silent Knight control panel.</p> <p>The fire alarm system was observed to be in good condition. No deficiencies were observed during the assessment.</p>	Good
	Fire Protection/Suppression	<p>A fire suppression system is present for the range hood in the kitchen with a tank mounted to the wall at the ceiling. The remaining fire suppression system consists of fire extinguishers throughout the building.</p> <p>Visual assessment showed these are in average condition. The majority of the extinguishers were up to date with their inspections. The extinguishers in AHU1, MAINMECH, OSSTO, and the 100-wing were out of date with their inspections.</p>	Average

1. Repair any equipment that was noted with excessive noise/vibration.
2. Address any rust or corrosion observed on the equipment, its associated piping, or any other sub-asset by cleaning, repainting, or repairing to prevent further deterioration.
3. Replace HVAC equipment that is beyond its expected design life before failure occurs.
4. Repair HVAC equipment noted to have evidence of leaks.
5. Replace the pressure gauge to chilled water pump (CWP-2).
6. Remove all HVAC equipment that is no longer in use and has been abandoned in place.
7. [Add ventilation to the conference room off of the main office \(requested by facility staff\).](#)

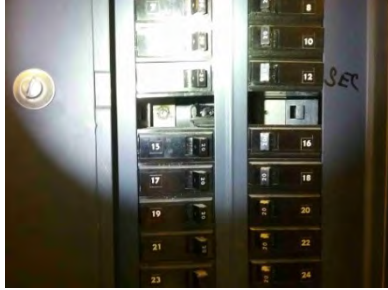
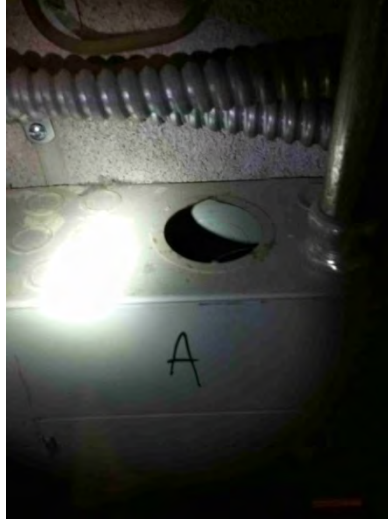
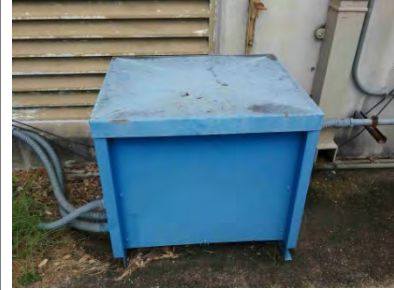
Electrical	Electrical Distribution	<p>The electrical service enters the building at the 277/480-volt, 1600-amp main switchboard located outside, near the MAINMECH room. The service feeds transformers and panelboards, located in various electrical rooms throughout the building. The building does not have a lightning protection system.</p> <p>The electrical distribution equipment appeared to be in average condition. The majority of the electrical panelboards and transformers were original to the building construction and were near their end of life expectancy.</p> <p>Three panelboards were missing breaker covers, and the busing was exposed behind the breaker board. This condition could be considered a life safety hazard. These panels included: LVD located in AHU3, LVA located in MAINMECH, and A located in AHU4. Panel A also had an open knock-out port that should be sealed.</p> <p>One transformer, located in the cooling tower area, was found to be painted, including the data tag. This transformer should have a new data plate installed.</p> <p>The facility staff reported that most of the electrical</p>	Average

System	Subsystem	Condition and Deficiency Overview	System Condition Rating
		distribution equipment was original and near their end of life expectancy. Faculty also reported that the distribution panelboard for the administration area was at full capacity and needed to be upgraded, as additional circuits were required.	
	Lighting	<p>The building's exterior lighting consists of high pressure sodium/metal-halide, fluorescent, and LED (light-emitting diode) luminaires that are located at building egresses, covered walkways, and exterior walls. The interior lighting consists primarily of fluorescent luminaires. Emergency lighting luminaires are present in the corridors and multi-purpose rooms that connect the classrooms.</p> <p>The lighting for the building appeared to be in average condition. Several exterior luminaires appeared to be cracked or aged past their design life. A few exterior luminaires were on during the day. Observed interior lighting deficiencies included dim lamps, broken/missing lenses, and non-functional fixtures. These deficiencies were especially prominent within the student restrooms and administration areas. The stage has a lighting module for the stage lighting. This lighting module was found to have significant arcing when the light switches were activated.</p> <p>There were several issues in the branch wiring, including damaged or loose roof top conduit and missing junction box covers. Several exterior receptacles were found with broken or non-sealed covers. Several exterior and interior electrical receptacles were observed to be in poor condition. Many classrooms featured electrical outlets near sink areas that should be replaced with GFCI (ground fault circuit interrupter) receptacles.</p> <p>The faculty have requested additional exterior lighting at the portable buildings, playground, and the loading dock. The faculty also requested luminaire replacements for the classroom restrooms. Faculty have stated that the power packs for the luminaires are consistently failing, specifically the 277-volt luminaires.</p>	Average

1. Immediately provide missing breaker cover plates and knockout plugs for all panels with open slots, as these instances should be considered life safety hazards.
2. Install a data tag for the exterior transformer in the cooling tower area.
3. Replace the stage lighting breaker module due to significant internal arcing.
4. Replace student restroom luminaires.
5. Develop a plan to replace all original panelboards and transformers in the next five years.
6. Replace or install an additional panelboard within the administration area to provide additional circuits, as requested by faculty.
7. Replace or repair damaged roof top conduit for HVAC and ventilation equipment.
8. Remove abandoned Token Ring receptacles that remain within the building.
9. Replace all exterior luminaires with LED luminaires.

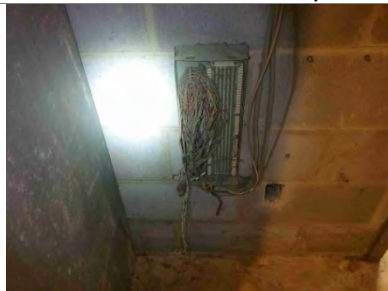
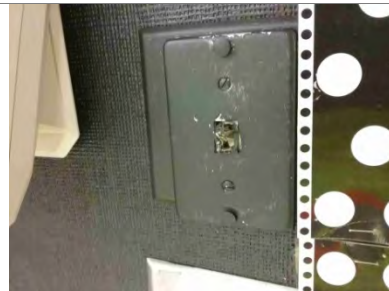
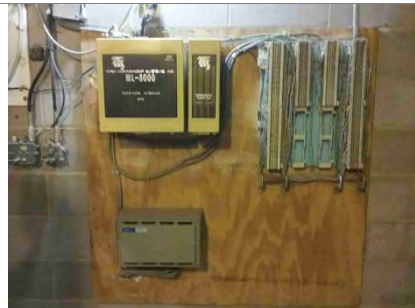
Communications & Security	The building is equipped with telecommunications/data/cable systems with the main backbone equipment located in the MDF (main distribution frame) and IDF (intermediate distribution frame) rooms. Networking Wi-Fi access points are	Average

System	Subsystem	Condition and Deficiency Overview	System Condition Rating
		<p>installed throughout the building. VOIP (voice over internet protocol) telephones are used for voice communications. Remnants of 1980s Token Ring LAN networking are still present throughout the building. The building's security consists of surveillance cameras, motion detectors, and a proximity card access system.</p> <p>The communications and security system were observed to be in average condition. The building had telephone distribution boards that appeared to be abandoned. Several classrooms were found with damaged telephone receptacles. The intercom system equipment was observed to be outdated past its service life expectancy. Faculty requested additional surveillance cameras for the exterior, specifically areas at or near the playground and portable buildings. Faculty also reported that the intercom system needed to be updated.</p>

1. Replace interior and exterior electrical receptacles that were worn or damaged.
2. Replace leaking exterior electrical receptacle covers.
3. Install additional exterior surveillance cameras for additional coverage of the portable building and playground area, as requested by faculty.
4. Install additional exterior luminaires for the portable building, playground, and unloading dock areas, as requested by faculty.
5. Update the campus intercom system, as requested by faculty.

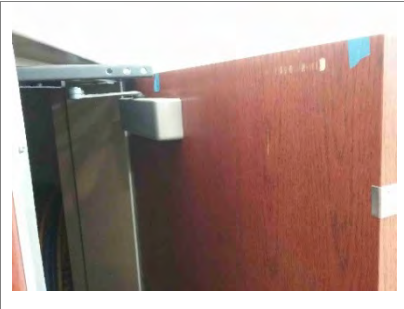
System	Subsystem	Condition and Deficiency Overview	System Condition Rating
Interior Construction	Interior Walls	Interior walls are constructed of CMU. An interior window with a painted hollow metal frame is installed in the wall between the main gymnasium and the gymnasium office. All interior walls appeared to be in good condition.	Good
	Interior Doors	Interior doors are stained solid-core wood set in painted hollow metal frames. All doors appeared to be in good condition, but a small amount of scuffing was observed. The door to room 102 had broken closer coordinator hardware that required to be re-attached to the door so that damage does not occur to the door.	Average
	Interior Specialties	System not present.	N/A
Stairs	Exterior Stairs	System not present.	N/A
	Interior Stairs	System not present.	N/A
Interior Finishes	Interior Wall Finishes	Tectum acoustic panels are installed in the upper areas of the gymnasium walls. Paint finish is applied to CMU elsewhere. Ceramic tile wainscots are installed in the restrooms. The coach's shower is entirely finished with ceramic tile. Finishes appeared to be in good condition.	Good

1. Repair or replace the door closing coordinator hardware for the interior doors to room PE-102.

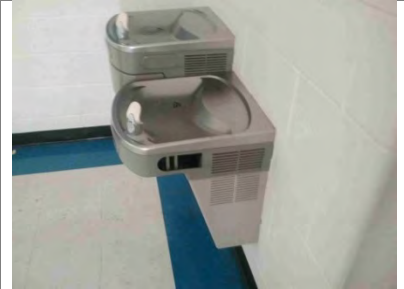
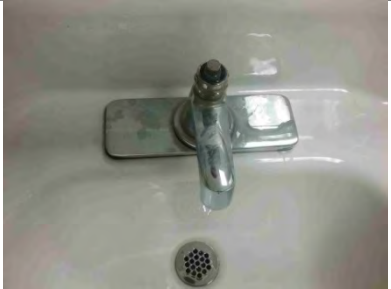
Plumbing Fixtures

System	Subsystem	Condition and Deficiency Overview	System Condition Rating
		The majority of plumbing fixtures were observed to be in average working condition. The shower located inside the gymnasium office had items stored in it and was unable to be assessed for operation. Visual assessment showed it appeared to be in average condition. Janitorial closet PE106 had active condensate draining from mezzanine units. The female restroom PE110 had a sink missing a faucet and leaking. One of the drinking fountains had a pushbutton missing.	
	Domestic Water Distribution	A GWH is in the mezzanine area of BLDG-154B. The unit feeds the gymnasium shower and was newer and in good condition. The plumbing distribution equipment was observed to be in average condition with evidence of leaks on the connecting piping to the sink in female restroom PE110. The domestic water system appeared to be in average condition with typical wear and tear associated with the system's age and general daily use.	Average

1. Remove items for shower in Gym Office
