## Guerrero Thompson Elementary School Site Summary

## Main School Building – BLDG-186A

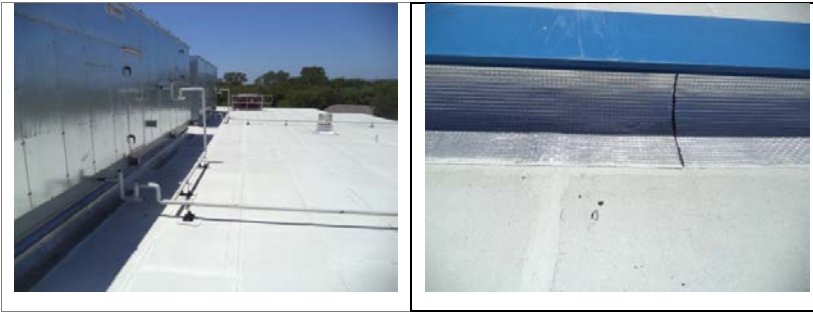
### Roofing Deficiency Examples

Roofing	The roof material consists of modified bitumen and was verified through visual survey.  Roof system was observed to be in good condition. It was reported by facility maintenance staff that leaking occurred in sporadic areas when a significant rain event occurred and there was a potential flashing problem around the mechanical units. These conditions could not be visually verified at the time of survey.		Good

System	Subsystem	Condition and Deficiency Overview	System Condition Rating
		Flashing was observed to be intact and functioning as intended around HVAC (heating, ventilating, and air conditioning) equipment on the roof. It was reported that drainage from roof facility-wide was in good condition. It was reported that the roof drainage consists of gutters and downspouts that drain to an under drain system and there were no deficiencies reported. Covered walkways appeared to be in good condition, as did the roof system.	
<b>Interior Construction</b>	Interior Walls	The interior walls of this facility consist of drywall panel completions and block CMU. The administration offices, library, nurse's offices, gymnasium, and art room have these types of finished surfaces. Classrooms consist mostly of drywall painted finishes. Restrooms consist of ceramic tile on the walls with the upper two feet consisting of drywall. This was observed as common for all restrooms in this facility.  The interior walls appeared to be in good condition with instances of minor abrasions observed on some wall surfaces in various classrooms. The wall conditions were observed to be in good condition.	Good

1. Further investigate the roof areas where sporadic leaking has been reported during heavy rain events in the vicinity of HVAC equipment. .

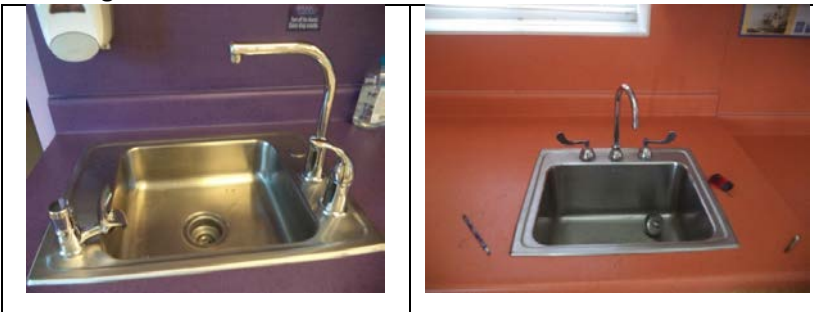
#### Plumbing Fixtures

<b>Conveying</b>	An elevator is present at this facility and services the 400-, 500-, 600-, and 700-wings. It has a 3,500-pound capacity and is certified until September 2016.  This system was observed to be in good condition.		Good
<b>Plumbing</b>	Plumbing Fixtures	The building has public restrooms for men, women, and students, and separate staff restrooms located throughout the facility. The adult facilities have traditional plumbing fixtures. The students' restrooms have larger basin-type sinks and fixtures with manual faucets, along with floor-mounted wall toilets with manual flushing mechanisms and wall-hung urinals in the male restrooms with manual flushing mechanisms. There are service sinks in the janitorial closets, and water fountains located within the facility, typically near or between restrooms.  The restroom plumbing fixtures were observed to be in good condition as the fixtures were operational and showed no signs of malfunctioning parts.  It was reported that the long-neck-type faucets servicing the general classroom areas were easily loosened by students tugging and pulling on them. These systems were observed as secure and in good condition at the time of this assessment.	Good

1. Replace all long-necked plumbing fixtures with standard faucets to avoid damage by children as stressed by plumbing maintenance support staff.

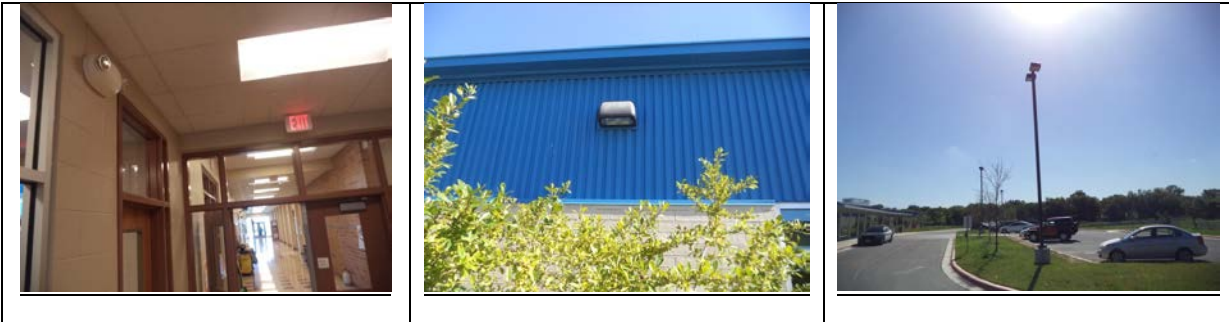
#### Lighting

Lighting	<p>The lighting for the building was observed to be in average condition at the time of this survey. The building's exterior lighting consists of dropdown metal halide luminaires that are located along the parking lots of this facility. It was reported that the electrical department would prefer to replace the exterior wall washer fixtures with standard wall pack luminaires to (LED) units. It was reported that the corridor fluorescent lighting has (smart) ballasts that are now obsolete and inadequate with regard to light strength and coverage. It was reported that parking lot lighting was inadequate.</p> <p>The interior lighting consists primarily of 2'x4' T8 fluorescent luminaires set in troffers throughout the facility. Library and specific open locations have suspended low-bay fluorescent fixtures with standard T-8 florescent luminaires.</p>	Average
	Communications & Security	<p>It was reported that Wi-Fi worked well at this facility.</p> <p>This facility has a security system including alarms, surveillance cameras, and card readers. It was reported that the system as a whole was operational and functioning as intended.</p> <p>It was reported that the public address system was basic and functioned poorly. This can be a safety issue during an emergency situation as stressed by the staff.</p> <p>It was reported that camera coverage was good and resolution was sufficient facility-wide, but more cameras were needed in the main corridor's purple area common locations. This system was observed to be in good condition.</p>	Good

1. Evaluate the exterior drop down parking lot lighting for inadequate illumination strength, and potentially convert to a more energy efficient maintenance-friendly fixture. Dialog must include administration and building staff.
2. Evaluate corridor fluorescent lighting where smart ballast are present and have become troublesome with regards to replacement parts as well as illumination strength of bulbs.
