Harris Elementary School Site Summary

| Address | 1711 E Wheless Lane Austin, TX 78724 |

Main School Building – BLDG-118A

| Inspection Date | June 28-29, 2016 |

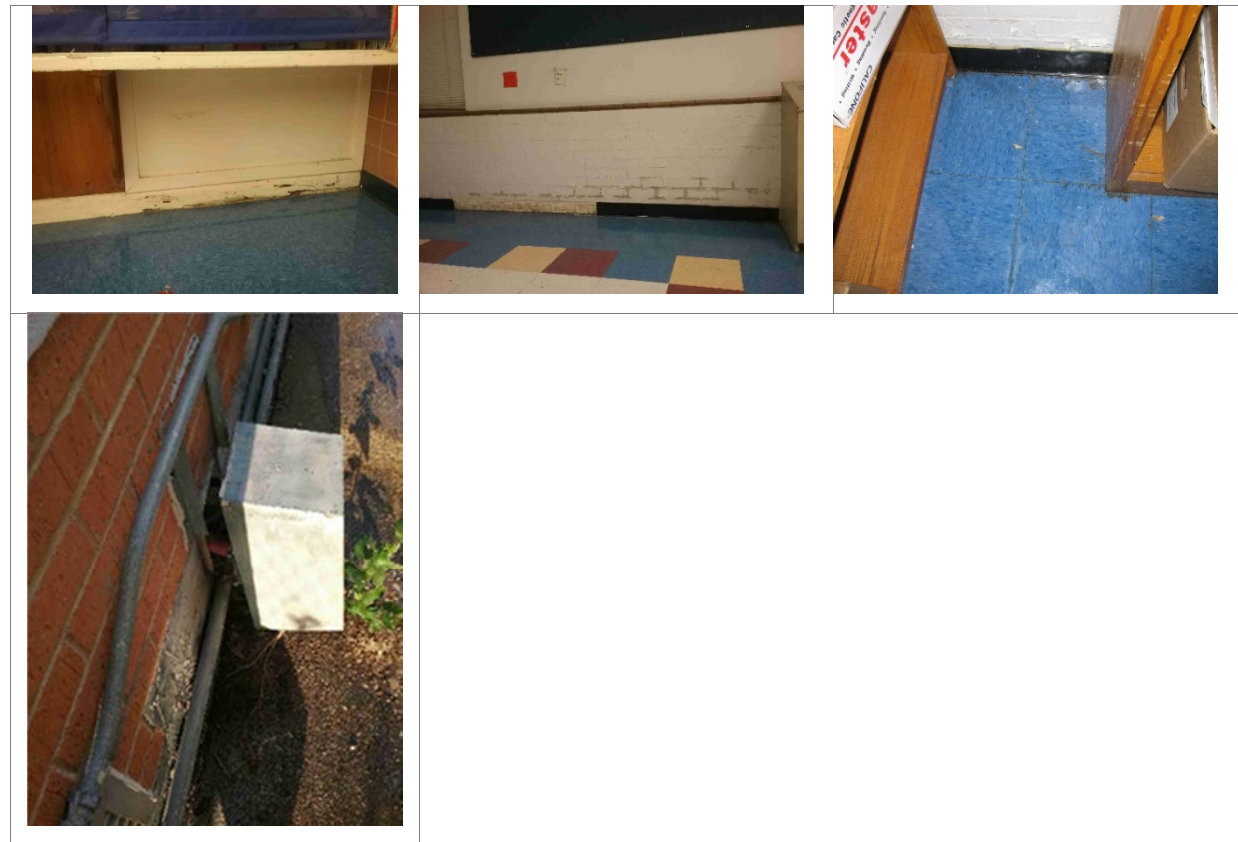
| System | Subsystem | Condition and Deficiency Overview | System Condition Rating |
|---|---|--|---|
| Exterior | Exterior Walls | <p>The exterior of the building consists of a brick and cement plaster façade. The classroom wings have verandas which serve as corridors to these classrooms. These verandas are protected above by painted, roof form-board soffits.</p> <p>The walls and soffits appeared to be in good condition. Steel columns supporting the outer edges of the veranda roof/soffits were being painted at the time of the assessment. An isolated location was observed where sheet metal housing once sealed a utility penetration at the base of a wall. It has become dislodged which would allow pests and water to possibly enter the building. The interiors of the walls in the 300-west wing appeared to have been subjected to moisture intrusion. There was rot along the interior base of the exterior south wall in room 308. Paint was peeling from the interior face of the north walls of room 309 & room 310. A rain event occurred during the assessment. Water was observed seeping onto the floor from the interior face of the north exterior wall in room 312.</p> | Average |

1. Inspect the exterior perimeter for holes or utility penetrations that require to be sealed. Seal all penetrations.
2. Investigate and correct the source of the moisture damage to floors and walls at the interior perimeter of the west 300-wing. Ceilings do not appear to be damaged and therefore moisture intrusion could either be wicking from the foundation or entering through wall/window assemblies.

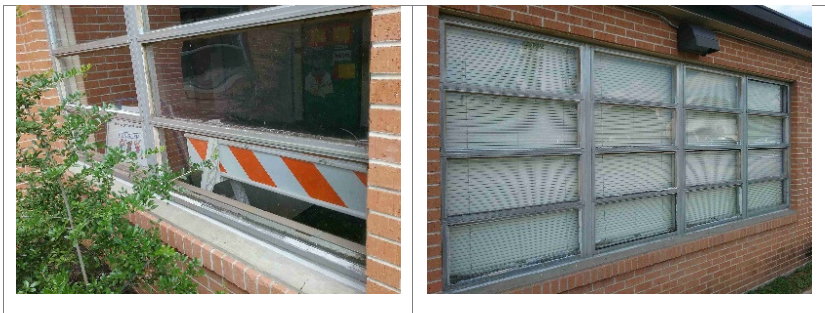
| System | Subsystem | Condition and Deficiency Overview | System Condition Rating |
|---|---|--|---|
| | Exterior Windows | <p>The exterior windows consist of single pane glazing units with aluminum frames.</p> <p>Overall, all of the windows appeared to be in average condition. However, windows in the administration and main entrance area appeared to be in very poor condition. The glazing seals were observed to be</p> | Average |

| System | Subsystem | Condition and Deficiency Overview | System Condition Rating |
|---|---|--|---|
| | | deteriorated. The paint finish of the lintels located at the heads of the windows was failing. The sealant installed at the perimeter of the units was degraded. | |

3. Replace or repair windows in the administration and main entry areas. Repairs should include the replacement of glazing compound around glass panes. Re-paint steel lintels above the window units. Inspect the sealant & flashing around the perimeter of the window units for compromised conditions. Correct conditions as necessary.
4. Replace the main entry doors adjacent to the administration area and install new hardware.

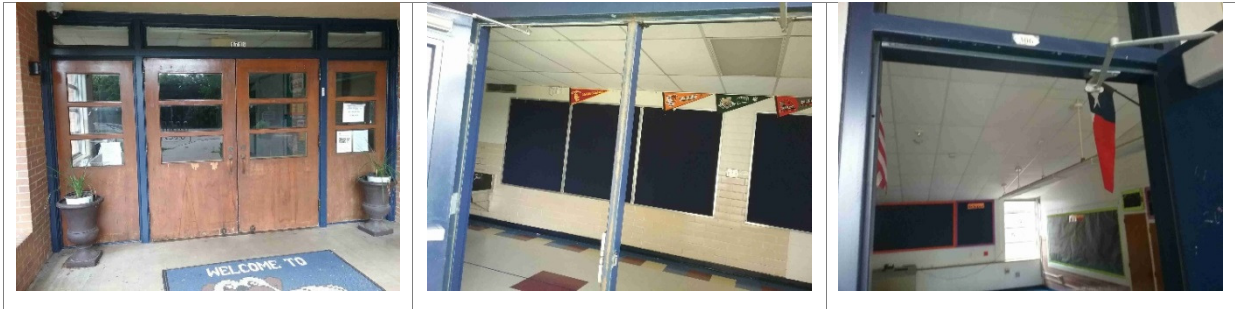
| System | Subsystem | Condition and Deficiency Overview | System Condition Rating |
|---|---|--|---|
| | Exterior Doors | <p>The main entrance doors are solid-core wood with a stained finish and are set in a painted wood frame. All other exterior doors are painted hollow-metal and are set in painted, hollow-metal frames.</p> <p>The entry doors appeared to be in very poor condition. All other doors appeared to be serviceable though it was reported that doors between the 300-wing and the corridors did not close properly. It was also reported that exterior doors adjacent to Mechanical room 100 experienced leaking. All of the exterior doors lacked weather-stripping.</p> | Poor |

1. Inspect the perimeter of all exterior doors for missing or damaged weather-stripping. Weather-stripping should either be replaced where damaged, or doors should be otherwise retro-fit for new where none existed before. The meeting stile of double doors are particular locations where weather-stripping was observed to be missing.

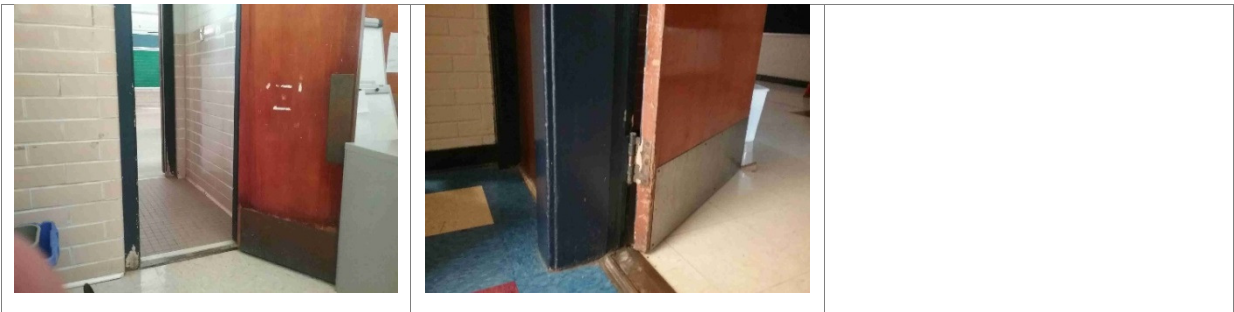
| System | Subsystem | Condition and Deficiency Overview | System Condition Rating |
|---|---|--|---|
| | Interior Doors | The mix of new and older interior doors are of solid-core wood construction. Some have view panels. These doors are either stained or painted. The older doors are installed in painted wood frames. Newer doors are installed in painted hollow-metal frames. The newer doors including hardware were observed to be in good condition. Older doors and their hardware were in average to poor condition. Older doors were gouged and dented. The older hardware was loose, worn, and ill fitting. | Average |

1. Survey the condition of interior doors. For the most part, interior doors are in serviceable condition, but replace or refurbish door and door hardware observed to be in poor condition.
2. Seal the utility penetrations in the ceiling of Electrical Closet-200.

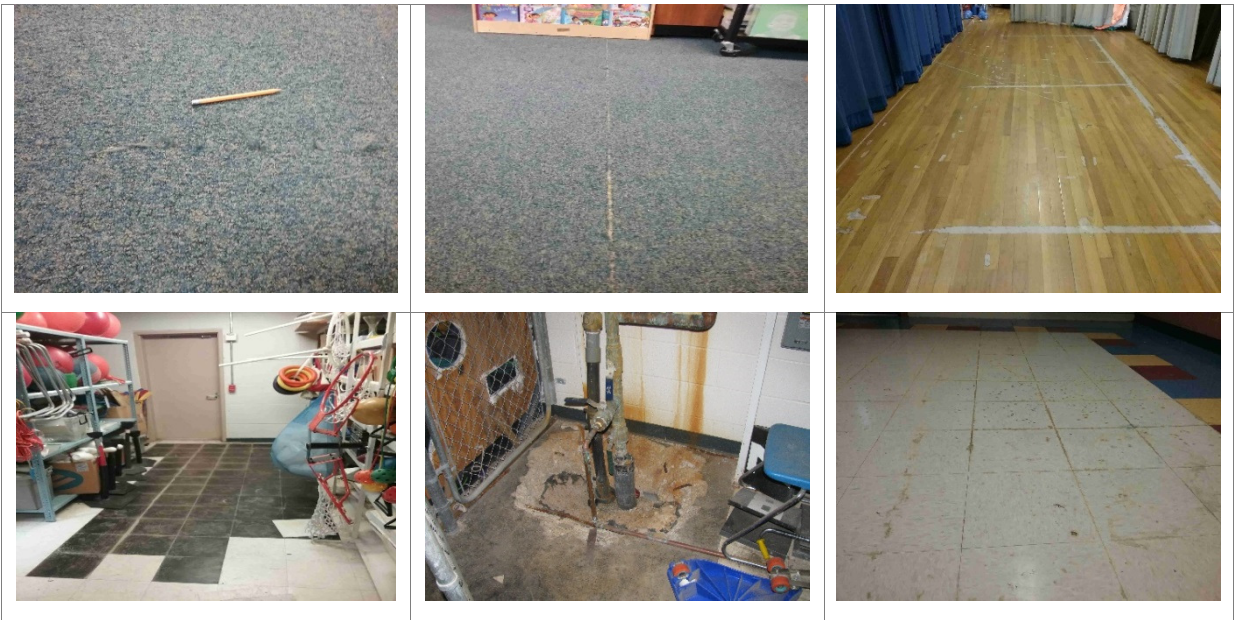
Interior Floor Finishes

| System | Subsystem | Condition and Deficiency Overview | System Condition Rating |
|---|---|--|---|
| | | <p>tile forms the base. Athletic flooring tiles are installed in the gymnasium. Broadloom carpet is installed in the library. The cafeteria stage floor is wood plank.</p> <p>The library carpet is torn and the seams are worn. The cafeteria stage floor is in good condition but the finish is worn. Tiles are missing in the gymnasium electrical equipment room and there is an unsealed hole in the floor of this space. Tile is damaged in room 309. It was reported that the rubber sheet floor finish at the main corridor ramp and the resilient tile in the gymnasium were becoming unglued but evidence of this was not observed while on site.</p> | |

1. Replace the library carpet with a new carpet tile system.
2. Refinish the wood cafeteria stage floor to maintain a uniform appearance.
3. Replace missing floor tiles in the gymnasium electrical closet. Fill the dished-out area in the southwest corner of the room with grout/concrete level to the top of the floor.
4. Repair and replace corridor ceiling tiles that are broken, sagging or mis-aligned.
5. Repair/replace finishes in west 300-wing once the solution to the moisture problems there are resolved.

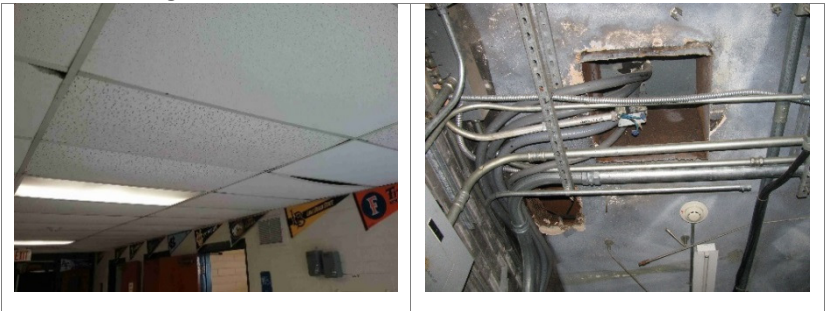
| System | Subsystem | Condition and Deficiency Overview | System Condition Rating |
|---|---|--|---|
| | Interior Ceiling Finishes | <p>2'x2' vinyl-faced, lay-in tile is installed in the kitchen. The gymnasium does not have a ceiling and is open to the painted bottom of the roof structure above. Painted gypsum wallboard is installed at the staff restroom. Otherwise, 2'x4' lay-in ceiling tile & grid is installed throughout the building.</p> <p>Open penetrations through the ceiling of 200-wing Electrical Equipment Closet were observed that could potentially allow the entry of pests. The 2'x4' tile appeared to be sagging, miss-matched, and warped in many areas.</p> | Average |

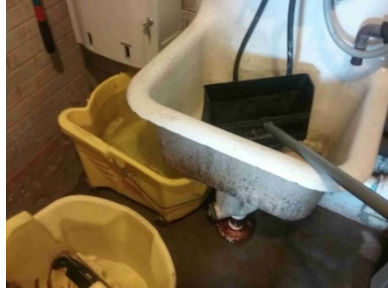
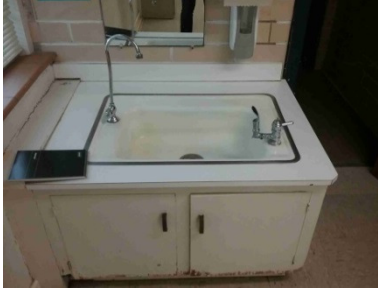
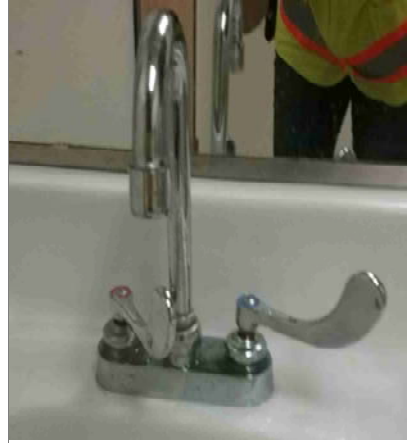
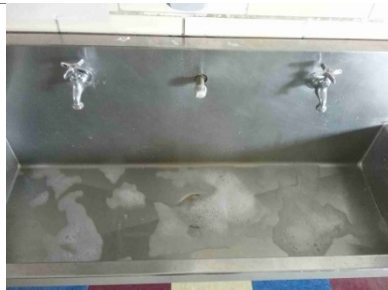
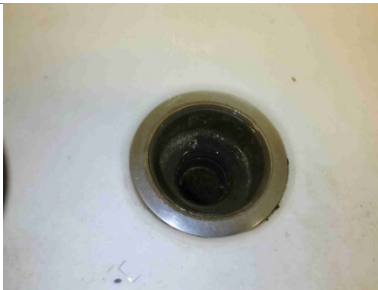
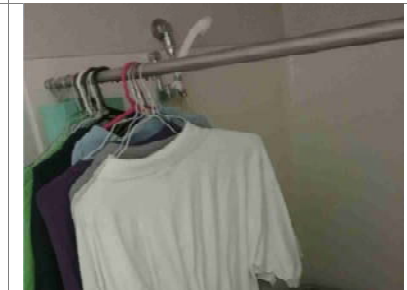
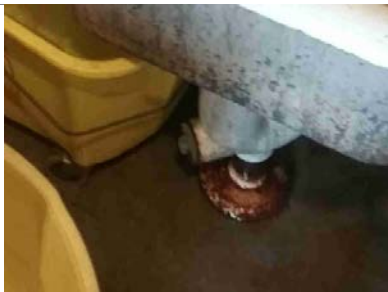
| System | Subsystem | Condition and Deficiency Overview | System Condition Rating |
|---|---|--|---|
| Plumbing | Plumbing Fixtures | <p>The building contains predominantly single-use restrooms throughout the facility, with multi-use restrooms found outside of the library. Typical restrooms have floor mounted vitreous china water closets with manual flush valves. Additionally, wall hung vitreous china urinals with manual flush valves are located in the dedicated men's restrooms. Typical classrooms contain a single basin vitreous china sinks with a drinking fountain attached. Stainless steel and vitreous china drinking fountains can be found throughout the building in the corridors. A stainless steel handwashing trough is found outside the cafeteria.</p> <p>The restroom plumbing fixtures are in average condition. The fixtures were typically aged and in the 100- and 200-wings of the building were reported to be original to the building but still operational. The sink in</p> | Average |

| System | Subsystem | Condition and Deficiency Overview | System Condition Rating |
|---|---|---|---|
| | | <p>the administration restroom was observed to be leaking, additionally the sink had a hot water handle, but had no hot water source connected. classroom 307 contained a sink but did not contain a drinking fountain. There is a shower located in the gymnasium office; the shower was full of clothes and other items, therefore functionality of the fixture and drain could not be assessed. Visual assessment of the shower did not show any major deficiencies. Handwashing trough appeared to not be draining quickly and to have a clog.</p> <p>A commercial kitchen is located in the school's cafeteria. The kitchen contains stainless steel kitchen equipment, including a three basin prep sink. It also has various wall mounted vitreous china sinks for personal use. One of the knobs on the bathroom sink located inside the kitchen was observed to deliver no flow. The building also has service sinks located in various janitorial closets. These were in average to poor condition, some showing signs of leaks and corrosion around the base. One of the janitorial sinks in the mechanical storage closet off the 100-wing (mech-100-mech) showed severe leaking, flooding into a mop bucket that was full, and then all over the floor of the closet.</p> <p>Majority of plumbing fixtures are in working condition, but show minor signs of deterioration. Multiple plumbing fixtures show signs of corrosion around their base. Aged plumbing fixtures should be replaced in order to maintain a functioning system.</p> | |

1. Replace aged plumbing fixtures in order to maintain a functioning system.
2. Repair sinks where there is evidence of corrosion or leaks.
3. Repair or replace any damaged or missing piping insulation as needed at all facilities.
4. Address any rust or corrosion observed on the equipment, its associated piping, or any other sub-asset by cleaning, re-painting, and/or repairing by any other means to prevent further deterioration.

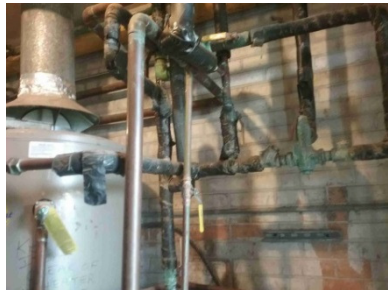
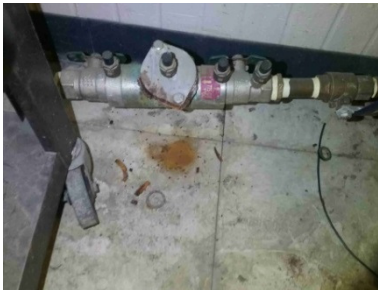
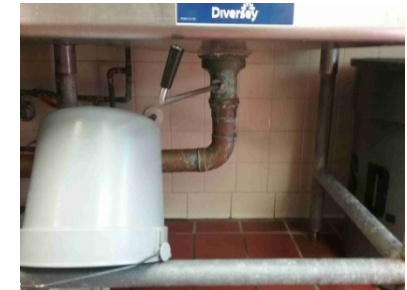
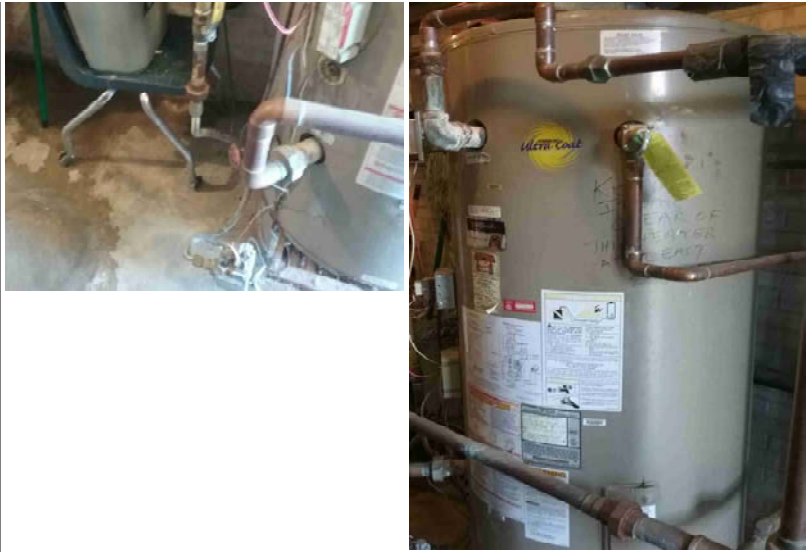
| System | Subsystem | Condition and Deficiency Overview | System Condition Rating |
|---|---|---|---|
| | Domestic Water Distribution | <p>Domestic hot water is supplied to the administration office, the nurse's office, and the gymnasium restroom via small 4-6 gallon water heaters. Additionally there is a larger 69-gallon water heater in the mechanical storage closet off of the 100-wing (mech-100-mech). It is possible this heater feeds the kitchen as no water heater was found when inspecting the kitchen. Domestic hot water is not supplied to the classroom plumbing fixtures.</p> <p>The domestic water system is in average condition with typical wear and tear associated with the system's age and general daily use. The large heater in mech-100-mech was aged and out of date, with some wires dangling off the side and was observed to be making a whistling and clinking noise during assessment. The kitchen was reported to have issues</p> | Average |

| System | Subsystem | Condition and Deficiency Overview | System Condition Rating |
|---|---|---|---|
| | | consistently receiving hot water in the facility interview. The plumbing distribution equipment was observed to be in average condition with damaged insulation and corrosion and rust observed on piping throughout the building. | |

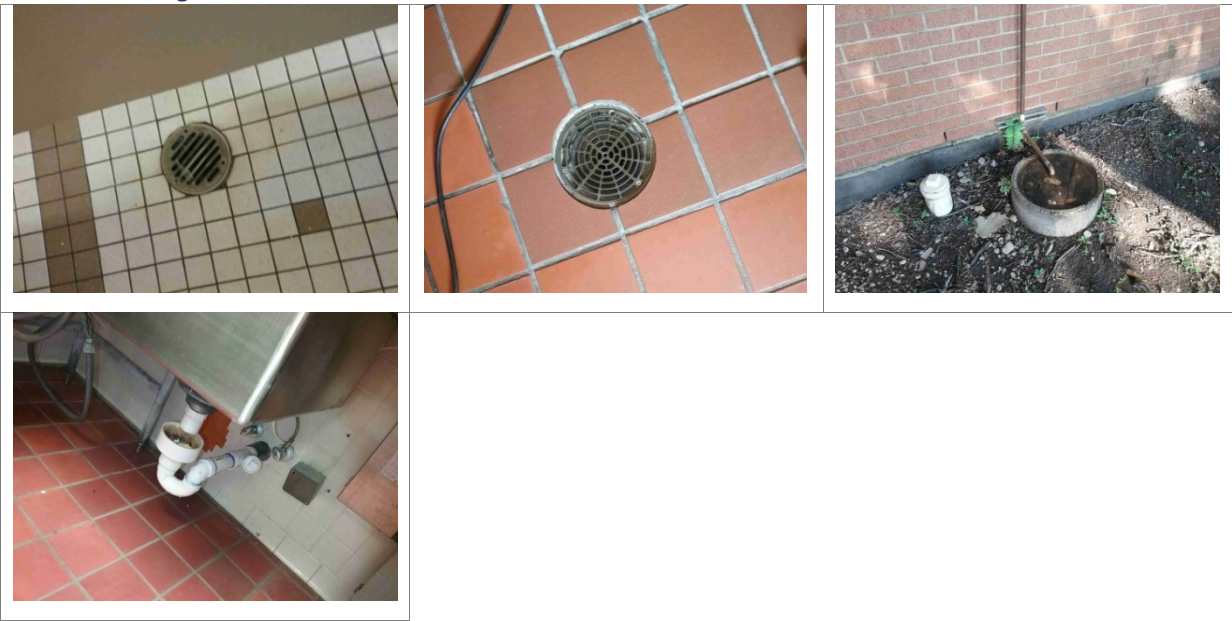
| System | Subsystem | Condition and Deficiency Overview | System Condition Rating |
|---|---|---|---|
| | Other Plumbing | Exposed insulated piping was observed to be running along the ceiling and walls in various different rooms throughout the building. Metal floor drains were observed in the bathroom and kitchen areas. It was reported in the facility interview that the dishwasher floor drain is not properly sized. Visual assessment did not show any obvious clogs but drains in bathrooms off of the 100-wing and in the corridor outside the library were observed to be emitting an unpleasant odor. It was reported in the interview minutes that the kitchen drain line and grease trap is undersized and has odor problems. Rain water drains were observed around the outside of the building. Some of these were observed to be clogged with debris. | Poor |

1. Repair leak flooding the floor in mech-100-mech, and clean up any standing water.
2. Repair clogged hand washing trough outside of the cafeteria.
3. Verify functionality of the gymnasium shower.

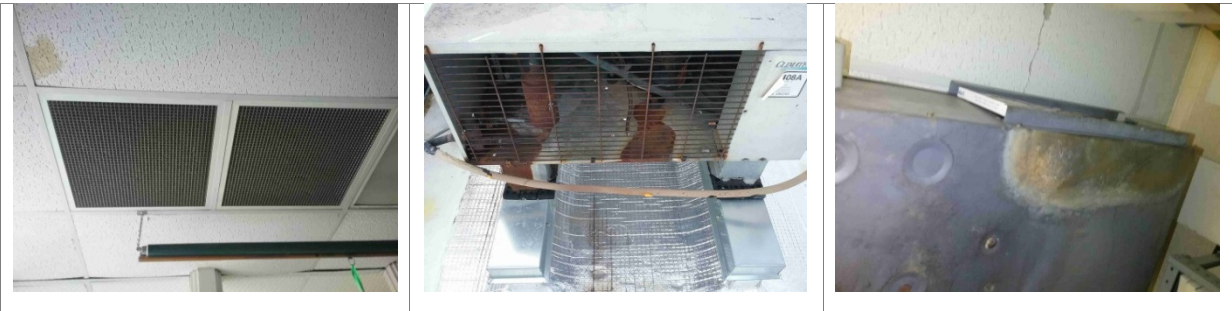
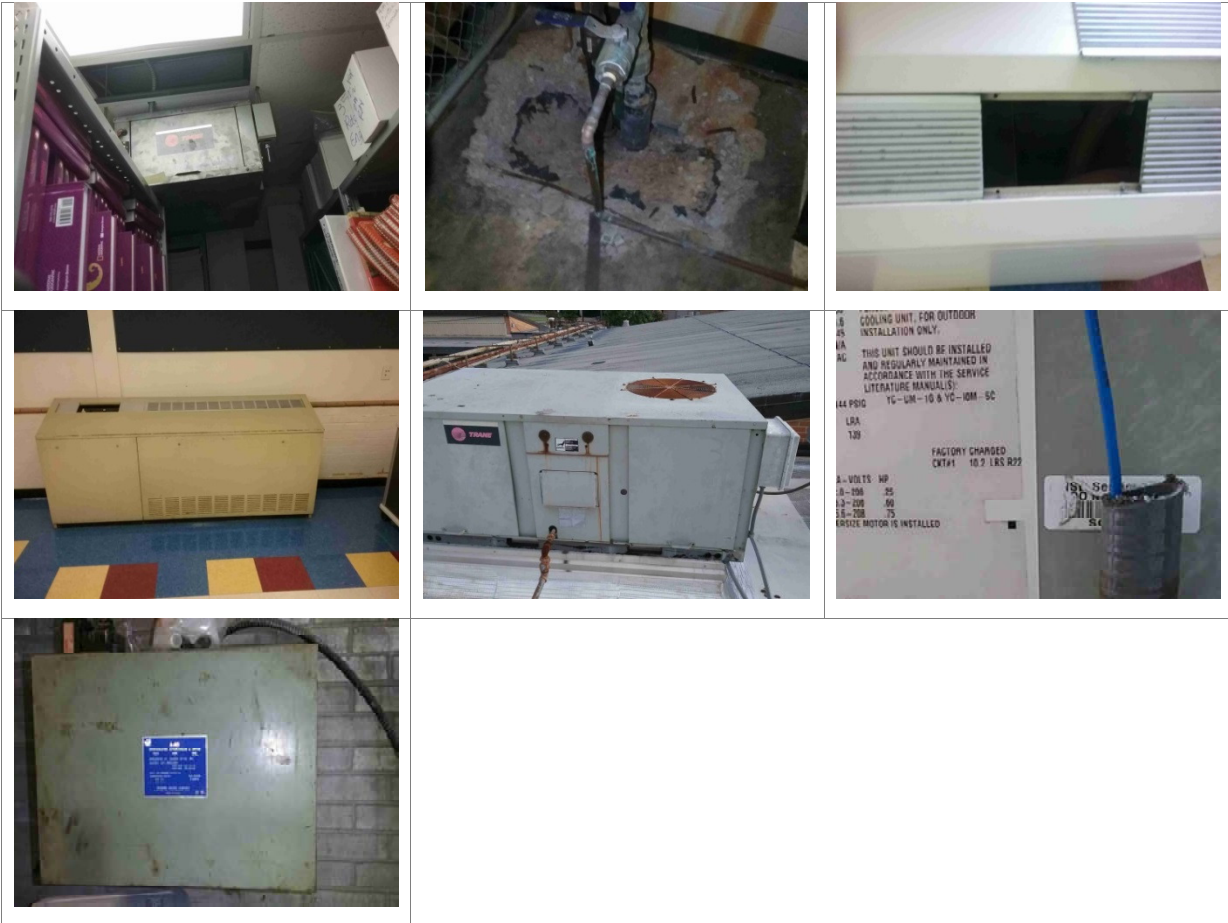
Mechanical/HVAC System Deficiency Examples

| System | Subsystem | Condition and Deficiency Overview | System Condition Rating |
|---|---|---|---|
| Mechanical/ HVAC | <p>The building's HVAC (heating, ventilating, and air conditioning) system is composed of geothermal heat pumps, RTUs (roof top units), roof top AHUs (air handling units), and split systems for individual zone temperature controls. The administration office, cafeteria, gymnasium, and library are controlled using RTUs and AHUs as well as split systems containing heat pumps and cooling condenser units. Classrooms are temperature controlled using a geothermal heat pump system designated for each classroom. Multiple roof top exhaust fans ranging in size serve the building.</p> <p>The HVAC system is in average condition; however, some pieces of equipment are past their expected design life and show signs of degradation and minimal signs of rust and corrosion. Geothermal units are aged and out of date. Water source heat pumps for the units were not accessible, assumed to be inside the unit and in average condition. It was reported that some of these units have been known to leak onto the floor. Condensation leaks were observed on the ceiling in the library, additionally it was reported in the facility interview that condensation has been known to leak in the cafeteria. Two heat pumps were found in the gymnasium storage, the ground around the pipes feeding these pumps is found to be all dug up leaving a hole in ground. Several of the units use R-22 refrigerant, which is an outdated refrigerant that is being phased out of use. An energy recovery unit on the roof was found to have the power switched to off. In the mechanical room off the 200-wing there was a refrigerated aftercooler and dryer that had no apparent connections and was no longer in service. The geothermal unit found in the corridor across from the cafeteria was missing its control panel and was not operational. Exhaust fans for the girl's bathroom between classrooms 103/104 and 201/202 are not working.</p> | | Average |

1. Replace HVAC units that use R-22 refrigerant, which is an outdated refrigerant that is being phased out of use. These systems may need to be replaced before they reach the end of their design life due to refrigeration restrictions.
2. Address any rust or corrosion observed on the equipment, its associated piping, or any other sub-asset by cleaning, re-painting, and/or repairing by any other means to prevent further deterioration.
3. Address any equipment at all of the campus facilities that were noted with excessive noise/vibration by repairing the motor, changing the belt, or any other means to promote efficiency.
4. Replace HVAC equipment that is aged beyond its expected design life.

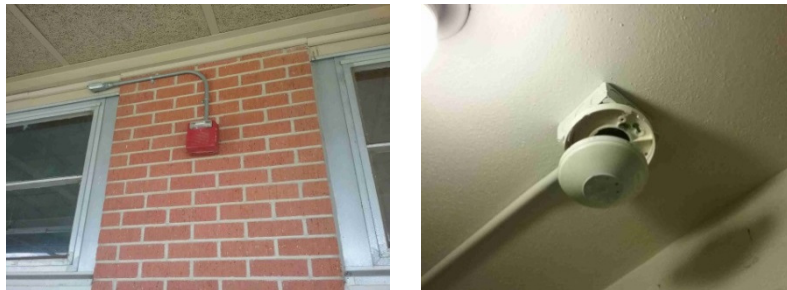
| System | Subsystem | Condition and Deficiency Overview | System Condition Rating |
|---|---|--|---|
| Fire Protection | Fire Alarm | The building has a fire alarm system that consists of alarm and signaling devices such as horns/annunciators, strobes, horn/strobe combos, pull stations, and detectors. The fire alarm system was observed to be in average condition due to some of the fire alarm end devices being aged or worn from outdoor exposure. One heat detector, within room STO300, is improperly secured and is hanging. The campus faculty has reported that the fire alarm randomly trips for the building. | Average |

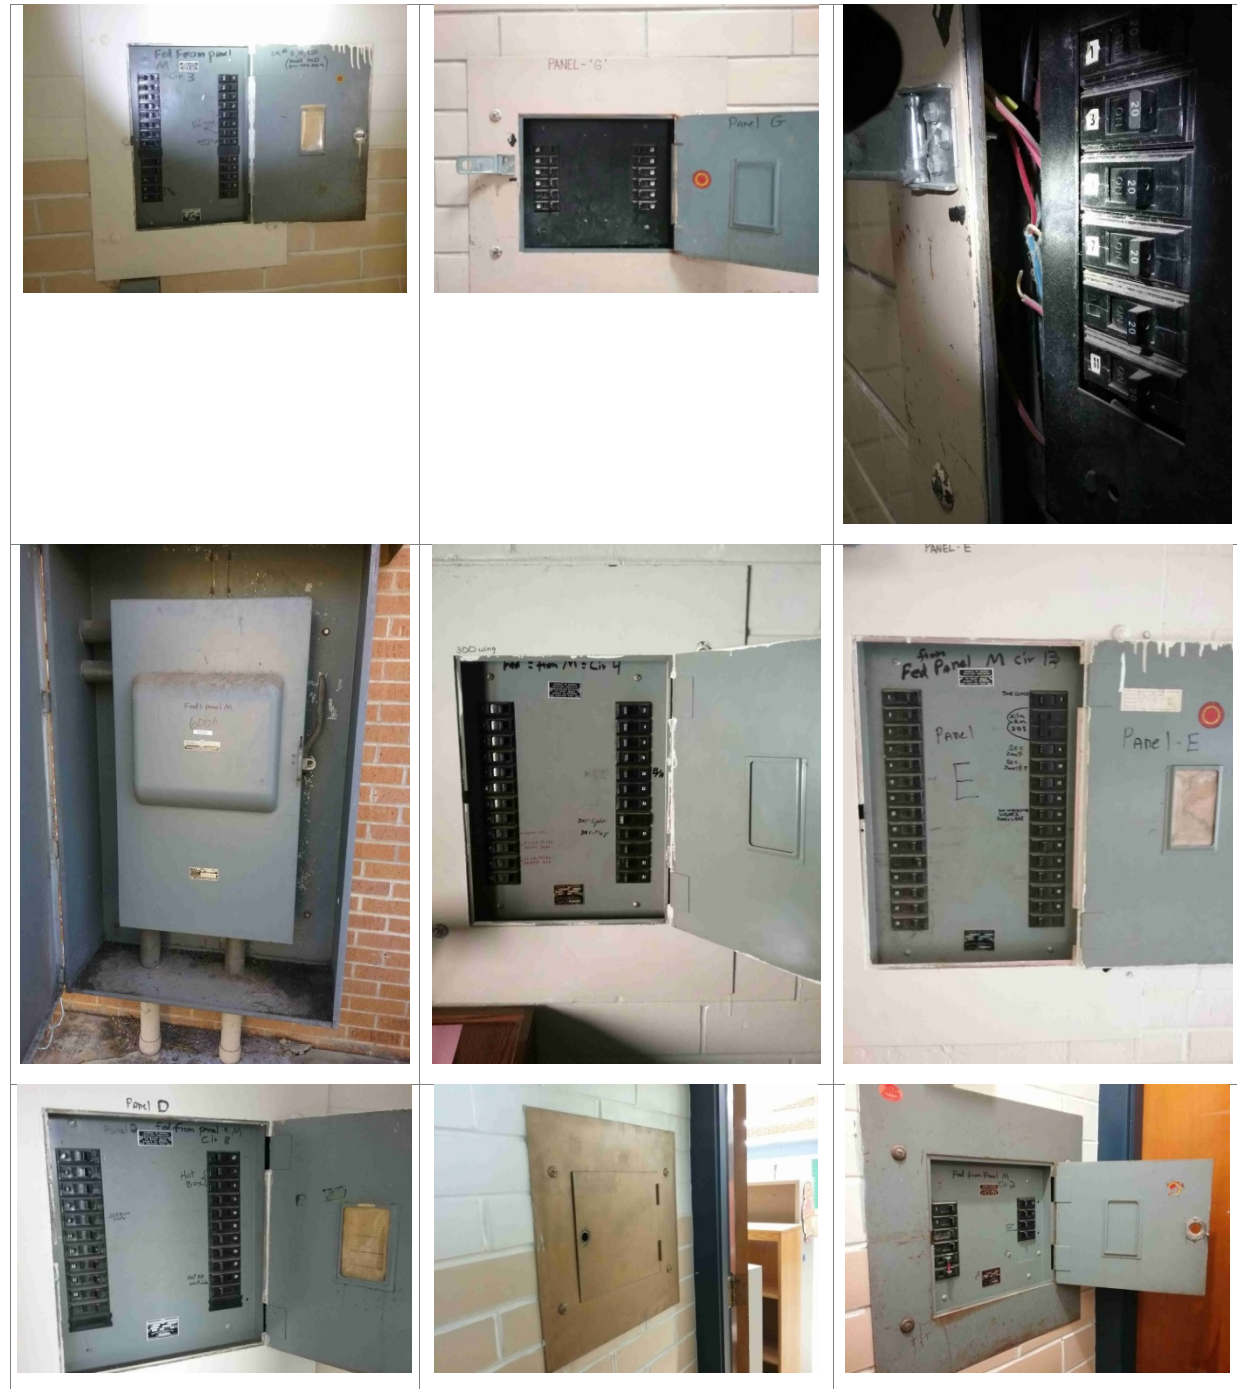
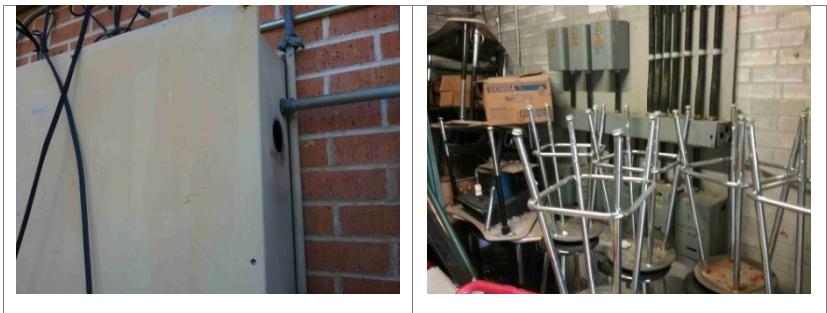
| System | Subsystem | Condition and Deficiency Overview | System Condition Rating |
|---|---|--|---|
| Electrical | Electrical Distribution | <p>The electrical service enters the building at the 208Y/120-volt 2000-amp main switchboard located in the fenced-in electrical utility area on the north end of the complex. The main switchboard feeds several main panelboards which distribute to smaller panelboards. The building does not have a lightning protection system.</p> <p>The electrical distribution equipment was observed to be in average condition. The majority of the assets have been replaced or added in the past 20 years. There are several asset and non-asset panels that appeared original to the 1955 construction or from the 1960s and have exceeded their life expectancy. The first is an unnamed 225- amp Trumbull Electric panel in the main entrance corridor, west of the administration office. Second is Panel E, a 200-amp GE (General Electric) panel, located in the main C1 corridor nears the 300-wing. The third is an unnamed 200-amp GE panel located in room CUSTOFC. The fourth is Panel G located within the gymnasium. The capacity and manufacturer of the panel is unknown due to a missing data plate. This panel is improperly installed and allows for access to the wiring on the sides. There are also several exposed wire leads that are visible and could potentially be a life safety concern if they are live. The fifth is Panel G, a 100-amp Trumbull Electric panel, located on the cafeteria wall within corridor C1. The</p> | Average |

| System | Subsystem | Condition and Deficiency Overview | System Condition Rating |
|---|---|---|---|
| | | <p>sixth is a 100-amp GE panel located in the bathroom connection between rooms 105 and 106. The seventh is a 100-amp GE panel located between rooms 205 and 206.</p> <p>There is an assortment of electrical shutoff switches in the building that have exceeded their life expectancy.</p> <p>There is a large junction panel on the exterior of the building in the fenced in electrical utility area located on the north end of the building. This panel has an exposed knockout port that provides a pathway for water infiltration and animal life into the building, not to mention damage to internal wiring.</p> | |

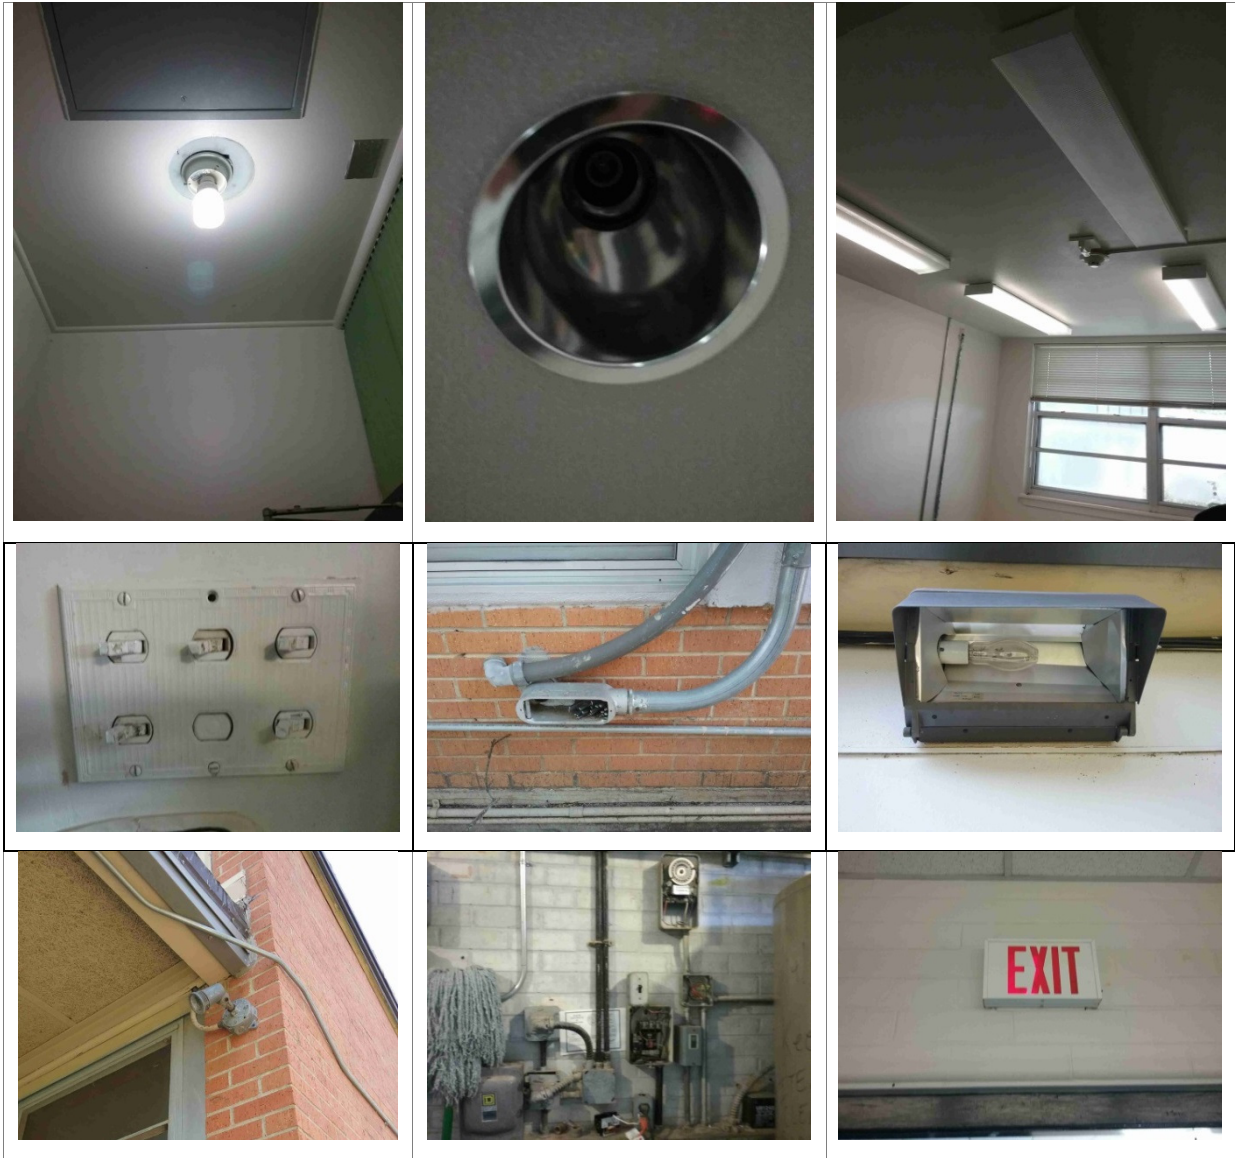
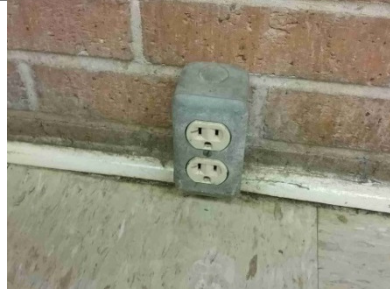
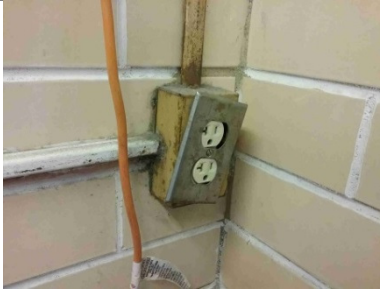
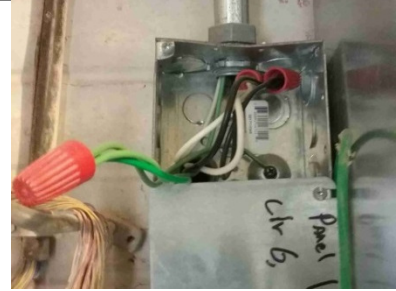
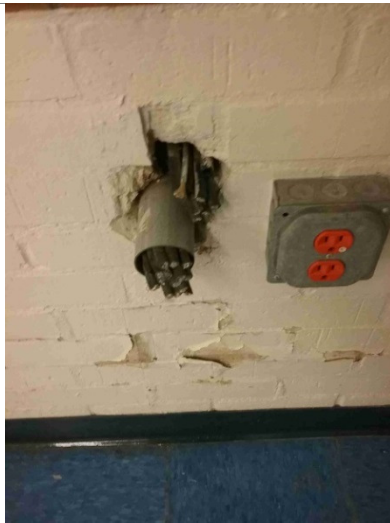
| System | Subsystem | Condition and Deficiency Overview | System Condition Rating |
|---|---|---|---|
| | Lighting | <p>The building's exterior lighting consists of metal-halide and LED (light-emitting diode) luminaires. Exterior lighting is predominately present on the main entrance of the building and at the kitchen unloading area. Exterior lighting is also present on the covered walkway on the classroom wings. The interior lighting consists of primarily fluorescent light luminaires throughout the building.</p> <p>The lighting for the building was observed to be in average condition. Many interior luminaires appeared to be aged past their design life. Observed deficiencies include missing lenses, missing bulbs, and burned out bulbs. Some luminaires appeared to have been abandoned and not removed. There are exit signs present in the building; however several appeared to be dim or partially visible at the time of assessment.</p> <p>The building has a variety of deficiencies in branch wiring. Several conduit junction boxes were exposed. There is also several areas where cabling has been cut and left in place. Many of the light switches throughout the building are severely dated and have exceeded their life expectancy. There are also older electrical receptacles in the classrooms that are worn and have exceeded their useful life. Worn light switches and electrical receptacles can create life safety issues due to internal arcing when used.</p> | Average |

1. Remove any floor receptacles found in the classroom wings as they are being phased-out of use district-wide.
2. Consider replacing all outdated or poor condition luminaires with LED luminaires with dimming capabilities.
3. Replace bulbs in dimly lit exit luminaires or consider replacing with LED fixtures.
4. Repair issues with electrical branch wiring conduit and communication system conduit. This includes loose conduit, exposed junction boxes, and exposed receptacles.
5. Replace electrical receptacles and lighting switches that have exceeded life expectancy.

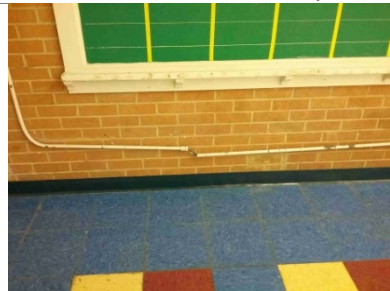
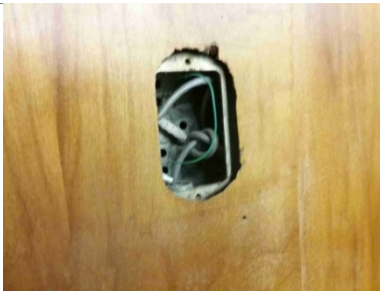
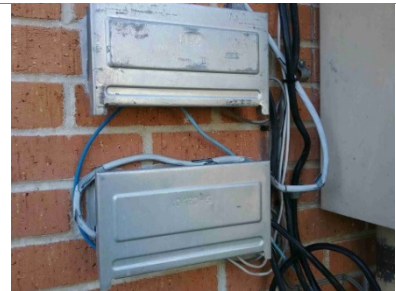
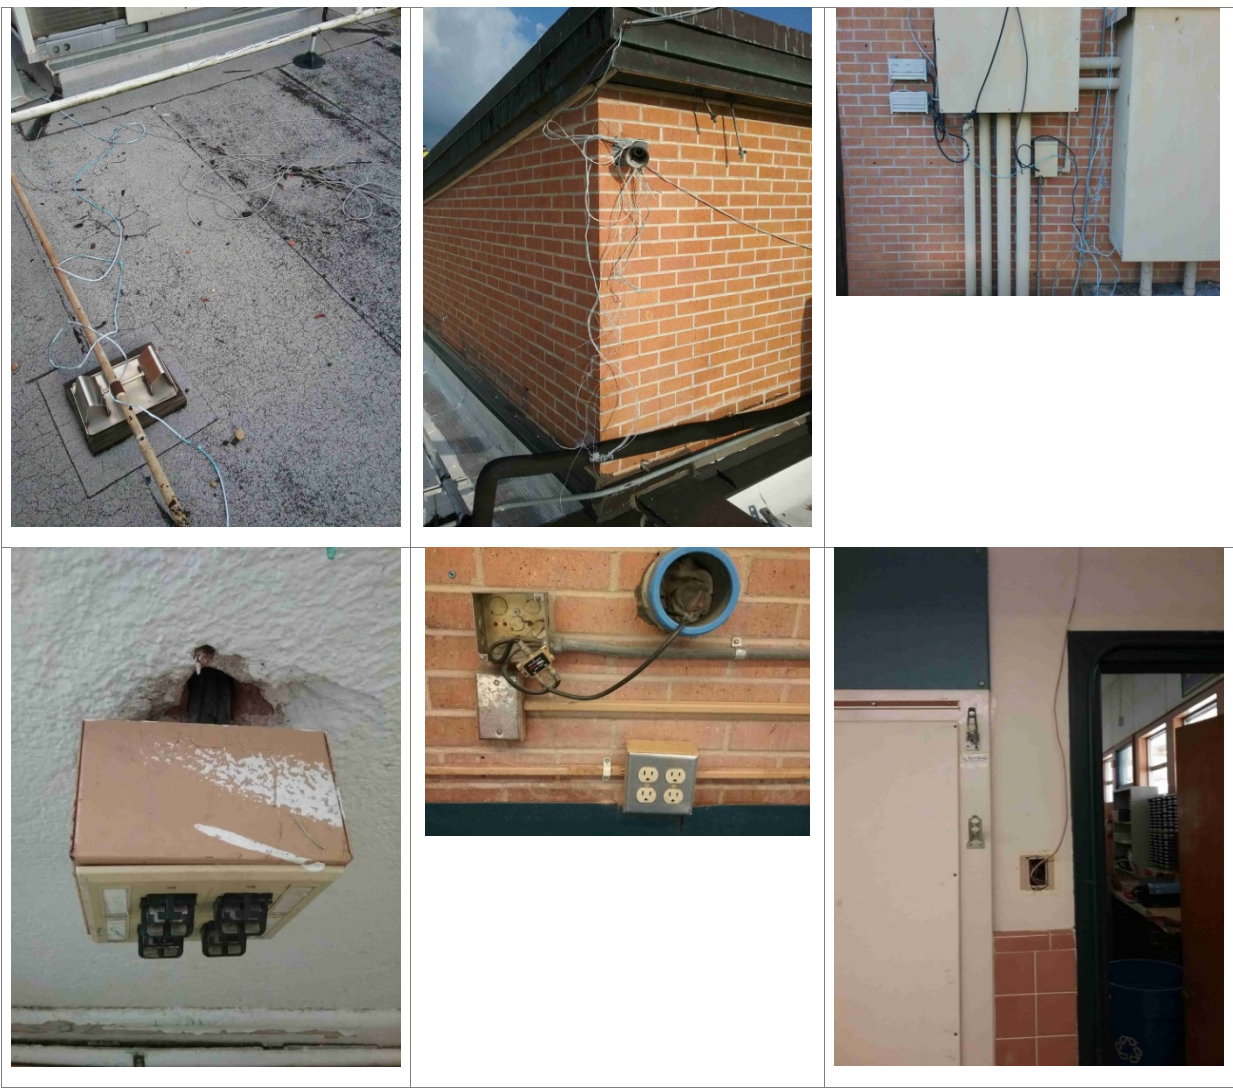
Communications & Security

| System | Subsystem | Condition and Deficiency Overview | System Condition Rating |
|---|---|--|---|
| | | main backbone equipment is located in an inaccessible room. Some classrooms have hardwired telephones, but it appeared the VOIP (voice over internet protocol) is utilized for communications. The building also has receptacles for an early IBM Token Ring network that is most likely no longer in use. Several areas of the building have old networking cabling that is improperly secured and eroded. There are also areas where communication cabling is exposed in improperly covered outlets or loose conduit. There is also a large portion of networking/telephone cabling on the roof that is unsecured and damaged from weather exposure. | |

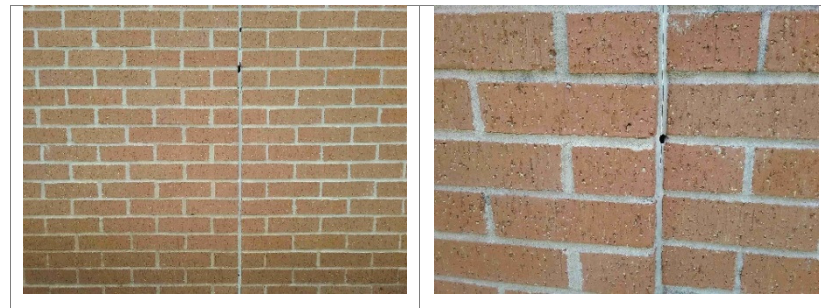
| System | Subsystem | Condition and Deficiency Overview | System Condition Rating |
|---|--|---|---|
| Exterior | Exterior Walls | The exterior finish is entirely masonry. The east & west (end) walls are entirely brick. The north & south (long) walls are brick with concrete masonry unit coursing at the base. Plaster soffits are installed at the entries. The exterior walls and soffits were observed to be in good condition except for some compromised sealant at the masonry control joints. | Good |

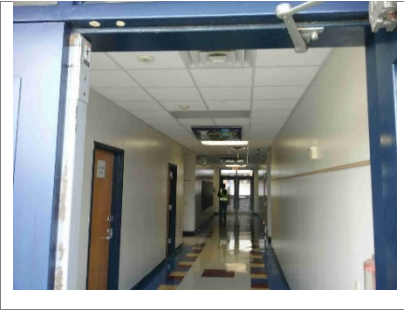
| System | Subsystem | Condition and Deficiency Overview | System Condition Rating |
|---|--|---|---|
| | Exterior Doors | Exterior doors are painted hollow-metal doors with half, vision panels. These are installed in painted, hollow-metal frames. Though doors were observed to be in good condition, the doors lack complete weather-stripping. | Good |

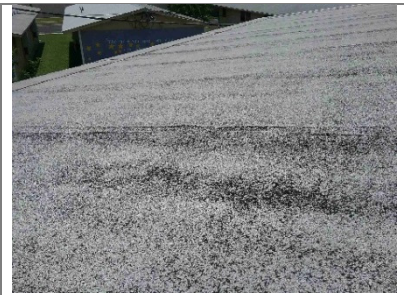
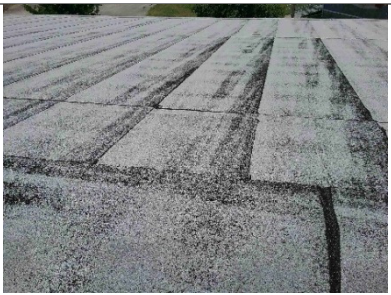
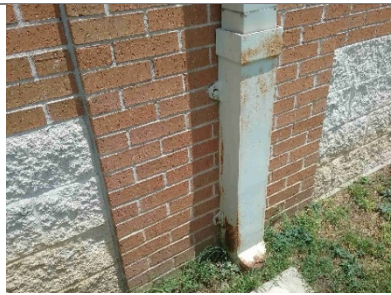
Roofing Deficiency Examples

| System | Subsystem | Condition and Deficiency Overview | System Condition Rating |
|---|--|---|---|
| Roofing | The roofing consists of a modified bitumen membrane which slopes slightly toward metal gutters and downspouts. The roof appeared to be in serviceable condition, but is beginning to show signs of wear. The granular ballast is beginning to wash away from the top of the membrane and blisters are appearing at the sheet joints. It was reported that water from the roof was entering room 401. Metal drip edges, gutters, and downspouts appeared to be in good condition. The painted, metal downspout boots are showing rust. | | Average |

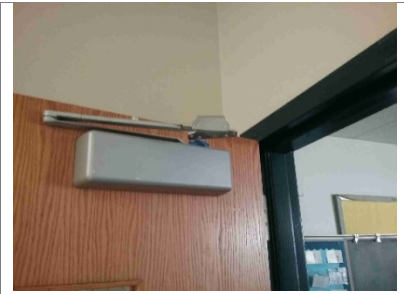
| System | Subsystem | Condition and Deficiency Overview | System Condition Rating |
|---|---|--|---|
| | Interior Doors | Interior doors are stained and are of solid-core wood construction set in painted, hollow-metal frames. While all doors, frames, and hardware appeared to be in good condition, the closer hardware on the door to classroom 401 needs to be re-attached to the door frame head. | Good |

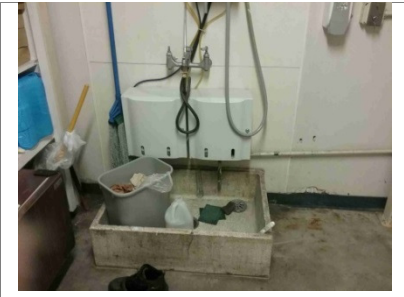
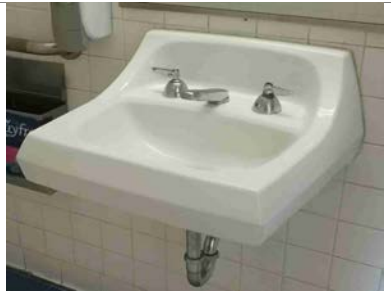
| System | Subsystem | Condition and Deficiency Overview | System Condition Rating |
|---|---|--|---|
| Plumbing | Plumbing Fixtures | The building's classrooms contain a single basin stainless steel sink with a drinking fountain attached. Each pair of classrooms had two single-use restrooms containing a floor mounted vitreous china water closet in the connection between the two classrooms. A teacher's single use restroom is located in the corridor outside of classroom 402 that contains a floor mounted vitreous china water closet and wall mounted vitreous china sink. Classroom 411, the art room, contains three stainless steel basin sinks and one large wall mounted vitreous china sink. Additionally it contains a single use bathroom with a floor mounted vitreous china water closet and wall mounted vitreous china sink. | Average |

| System | Subsystem | Condition and Deficiency Overview | System Condition Rating |
|---|--|---|---|
| | | The fixtures were observed to be in average to good working condition. The sink in the teacher's restroom only had hot water feeding it. The building also has a mop drain located in the custodial closet (C400). It is in average condition; some showing signs of leaks and degradation. | |

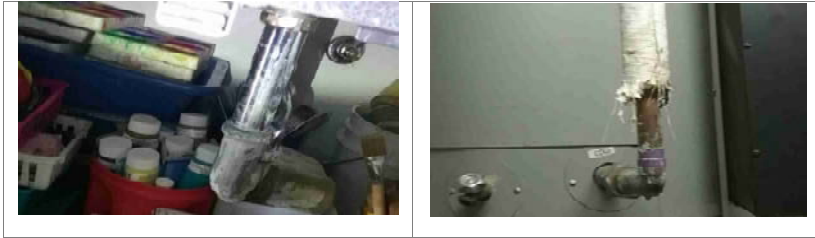
Domestic Water Distribution System

| System | Subsystem | Condition and Deficiency Overview | System Condition Rating |
|---|--|---|---|
| | Domestic Water Distribution | A water heater, approximately 20-gallon capacity, was found in the janitorial closet (CC400). The heater is mounted above head height, making it difficult to inspect. It was observed to be in good working condition. The plumbing distribution equipment was observed to be in average condition with damaged insulation and corrosion and rust observed on piping in some of the spaces. | Average |

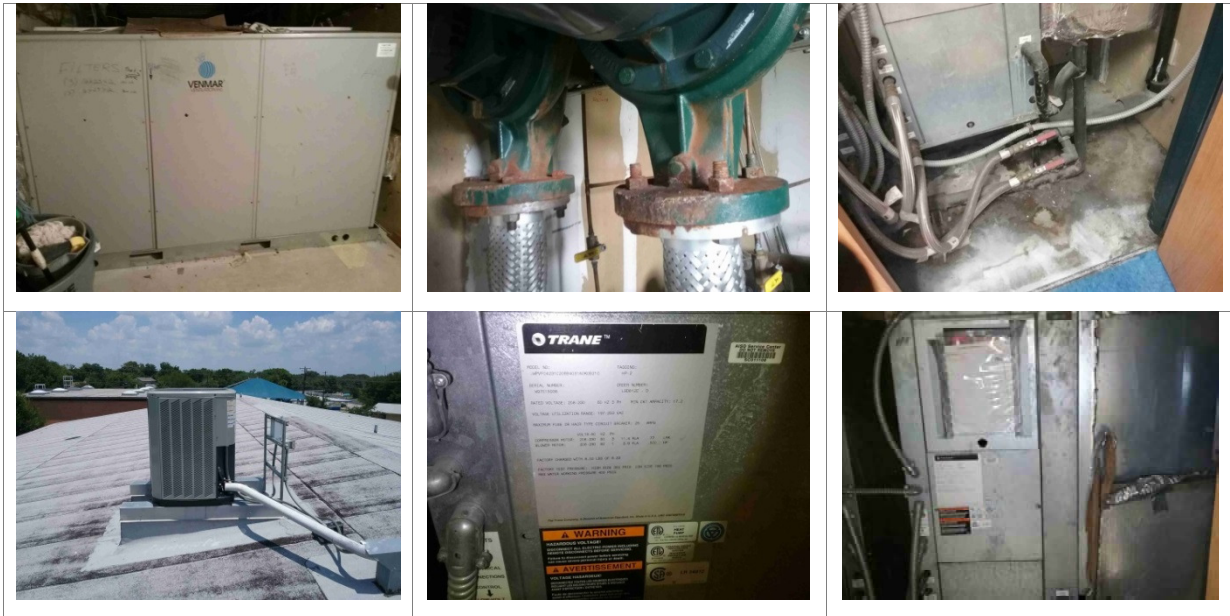
Mechanical/HVAC System Deficiency Examples

| System | Subsystem | Condition and Deficiency Overview | System Condition Rating |
|---|--|---|---|
| Mechanical/ HVAC | The building uses a split-system with roof top condenser air conditioner unit, AHU in the mezzanine, and a heat pump unit for each individual classroom. The majority of the heat pump units were installed in 1997. Multiple exhaust fans serve the building's restroom facilities. The HVAC system was observed to be in average condition. The AHU in the mezzanine was enclosed from all three sides and manufacturing information was not able to be gathered, but the unit appeared to be in average working condition. Several of the heat pump units use R-22 refrigerant, which is an outdated refrigerant that is being phased out of use. Heat pump feeding classroom 411 was observed to be operating louder than the other units. The roof top condenser unit was observed to be making an abnormal vibrating noise when shutting down. Exhaust fans appeared to be in good working condition. | | Average |

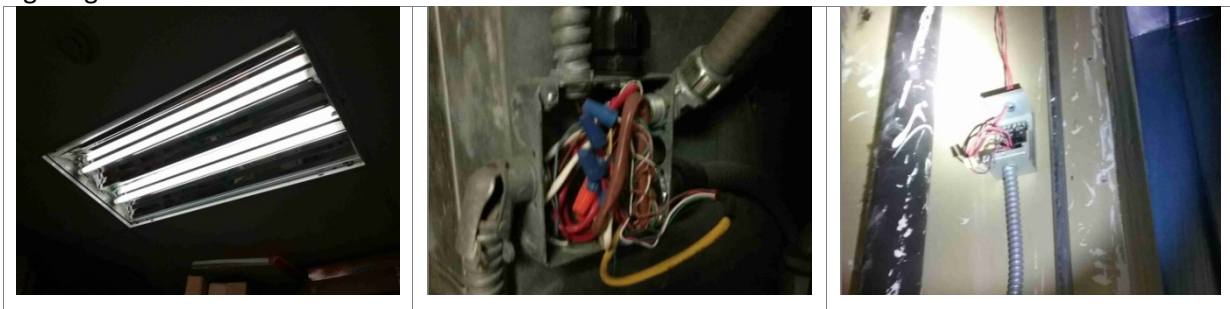
| System | Subsystem | Condition and Deficiency Overview | System Condition Rating |
|---|---|--|---|
| | Lighting | The building's exterior lighting consists of metal-halide and LED luminaires. The interior lighting consists of primarily T8 fluorescent luminaires flush mounted in the ceiling. The lighting for the building was observed to be in good condition. The luminaire for room BKRM400 is missing the fixture cover. | Good |
