Harris Elementary School Site Summary

| Address | 1711 E Wheless Lane Austin, TX 78724 |

Main School Building – BLDG-118A

| Inspection Date | June 28-29, 2016 |

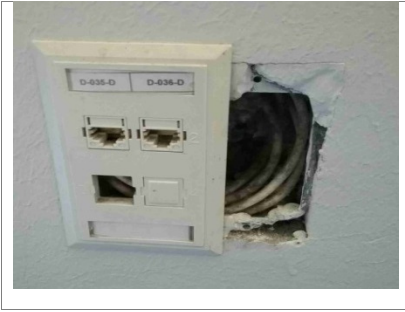
| System | Subsystem | Condition and Deficiency Overview | System Condition Rating |
|---|---|--|---|
| | Communications & Security | Interior security cameras are located in the building corridors and the classrooms have motion detectors. No security deficiencies were observed during the assessment. The timeclock system appeared to be in good condition. The building is equipped with tele/data systems. One LAN (local area network) receptacle is improperly installed and has networking cabling exposed through the wall. | Good |
