Hart Elementary School Site Summary

Address	8301 Furness Austin, TX 78753
Number of Permanent Campus Facilities	2
Original Year of Construction	1998
Total Campus Building Area (combined)	80,042 SF

Introduction

Main School Building – BLDG-163A

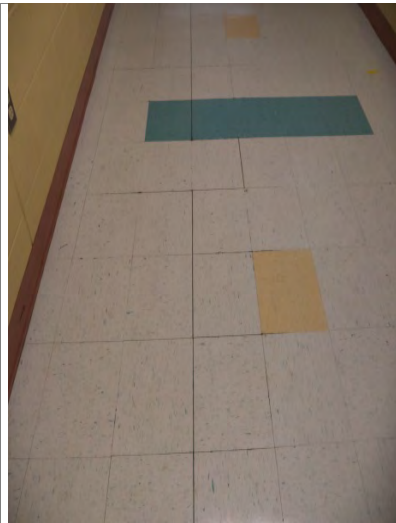
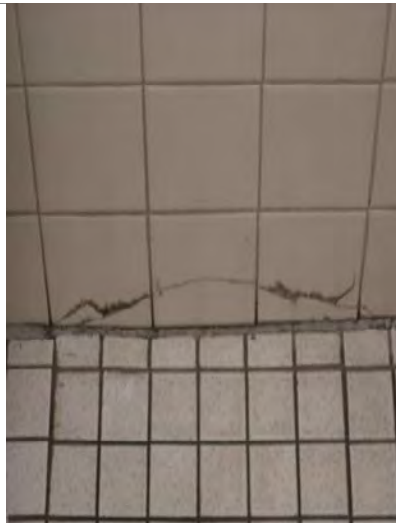
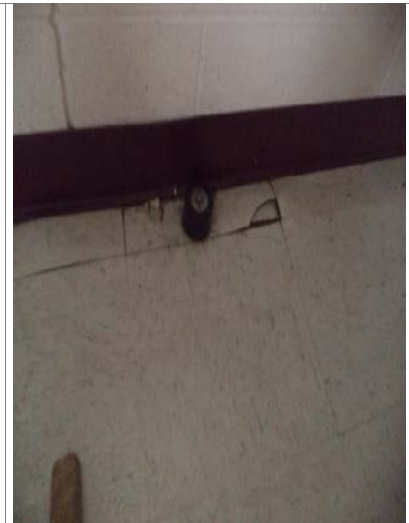
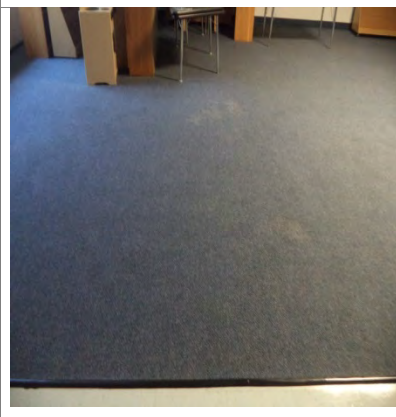
System	Subsystem	Condition and Deficiency Overview	System Condition Rating
Interior Finishes	Interior Wall Finishes	<p>In this facility, the drywall partitions as well as CMU corridor walls are painted. There is ceramic tile on two walls in each of the classroom's in-suite restrooms and in the kitchen areas.</p> <p>The interior wall finishes were in average condition due to building age and were showing signs of wear.</p> <p>Building staff reported damage in the janitorial closets to the drywall caused by splashing water.</p>	Average
	Interior Floor Finishes	<p>The majority of floor finishes in this building consist of VCT (vinyl composition tile), including the gymnasium and cafeteria. There is carpet in the administration office, the councilor's office, the library, and the kindergarten classrooms. The restrooms have ceramic tile flooring.</p> <p>It was reported that all of the carpet was at the end of its design life and should be replaced.</p> <p>It was observed and reported that vinyl tiles were lifting in the cafeteria in front of the stairs to the stage.</p> <p>It was observed that separation was occurring in the vinyl tile in corridor 100.</p> <p>The flooring appeared to be in good condition as only minor cracking was observed in isolated cases in the vinyl tile flooring system.</p> <p>A broken ceramic tile was observed in restroom 203 and another in the women's restroom in Corridor 6.</p> <p>Vinyl tile separation was observed in corridor 100.</p> <p>The carpet in the kindergarten classrooms was observed to be stained.</p> <p>It was observed that there is water-damaged tile in the corridor.</p>	Good

1. Replace cracked and broken vinyl floor tiles.
2. Replace the all vinyl tile in corridor 100.
3. Replace cracked ceramic tile.
4. Replace carpet in all areas currently carpeted.
