# Houston Elementary School Site Summary

<b>Address</b>	5409 Ponciana Drive Austin, TX 78744
<b>Number of Permanent Campus Facilities</b>	4
<b>Original Year of Construction</b>	1976
<b>Total Campus Building Area (combined)</b>	81,206 SF

## Main School Building – BLDG-162A

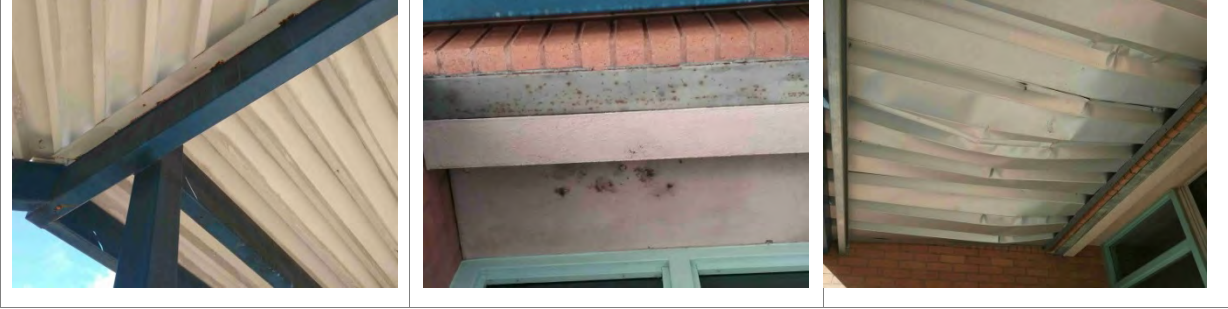
### Exterior Walls

System	Subsystem	Condition and Deficiency Overview	System Condition Rating
<b>Exterior</b>	Exterior Walls	The exterior of the building consists of a brick façade. The exterior of the building appeared in average condition. The walkway structure was rusted in many areas. The metal lintels over the doors and windows were pitted with rust. The metal overhang over the east exit door was severely bent.	Average
	Exterior Windows	The windows are single-paned aluminum metal frames inset into the brick façade. There was no indication that there was any problems with the windows. They appeared to be in good condition.	Good
	Exterior Doors	There are many double exterior metal doors with lites throughout the building. Some exterior doors are solid metal with no lites. The exterior doors were observed to be in average condition. Paint on the door frames and doors was chipped in well-used areas. There was rust at the bottom of door frame number 304, and ants were infiltrating.	Average

1. Repair the rusted structures of the walkways.
2. Investigate animal infiltration into the building at door frame 304.
3. Replace or repair the bent overhang at the exit door.

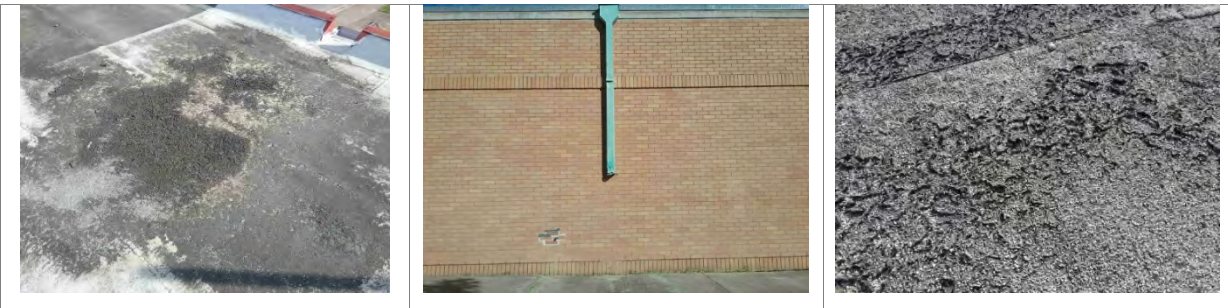
<b>Roofing</b>	The main building has a modified bitumen roof covering. The roofing was observed to be in average condition. The majority of the roof had evidence of ponding throughout. Some areas on A-02 had significant blistering. The Staff reported that the downspouts outside of rooms 107, 109, and 111 were clogged. The downspout on the east wall was missing approximately five feet from the sidewalk.		Average

1. Investigate areas of ponding near the scuppers.
2. Repair the missing bottom section of the downspout. Investigate roof blisters.
3. Unclog downspouts outside of rooms 107, 109, and 111, and implement a preventive maintenance procedure to check/clean downspouts on a regular basis to avoid future clogs.

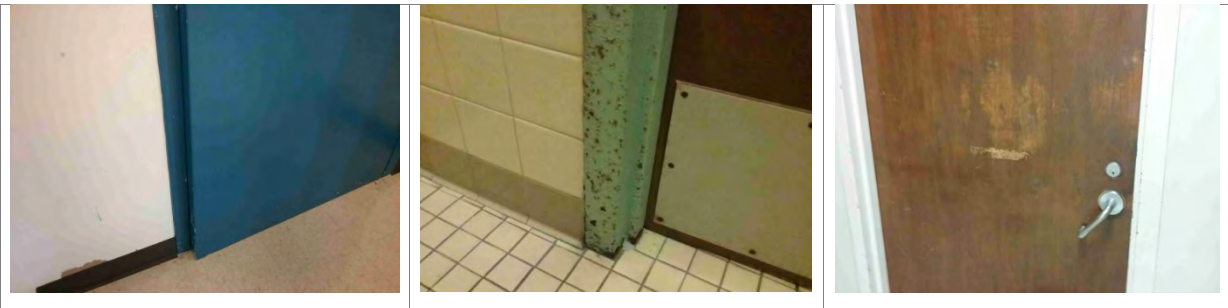
### Interior Doors

System	Subsystem	Condition and Deficiency Overview	System Condition Rating
<b>Interior Construction</b>	Interior Walls	The interior walls are gypsum board in the classrooms, administration area, library, and lobby. There is CMU (concrete masonry unit) in the cafeteria areas. This school is unique in that the classroom and library walls are only half walls that reach a height of six feet.  The walls appeared to be in average condition.	Average
	Interior Doors	The interior doors are wood veneer with a lite in metal frames. Some are solid wood doors without side lites. Some doors are painted and have louvers.  The interior doors appeared to be in average condition. The paint on the doors, lite frames, and astragals was chipped. Classroom restrooms' door frames were particularly rusted and pitted at the bottom. The door to the "breakfast room" off the cafeteria would not close. Most doors were worn, scratched, or chipped.	Average

1. Repaint chipped door frames and exit door interiors.
2. Replace or repair the classroom restrooms' rusted door frames.
3. Investigate the construction of walls and doors that reach the ceiling tile to ensure classroom privacy.
4. Repair the breakfast room door so that it closes properly.

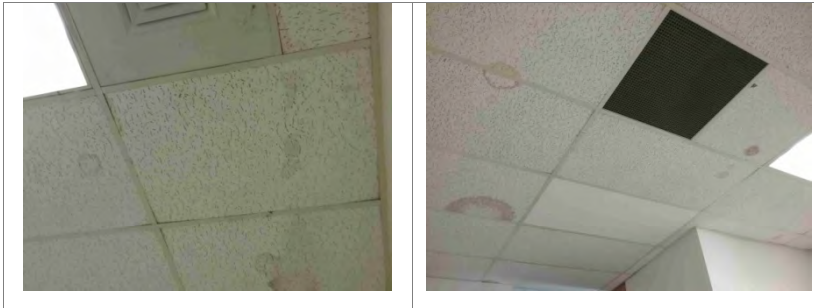
#### Interior Ceiling Finishes

Interior Ceiling Finishes	The interior ceilings are ACT (acoustical ceiling tile) in metal grid in the classrooms, administration areas, library, and cafeteria. There are gypsum board ceilings in the restrooms.  The ceiling systems appeared to be in average condition. There were many ceiling stains in the classrooms, male restroom, and teacher lounge area and significant stains on the east end of the building. It	Average

System	Subsystem	Condition and Deficiency Overview	System Condition Rating
		was reported by two staff members that the stains were suspected to be caused by animal urine, and both had heard animals in the walls and ceilings.	
<b>Conveying</b>	System not present.		N/A
<b>Plumbing</b>	Plumbing Fixtures	<p>The facility contains multiple plumbing applications that service one level, consisting of in-classroom student restrooms, staff restrooms, janitorial closets with service sinks, and one commercial kitchen. The restrooms that are located inside classrooms have vitreous china floor-mount toilets with manual flushing valves. The classroom restrooms are not equipped with sinks; however, the classrooms have laminated particle board vanities with stainless steel sink/bubbler combinations mounted inside the vanities. The remainder of the facility's restrooms have vitreous china sinks with manual or metering faucets, along with vitreous china floor/wall-mount toilets and urinals with manual flushing valves. There are also wall-mounted service sinks in the janitorial closets.</p> <p>This building's restroom plumbing fixtures were observed to be in average condition. The staff reported the following deficiencies or planned/requested renovations with regard to the facility's plumbing fixtures:</p> <p>The public restrooms WRRCAFE TOILETF and MRRCAFE TOLIETM and student restrooms 100RR TOILET and 102RR TOILET are scheduled for renovation to create handicap access during the summer of 2017. It was reported that the sinks, faucets, and toilet fixtures throughout the campus were beyond their useful life and should be replaced. It was also reported that there was only one janitorial closet floor sink in the kitchen and staff requested that the janitorial closet CC300 also have a floor sink installed.</p> <p>The plumbing fixtures observed throughout the building were very aged, and some appeared to be original construction. Though the fixtures were aged, they were all functioning at the time of assessment.</p> <p>Other specific deficiencies noted during the assessment were many of the toilets appeared to flush slowly or had an insufficient amount of water volume, and the restroom partitions were also observed to be corroding.</p>	Average

1. Replace stained ceiling tile as needed.
2. Touch up paint on walls.
3. Repair gypsum board at wall corners where damaged.

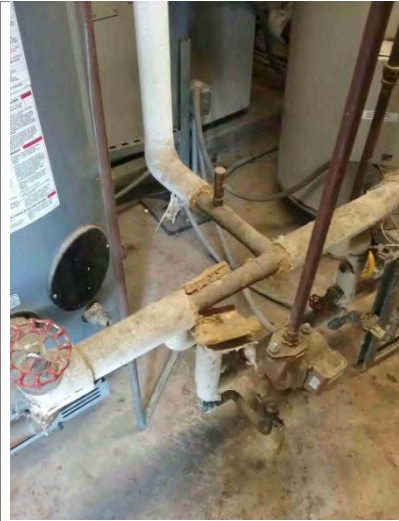
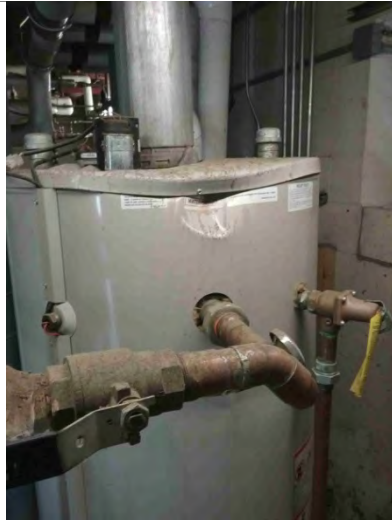
### Domestic Water Distribution

System	Subsystem	Condition and Deficiency Overview	System Condition Rating
	Domestic Water Distribution	<p>The majority of the plumbing fixtures observed in this facility are not serviced by any domestic water distribution equipment, such as vertical water heaters. The remainder of the plumbing fixtures are in the commercial kitchen and appear to be serviced by two water heaters. The vertical GWHs (gas water heaters) are located in the main mechanical room and have the ability to produce 200 MBH and hold 100 gallons.</p> <p>Staff reported the following deficiencies or planned/requested renovations with regard to the facility's domestic water distribution system:</p> <p>It was reported that a three-inch water line was discovered to be leaking under the mechanical room that contains AHU (air handling unit)-6. The line was repaired; however, AISD Service Center Plumbing Staff stated that the water line to the building would have to be replaced. It was also reported that the facility's cast iron sanitary sewer and water lines were deteriorating and needed to be replaced. Additionally, it was reported that the sanitary sewer was corroding and needed to be replaced. The sanitary sewer had spot repairs based on work order requests, but was a recurring problem.</p> <p>The domestic distribution system was observed to be in average condition at the time of assessment. The following deficiencies were observed:</p> <p>During the assessment, one vertical GWH (SC004613) was observed to be aged and out of date based on its typical design life and had damaged insulation. The other vertical GWH (SC004614) was approaching the end of its typical design life, and the water heater's enclosure was dented and damaged.</p>	Average

6. Plan for replacement of the vertical GWH SC004613, and replace damaged or missing pipe insulation.
7. Plan for replacement of the vertical GWH SC004614 and replace dented and damaged enclosure.

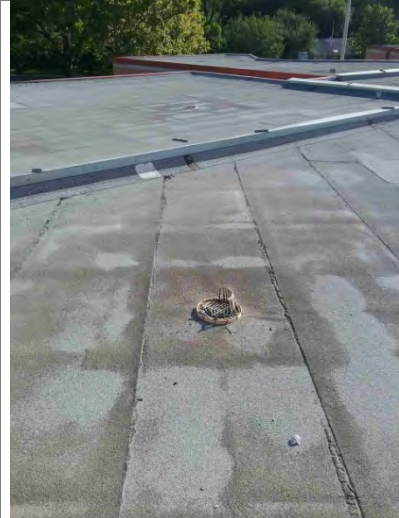
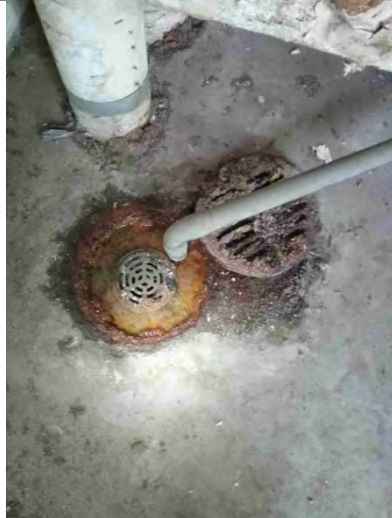
### Other Plumbing

Other Plumbing	<p>The drains are predominantly designed with an interior type drainage system. In addition, all drains are equipped with either a plastic dome or flat carbon type covers. Many of the drains observed throughout the facility were aged and had corroded or broken covers but appeared to be functioning.</p> <p>Andrew Miller, ASID Construction Management, requests that the grease trap be considered for replacement. Andrew Miller also requested that the district should investigate the strong odor at the sanitary sewer manhole adjacent to the mechanical room.</p>	Average

8. Replace all broken roof drain covers and corroded flat drain covers throughout the building.
9. Consider replacement of the grease trap.
10. Investigate the source of the strong odor at the sanitary sewer manhole adjacent to the mechanical room.

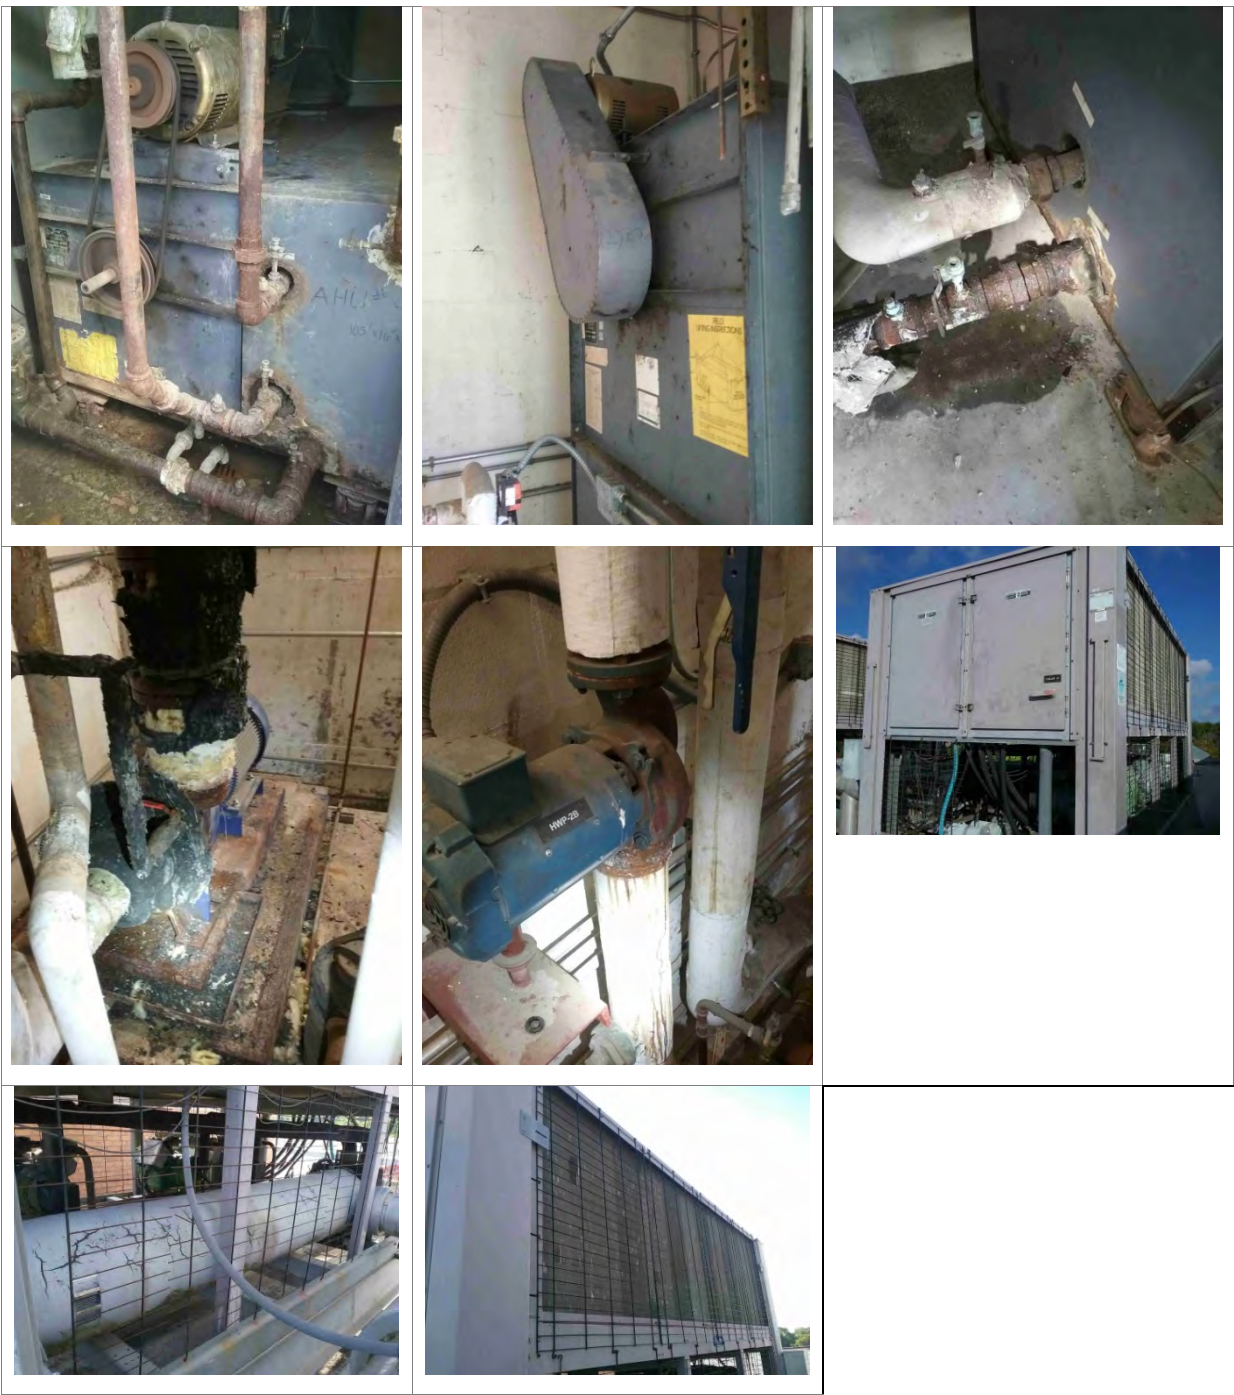
System	Subsystem	Condition and Deficiency Overview	System Condition Rating
<b>Mechanical/ HVAC</b>	<p>This building has multiple HVAC (heating, ventilation, and air conditioning) systems that service one floor level. The major mechanical equipment consists of indoor central station AHUs (air handling units). The HVAC system also includes two large roof top-mounted, rotary air-cooled chillers that have refrigeration cooling capacities of 110-TON and two horizontal gas-fired boilers with rated output capacities of 1,500 MBH.</p> <p>There are 14 HVAC systems throughout the building. The estimated capacities of the roof-mounted EFs (exhaust fans) range from 150 to 1,300 CFM (cubic feet per minute). The refrigeration capacities of HVAC units range from 2.5- to 110-TON.</p> <p>Staff reported the following deficiencies with regard to the facility's HVAC systems:</p> <p>It was reported that the EF in the art classroom was hard to reach and required frequent maintenance. Staff requested that the fan be replaced for ease of access and vented through the roof. It was also reported that the EFs throughout the facility were old and required frequent maintenance. It was requested that they be replaced and vented through the roof.</p> <p>The mechanical/HVAC systems for this facility were observed to be in poor condition. Many of the deficiencies observed were extreme aging of equipment and enclosure and piping damage due to excessive corrosion. Another widespread observed deficiency was the use of outdated refrigerant in some of the existing HVAC systems, refrigerant type R-22.</p> <p>Additional HVAC deficiencies were:</p> <p>The roof top-mounted chillers were installed in 1999 and originally charged with R-22 refrigerant. They are nearing the end of their typical design service life. The units had insulation damage from exposure to the elements and damage to compressor fins from weather. The chillers' ancillary equipment, such as condensation or chilled water centrifugal pump enclosures and discharge/return piping, were excessively corroded. Another deficiency observed was in regards to all the indoor AHUs. The AHUs appeared to have been installed when the building was constructed in 1976. The units observed had extreme corrosion on their enclosures. Additionally, The boilers' ancillary equipment had observed deficiencies, such as, the hot water supply pumps were corroded and had damage to their discharge and supply piping. Finally, the kitchen supply air EF, KSU-1 (SC004724) was observed to have reached the end of its typical design service life and had a weathered enclosure at the time of assessment.</p>		Poor

1. Continue preventive maintenance on aged EFs and plan for replacement of the fans in the future as they continue to age. In addition, when replacing EFs, vent the newly installed fans through the building's roof. [Request new exhaust fans be considered to exhaust into the crawl space rather than creating more penetrations within the roof \(requested by Andrew Miller, AISD Construction Management\).](#)
2. Replace equipment that uses R-22 refrigerant.
3. Continue conducting preventive maintenance checks and services for HVAC systems. Plan to replace all HVAC equipment.
4. Clean, repaint, or repair any rust or corrosion on the ancillary equipment for the boilers, such as the hot water supply pumps, its associated piping, or any other sub-asset to prevent further deterioration.

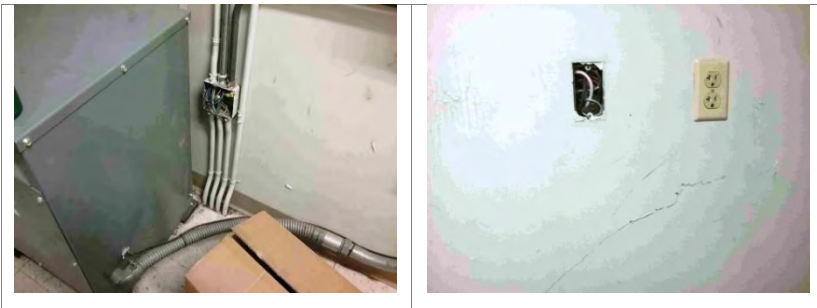
#### **Electrical Distribution**

<b>Electrical</b>	Electrical Distribution	<p>Electrical room 200 is on the northeast corner just inside the main entrance. There are two transformers and multiple panelboards housed in this room, feeding the building.</p> <p>Although the equipment did not appear to need replacement, there were concerns observed causing an</p>	Average

System	Subsystem	Condition and Deficiency Overview	System Condition Rating
		average condition rating. An external junction box located on the right-hand side of the 45 kVA transformer in electrical room 200 did not have an enclosure cover installed. Certain cables in the junction box were observed to be energized. There was also an in-wall bang-on box in electrical room 200 that was missing a cover.	
	Lighting	The exterior of the building is outfitted with what appears to be wall-mount HID fixtures located near the roofline of the building. Covered walkways are illuminated by surface-mounted ceiling fixtures. The interior lighting is mainly fluorescent with the occasional screw-type fixture in closets. The front entry is illuminated by recessed can fixtures. There are exit signs at every exit that were illuminated.  The lighting was observed to be in good condition.	Good
	Communications & Security	There is a Gemini security system currently installed with multiple keypads at various entrances. Motion detectors are installed in interior areas, and security cameras are installed throughout the interior of the building and strategically on exterior corners and walls.  There were no damaged security panels or cameras observed.  There are also door frame-mount proximity readers for access into certain entrances.  The equipment was observed to be in good condition.  A communication closet exists in the southeast janitorial closet, housing network switches, hubs, and routers in a rack-style configuration. The facility appeared to have wireless routers installed in classroom ceilings strategically throughout the building.  The equipment was observed to be in good condition.	Good

1. Install covers on old horn/strobe combination units or install replacement equipment.
2. Install covers on junction boxes that have exposed wiring located in electrical room 200.

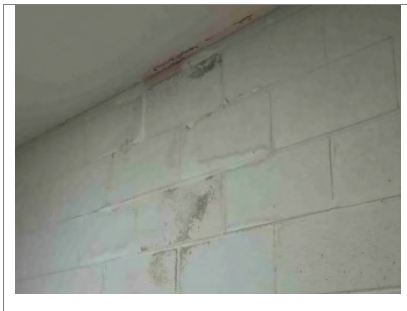
### Interior Wall Finishes

Interior Specialties	System not present.	N/A
<b>Stairs</b>	Exterior Stairs	System not present.	N/A
	Interior Stairs	System not present.	N/A
<b>Interior Finishes</b>	Interior Wall Finishes	The interior walls are painted CMU in the gymnasium. There is ceramic tile in the restrooms. The walls appeared to be in good condition. There was water damage to the CMU wall in the male restroom.	Good

1. Repair CMU damage in the male restroom caused by a past leak.

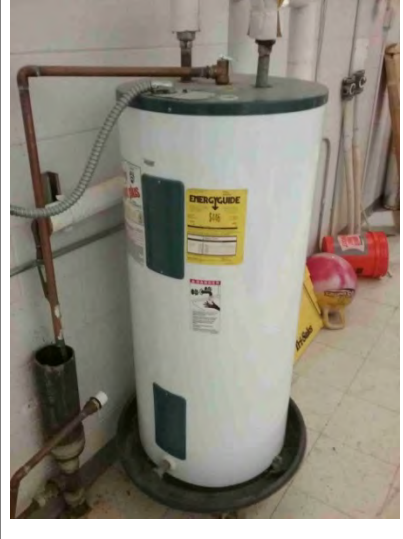
### Domestic Water Distribution

Domestic Water Distribution	The plumbing fixtures located in the staff office are serviced by a vertical electric water heater that has a 40-gallon capacity. The remainder of the plumbing fixtures are not serviced by this water heater.  The water heater for this building was installed in 1991 and had surpassed the end of its typical design life.  The domestic water distribution plumbing and equipment were observed to be in average condition.	Average
	Other Plumbing	The roof drains are predominantly designed with an interior type drainage system.  The roof drains appeared to be in good condition.	Good
<b>Mechanical/ HVAC</b>	This building has multiple types of HVAC applications that service one floor level. The major mechanical equipment consists of split system roof top-mounted units and indoor AHUs.  There are four HVAC systems throughout the building with refrigeration capacities of 7.5-TON. These systems were installed in either 2005 or 2012, and all utilize the approved R-410a refrigerant.  The mechanical/HVAC systems for this facility were observed to be in good condition.		Good

1. Plan for replacement of the water heater.

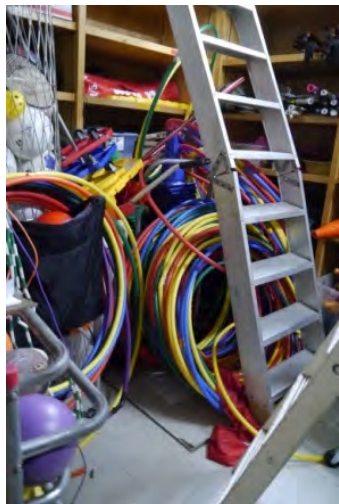
The crawl space cPulP P    t be PobserveP as the access hatch was bIPckeP with gPm equipmePt as seeP iP the image belPw. P
