## Jordan Elementary School Site Summary

### Introduction

## Main School Building – BLDG-178A

## Stand-Alone Classroom Building – BLDG-178B

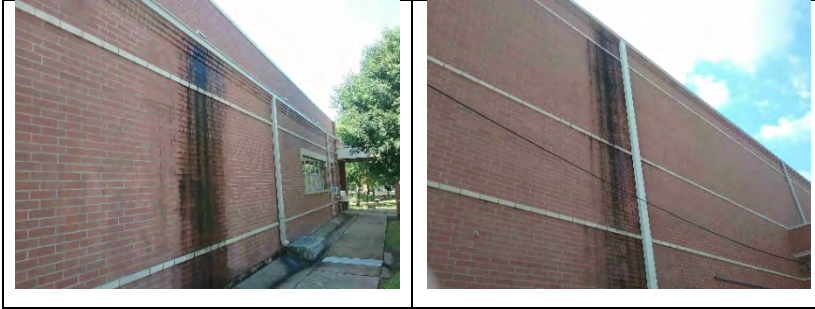
### Exterior Walls

System	Subsystem	Condition and Deficiency Overview	System Condition Rating
Exterior	Exterior Walls	<p>The exterior walls are original brick façade with synthetic plaster panels located at the walkway canopy near the main entrance. Parapets have prefinished metal caps. Gutters are mostly continuous at building perimeter and integrated into the roof/wall edge. There is a solid brick screen wall that conceals the loading dock area.</p> <p>The brick walls are original to the building and were observed to be in good condition. There are areas where gutters and/or scuppers have allowed water from roof to discolor the brick.</p>	Good
	Exterior Windows	<p>The window units are aluminum frame with single pane glazing that are original construction.</p> <p>Windows appeared to be in good condition; however, sealant at masonry is dry and starting to show cracks indicating end of sealant life cycle.</p>	Good

1. Clean discolored brick surfaces. Evaluate performance of roof scuppers and gutters and determine the source of the problem with roof water on brick surfaces.
2. Replace aging sealant around windows and at masonry joints and flashings.
3. Replace door and frame at kitchen entrance.

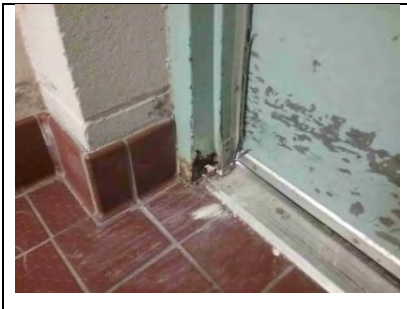
### Exterior Doors

System	Subsystem	Condition and Deficiency Overview	System Condition Rating
	Exterior Doors	<p>There is one primary public entryway located at the west side of the building and there are other secondary entrances located around the building. These doors are metal with a metal frame. Entrances have transoms and side-lites and doors have vision panels. The remaining service doors around the facility are metal.</p> <p>The exterior doors were observed to be in good condition except the door at the kitchen entrance was observed to be rusting at the bottom and the base of the frame. It is reported the kitchen entrance door does not close properly.</p>	Good
<b>Roofing</b>	<p>The roof material covering the building is built-up asphalt with a granular topping. The roof appears to be original to building but may have had some repairs over time. Roofs slope to the perimeter and there are no internal roof drains. There are some parapet walls that have scuppers that drain to a perimeter gutter system. There are metal walkway canopies at main entrance and bus drop off area. The main entrance has a pyramid skylight incorporated into the walkway system.</p> <p>The roof has exceeded its expected life cycle. A small area of gravel had been removed at area A-01 exposing the tared felts which were observed to have significant crazing. This condition may be indicative of the roof in general. There are reported roof leaks in wings; 100, 200 and 300. There were no visible defects (i.e. tears or ponding) observed in the roof or gutter system; however, no flashing was observed between gutters and top of brick. The metal canopy walkway system was observed to be in good condition. Debris has collected on canopies and tree limbs are encroaching onto the roof surface.</p>		Average

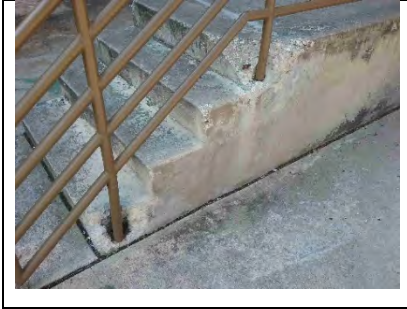
System	Subsystem	Condition and Deficiency Overview	System Condition Rating
<b>Stairs</b>	Exterior Stairs	<p>The exterior stairs are located adjacent to the loading dock at the kitchen. The stairs are concrete with a steel railing.</p> <p>There was damage to concrete at points where the railings were connected to the stair structure. Damage appeared to be the result of vehicle contact. Bolts were sheared and large chunks of concrete were missing where the rail attaches to the stairs.</p>	Poor
	Interior Stairs	<p>The interior stairs and ramp are for stage access and are constructed of concrete with steel railings.</p> <p>The stairs, ramp, and associated railings appear to be in good condition.</p>	Good
<b>Interior Finishes</b>	Interior Wall Finishes	<p>The interior walls are painted gypsum board. In the corridors, plastic laminate panels cover the bottom 4' of some wall surfaces.</p> <p>Interior wall finishes were observed to be in good condition with some marring and scuffing.</p>	Good

1. Repair damaged concrete stairs and secure metal railing.

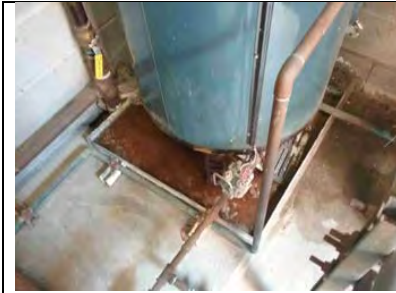
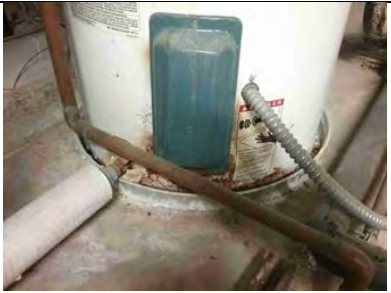
Domestic Water Distribution	Domestic hot water was supplied to the nurse and lounge restrooms, and the custodial closets by electric water heaters (EWHs) that were less than 10-gallon. These water heaters were observed to be in good condition. The kitchen has hot water supplied to the hand sinks and the dishwasher from two 92-gallon gas water heaters (GWHs) located in the "KITMECH" room. Both of these GWHs appear original to the building and are nearing the end of their service life. The GWH serving the dishwasher was in poor condition and was noted having corrosion and excessive condensation. The 30-gallon EWH located in the gym mezzanine supplies hot water to the shower in the gym office. This water heater was rated in average condition and had corrosion around the bottom of the tank. The domestic water distribution system was observed to be in average condition based on the deficiencies seen.	Average

1. Consider replacement of aged GWHs located in the "KITMECH" room.

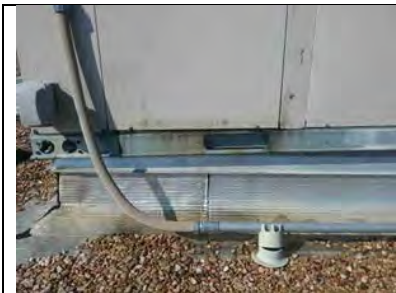
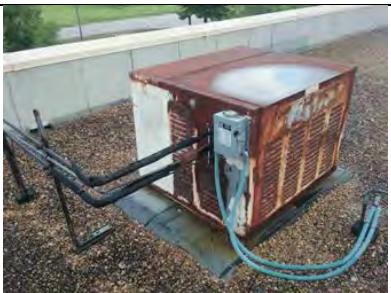
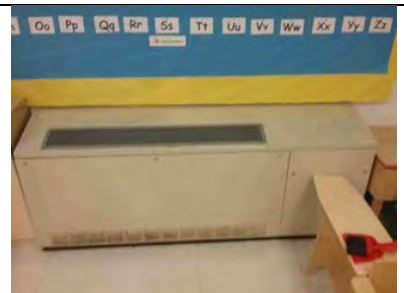
### Mechanical/HVAC System Deficiency Examples

System	Subsystem	Condition and Deficiency Overview	System Condition Rating
		<p>sizes ranging from 4,000 cubic feet per minute (CFM) to 6,000 CFM. Package units are located on the rooftop that serves the HVAC system throughout the facility. The majority of the package units on the rooftop were observed to be in good condition but contained R22 refrigerant. One of the rooftop units (RTUs) was observed to be in poor condition due to excessive condensation dripping from the housing of the unit. Two split system heat pumps that were not shown on the facility drawings were located on the exterior of the 200- and 300-wings of the building and serve the classroom heat pump consoles in these wings. The 3-ton units manufactured in 2009 use HCFC (hydrochlorofluorocarbon)-22 refrigerant but they were observed to be in good condition. A refrigeration unit located on the rooftop was observed to be in poor condition with severe corrosion visible. The classrooms each have individual heat pump consoles that appear to be original to the building and beyond their service life. Thirty-five of these units located throughout the facility and classrooms appear to be functioning properly and were rated to be in average condition. The heat pumps in rooms 208 and 303 appeared to have been replaced with newer units and were observed in good condition.</p> <p>The HVAC system was observed to be in average condition with all of the prior mentioned deficiencies. The only deficiency that was frequently noted was the use of R22 refrigerant in most of these units.</p>

1. Replace all equipment that uses R-22 refrigerant. The refrigerant is being phased out of manufacturing in the near future.
2. Investigate the cause of the excessive condensation from RTU-2 with asset barcode id: SC018027.
3. Consider replacement of all heat pump consoles located throughout the building that are estimated to be beyond their service life.

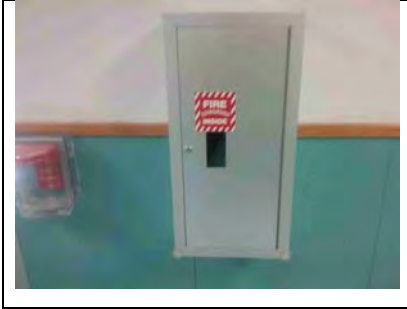
### Fire Protection/Suppression

<b>Fire Protection</b>	Fire Alarm	The fire alarm consisted of horn and strobe combination, pull stations, and detectors within this facility, visually perceived to be in good working order. No visual signs of malfunctioning or degradation of the system as a whole although most of the equipment in this facility may have outlived its design life expectancy.	Good
	Fire Protection/Suppression	The building has a dry standpipe system for fire protection sprinklers that appears to serve the mezzanine. The external access point for the fire protection system was located outside of the custodian office and was observed to be in good condition. The kitchen vent hoods had a wet chemical solution fire suppression system, which appeared in average condition. Portable fire extinguishers placed throughout the facility protect the rest of the building. The extinguishers in the corridors of the building were noted as being inaccessible because they were located inside of locked metal cases. These cases need to be unlocked to make them accessible during an emergency. All observed portable fire extinguishers had inspection tags dated January 2016 and were in good condition.	Good

1. Unlock all of the cabinets that are holding fire extinguishers throughout the building to make them accessible during an emergency.
2. Although fire protection is in place and perceived as functioning as intended, due to this system's age prudence would suggest further evaluation by a fire protection specialist, to include consideration for potential upgrades, i.e. emergency lighting to illuminate floors in corridors if a fire causes a blackout.

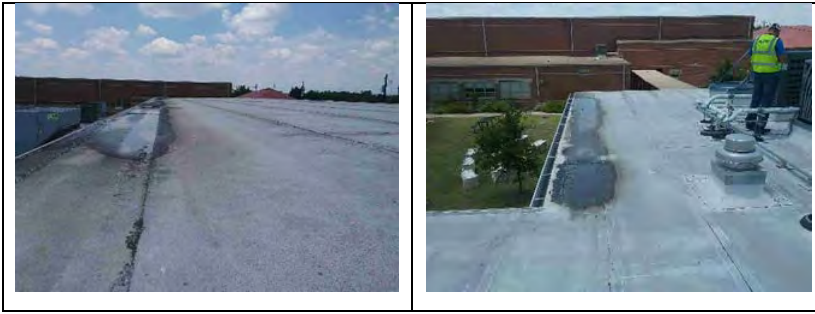
### Roofing Deficiency Examples

System	Subsystem	Condition and Deficiency Overview	System Condition Rating
<b>Exterior</b>	Exterior Walls	The exterior walls are constructed of CMU with brick veneer. At the raised roof area above room 400, the exterior walls are surfaced with prefinished metal panels.  The exterior walls were observed to be in good condition.	Good
	Exterior Windows	The window units are aluminum frame with single pane glazing that are original construction. Exterior windows have operable sash, windows at raised roof are fixed with solar screen on interior side for light control. Windows appeared to be in good condition.	Good
	Exterior Doors	In the building, there are two sets of painted steel entry doors in metal frames. Doors have vision panels and panic hardware.  The doors were observed to function properly and appeared in good condition.	Good
<b>Roofing</b>	The roofing is modified bitumen and is at less than half its expected service life. There are continuous gutters with downspouts at the building perimeter at both upper and lower roofs.  Other than some ponding along the south side roof edge at both the upper and lower levels, the roof appeared to be in good condition.		Good

1. Investigate the cause of ponding on roof and repair.
