Joslin Elementary School Site Summary

Address	4500 Manchaca Road Austin, TX 78745
Number of Permanent Campus Facilities	3
Original Year of Construction	1954
Total Campus Building Area (combined)	45,628 SF

Main School Building – BLDG-120A

Stand-Alone Classroom Building – BLDG-120B

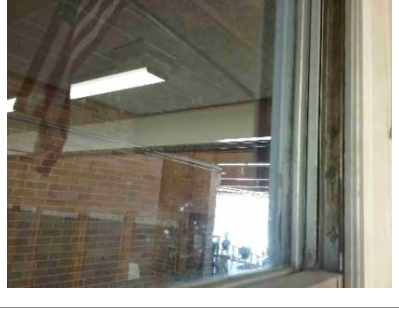
System	Subsystem	Condition and Deficiency Overview	System Condition Rating
Exterior	Exterior Walls	The exterior is primarily a brick finish with plaster accent panels. The exterior steel columns and primary roof framing are exposed. The underside of extended roof panels are exposed and painted to form soffits and covers for walkways located directly below. The exterior appeared to be in good condition.	Good
	Exterior Windows	Exterior windows are single-glazed, ganged, aluminum windows with awning sashes below. Some original upper panels have been replaced with newer, translucent, double-wall polycarbonate lights. South classrooms have an older style window. The windows in the south most four classrooms had no weather-stripping. Considering their age and deficiencies, the windows were observed to be in average condition.	Average
	Exterior Doors	Main entrance doors are painted hollow metal in painted hollow metal frames. North wing classroom doors are painted hollow metal in painted wood frames. South wing doors are painted hollow metal in painted hollow metal frames. The main entrance doors appeared to be in average, serviceable condition. Classroom doors appeared to be in average condition but some did not completely close on their own. Corridor doors were in average condition and were missing weather stripping.	Average

1. Replace, or if possible, retrofit the older style windows installed in the south most four classroom's exterior walls with weather stripping.

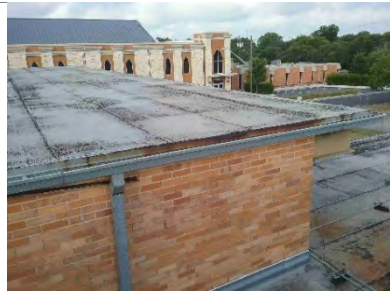
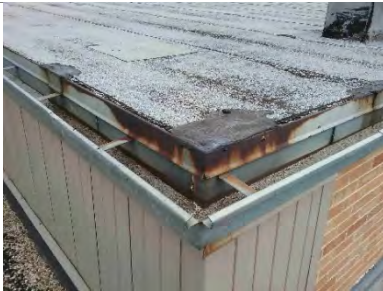
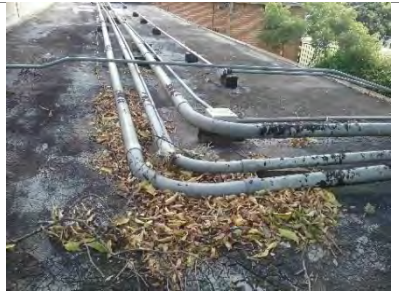
Roofing Deficiency Examples

Roofing	Three different roof systems are installed on the building. Approximately equal areas of roof are covered with either a modified bitumen system or a built-up		Average

System	Subsystem	Condition and Deficiency Overview	System Condition Rating
		<p>system. These areas drain to perimeter metal gutters and downspouts. A more recent addition for enlarging the cafeteria is roofed with a newer standing seam metal system that also forms the edge fascia and soffit beneath. The metal roof is designed without gutters, drains, or downspouts.</p> <p>The different roof systems appeared to be in average condition. Much of the metal flashing and metal drip edge, though, appeared to be rusting. Some piping support was missing, resulting in debris collecting on the roof surface. The paint finish on downspouts was peeling.</p>	
Interior Construction	Interior Walls	<p>Interior walls are primarily painted gypsum wallboard on conventional framing with some ceramic tile finish in the east wing. Interior walls in the west wing are CMU (concrete masonry unit) with structural clay tile lower walls and integral base. Jalousie windows are installed between the corridor and cafeteria and appeared to be in good condition. Fixed lights in a painted wood frame are installed between the cafeteria and kitchen. It is in good condition. Structural clay tile forms the walls in the kitchen, between the kitchen and the cafeteria, and between the cafeteria and corridor. It is in good condition. The interior walls in the administration area are either gypsum wallboard on conventional framing, CMU, structural glazed tile or a combination of all. Shared light panels and stained wood louvers are installed between the main office and corridor. There are expansion joint covers in the cafeteria where the north addition abuts the existing.</p> <p>Though aged, the original structural clay tile still appeared to be in good, functioning condition as were other walls.</p>	Good

1. Inspect all roof surfaces for required maintenance.
2. Support surface-installed piping above roof surfaces.
3. Clear debris off the roof surfaces and gutters.
4. Evaluate the possibility of replacing rusted, metal flashings. Monitor drip-edge flashings for rust degradation.
5. Repaint downspouts where required.

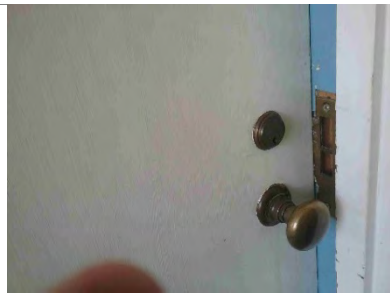
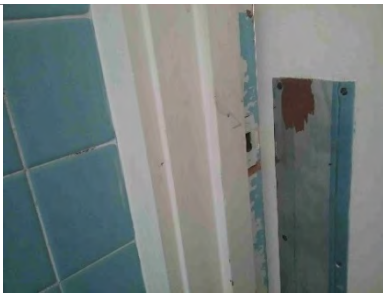
Interior Doors	<p>The classrooms are separated by toilet rooms. Doors between classrooms and toilet rooms are painted solid-core wood construction in painted wood frames. The administration/cafeteria area has painted and stained wood doors that are in stained wood frames.</p> <p>Doors between classrooms and toilet rooms showed quite a bit of age and were ill fitted. Some could not be closed. Doors in the administration/cafeteria area appeared to be in good condition.</p>	Poor
	Interior Specialties	System not present.	N/A
Stairs	Exterior Stairs	System not present.	N/A
	Interior Stairs	<p>There are short runs of wood stairs between the cafeteria and cafeteria stage.</p> <p>These wood stairs with handrails appeared to be in good condition.</p>	Good

1. Replace interior doors, frames, and hardware in the classroom wings that are in poor condition. The doors between toilet rooms and classrooms, in some cases, were unable to be closed.

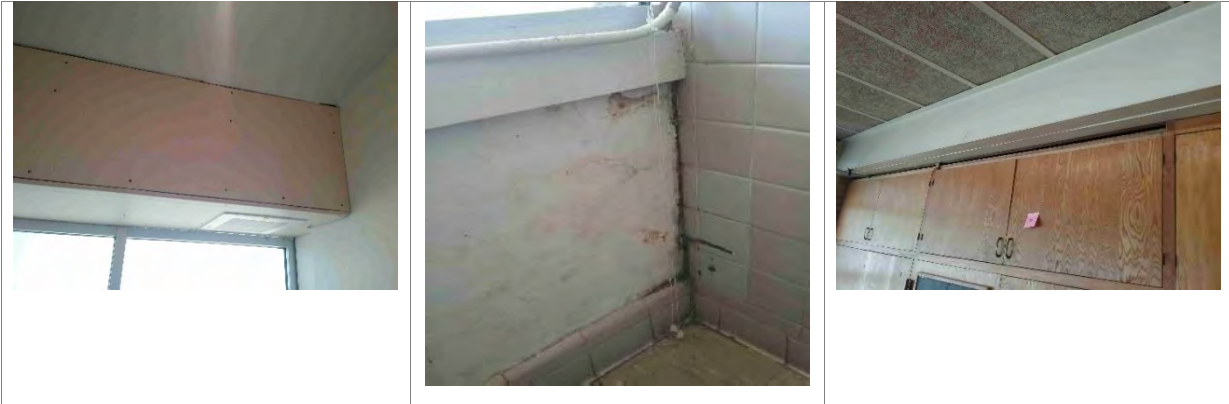
System	Subsystem	Condition and Deficiency Overview	System Condition Rating
Interior Finishes	Interior Wall Finishes	<p>Interior walls are primarily painted gypsum wallboard on conventional framing with some ceramic tile finish in the east wing. Interior walls in the west wing are CMU with structural clay tile lower walls and integral base.</p> <p>Painted wood storage closets are either set into or against interior classroom walls. The south most four classrooms have built-in, stained storage closets.</p> <p>The gymnasium has stained wood paneling set between natural finished brick pilasters. Jalousie windows are installed between the corridor and cafeteria. Fixed window lights in a painted wood frame are installed between the cafeteria and kitchen. Structural clay tile forms the walls in the kitchen, between the kitchen and cafeteria, and between the cafeteria and corridor. The interior walls in the administration area are either gypsum wallboard on conventional framing, CMU, structural glazed tile or a combination of all. Shared light panels and stained wood louvers are installed between the main office and corridor. There are expansion joint covers in the cafeteria where the north addition abuts the existing.</p> <p>Wall finishes in the classroom wings appeared to be in worn or partially restored condition. Surfaces in all other areas appeared to be in average condition.</p>	Average

1. Complete the finishing of classroom-wing walls and apply new paint.
2. Repair and refinish stained woodwork in the south most four classrooms.
3. Examine the ceiling grid system in the classroom wings for serviceability. Replace sagging, broken ceiling tiles. If feasible, consider installing a 2'x2' system in order to minimize the sagging of tiles.

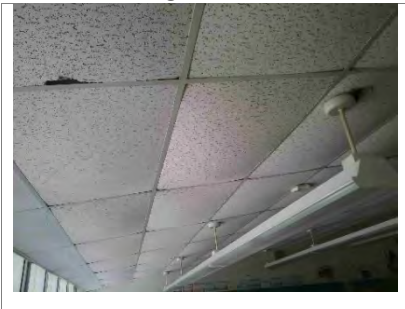
Interior Ceiling Finishes

System	Subsystem	Condition and Deficiency Overview	System Condition Rating
		The 2x4 tile and grid systems in the classroom wings appeared to be sagging, broken, and ill-fitting. All other ceiling finishes appeared to be in good condition.	
Conveying	System not present.		N/A
Plumbing	Plumbing Fixtures	<p>BLDG-120A of Joslin Elementary School contains predominantly single-use restrooms throughout the facility, with multi-use restrooms found outside of the gymnasium and administration areas. Typical restrooms have floor-mounted vitreous china water closets with manual flush valves. Additionally, wall-hung vitreous china urinals with manual flush valves are located in the dedicated multi-use male restrooms. Typical classrooms contain a single-basin stainless steel or porcelain enamel metal sink with a drinking fountain attached or a porcelain enamel metal sink with separate vitreous china drinking fountain. Stainless steel drinking fountains can be found in the corridors of the building.</p> <p>A lounge contains a stainless steel double-basin sink. There is a porcelain enameled steel handwashing basin sink outside of the cafeteria that has three faucets. The kitchen contains stainless steel kitchen equipment, including a three-basin prep sink. It also has various wall-mounted vitreous china and stainless sinks for personal use. The building has service sinks located in various janitorial closets. There are showers located in the gymnasium office and in room 101.</p> <p>The majority of plumbing fixtures were observed to be in poor working condition, aged and showed signs of deterioration. The drinking fountain in room 205 was cracked and had low flow. The sink in the administration's female bathroom (WFRRADM) was observed to stick on longer than expected. The coated metal handwashing basin sink outside the cafeteria had three faucets. All three faucets were observed to leak. There is a vitreous china personal sink in the kitchen that was observed to leak. The corner sinks in restrooms in rooms 201-206 were old and did not work. They appeared to be abandoned in place. No flow was observed when only the hot water handle of restroom 101HRR's sink was turned on. The sink in room 102 had leakage from both faucets. The gymnasium office sink was spurting uneven flow. The water also had a gray tone. The handheld shower head in the gymnasium office was observed to be leaking.</p> <p>There is a toilet seat in BRRGYM that is undersized.</p>	Poor

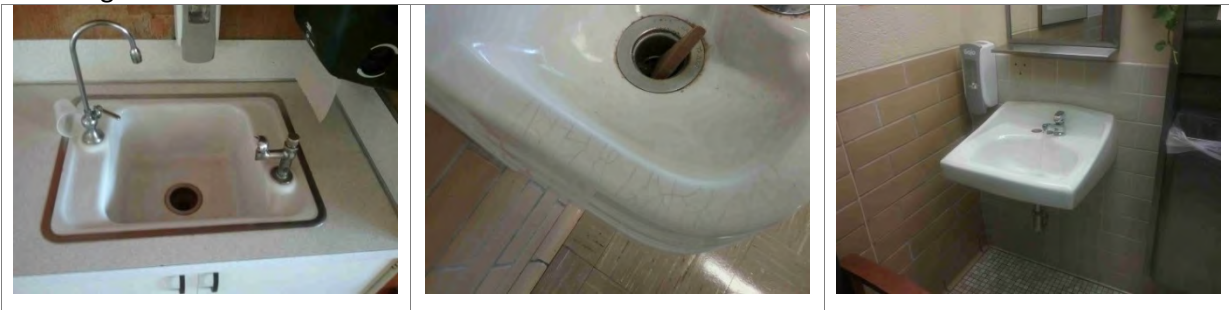
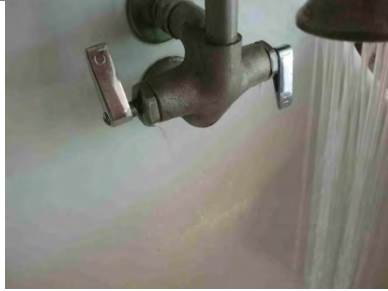
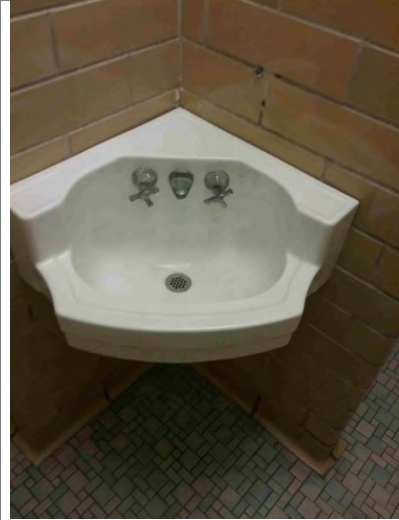
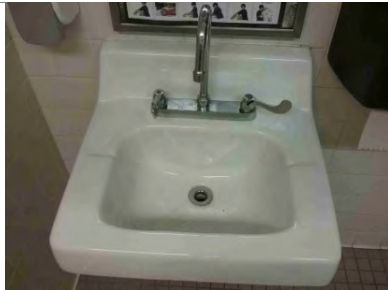
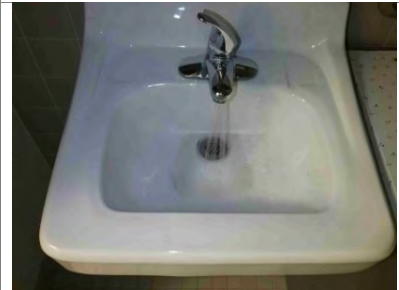
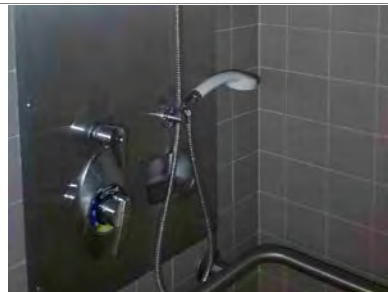
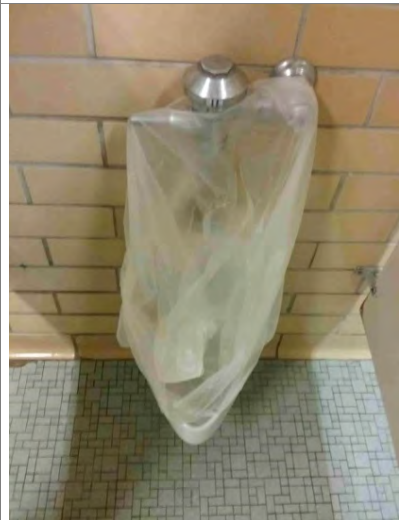
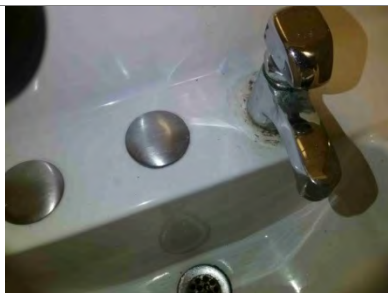
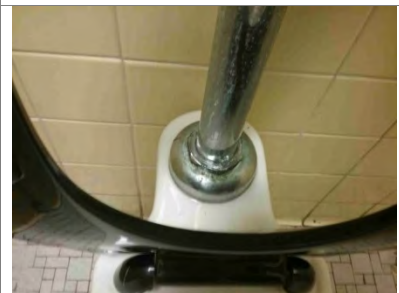
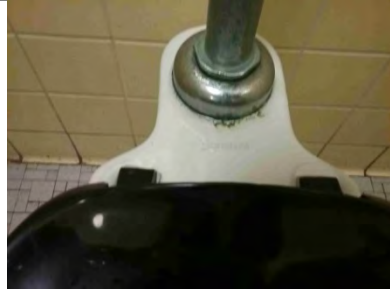
Plumbing Fixtures

System	Subsystem	Condition and Deficiency Overview	System Condition Rating
		Corrosion was observed on fixtures in BRRGYM, and an odor was being emitted. One of the urinals in this restroom appeared to not be operational and had a garbage bag over it. There was leakage observed from the toilet in the restrooms off rooms 102 and 104. The sinks in the janitorial closets were observed to be in average to poor condition, with some showing signs of leaks and corrosion around the base.	
	Domestic Water Distribution	Domestic hot water to the kitchen is provided by a 75-gallon water heater stored in the mechanical room (KITMECH) located inside the kitchen. A 50-gallon electric water heater was next to a washer and dryer in room 101LAUN. The unit is approximately 20 years old but appears to be in average condition with minor corrosion and rust on the connections. Various smaller electric water heaters are located throughout the building to provide heated domestic water to specific locations in the school (i.e., administration area and gymnasium shower). Domestic hot water is not supplied to the classroom plumbing fixtures. Damaged insulation, corrosion, and rust were observed on piping throughout the building. The plumbing distribution equipment was observed to be in average condition with typical wear and tear associated with the system's age and general daily use.	Average

1. Replace aged plumbing fixtures to maintain a functioning system.
2. Replace the cracked drinking fountain in room 205.
3. Remove fixtures that have been abandoned in place and no longer function.

4. Repair gymnasium hand-held shower head that was observed to be leaking.
5. Repair water closets observed to have evidence of leaks.
6. Repair urinal in BRRGYM that has been bagged.

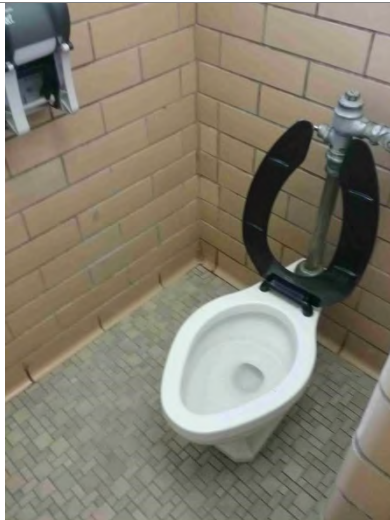
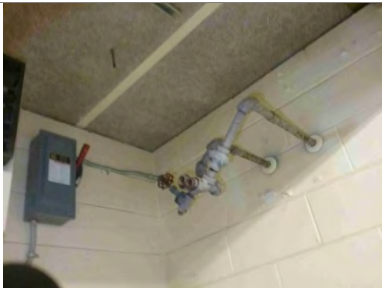
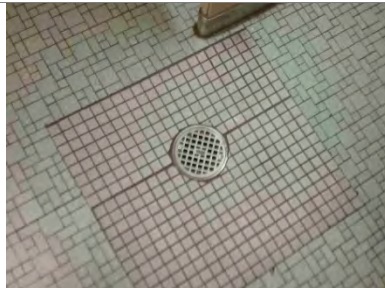
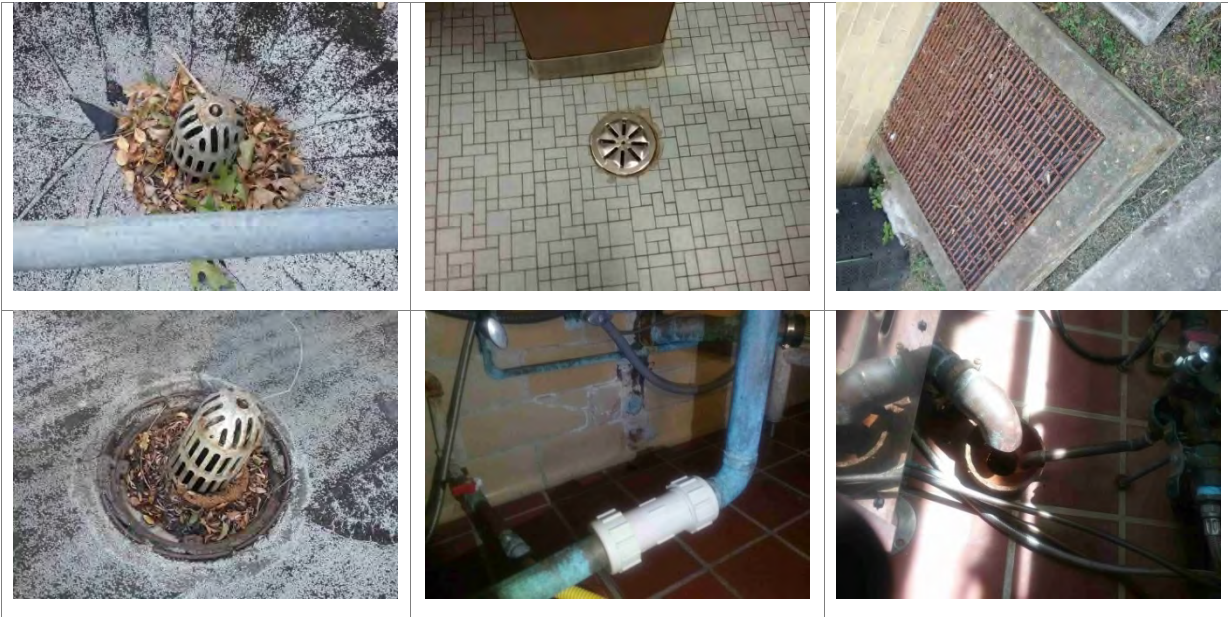
Other Plumbing	The restrooms in room 206 and the male gymnasium (BRRGYM) were observed to be emitting a smell. The floor drains in the kitchen appear to be in average condition and working well. The grease trap in the kitchen was reported in the facility interview to not be draining properly, causing a chronic foul smell. There is abandoned piping in the gymnasium restrooms (BRRGYM and GRRGYM). Roof drains had grates to prevent debris from blocking, but debris was observed surrounding the grate. Corrosion and rust were observed on the kitchen piping fixtures.	Average
Mechanical/ HVAC	The HVAC (heating, ventilating, and air conditioning) system is composed of geothermal water pump units, packaged RTUs (roof top units), heat pump systems, and package units for individual zone temperature controls. A separate geothermal unit is designated for each classroom and administration room. WSHPs (water source heat pumps) in each classroom were not accessible, assumed to be stored within the unit and working properly. RTUs feed the gymnasium and cafeteria. The cafeteria stage houses two ceiling-mounted heat pump units. Two space heaters are outside the gymnasium restrooms (BRRGYM and GRRGYM). Multiple roof top EFs (exhaust fans) ranging in size serve the		Average

9. Replace water heaters that are beyond their expected design life before failure occurs.
10. Inspect, clean and repair plumbing in multiple bathrooms that are emitting an unpleasant odor.

11. Clean and flush out all floor drains to ensure adequate drainage; it was reported these are not draining properly.
12. Clean out storm and condensate exterior drains to avoid plugging and backup.

13. Inspect the grease trap in the kitchen and clean or replace as necessary.

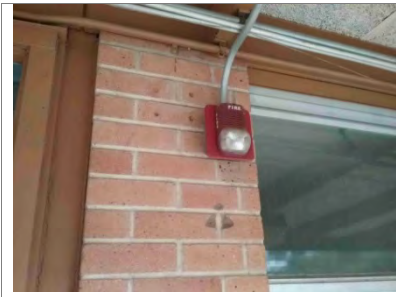
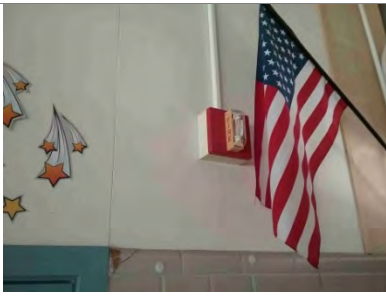
Fire Protection	Fire Alarm	<p>The building has a fire alarm system that consists of alarm and signaling devices such as horns, strobes, horn/strobe combinations devices, pull stations, detectors, and a system annunciator. The fire alarm system is controlled by the Silent Knight control panel.</p> <p>The fire alarm system was observed to be in average condition due to some of the fire alarm end devices being near their end of life or worn from outdoor exposure. It should also be noted that the book storage spaces do not have fire detection.</p>	Average
	Fire Protection/Suppression	<p>A fire suppression system is present for the range hood in the kitchen with a tank mounted to the wall at the ceiling. A single sprinkler head was observed in the CCGYM room that did not appear to be functional.</p> <p>The remaining fire suppression system consists of fire extinguishers throughout the building. Visual inspection showed these appeared to be in average condition. The majority of the extinguishers were up to date with inspections, but the extinguisher in the gymnasium was past due on its annual inspection.</p>	Average

1. Inspect extinguishers that are past due on their annual inspections, and replace if necessary.
2. Remove sprinkler heads that are no longer in use.
3. Install additional fire detection end devices within book rooms.

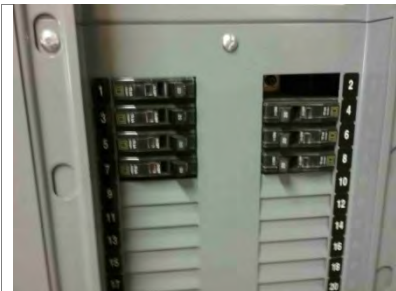
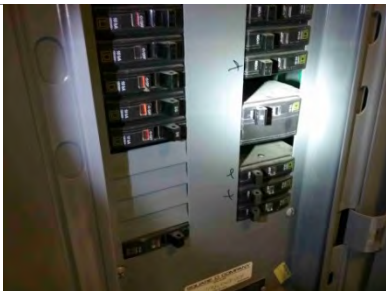
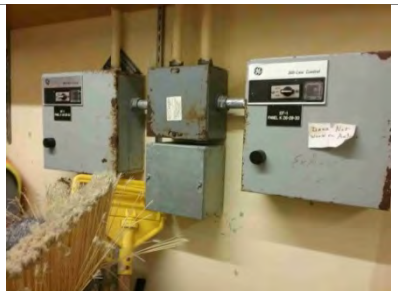
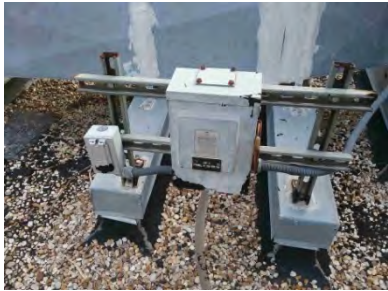
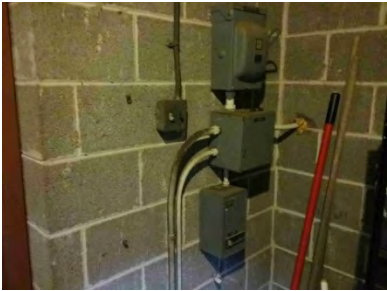
Electrical	Electrical Distribution	<p>The electrical service appears to enter the building at the 120/208-volt, 800-amp main panelboard located in the IDF (intermediate distribution frame) room (the main switchboard for the campus is located in BLDG-120B). The 800-amp panelboard feeds a variety of HVAC equipment and smaller subpanels. The building does not have a lightning protection system.</p> <p>The electrical distribution equipment was observed to be in average condition. The majority of the panelboards have been replaced in different phases.</p>	Average

System	Subsystem	Condition and Deficiency Overview	System Condition Rating
		<p>Two panelboards, Panel N and Panel TP1B, had missing breaker covers, and the bussing was exposed behind the breaker board. This condition is a life safety hazard, and breaker covers should be installed immediately. There are several safety switches and equipment controls for equipment throughout the building that are dated and past life expectancy.</p> <p>The faculty has reported that breakers commonly trip due to overloaded circuits.</p>	
	Lighting	<p>The building's exterior lighting consists of metal-halide and fluorescent luminaires that are located near parking lots, playground, covered walkways, and building egresses. Exterior luminaires are made up of a variety of different fixture types but are predominately wall-mounted lights and canopy lights. The interior lighting primarily consists of recessed troffers, surface mounted strip lights, and suspended strip light, and recessed downlight fluorescent luminaires. Some storage rooms still feature dated screw-in lamp style luminaires.</p> <p>The lighting for the building appeared to be in average condition. Many interior and exterior luminaires appeared to be aged past their design life. Observed deficiencies included worn and discolored lenses, dim lighting, and non-functional fixtures. There are exit signs present in the building, but several were found to be poorly lit. There was also an instance of a temporary shop light being used as a permanent fixture in room IDF.</p> <p>There were several issues in the branch wiring, including damaged or loose conduit and missing junction box covers. Open conduit could lead to water and insect infiltration into the electrical systems. Several exterior receptacles were found with broken covers, without covers, or severely worn. Some interior electrical receptacles were found to be worn, have broken cover plates, or ground lugs (from a device plug) broken off inside the receptacle. The 100-wing classrooms were found with non-grounded electrical receptacles installed for overhead clocks. Many classroom light switches were worn and past their life expectancy. The faculty has reported that there are common issues with the electrical receptacles and associated circuits in the classrooms that result in tripped circuits. The faculty has also reported inadequate lighting in the restroom vestibules between</p>	Average

1. Immediately provide missing breaker cover plates for all panels with open slots, as these instances should be considered life safety hazards
2. Install a permanent luminaire in room IDF.
3. Repair loose or open conduit throughout the interior and exterior of the building.
4. Replace exterior electrical receptacle covers that are damaged or not present.
5. Install additional lighting for the nurse's office, under covered walkways for 100-/200-wing classrooms, and in the restroom vestibules in the 100-/200-wing classrooms, as recommended by campus faculty.

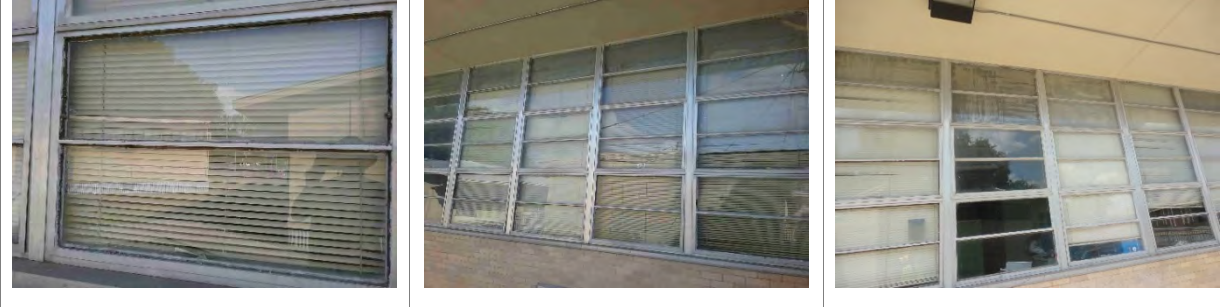
System	Subsystem	Condition and Deficiency Overview	System Condition Rating
Exterior	Exterior Walls	The exterior is all brick with cement plaster soffits above the south and north walls. An entry soffit exists over the west entry. These durable surfaces appeared to be clean and in good condition. The south roof fascia requires painting (see Roofing).	Good
	Exterior Windows	Windows are ganged, single-glazed, aluminum units with bottom awning sashes. The exterior windows appeared to be in poor condition. Most sash lights were missing putty. Interior film, particularly on the upper lights on the south side, showed age and was discolored. Several lights appeared to have been damaged by BB gun pellets.	Poor
	Exterior Doors	The only exterior doors are located at the west end of the building. This pair of painted, hollow metal, double doors is set in a painted hollow metal frame. The frame has fixed single-glazed sidelights and a transom. These doors appeared to be in average condition, though the paint finish was failing.	Average

1. Replace damaged glass lights. Re-putty window sashes as required. Replace existing interior window film where currently applied. This is an aesthetic suggestion and not necessarily a requirement.
2. Prepare the west exterior door assembly for paint and apply a new paint finish.

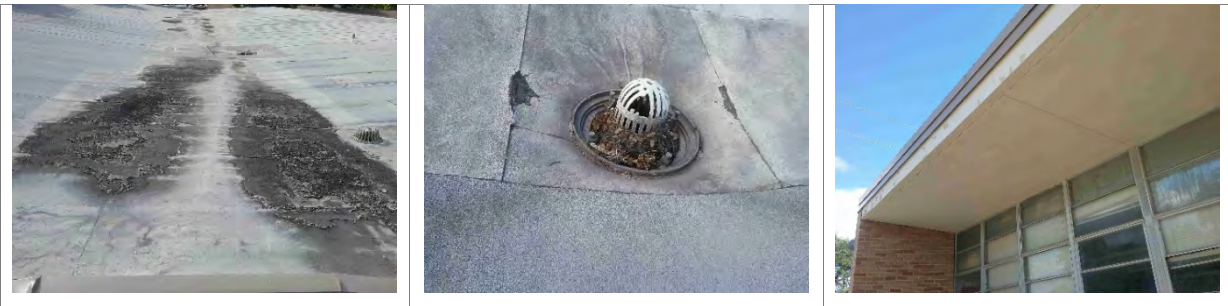
System	Subsystem	Condition and Deficiency Overview	System Condition Rating
Roofing		<p>The roof is a modified bitumen system. The roof surface drains to a center valley where two roof drains are installed. The two drains discharge out of scuppers installed on the side of the building exterior walls.</p> <p>The roof appeared to be in average condition. Evidence of ponding in the valley area was observed and may cause future, accelerated aging. Staining of the corridor's ceiling finish directly below the valley area suggested that damage had occurred in the past. Debris around one of the two roof drains also may be the cause of or contributing to the damage. The fascia below the south face of the roof appeared to be in good condition but requires paint.</p>	Average
Interior Construction	Interior Walls	<p>Corridor walls are CMU or wood frame with either infill wood or wallcovering tack panels in the middle, wood jalousie vents below and jalousie windows above. Walls between classrooms are of CMU above with structural clay tile below.</p> <p>Walls appeared to be in good condition.</p>	Good

1. Examine the possibility of forming cricket roof areas between drains to create a better functioning drainage system.
2. Clean and repair the east roof drain.
3. Prepare the south fascia below the roof drip metal edge for paint and apply a new paint finish.

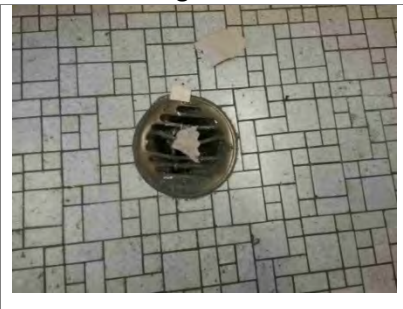
Other Plumbing	<p>Minimal "other plumbing" was visible during inspection. Floor drains in the multi-use restrooms (GRR300 and BRR300) appear to be in average condition. The male restroom's floor drain had damage to the grate.</p>	Average
Mechanical/ HVAC	<p>BLDG-120B's HVAC system is composed of geothermal water pump units in the individual classrooms and heat pump systems to feed the library. Bathrooms also contain on-ceiling heat pumps and EFs. WSHPs in each classroom were not accessible, assumed to be stored within the unit and working properly.</p> <p>The HVAC system appeared to be in average condition; however, the majority of the equipment is past its expected design life. Some units show signs of degradation with rust and corrosion. Like the main building, geothermal water pump units were approaching end of useful life, and it was reported in the facility interview that water needs to be manually added twice a year. This is not normal recommended maintenance for these units but was reported to be necessary to keep them functioning. It is suspected there may be a leak in the geothermal well system. Additionally it was reported in the facility interview that the geothermal units in the corridor (SC008331 and SC008306) do not work.</p> <p>The geothermal unit in room 302 was making a buzzing noise when operating. The heat pump systems in the ceiling of the bathrooms (GRR300 and GRR300) were not operating during inspection, and surrounding areas were observed to be very warm. Old TRANE heating units were found in the majority of classrooms. It was reported that they were no longer in use and abandoned in place. Multiple HVAC units were observed to be using R-22 refrigerant, which is an outdated refrigerant that is being phased out of use.</p>		Average

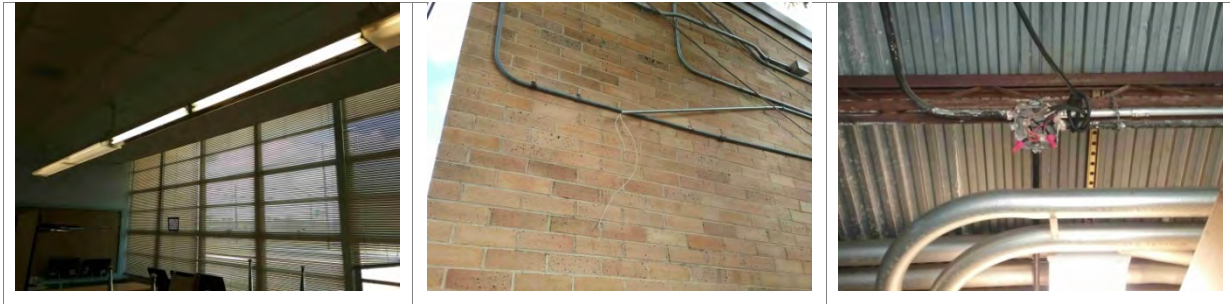
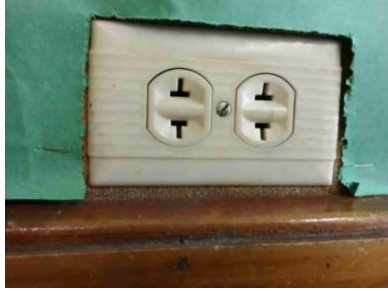
Lighting	<p>The building's exterior lighting consists of metal-halide luminaires (wall mounted and canopy style) at the building egresses and on each side of the building. The interior lighting primarily consists of suspended strip light T8 fluorescent luminaires.</p> <p>Building exit luminaires were found to function properly. The lighting for the building was observed to be in average condition. The only lighting deficiencies found during the assessment were loose or missing lenses from interior luminaires. Several deficiencies were found related to branch wiring: loose or open conduit on the building exterior, dated or worn electrical receptacles, a non-grounded electrical receptacle in room 301, and worn light switches throughout the building. It is worth noting that room 310 has a defective light switch that required the switch be forced up to activate the classroom lights.</p>	Average

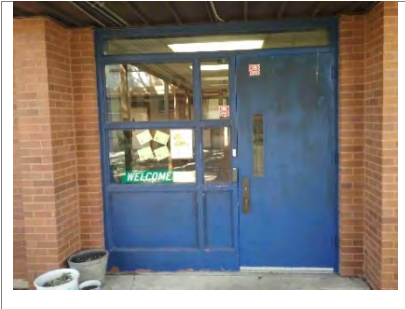
System	Subsystem	Condition and Deficiency Overview	System Condition Rating
Exterior	Exterior Walls	The exterior finish is brick on three sides and a brick and plaster finish on the south gable wall. All walls appeared to be in good condition, including the soffit formed by the roof system (see Roofing).	Good
	Exterior Windows	Exterior windows are single-glazed, single-hung, aluminum units. Larger south windows are fixed with opaque bottom panels. All units appeared to be well sealed and in good condition.	Good
	Exterior Doors	There is a single painted hollow metal door in a painted hollow metal frame. The frame includes a sidelight and transom. The door appeared to be in good operable condition; however, the paint finish was beginning to exhibit deterioration and therefore the overall system was rated as average.	Average
Roofing	A standing seam metal pan roof system is installed. The panels also form the edge fascia and soffit beneath. This roof system appeared to be providing good service.		Good

1. Prepare the west exterior door assembly for paint and apply a new paint finish.

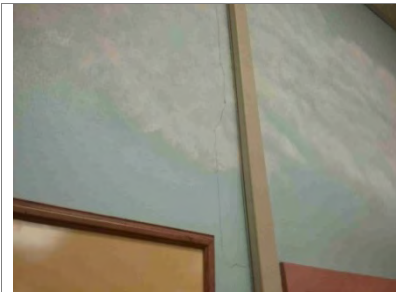
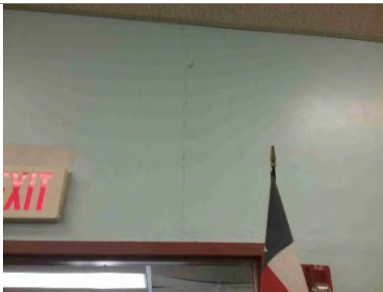
Interior Construction	Interior Walls	Walls are gypsum board on conventional stud framing. The walls appeared to be in good condition, but were rated as average because cracks have formed above several interior wall openings.	Average

1. Examine several locations where the gypsum wallboard has cracked near adjacent wall openings in the library main room. The fact that no damage was noted to the exterior wall suggests that there is no abnormal structural movement, though this should not be ruled out. It is, however, common practice to install drywall control joints above drywall openings. This was not done when the interior walls were constructed. It is suggested that these be added vertically at the locations of existing cracks if wall repair/renovations are considered.

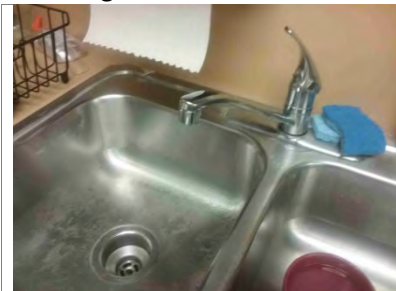
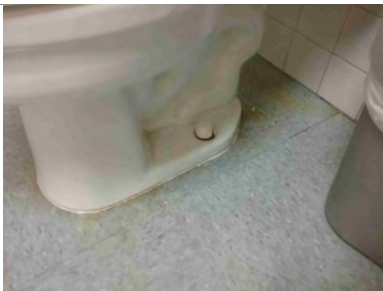
Conveying	System not present.		N/A
Plumbing	Plumbing Fixtures	The library contains a stainless steel double-basin sink and a single-use restroom. The restroom contains a floor-mounted vitreous china water closet and wall-mounted vitreous china sink. Plumbing fixtures were observed to be in average working condition, with some showing minor signs of deterioration but still operational. There was no hot water to either of the sinks. The water closet had evidence of leaks around the base.	Average
	Domestic Water Distribution	No hot water was observed to be fed to the building. The plumbing distribution equipment appeared to be in good condition with no observed corrosion or rusted piping throughout the building.	Good
	Other Plumbing	Minimal "other plumbing" was visible during inspection. Floor drains in the restroom appeared to be in good condition with no signs of corrosion to the grate.	Good

1. Repair any water closet with evidence of leaks underneath.

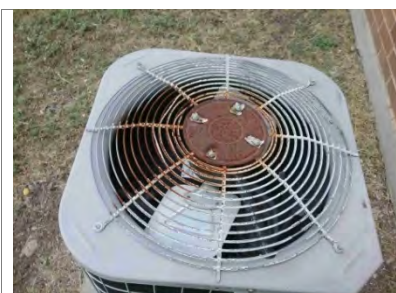
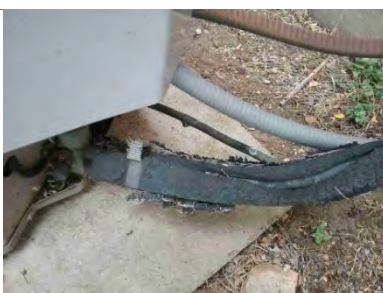
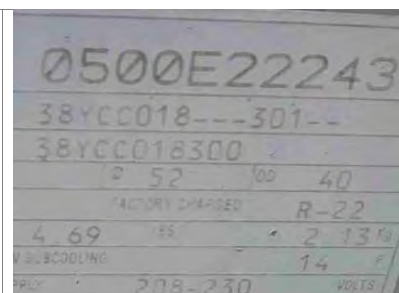
System	Subsystem	Condition and Deficiency Overview	System Condition Rating
Mechanical/ HVAC	<p>BLDG-120C's HVAC system is composed of heat pump systems and exterior air conditioner condenser units. The restrooms contained an EF.</p> <p>The HVAC system appeared to be in average condition. One of the exterior AC condenser units was aged and out of date with signs of corrosion and rust. The unit also had damage to the insulation on the refrigerant lines and was using R-22 refrigerant, which is an outdated refrigerant that is being phased out of use. Two heat pump systems were noted on the floorplan, but only one was observed in the assessment. This unit (HP SC008314) was relatively new and in good condition. The unit that was not located is possibly in the ceiling but was unable to be assessed.</p>		Average
Fire Protection	Fire Alarm	<p>The building has a fire alarm system that consists of alarm and signaling devices such as horns, strobes, horn/strobe combination devices, pull stations, detectors, and annunciation systems. The fire alarm system is controlled by the Silent Knight control panel.</p> <p>The fire alarm system was observed to be in good condition.</p>	Good

1. Verify functionality of ceiling-mounted heat pump units in the multi-use restrooms.
2. Address any rust or corrosion observed on the equipment, its associated piping, or any other sub-asset by cleaning, repainting, or repairing to prevent further deterioration.
3. Repair or replace any damaged or missing piping insulation as needed at all facilities.

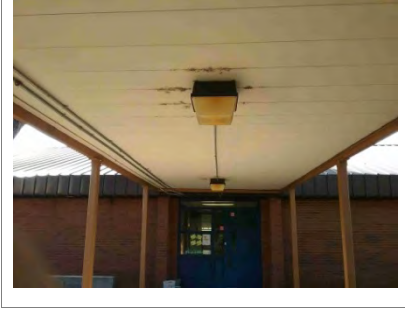
Fire Protection/ Suppression	<p>Fire suppression is achieved through the use of portable fire extinguishers only. There is no automatic sprinkler system.</p> <p>Visual inspection of the fire extinguishers determined they were in good condition and annual inspections were up to date.</p>	Good
Electrical	Electrical Distribution	<p>Distribution for BLDG-120C is located in room LIBHP via a single 120/208-volt, 250-amp panelboard that was installed in 2000.</p> <p>The electrical distribution equipment appeared to be in good condition. No major deficiencies were found during the assessment.</p>	Good
	Lighting	<p>The building's exterior lighting consists of metal-halide canopy luminaires on the covered walkway at the main entrance. The interior lighting primarily consists of recessed troffer T8 fluorescent luminaires.</p> <p>The lighting for the building appeared to be in good condition. The external luminaires on the covered walkway were found to be dated and discolored.</p>	Good
