Kiker Elementary School Site Summary

Introduction

Main School Building – BLDG-180A

Stand-Alone Classroom Building – BLDG-180B

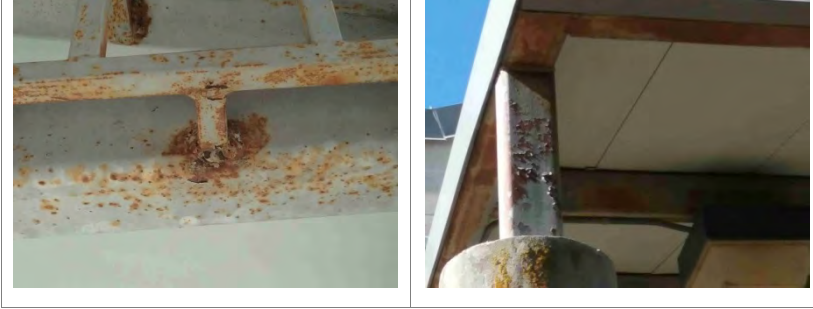
Exterior Walls

Roofing	A built-up roof covers the main part of the building. A standing seam metal roof system covers the pedestrian walkways. The roofs appeared to be in good condition. There were trees lying on the metal overhang roof of the library. In a few areas, the built-up aggregates material was swept away from the roof, exposing the substrate material. The paint was peeling on the downspouts on the north side of the building. Rust was present on metal components.		Good

1. Repair and repaint rusted walkway structures.

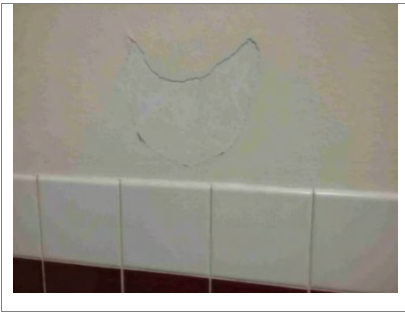
System	Subsystem	Condition and Deficiency Overview	System Condition Rating
Interior Construction	Interior Walls	The interior walls are gypsum board in the classrooms, lobby, administration area, library, and cafeteria. There is CMU in the gymnasium. The corridors are gypsum board at the top and plastic laminate from the floor upward of 4 feet. The walls appeared to be in good condition. There were many areas where the gypsum board paper covering had been scraped down to the metal edging.	Good
	Interior Doors	The interior doors are solid core wood veneer with a lite in metal frames. There are solid wood doors without side lites. The doors have knobs, not levers. The doors appeared to be in good condition.	Good
	Interior Specialties	System not present.	N/A
Stairs	Exterior Stairs	The exterior stairs are concrete with metal handrails on either side. The stairs appeared to be in good condition.	Good

1. Repair gypsum board tears at wall corners where damaged.
2. Repair chipped door frames.

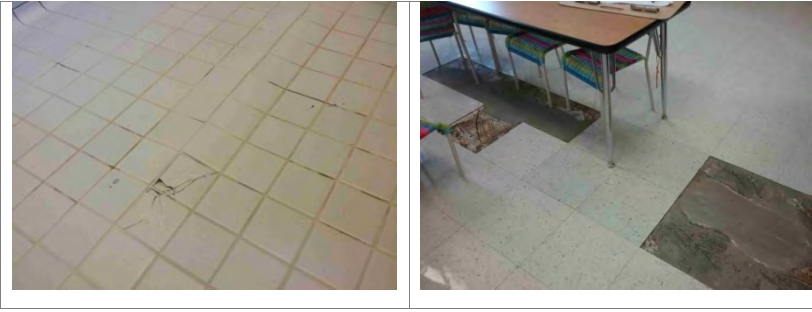
Interior Stairs	System not present.	N/A
Interior Finishes	Interior Wall Finishes	The interior walls are painted gypsum board in the classrooms, administration area, lobby, library, and cafeteria. There is CMU in the gymnasium. The corridors are gypsum board at the top and plastic laminate from the floor upward of 4 feet. Most of the wall finishes were observed to be in good condition. 10% of the cafeteria walls were scraped and gouged.	Good
	Interior Floor Finishes	The interior floor finishes are VCT (vinyl composition tile) in the administration offices, corridors, cafeteria, and classrooms. Ceramic tile is in the restrooms and nurse's office, and quarry tile in the kitchen. The flooring is carpet in the library, administration offices and classrooms in the 100-wing. There is a carpet sport court in the gymnasium. There is wood flooring on the stage. Most floor finishes were observed to be in good condition. There was ceramic tile buckling in the male restroom in room 202. There was missing VCT tile in room 504.	Good

1. Repair the vinyl tile floor in room 504.
2. Repair the buckling ceramic floor tile in male restroom 202.

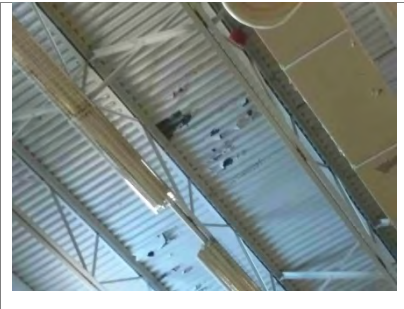
Interior Ceiling Finishes

System	Subsystem	Condition and Deficiency Overview	System Condition Rating
		joists. The ceiling systems were observed to be in good condition. The roof decking paint was peeling off the decking.	
Conveying	System not present.		N/A
Plumbing	Plumbing Fixtures	<p>The facility contains multiple plumbing applications that service one floor level, consisting of student restrooms, staff restrooms, janitorial closets with service sinks, and one commercial kitchen.</p> <p>The restrooms that are located inside of the classrooms have vitreous china floor-mount toilets with manual flushing valves. The classroom restrooms are not equipped with sinks; however, the classrooms have laminated particle board counter tops with stainless steel sink/bubbler combinations. The remainder of the facility's restrooms has vitreous china sinks with manual or metering faucets, along with vitreous china floor/wall-mount toilets and urinals with manually operated flushing valves. There are also wall-mounted service sinks in the janitorial closets.</p> <p>This building's plumbing fixtures were observed to be in average condition.</p> <p>Staff reported that all of the plumbing fixtures servicing the restrooms were aged and outdated. It was also reported that the stainless steel trough hand-wash sink outside of the cafeteria did not drain properly.</p> <p>The plumbing fixtures were observed to be fairly aged throughout the building but were all functional at the time of assessment. There were no specific functional plumbing fixture deficiencies noted aside from the one trough sink not draining properly.</p>	Average

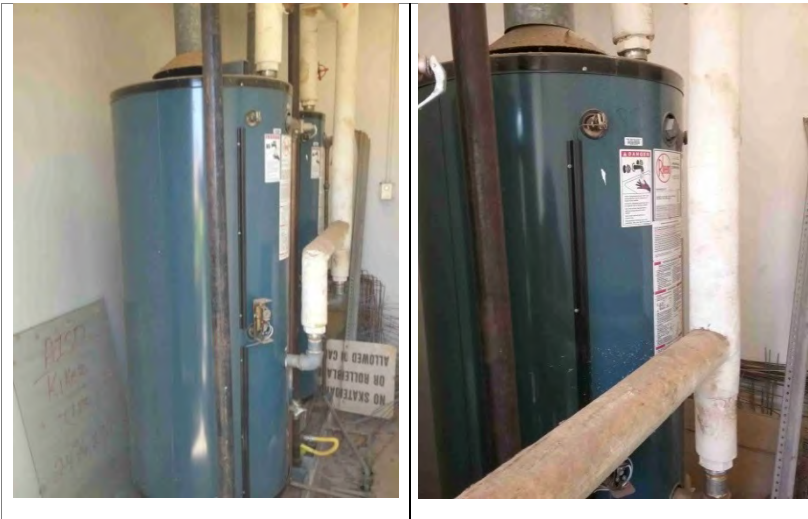
Domestic Water Distribution	<p>The fixtures in the commercial kitchen appear to be serviced by two GWHs (gas water heaters) located in the main mechanical room. The GWHs have the ability to produce 200 MBH and hold 99 gallons.</p> <p>The Staff reported that the domestic water distribution piping's isolation gate valves were not opening and closing properly, and they had requested the valves be replaced with ball valves. Additionally, it was reported that the wastewater and water lines under the kitchen were deteriorating and in need of replacement. It was also reported that GRLR300 and BYRR300 had been converted to adult-only restrooms but were not serviced</p>	Average

System	Subsystem	Condition and Deficiency Overview	System Condition Rating
		<p>with hot water. Lastly, it was reported that the two GWHs that service the kitchen were old but still functioning well.</p> <p>The domestic distribution system was observed to be in average condition at the time of assessment. Both of the GWHs observed in the main mechanical room had installation dates of 1992 and had surpassed their typical service life.</p>	
	Other Plumbing	<p>The facility is equipped with both external and internal roof-type drainage systems.</p> <p>Staff reported that the french condensate drain system which serviced the classroom HVAC (heating, ventilating, and air conditioning) units had collapsed and caused clogging issues.</p> <p>Other plumbing appeared to be in good condition at the time of assessment. There were no other plumbing system deficiencies noted.</p>	Good
Mechanical/ HVAC		<p>This building has multiple HVAC applications that service one floor level. The major mechanical equipment consists of RTUs (roof top units), split-system heat pump/air conditioning units, horizontal floor-mounted packaged unit ventilator systems, and indoor water source heat pump units.</p> <p>A total of 35 HVAC pieces of equipment were assessed throughout the building. The estimated capacity of the roof-mounted exhaust/supply air kitchen fan is 200 to 1,300 CFM (cubic feet per minute), and the estimated capacity for the roof-mounted HRU (heat recovery unit) is 1,500 to 3,000 CFM. The refrigeration capacities of the HVAC units are 1.5- to 25-TON.</p> <p>The mechanical/HVAC system for this building appeared to be in average condition at the time of assessment.</p> <p>Staff reported that all of the classroom packaged unit ventilators were old and consistently had maintenance issues. It was also reported that the administration/office was always too hot or too cold. Additionally, it was reported that the library units located in the mezzanine level above the library were consistently having maintenance issues.</p> <p>Of the 35 pieces of HVAC equipment observed, only 12 utilized an approved refrigerant. However, those 12 pieces were nearing the end of their typical service life at the time of the assessment. The general deficiencies consisted of aged equipment, enclosure/compressor fin damage due to excessive wear and tear, and the utilization of outdated R-22 refrigerant.</p> <p>Additionally, the air conditioning unit (ACU-11) located on the mezzanine level above the library had broken associated water piping and pump wall support, causing the assembly to hang by its hoses. Another observed deficiency was that all of the classroom unit ventilators had potentially been charged with R-22 refrigerant when they were originally installed. Lastly, the unit ventilator that</p>	Average

1. Continue preventive maintenance on aged plumbing fixtures and plan for replacement of the fixtures in the future as they continue to age.
2. Perform further investigation on why the handwashing trough sink outside the cafeteria is not draining properly.
3. Replace or repair the French condensate drains that service the classroom HVAC units.
4. Replace domestic water isolation gate valves to classrooms with ball valves.
5. Replace water and wastewater lines that service the kitchen.
6. Replace both of the GWHs that service the commercial kitchen.
7. Install instantaneous tankless water heaters under the sinks in GRLR300 and BYRR300 to provide faculty with hot water.

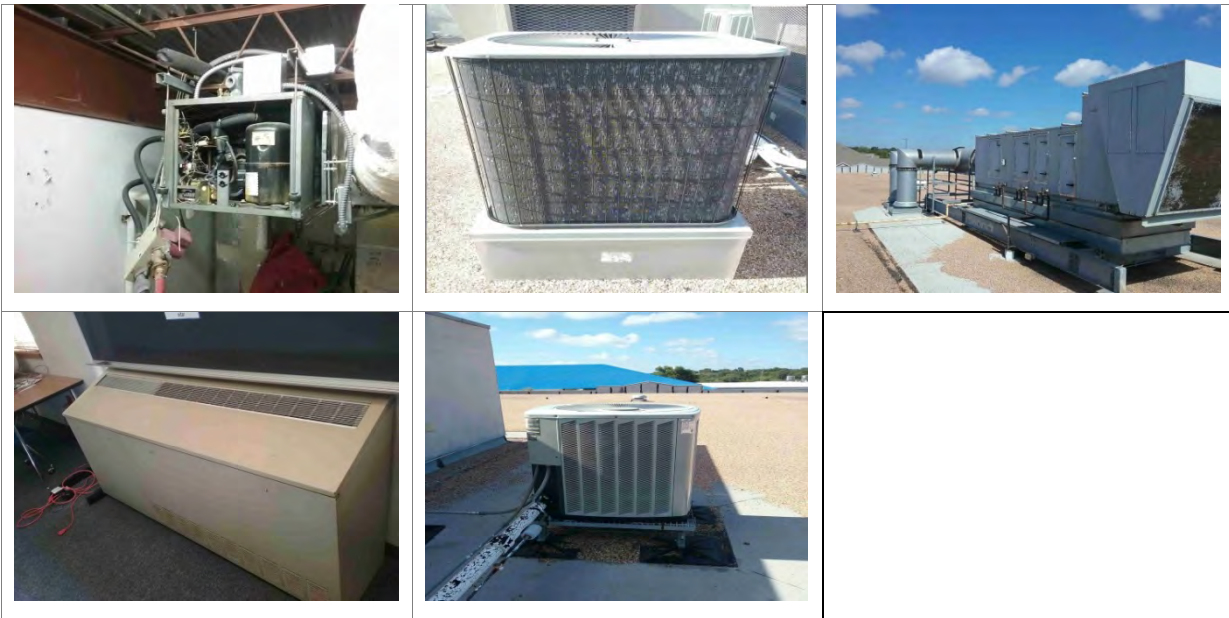
Mechanical/HVAC System Deficiency Examples

System	Subsystem	Condition and Deficiency Overview	System Condition Rating
	serviced the music room was not supplying conditioned air at the time of assessment.		
Fire Protection	Fire Alarm	<p>The building has a fire alarm system that consists of alarm and signaling devices such as horns/annunciators, strobes, horn/strobe combinations, pull stations, and detectors. The fire alarm system is controlled by a Silent Knight control panelboard.</p> <p>The remote annunciator indicated all systems were normal. The fire alarm system equipment was observed to be in good condition.</p>	Good
	Fire Protection/Suppression	<p>The building is not equipped with a fire sprinkler/suppression system. It is protected by portable fire extinguishers stationed throughout the building.</p> <p>All portable fire extinguishers observed were inspected within the last year based on their inspection tags.</p>	N/A
Electrical	Electrical Distribution	<p>The electrical service (utility transformer and exterior switchboard for the facility) appear to be located on the north side of the campus north of the gymnasium. The main electrical room houses a 480-volt 1200-amp switchboard that distributes power to transformers and panelboards. Numerous mechanical rooms and storage closets house transformers and sub panelboards to supply power to the building's end devices and mechanical equipment.</p> <p>The electrical distribution equipment appeared to be in good condition.</p> <p>The panelboard located in AHU-3A's mechanical room had the following deficiencies: the enclosure was not installed correctly and was using a piece of wood to keep it intact, cables were protruding between the enclosure and the door opening, and the flexible conduit from the transformer was damaged leaving feed cables exposed. This is a life safety issue.</p> <p>Numerous transformers in electrical rooms and storage closets were being used as shelves. The electrical equipment must be cleared for access.</p>	Good

1. Replace units that use R-22 refrigerant.
2. Continue conducting preventive maintenance checks and services for HVAC systems. Plan to repair or replace all aged and out-of-date HVAC equipment.
3. Repair the broken wall support for ACU-11's associated piping and pump assembly.
4. Repair the unit ventilator that services the music room.

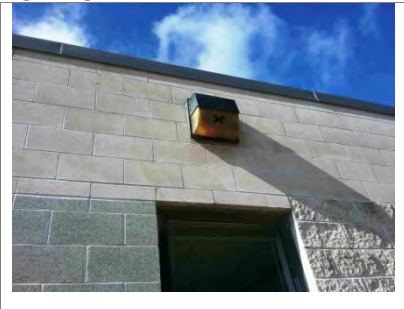
Lighting	<p>The exterior of the building is outfitted with what appears to be wall-mount HID (high-intensity discharge) fixtures located near the roofline of the building. Covered walkways are illuminated by surface-mounted ceiling fixtures and recessed screw-type fixtures. Pole lights are installed near the roadway sidewalk with no damage observed. The exterior lighting is being</p>	Average

System	Subsystem	Condition and Deficiency Overview	System Condition Rating
		<p>replaced with LED (light-emitting diode) fixtures.</p> <p>The exterior lighting was observed to be in average condition. It was reported by the facility staff that some lighting fixtures are damaged and not in working condition.</p> <p>The interior lighting is mainly fluorescent troffer fixtures in classrooms and corridors. The stage is equipped with specifically designed lighting to support stage productions. The gymnasium is equipped with hanging fluorescent-style fixtures, and screw-type fixtures exist in closets and electrical rooms.</p> <p>The interior lighting appeared to be in good condition.</p> <p>There are exit signs at every exit; however, various signs were not illuminated.</p>	
	Communications & Security	<p>There is a Gemini security system currently installed with multiple keypads at various entrances. Motion detectors are installed in interior areas, and security cameras are installed throughout the interior of the building and strategically on exterior corners and walls. There is a call box is located at the front entrance and proximity card readers at various entrances.</p> <p>The equipment was observed to be in good condition.</p> <p>An MDF (main distribution frame) communication closet exists in room 407. This houses network switches, hubs and routers in a rack-style configuration. The facility appears to have wireless routers installed in classroom ceilings and strategically throughout the building.</p> <p>The equipment was observed to be in good condition.</p> <p>The facility reported that the wireless internet was poor in certain areas but did not indicate exactly where. The facility also requested that a public address system be installed on the exterior of the building and additional exterior cameras be added for security needs.</p>	Good

1. Repair the conduit and enclosure for the hollow metal panelboard located in AHU-3A's mechanical room.
2. Replace light fixtures that are damaged beyond repair.

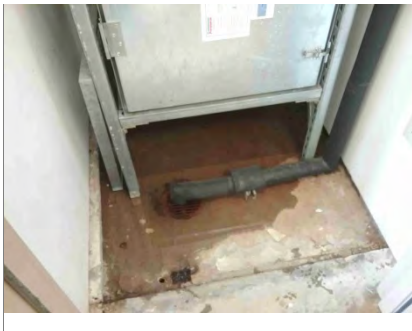
Plumbing System Deficiency Examples

System	Subsystem	Condition and Deficiency Overview	System Condition Rating
		good condition. The only observed deficiency was regarding AHU-15's condensation drain. The drain appeared to be clogged and was not draining efficiently.	
Mechanical/ HVAC		<p>This building has three types of HVAC applications that service one floor level. The major mechanical equipment consists of roof-mounted split-system heat pumps, one roof-mounted HRU, and multiple indoor AHUs.</p> <p>There were 21 HVAC pieces of equipment assessed throughout the building. The estimated capacity of the roof top HRU was 2,500 to 5,000 CFM. The refrigeration capacities of the HVAC units ranged from 2.5- to 4-TON.</p> <p>The mechanical/HVAC system for this facility appeared to be in average condition. The HVAC units had estimated installation dates of 2007. All of the HVAC equipment had been charged with R-22 refrigerant.</p>	Average

1. Unclog or replace the floor drain for AHU-15.
