## Kocurek Elementary School Site Summary

### Introduction

## Main School Building – BLDG-172A

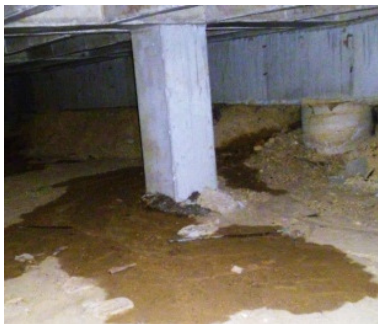
Water infiltration at building perimeter

1. Investigate source of water infiltration and mitigate
2. Investigate need for adequate ventilation
3. Soil bearing directly against underside of beams could cause future structural distress – consider installation of soil retaining panels around building perimeter to restore & protect voids under perimeter beams

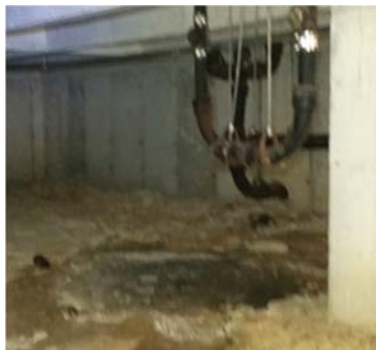
Wet soil under leaking pipe

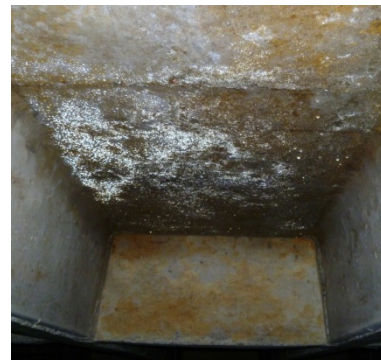
Condensation on underside of slab indicates poor ventilation

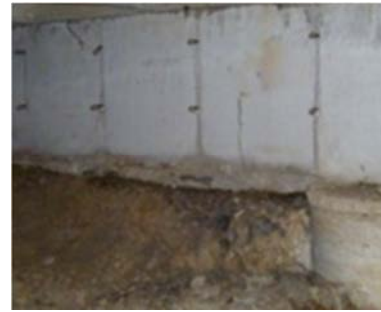
Soil in contact with bottom of perimeter beam

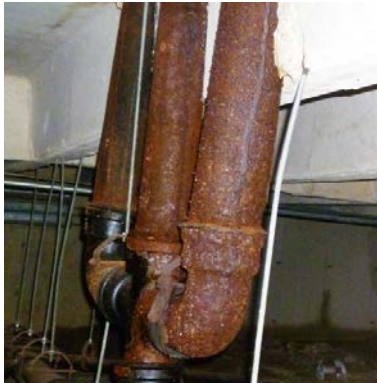
Corrosion in cast iron pipes

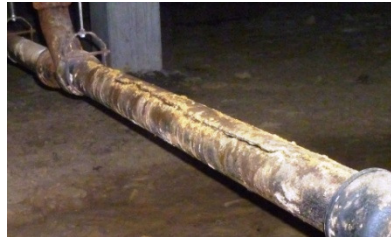
Cracked cast iron pipe

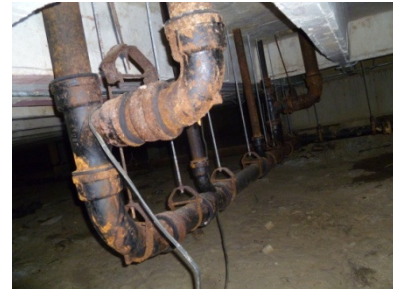
Rusted pipe & hangers

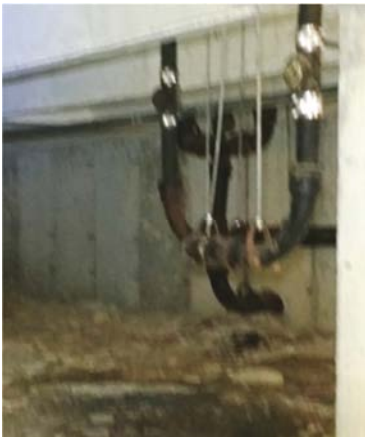
Leaking cast iron pipe

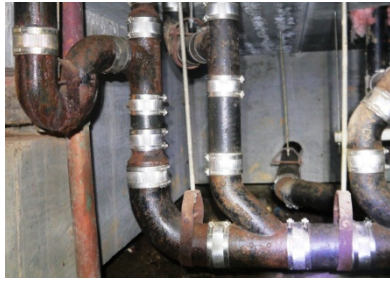
Minor rusting in cast iron pipe and rusted hangers

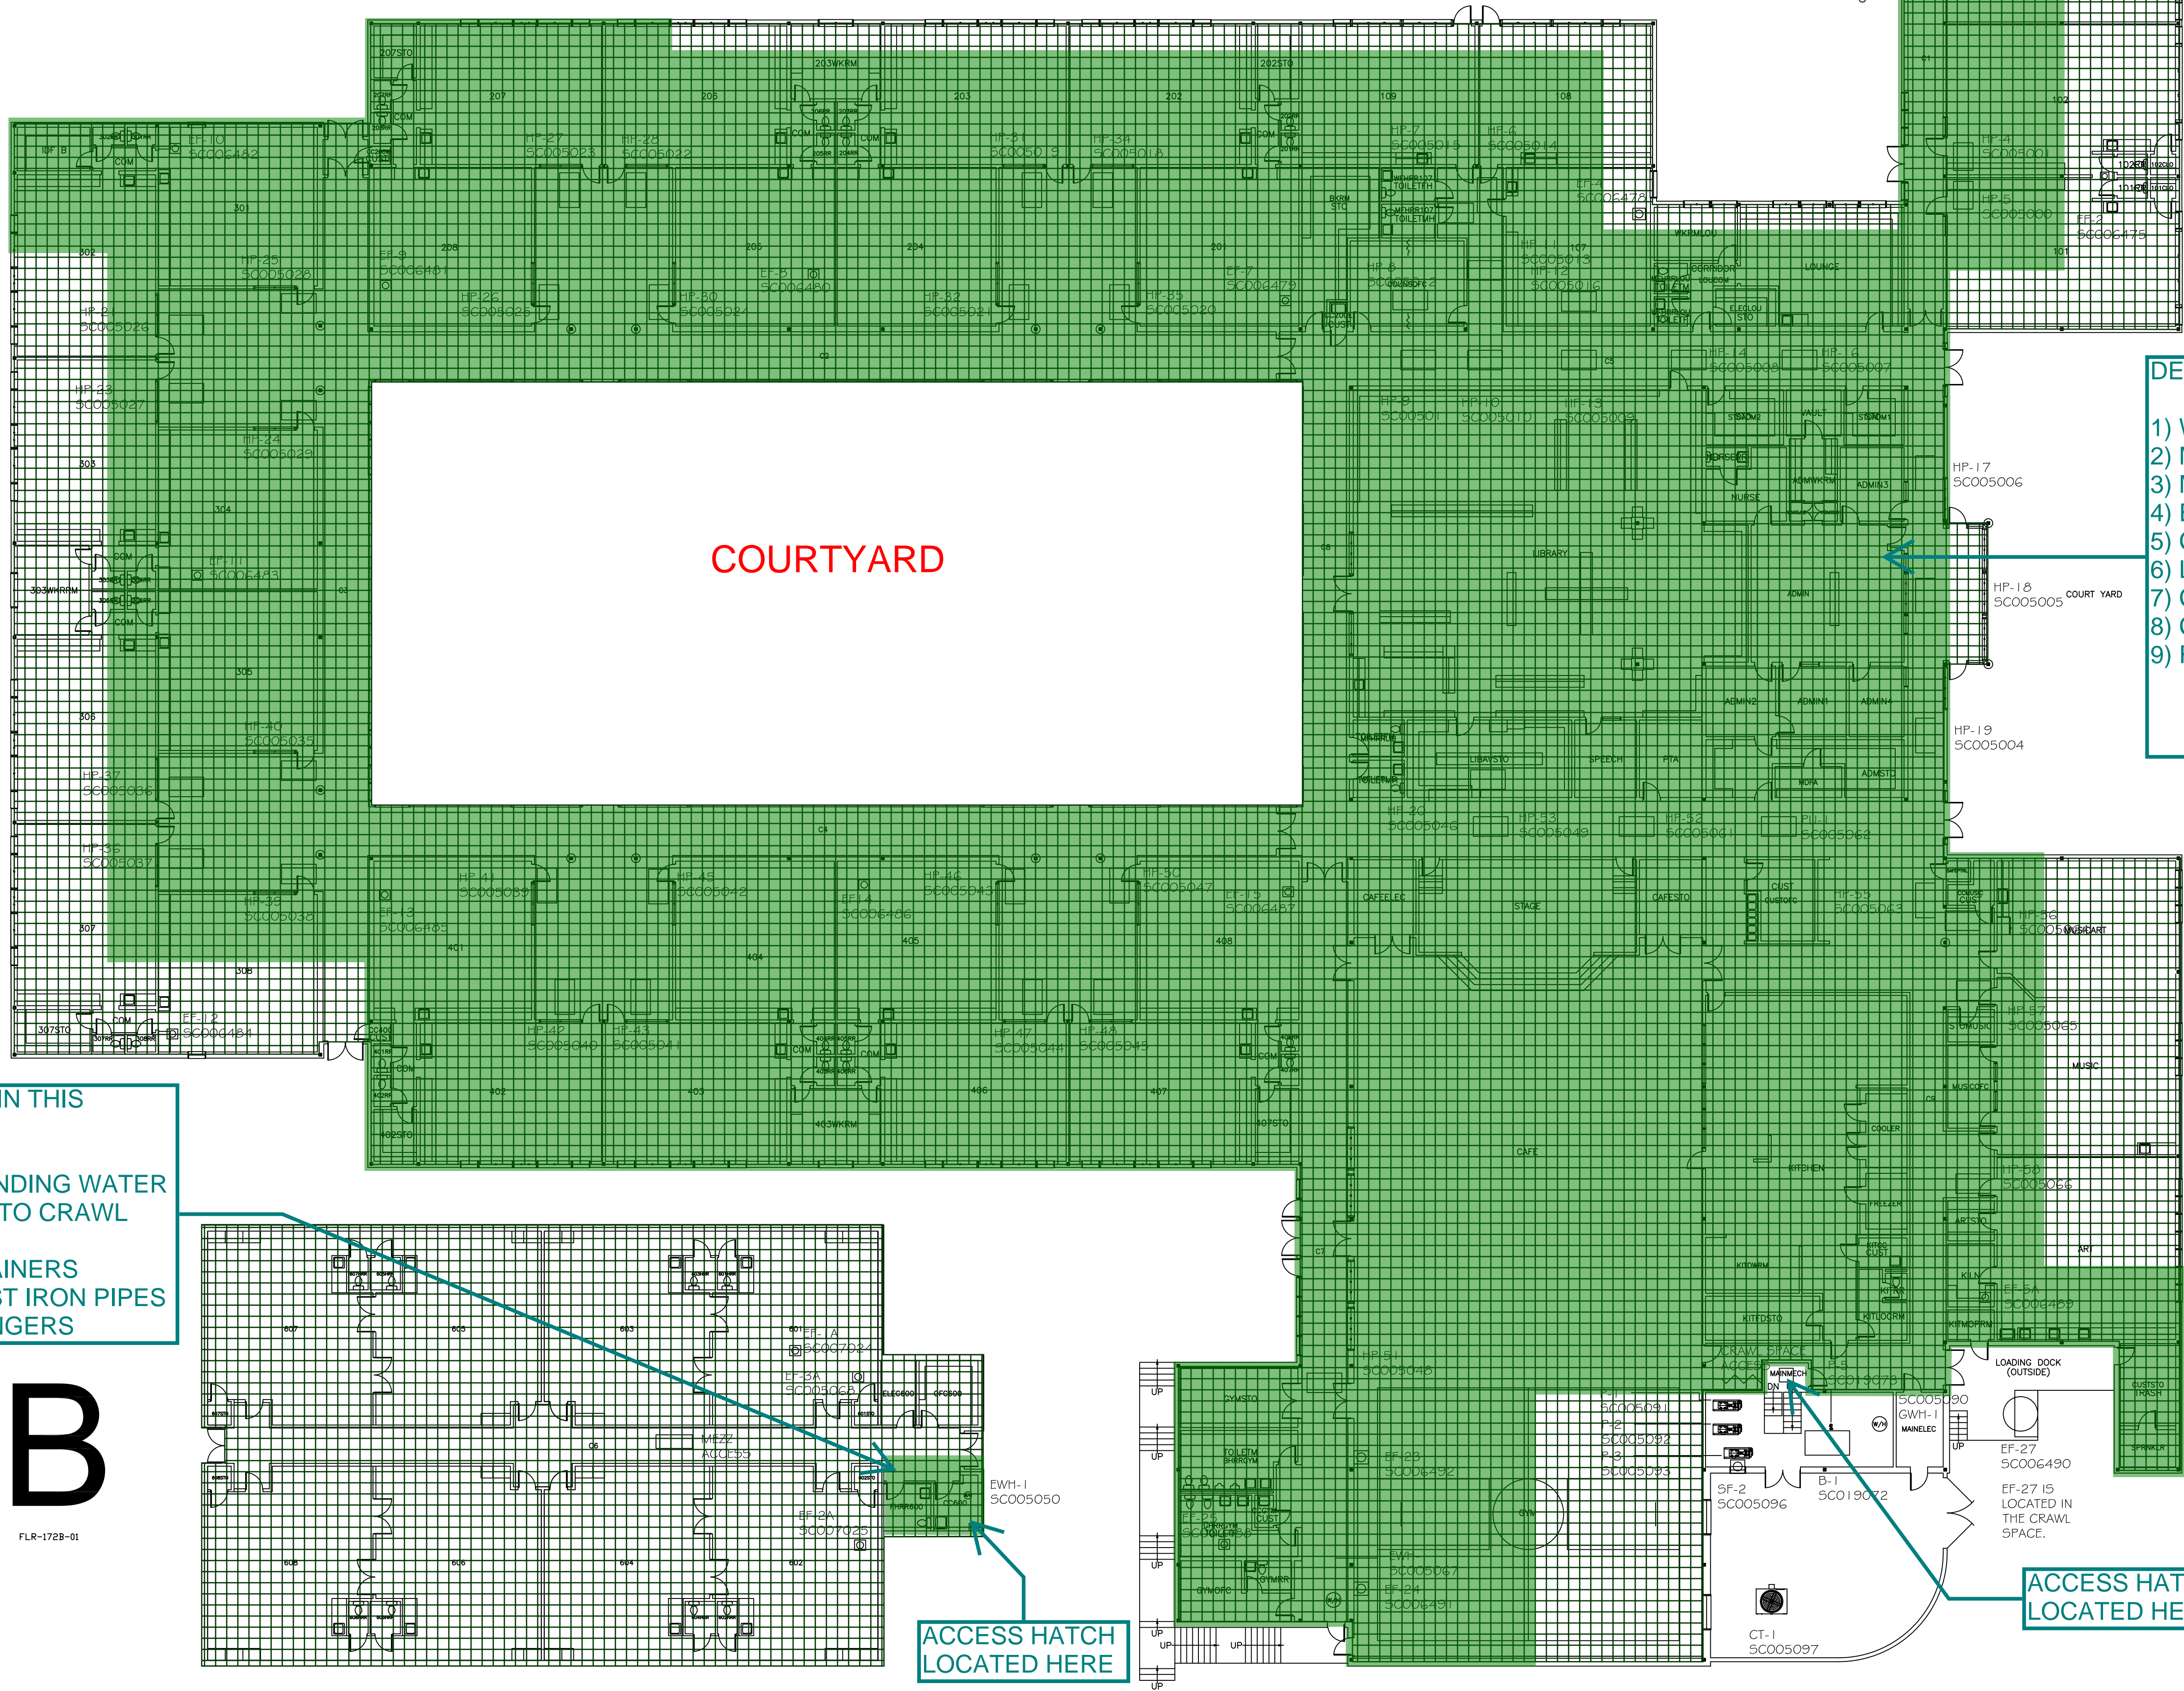
DWG:172-FLR-01

- DEFICIENCIES OBSERVED IN THIS LOCATION:
- 1) WATER INFILTRATION
  - 2) MODERATE HONEYCOMBING ON BEAMS
  - 3) MODERATE HONEYCOMBING ON JOISTS
  - 4) EXPOSED/CORRODED REBAR IN JOISTS
  - 5) CRACKED CAST IRON PIPE
  - 6) LEAKING PIPES
  - 7) CAST IRON PIPE TOUCHING GROUND
  - 8) CORROSION ON CAST IRON PIPES
  - 9) RUST ON PIPE HANGERS

- DEFICIENCIES OBSERVED IN THIS LOCATION:
- 1) SATURATED SOIL & STANDING WATER PREVENTED ACCESS INTO CRAWL SPACE
  - 2) FEW BROKEN SOIL RETAINERS
  - 3) MINOR RUSTING ON CAST IRON PIPES
  - 4) MINOR RUSTING ON HANGERS
