## Langford Elementary School Site Summary

## Main School Building – BLDG-168A

### Exterior System Deficiency Examples

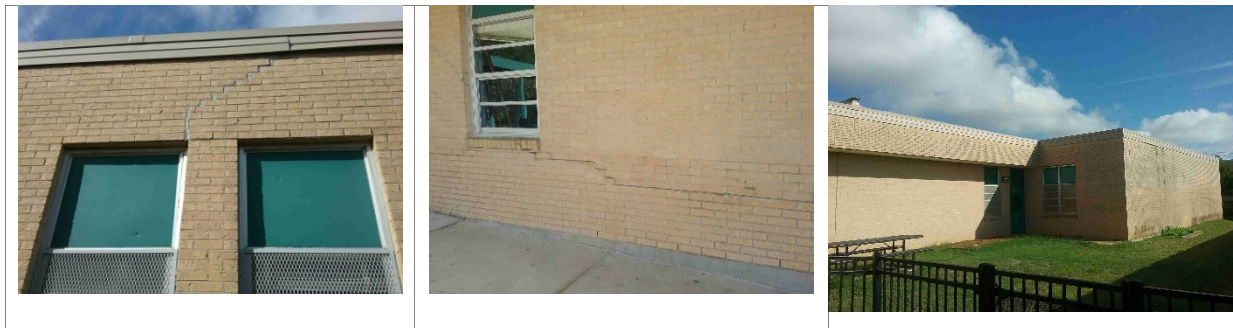
#### Exterior Walls

System	Subsystem	Condition and Deficiency Overview	System Condition Rating
Exterior	Exterior Walls	<p>The exterior walls are a brick façade on CMU (concrete masonry unit) support structure. There are exterior covered walkways and overhangs that have a painted stucco soffit.</p> <p>The exterior brick walls were observed to be in average condition due to age, dirt and possible water staining. There was a crack in the brick and mortar above the windows outside rooms 501 and 502. There were also cracks below the windows on the south façade under the covered walkway outside the music classroom. The foundation at this location also had hairline cracks. Facility staff reported a pest issue. The campus staff also reported issues with security and vandalism on the roof.</p> <p>Canopies on the front of the building at the main entrance are reported in the interview to have reached their life span and need to be replaced: pictures or observations?</p>	Average

1. Repair cracks on the north and south brick walls adjacent to windows. Perform an additional structural evaluation to determine the cause of the exterior cracking.
2. Replace exterior windows?
3. Replace exterior doors that are not functioning.

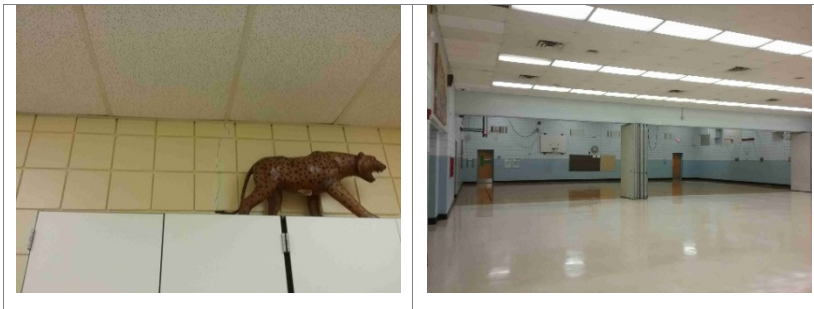
#### Interior Walls

<b>Interior Construction</b>	Interior Walls	<p>The interior walls are a mixture of CMU and gypsum board on metal studs. There are movable wall panels dividing classrooms in the 500-wing and between the 200- and 300-wings. There are movable partitions along corridors C4 and C7 to the adjoining classrooms. A movable partition wall separates the gymnasium and cafeteria. There are corrugated movable divider walls in the offices of each classroom wing.</p> <p>The interior walls were observed to be in average condition due to age. There was a crack above the millwork in the staff lounge, which suggested possible settlement. All of the movable partitions and corrugated dividers were aged and likely not used often. The movable partition in the gymnasium and cafeteria was aged and reportedly deteriorating. Facility staff requested the partition be replaced.</p>	Average
	Interior Doors	<p>The interior doors are wood veneer in painted hollow metal frames. The classroom doors have integral sidelite windows with vision glass on the top and an opaque panel at the bottom quarter. The doors also have vision panels into the classrooms.</p> <p>The interior doors were observed to be in good</p>	Average

1. Further investigate the cracks in the CMU in the staff lounge.
2. Replace the movable wall partition in the gymnasium and cafeteria.
3. Replace the movable partitions in corridors C4 and C7.

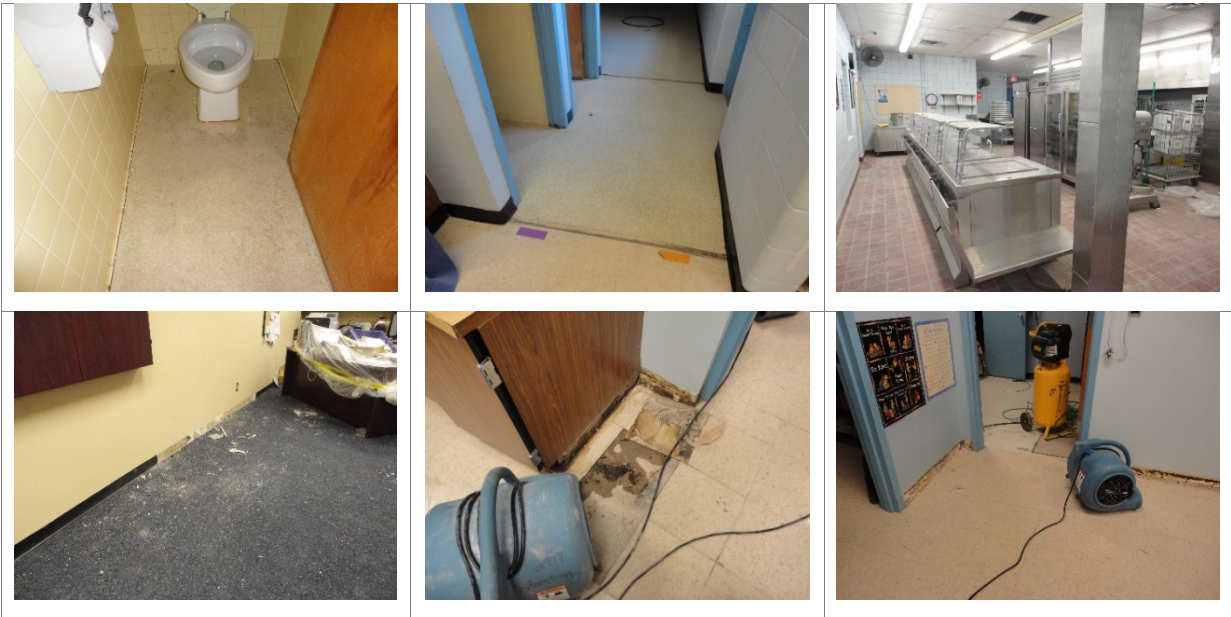
Interior Floor Finishes	The flooring finishes include VCT (vinyl composition tile) throughout the school in the corridors, classrooms, gymnasium, and cafeteria. The stage has wood flooring with rubber treads and risers. There is vinyl sheet flooring in the classroom restrooms and the administrative restrooms. The larger restrooms with multiple stalls have ceramic tile. The kitchen has ceramic tile. The library and administrative areas have carpet.  The interior floor finishes were observed to be in average condition due to age, wear, and discoloration. The sheet flooring in all the classroom restrooms was discolored and worn. The ceramic tile in the kitchen was	Average

System	Subsystem	Condition and Deficiency Overview	System Condition Rating
		aged, and the finish appeared to have deteriorated. The carpet in the administration area was worn, and an area of the cove base was damaged possibly due to construction that occurred. A portion of VCT and rubber cove base in rooms 400 and 401 was damaged due to the recent roof leaks being addressed. It is unknown if the tiles will be replaced as part of the repair work that was taking place.	
	Interior Ceiling Finishes	<p>The interior ceiling finish is a 2x4 ACT (acoustic ceiling tile) and metal grid system. The gymnasium has tectum panels at the roof structure. The cafeteria has a suspended ACT and grid. The restrooms have a painted gypsum board finish. The library has a more recently installed 2x2 ACT and grid system.</p> <p>Approximately 30% of the ACT in the building had been removed during the construction projects taking place at the time of the assessment. It was unknown if original or new ceiling tiles would be used when repairs were complete. The ceiling finishes were observed to be in average condition due to the age of the ceiling finish in undisturbed areas. Tiles were mismatched.</p>	Average

1. Replace the flooring in classroom restrooms.
2. Replace the ceramic tile flooring in the kitchen.
3. Replace the carpet in the administrative areas.
4. Replace the VCT in rooms 400 and 401.
5. Refinish damaged door finishes
6. Replace rubber base cove if it is not replaced as part of current construction activities.

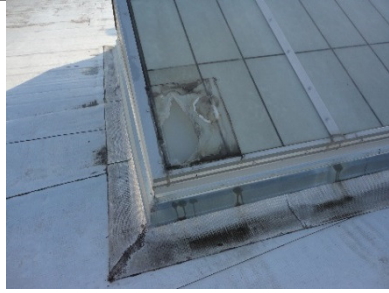
### Roofing Deficiency Examples

System	Subsystem	Condition and Deficiency Overview	System Condition Rating
	The roof covering appeared to be in good condition with some minor repairs needed. There was one area of cracking on the southwest corner of the skylight.		
<b>Interior Construction</b>	Interior Walls	The interior walls are gypsum board on metal studs with transom windows in the walls between the classrooms and corridors.  The walls were observed to be in good condition with control joints in appropriate locations at door and window corners.	Good
	Interior Doors	The interior doors are wood veneer with painted hollow metal frames. The classroom doors have half vision glass panels. There are matching painted hollow metal single-pane transom windows above the classroom doors.  The interior doors were observed to be in good condition.	Good
	Interior Specialties	System not present.	N/A
<b>Stairs</b>	Exterior Stairs	System not present.	N/A

1. Repair the Kalwall panel at the southwest corner of the skylight.
2. Replace the roof drain cover at the northeast roof drain.

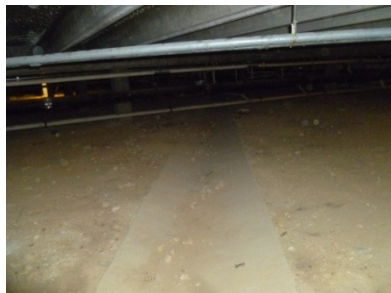
Damp soil	Damp soil due to water infiltration along perimeter	Dirt and rocks in drainage flume

Condensation on underside of precast deck	Shifted/rotated soil retaining panels

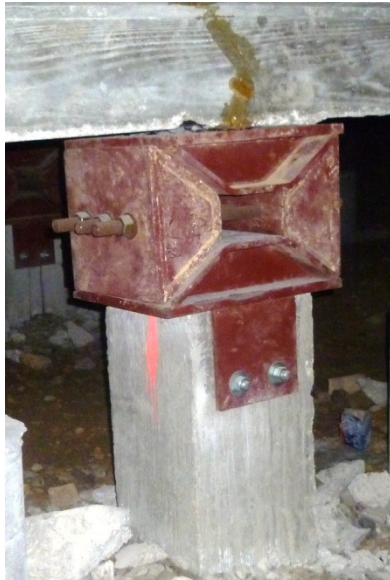
Column retrofit steel "box"  
Epoxy injected crack in beam above  
column

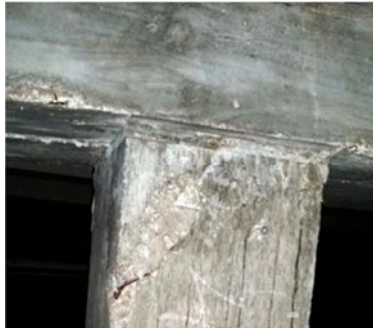
Diagonal crack at top of column, Minor  
beam and column spalling/honeycombing

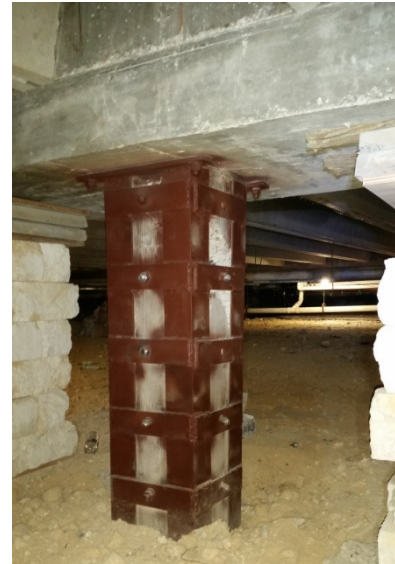
Column jacketed with steel retrofit and  
supported on either side by stacked  
masonry

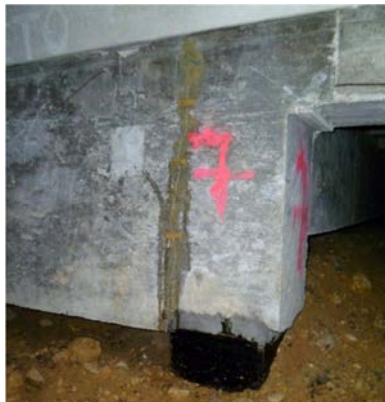
Beam with large crack that was epoxy  
injected

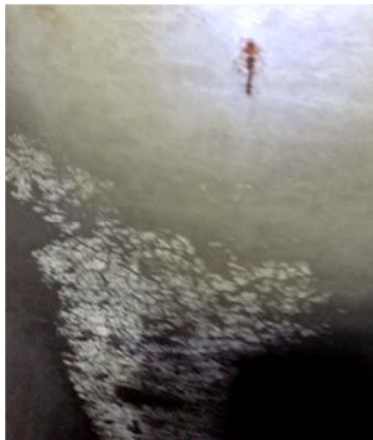
Exposed reinforcement under precast  
slab. Condensation under slab.

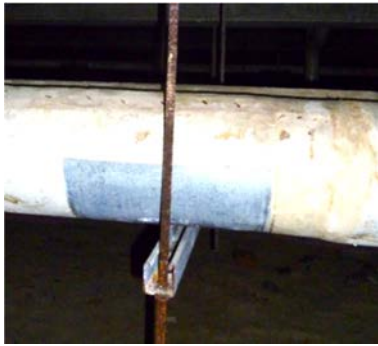
Rusting hanger rods

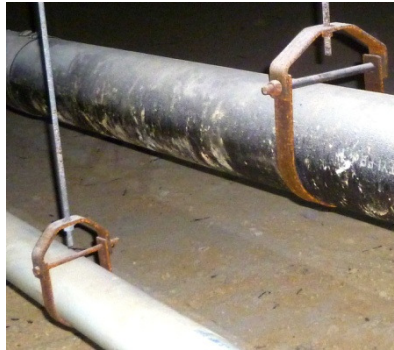
Rusting hanger support

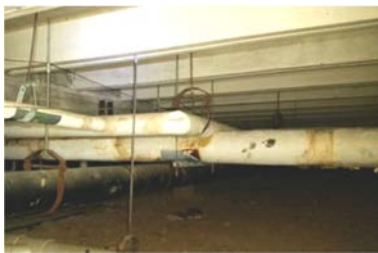
Pipe insulation in poor condition

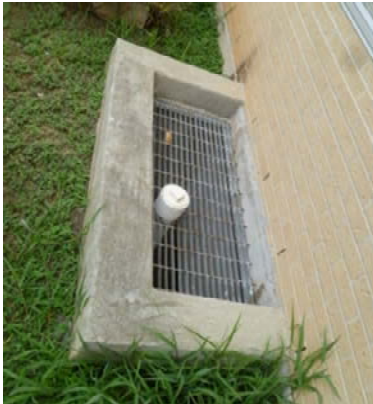
Areaway with grate welded down

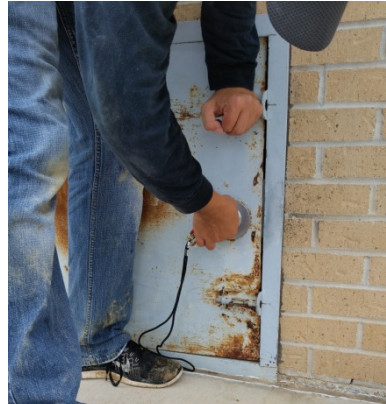
Door bent & could not be opened
