Lee Elementary School Site Summary

Address	3308 Hampton Road Austin, TX 78705
Number of Permanent Campus Facilities	4
Original Year of Construction	BLDG-121A – 1939 BLDG-121C - 1998 BLDG-121B – 1939 BLDG-PS006 - 1939
Total Campus Building Area (combined)	46,328 SF

Main School Building – BLDG-121A

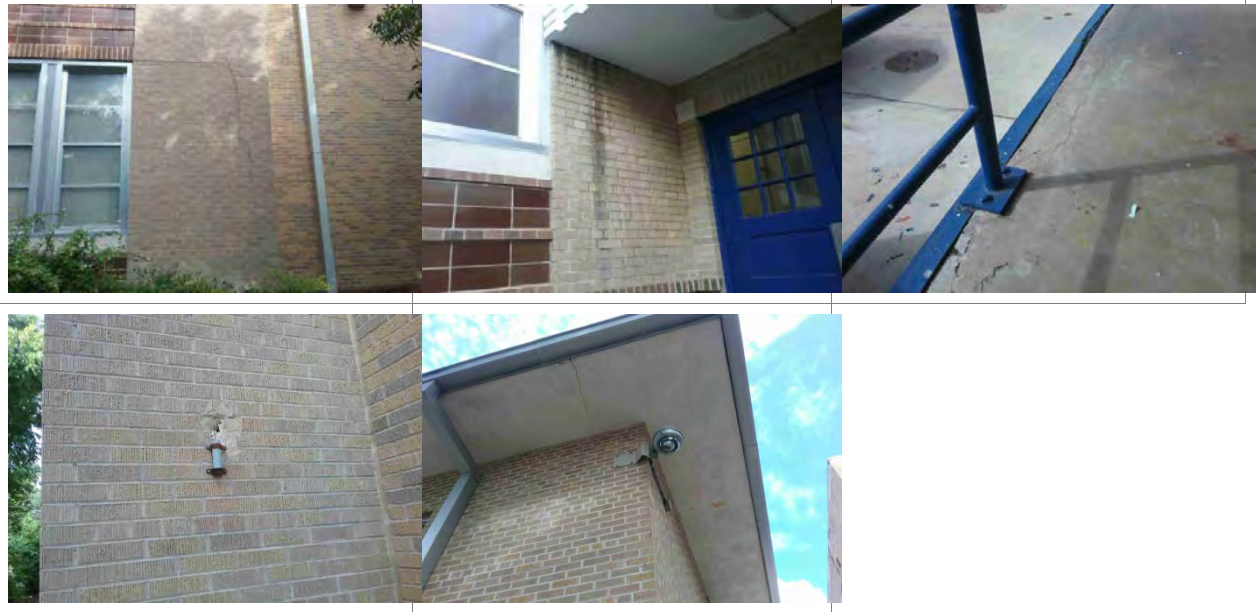
System	Subsystem	Condition and Deficiency Overview	System Condition Rating
Exterior	Exterior Walls	<p>The exterior walls are comprised of brick with stone accent on the original building and tile accents on the addition. The kitchen and cafeteria area includes some painted steel structural elements and a stucco soffit.</p> <p>The exterior walls were observed to be in average condition. Cracking in the brick work that shears through bricks was noted in several locations. The source of cracking could not be determined during the assessment but appeared to be limited to the exterior brick wythe. Cracking at the soffit was noted at the kitchen and cafeteria at regular intervals suggesting that the damage was the result of creep in the supporting structure of the stucco. Water appeared to be entering the joint between the concrete eyebrows and the adjoining brick wall as evidenced by staining on the brick. Minor physical damage was noted where a probe had been mounted on the exterior or where elements previously attached to the brick were removed. The loading dock area was noted has having both cracking in the brick and concrete elements, along with rusting of the edge angle of the dock and the support column base.</p>	Average

1. Investigate cracks at exterior brick and concrete elements for any structural implications.
2. Replace existing soffit material and determine if the support structure requires stiffening.

3. Repair damage to brick.
4. Replace metal elements at loading dock with galvanized elements.
5. Waterproof joint between eyebrows and brick walls.
6. Restore original metal windows.

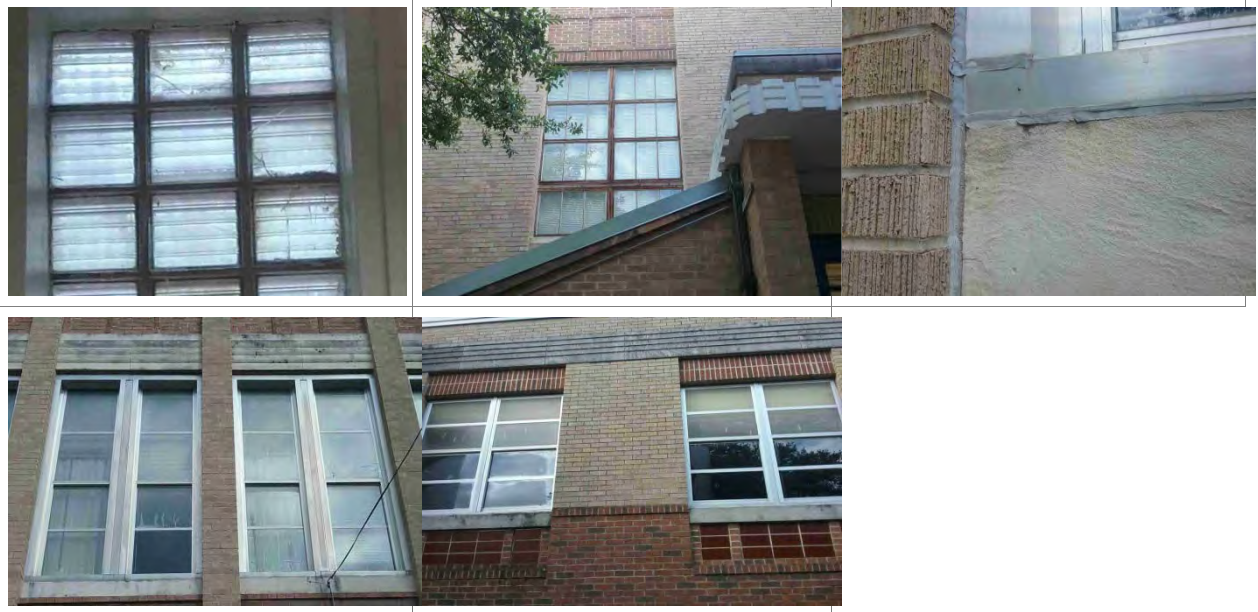
System	Subsystem	Condition and Deficiency Overview	System Condition Rating
	Exterior Windows	<p>The exterior windows are a mixture of fixed, single hung, casement and glass block construction. Window panes are constructed with both acrylic and fiberglass. Some of the window systems appear to be replacements and other are clearly original to the building.</p> <p>The exterior windows were observed to be in average condition. All sealants observed at windows appeared chalky and cracked. Casement and fixed windows original to the building where seen to be rusting. Surface-installed window tinting on the east side of the building was peeling off the windows. From the interior only one unit, in the auditorium, showed evidence of water leakage. From the interior and exterior glass block units were observed to be damaged.</p>	Average
	Exterior Doors	<p>The exterior doors are a mixture of wood doors in wood frames at most entrances and hollow metal doors mounted in hollow metal frames in mechanical spaces.</p> <p>The exterior doors were observed to be in average condition. It was noted in some instances there are collection of finish issues on the wood doors. This was primarily due to physical damage or failure in the paint system resulting in blistering of paint. At the auditorium exterior exit some of the painted wood veneer is missing. At the vestibule for these doors, a security grill has been installed across the opening. The grill is not designed for exiting and could be left padlocked while the building is occupied. This has created a hazard. Termite damage was noted at the exterior exit for the gymnasium.</p>	Average

7. Paint lintels with a rust inhibiting paint system.
8. Replace acrylic and fiberglass window panes with glass glazing.
9. Remove failing tinting film applied to windows. Replace with new tinting or glazing with integral shading.

10. Investigate leaking at window on the north side of the auditorium and repair as required.
11. Remove existing sealants at windows and replace with new.

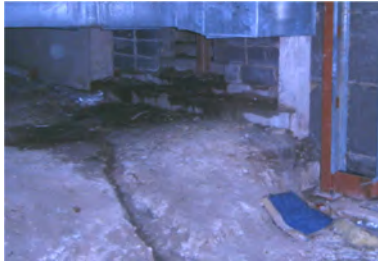
Water infiltration from abandoned staircase

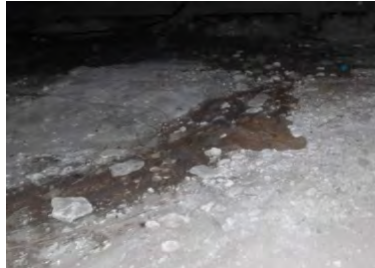
Water infiltration from under east perimeter

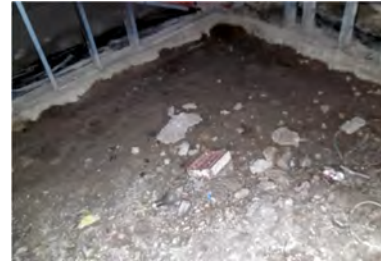
Damp soil around perimeter of northwest crawl space

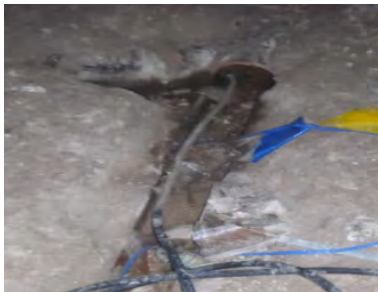
Large pipe in soil may be a drainage pipe, top of pipe is broken open for a length of roughly 10ft

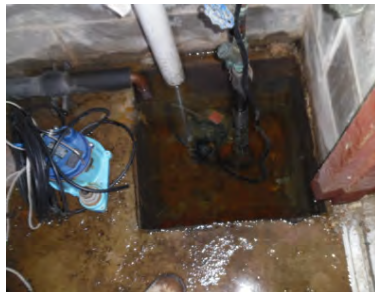
Pit holding water outside northwest access to crawl space, sump turned off

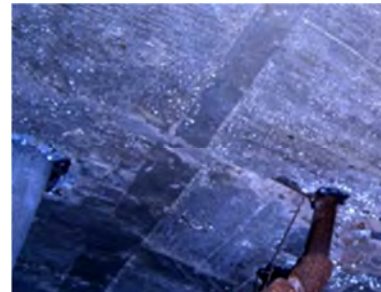
Moisture on underside of slab

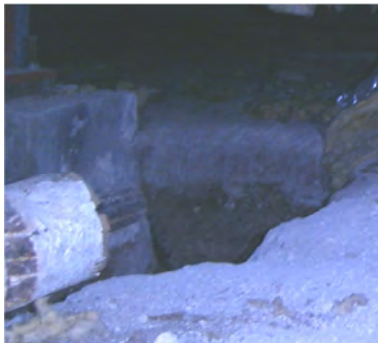
Large pit near interior pier/column

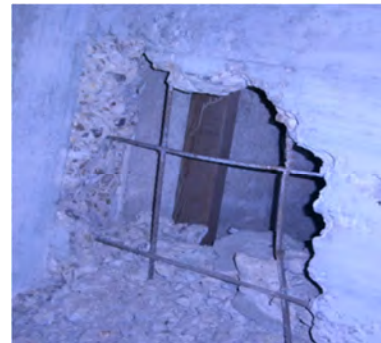
Large hole in wall adjacent to staircase

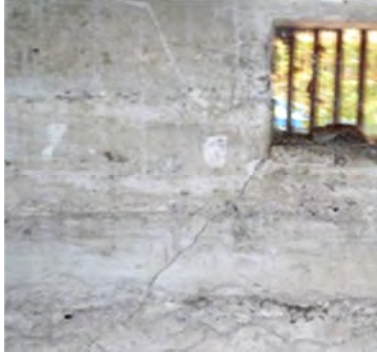
<p>Diagonal crack coming from wall vent</p>

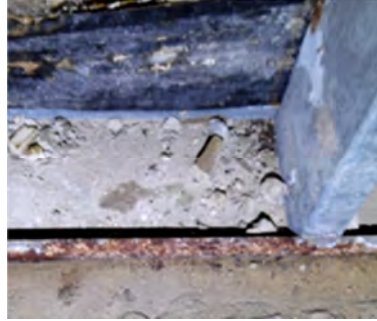
<p>corrosion at bottom of metal stud wall framing</p>

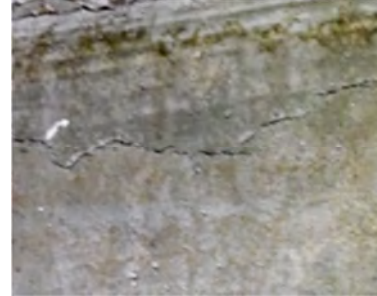
<p>Longitudinal crack in interior suspended beam</p>

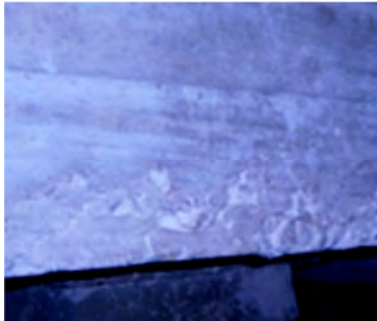
<p>Minor honeycombing in suspended beam</p>

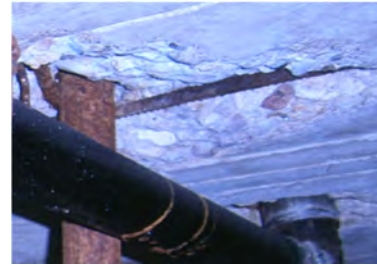
<p>Spalling and exposed/corroded reinforcing at pipe penetration</p>

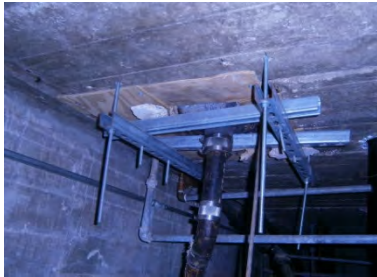
<p>Slab damage/repair covered by plywood</p>

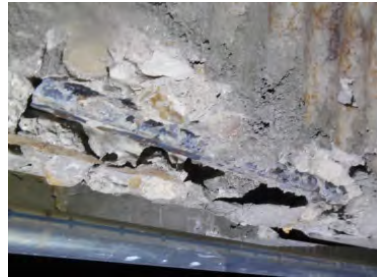
<p>Exposed longitudinal reinf'g in pan joist</p>

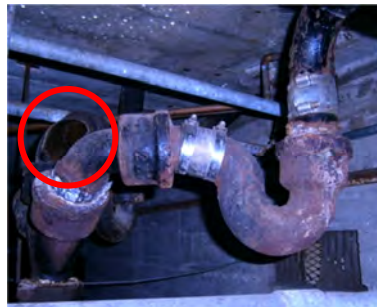
<p>Heavily rusted pipe, top of pipe busted open (circled in red)</p>

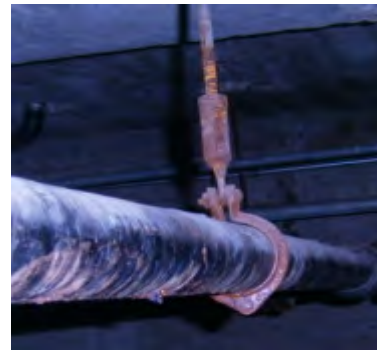
<p>Rusted pipe supports</p>
--	--	---

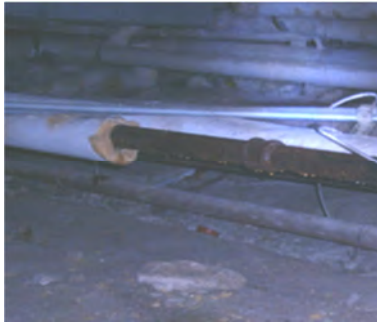
<p>Insulation removed at joint, pipe rusting, and pipe sweating</p>

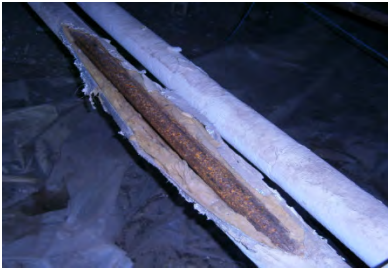
<p>Deteriorating pipe insulation</p>

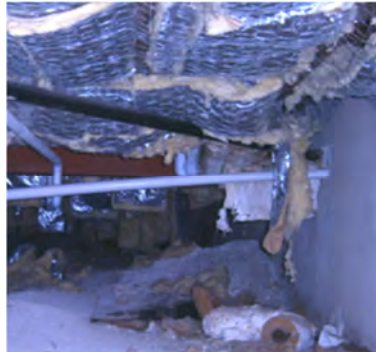
<p>Deteriorated/falling insulation below slab</p>
---	--	---

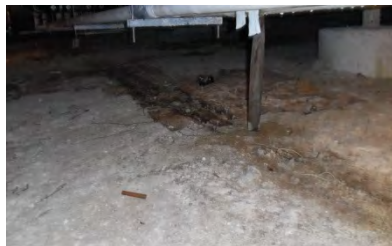
Damp soil under sweating pipes

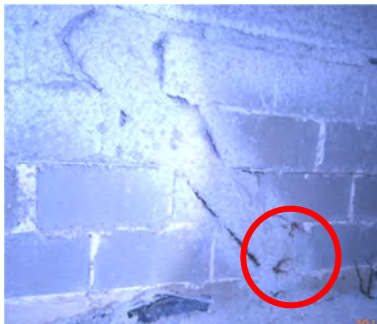
Diagonal brace with corroded base

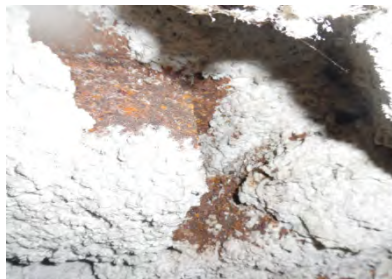
Corrosion at diagonal tube base

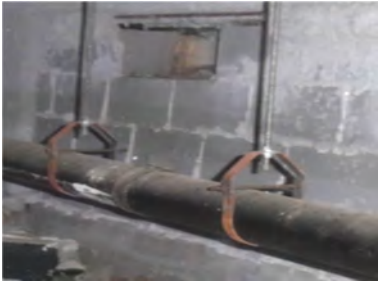
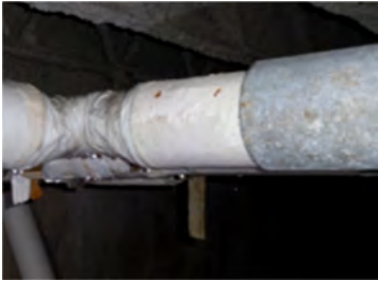
Minor rusting in pipe hangers	Moisture dripping from hanging pipes

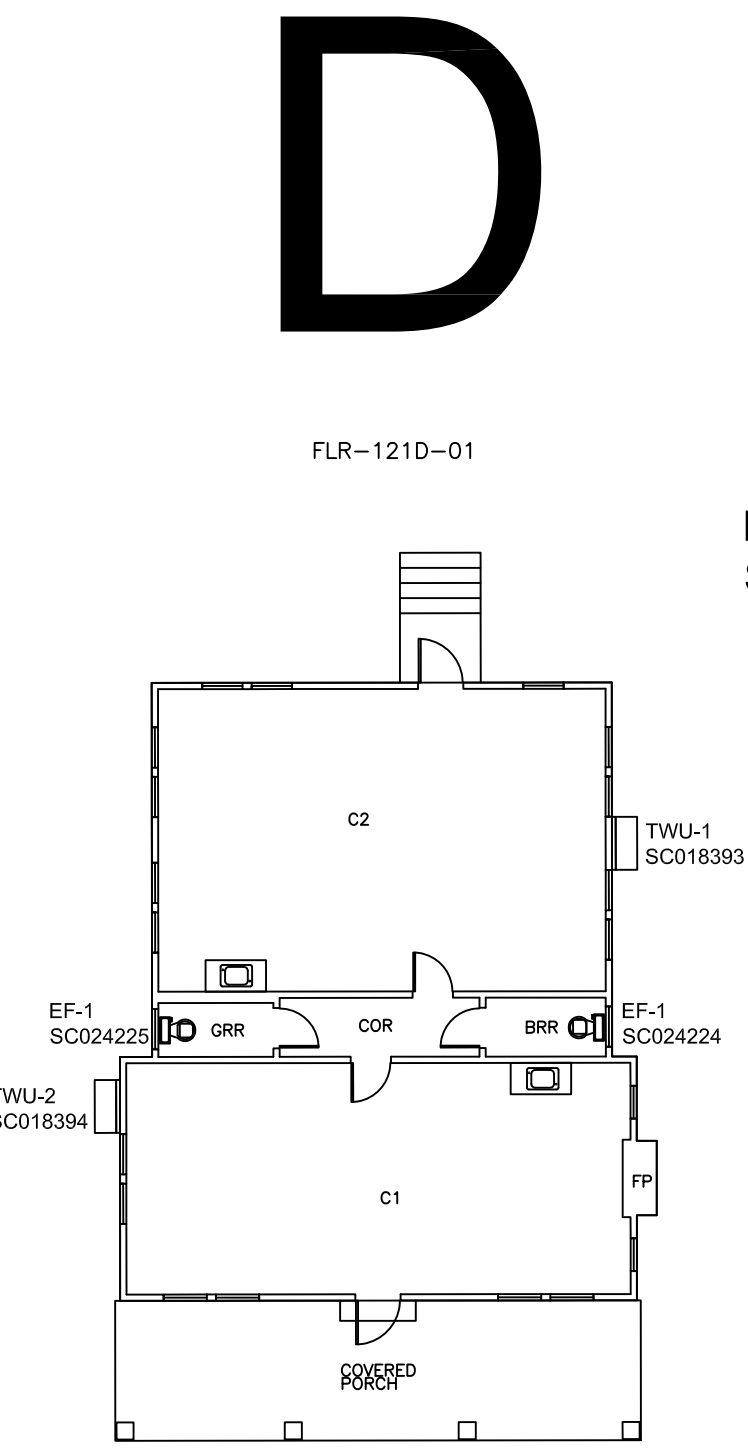
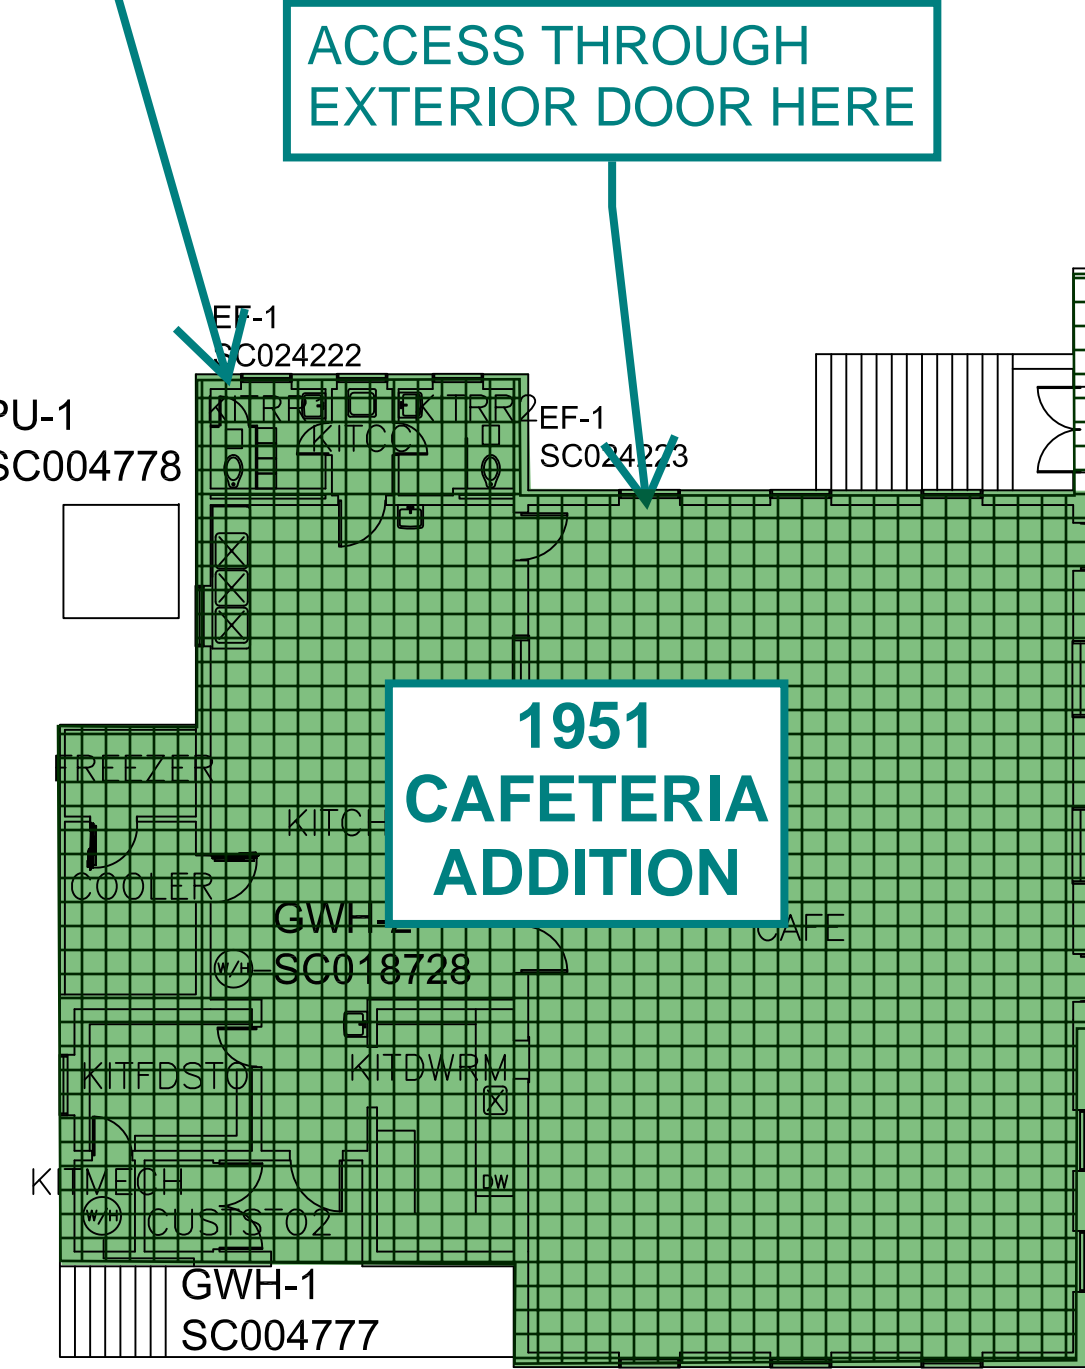
DEFICIENCIES FOUND IN THIS LOCATION:

- 1) DIAGONAL CRACK IN EXTERIOR WALL
- 2) HONEYCOMBING ON INTERIOR BEAMS, SLABS & COLUMNS
- 3) EXPOSED REINFORCING & DAMAGED SLABS AT PIPE PENETRATIONS
- 4) BROKEN PIPE
- 5) RUSTED CAST IRON PIPES AND PIPE HANGERS
- 6) CONDENSATION ON UNDERSIDE OF SLAB
