Linder Elementary School Site Summary

Address	2800 Metcalf Road Austin, TX 78741
Number of Permanent Campus Facilities	2
Original Year of Construction	1972
Total Campus Building Area (combined)	69,544 SF

CRAWL SPACE – Linder ES – Main School Building (BLDG-160A)

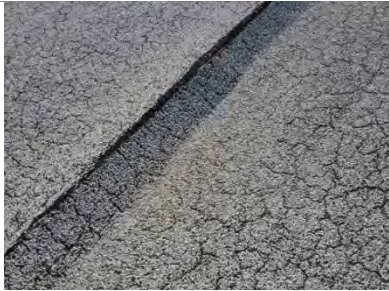
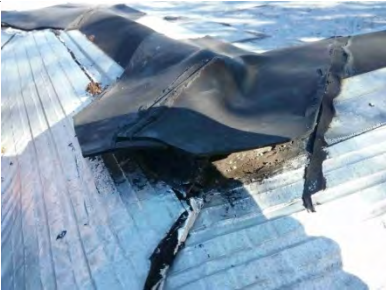
Roofing Deficiency Examples

System	Subsystem	Condition and Deficiency Overview	System Condition Rating
		<p>type.</p> <p>Roof A-07 was observed to be in poor condition. It was bubbling, cracking, and showing signs of ponding. The rubber coverings at the corners were coming loose. The other roofs were observed to be in average condition.</p>	
Interior Construction	Interior Walls	<p>The interior walls are gypsum board in the classrooms, administration area, and lobby. There is CMU (concrete masonry units) in the gymnasium and cafeteria areas. The corridors are gypsum board at the top and plastic laminate from the floor up to six feet.</p> <p>The walls appeared to be in good condition. There were some areas where the gypsum board had been scraped down to the metal edging.</p>	Good
	Interior Doors	<p>The interior doors are wood veneer with a lite in metal frames or solid wood doors without side lites.</p> <p>The interior doors appeared to be in good condition. The paint at door window frames and astragals was chipped, and some doors were worn and needed refinishing. The door to the male restroom in room 307 did not close and was gouging the VCT (vinyl composition tile) floor.</p>	Good

1. Investigate reroofing A-07 in the next few years to eliminate bubbling and cracking. Repair or replace adjacent corners at the same time.

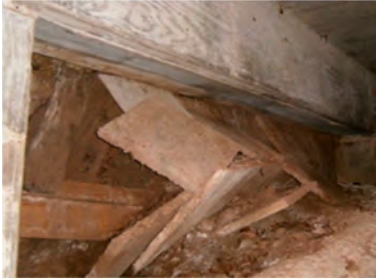
<p>Large pool in channel in crawl space</p>	  <p>Manmade channels cut into crawl space soils</p>	  <p>Abandoned drainage system in original building</p>
  <p>Water standing in bottom of clogged drain</p>	  <p>Mold on soil in north addition</p>	  <p>Wood retaining wall in place of soil retainers</p>

1. Investigate need for adequacy of drainage system, add drains as needed.
2. Re-grade manmade channels and surrounding soils so that water flows to sump.
3. Slope sides of manmade channels in accordance with OSHA requirements.
4. Investigate need to re-grade site so surface water flows away from building (instead of into crawl space).
5. Improve ventilation.

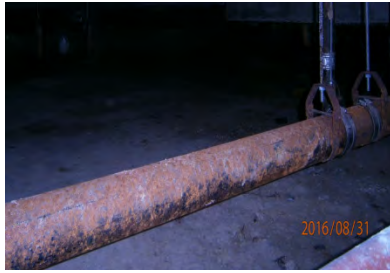
Rusting on pipe and pipe hangers

3. Clean mildly rusted pipes and paint to prevent further corrosion.
4. Repair or replace significantly rusted cast iron pipes and metal hangers.
5. Repair leaking HVAC.
6. Remove collapsed and saturated insulation and replace with new insulation.

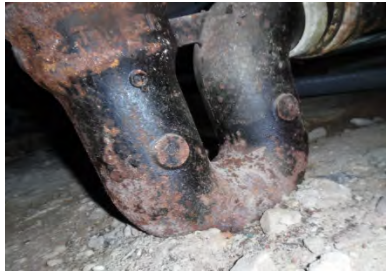
Pipe bend touching soil and rusting

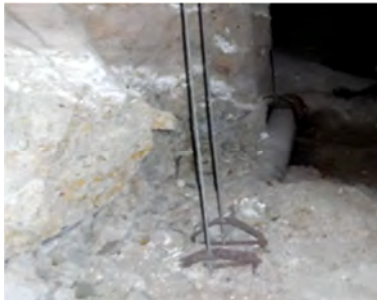
Suspended pipe is burried under soil in channel

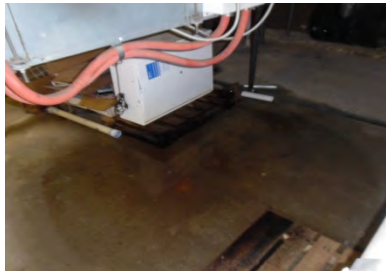
Pool of water under HVAC

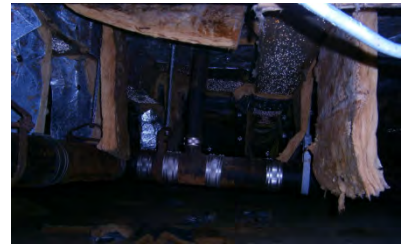
Saturated and collapsing insulation

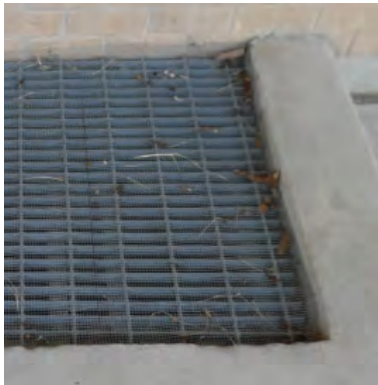
Areaway welded shut

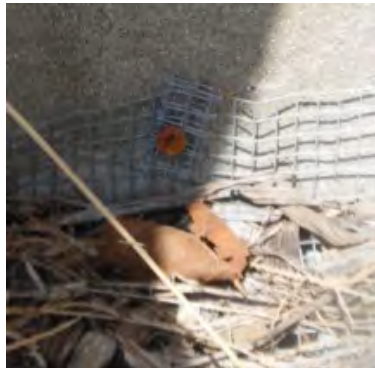
Areaway screwed shut

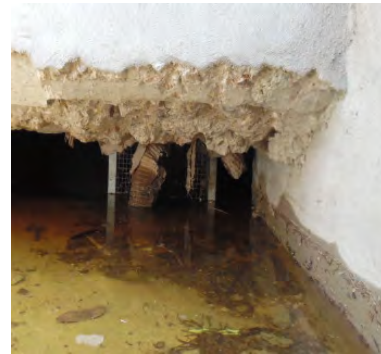
Standing water in areaway

1. Install drainage system in crawl space to prevent standing water.
2. Investigate need to re-grade site so surface water flows away from building (instead of into crawl space).
3. Investigate adequacy of ventilation.

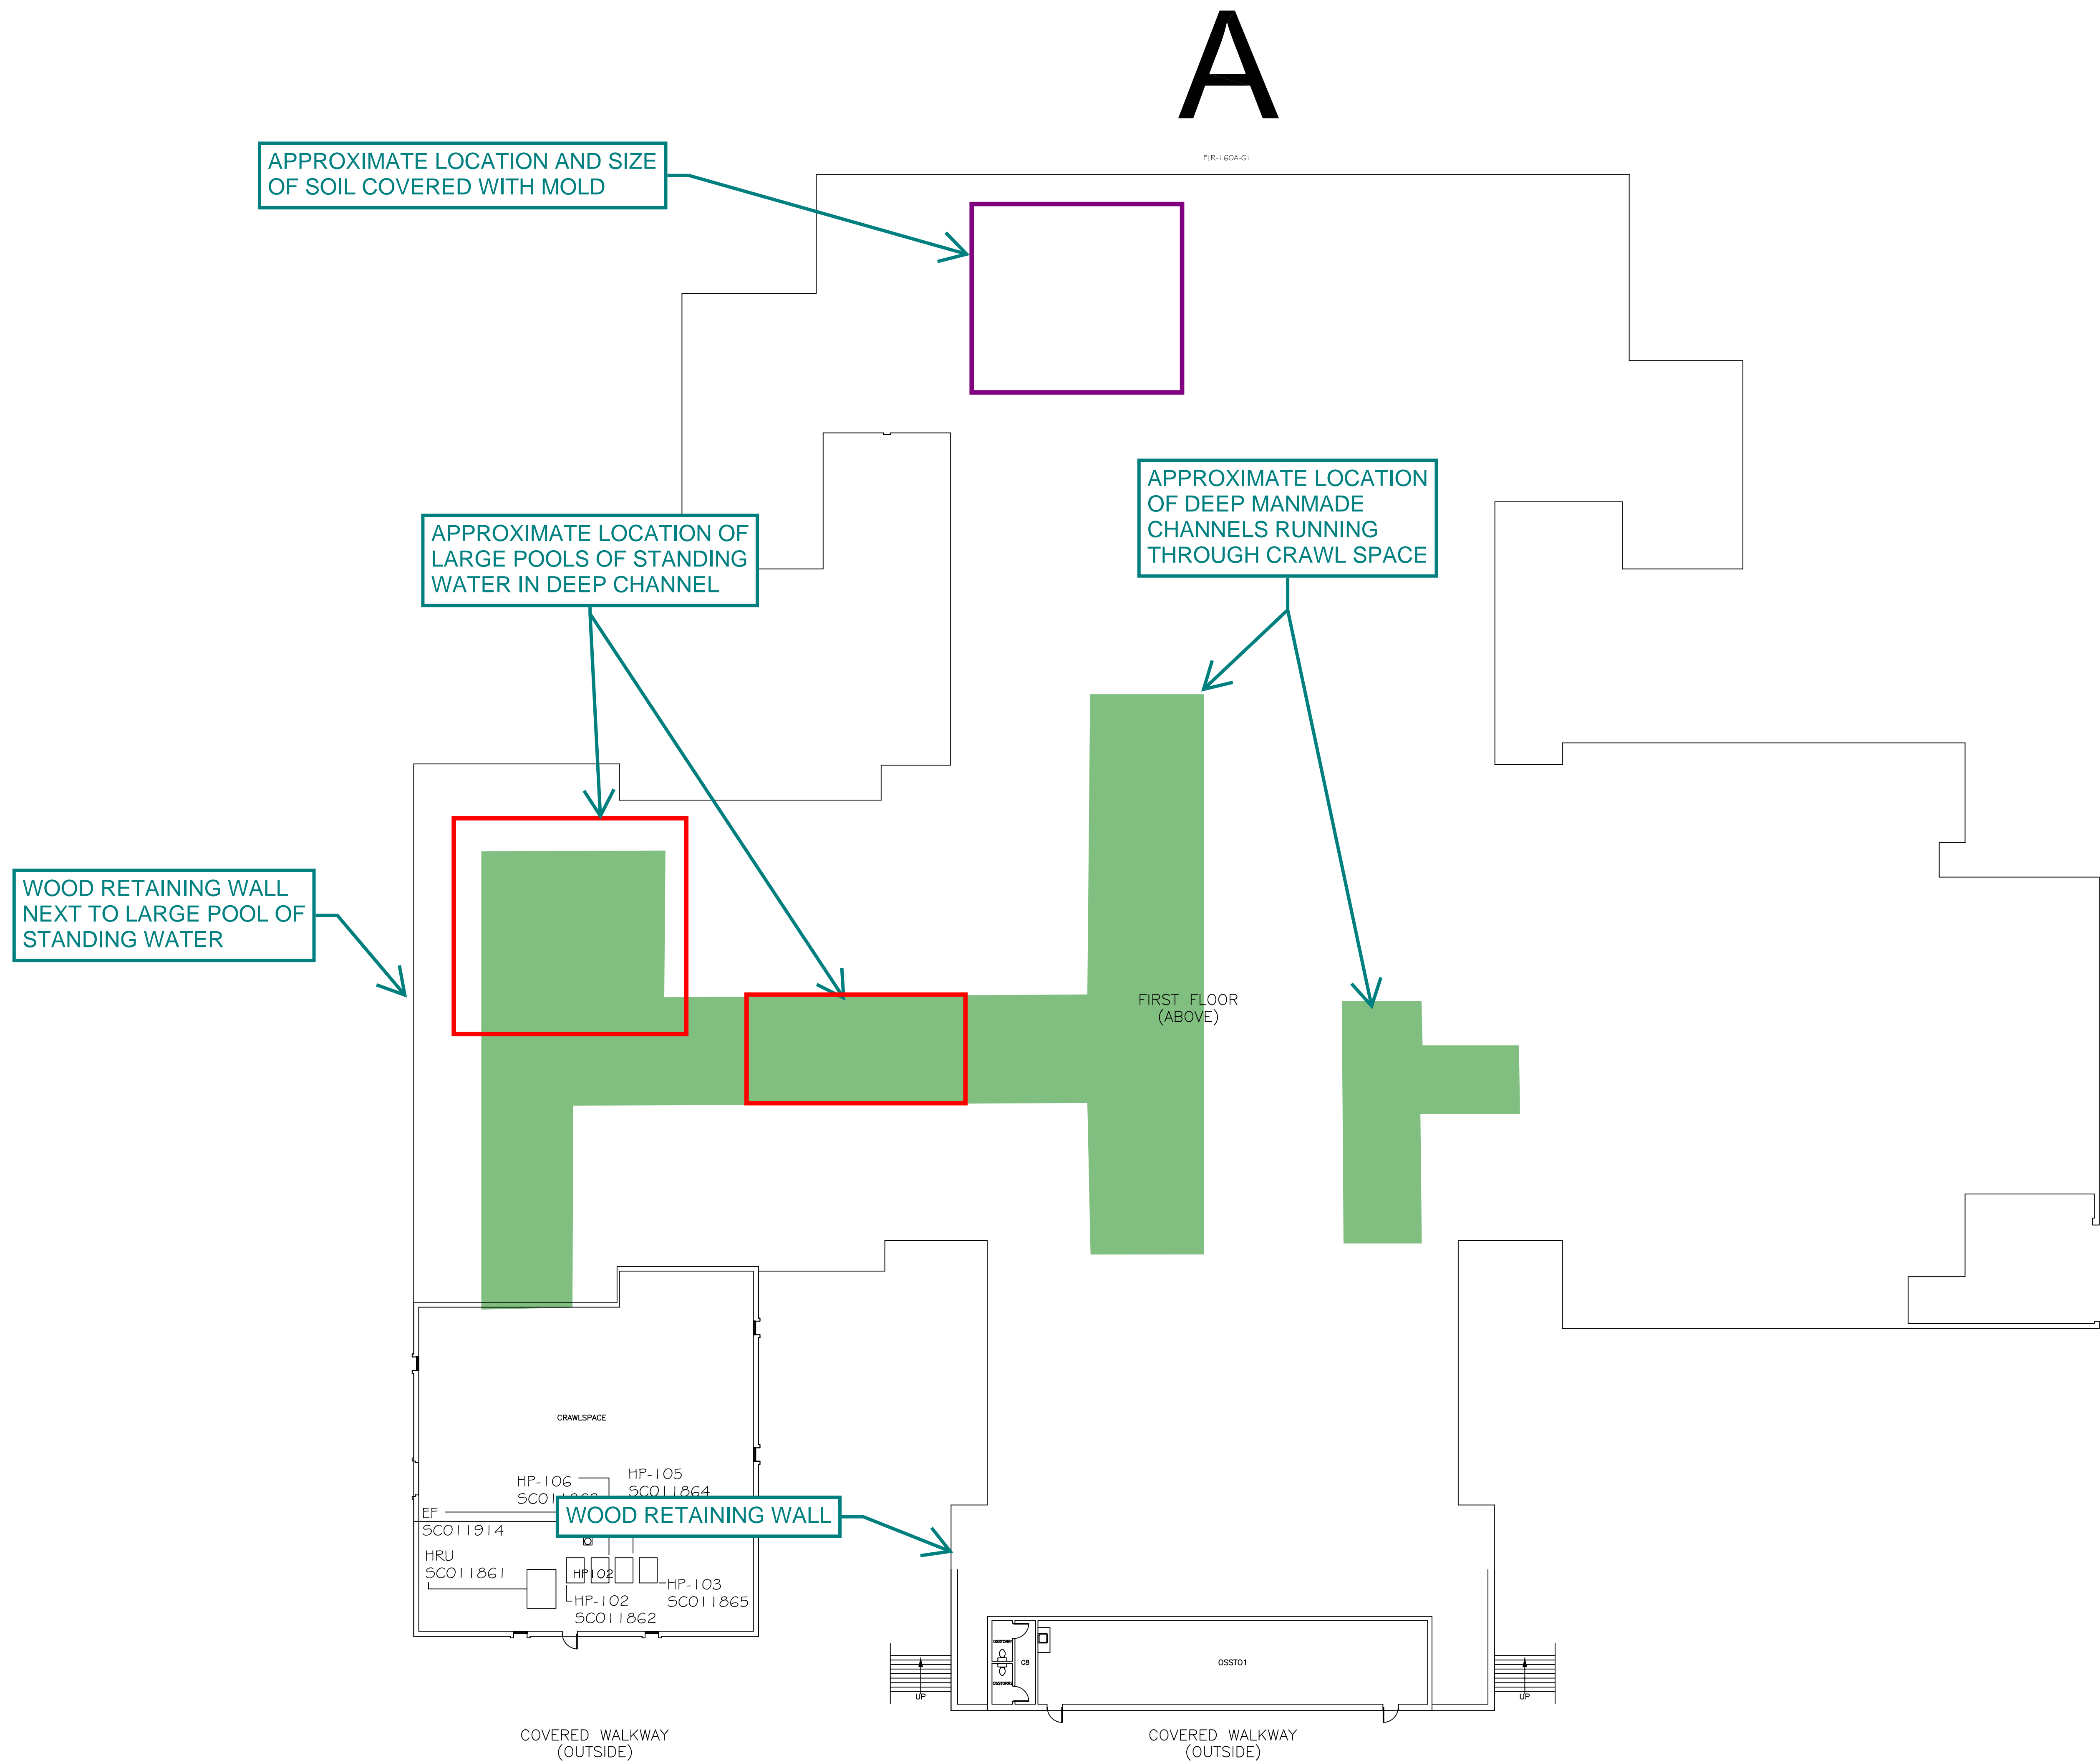
FLR-160A-01

- 1) EXPOSED/CORRODED REINFORCING AT ACCESS HATCH
- 2) RUSTED CAST IRON PIPES
- 3) CONCRETE MUSHROOMING AT TOP OF PIERS
- 4) STANDING WATER IN DRAINAGE GRATES
- 5) CONDENSATION ON PIPES AND UNDERSIDES OF THE SUSPENDED BEAMS
- 6) MOLD ON SOIL UNDER NORTH MOST CLASSROOMS
- 7) CRACKED, DAMAGED, FAILED SOIL RETAINERS
- 8) MINOR HONEYCOMBING IN INTERIOR BEAMS
- 9) FALLEN/DETERIORATING INSULATION

- 1) ACCESS WAS SEVERELY LIMITED DUE TO SHALLOW CRAWL SPACE (CRAWL SPACE WAS APPROXIMATELY 12" TALL)
- 2) RUSTING IN CAST IRON PIPES & METAL HANGERS
- 3) DOWNTURN OF SUSPENDED PIPE RESTING ON GRADE
- 4) HONEYCOMBING IN COLUMN

- 1) LARGE POOL OF WATER IN NORTH MOST AREA OF THIS SECTION OF INSPECTED CRAWLSPACE
- 2) WATER STANDING IN CRAWL SPACE DRAINS
- 3) SATURATED/ROTTING WOODEN RETAINING WALL
- 4) BROKEN/COLLAPSED CONCRETE SOIL RETAINERS
- 5) LONG UNBRACED PIER LENGTHS EXPOSED ADJACENT TO DEEP MANMADE CHANNELS
- 6) MUSHROOMING CONCRETE AT TOP OF PIERS
- 7) HONEYCOMBING IN BOTTOM OF COLUMN NEAR ACCESS DOOR
- 8) LIMITED CHIPPING/SPALLING AT INVERTED TEE BEAMS
- 9) WOOD FORMWORK CAST INTO A CONCRETE BEAM OVER ACCESS DOOR
- 10) SPALLED CONCRETE AT DOUBLE TEE PANEL FLANGE CONNECTORS

- 1) LARGE POOL OF STANDING WATER IN THE WEST CHANNEL
- 2) BROKEN SOIL RETAINERS ON THE EAST AND WEST EXTERIOR WALLS
- 3) MULTIPLE SOIL RETAINERS ON THE VERGE OF CAVING
- 4) WOOD RETAINING WALL DAMP AND SHOWED SIGNS OF ROT
- 5) MUSHROOMING IN TOPS OF PIERS
- 6) LONG UNBRACED LENGTHS OF PIERS EXPOSED ADJACENT TO MANMADE CHANNELS
- 7) WOOD SHORING SUPPORTING BEAMS INEAR RETROFITTED COLUMNS
- 8) HEAVILY RUSTED PIPES, HANGERS AND EQUIPMENT
- 9) AIR GAP ON EQUIPMENT DRAIN PIPES
