Lucy Read Pre-K School Site Summary

Address	2608 Rich Creek Austin, TX 78757
Number of Permanent Campus Facilities	2
Original Year of Construction	1961
Total Campus Building Area (combined)	37,232 SF

Main School Building – BLDG-131A

Stand-Alone Gymnasium – BLDG-131B

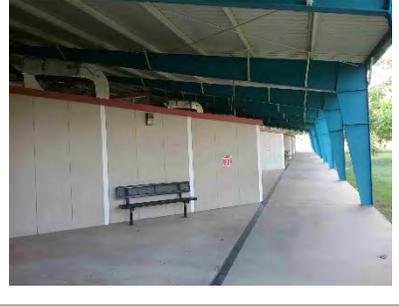
System	Subsystem	Condition and Deficiency Overview	System Condition Rating
Exterior	Exterior Walls	<p>The 100-wing and 200-wing classroom exterior walls have an exposed steel structure with painted cement-stucco panels. There is an upper secondary rigid-frame metal roof structure with exposed columns covering the classroom wings that provides shade and some weather protection to the classroom buildings below. The cafeteria, kitchen, administration, and library walls are metal framed with cement-stucco finish.</p> <p>The exterior building stucco walls were observed to be in average condition. Some portions of the exterior walls were reported to have been repaired or rebuilt due to problems with leaks. There were no cracks observed, nor was organic growth visible that would suggest a moisture problem at this time. The exterior rigid-frame structure had many surfaces where nesting birds were observed. The exposed steel structure on both the upper roof and the main building walls had begun to oxidize and there was peeling paint observed on the metal structure and on downspouts in a few areas. The conditions that support nesting birds are likely to promote pests and an unhealthy environment. Noxious odor was evident along the open-air walkways.</p>	Average

1. Further study alternatives to prevent roosting of birds and an environment that supports habitation for rodents and pests. Consider extending exterior walls or screening to create an enclosed space with proper ventilation for mechanical equipment.

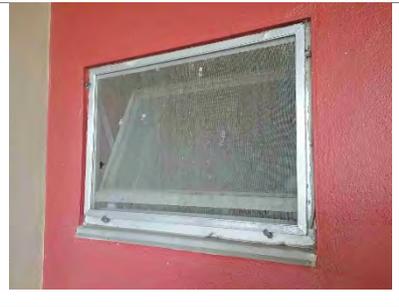
System	Subsystem	Condition and Deficiency Overview	System Condition Rating
	Exterior Windows	<p>The exterior windows are metal frame with single-pane glazing. The exterior windows at the restrooms have an operable sash. There are newer fixed metal-framed windows in the library.</p> <p>The exterior windows in restrooms were reportedly no longer operational. The classroom restrooms (where most exterior windows are located) did not have mechanical ventilation. The windows, therefore, provided that function, although not effectively. With a properly functioning exhaust system, the windows are not required to be operable. The sealant around the window frames was visibly aged and dry.</p>	Average
	Exterior Doors	<p>The exterior doors are steel with hollow metal frames. The main entry doors have side-lites and vision panels. There are no interior corridors in the classroom wings; therefore, classrooms are accessed from the exterior covered walkway. In addition to individual entry doors, classrooms have two 6-foot-wide metal, horizontal sliding, and commercial-grade patio doors. There are two metal sliding/folding gates that provide security to the courtyard between the classroom wings and the Stand-Alone Gymnasium.</p> <p>The exterior steel doors and frames were observed to be in average condition. The exterior sliding patio doors were not operational. Many patio doors had furniture blocking access or objects mounted across them. Door hardware was aged, worn, and appeared to be in poor condition. The folding gates were difficult to operate, and the lockset was marginally functional.</p>	Average

1. Replace aged sealants at exterior wall joints and around windows.
2. Paint exterior metal surfaces that have peeling or deteriorated finishes.
3. Further study whether the exterior windows in restrooms are required to provide ventilation per code. If required, repair or replace exterior windows.
4. Replace exterior door hardware to ensure proper operation and building security.

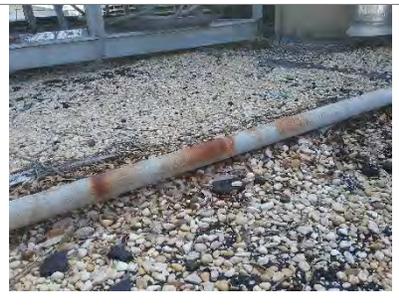
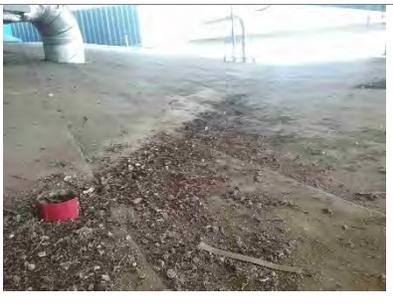
Roofing Deficiency Examples

Roofing	<p>The main building roof is mostly covered with a modified bitumen membrane. There is a small area of built-up roof over the kitchen. The 100- and 200-wing classrooms have an additional rigid-frame metal roof structure, approximately 4 feet above the primary building roof that provides weather protection to the roof below. The upper roof creates a covered walkway for access to individual classrooms. Mechanical equipment is located within this interstitial space. The library, administration areas, and cafeteria are not covered by the upper roof structure. There are metal gutters and downspouts along the upper roof edge and along some edges of the lower roof.</p> <p>The main building roof was not accessible and was viewed by the assessor from a ladder at a single point along the lower roof's edge. The modified bitumen roof above the cafeteria appeared to be in good condition. The built-up roof at the kitchen appeared to be aged with cracks and fibers exposed. The modified bitumen roof above both classroom wings were likely aged beyond their service lives. The metal upper roof was likely original to the building construction. The</p>		Average

System	Subsystem	Condition and Deficiency Overview	System Condition Rating
		upper roofs condition could not be determined. There were birds roosting in the interstitial space between the roofs creating an offensive odor and an unhealthy condition. Rodents were reported to inhabit this space. The gutters and downspouts were observed to be in good condition.	
Interior Construction	Interior Walls	The interior walls are metal framed with gypsum board panels. There are both wood and metal-framed interior windows with single-pane glazing. The interior windows at administration have a metal-framed jalousie window insert. The interior walls were observed to be in average condition. Some wear and scuffing were visible.	Average
	Interior Doors	The interior doors are solid core wood with both wood and metal frames. The doors from the cafeteria to the kitchen have been replaced and have aluminum commercial-grade frames. The interior door hardware was aged and difficult to operate. The interior doors, frames, and hardware were observed to be in average condition. Doors had visible scuffs, chips, and peeling veneer.	Average

1. Determine the source of roof or mechanical equipment leaks in corridor C1, and repair.
2. Replace the built-up roof area over the kitchen within the next five years.

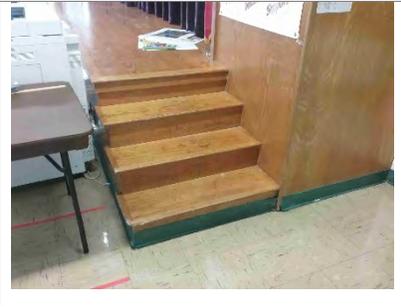
Interior Specialties	System not present.	N/A
Stairs	Exterior Stairs	System not present.	N/A
	Interior Stairs	There are wood steps that provide access to the stage in the cafeteria. The interior wood steps were observed to be in average condition with some visible wear and deteriorated finish.	Average
Interior Finishes	Interior Wall Finishes	The predominant interior wall finish is painted gypsum board with accent walls of wood paneling and brick. The kitchen walls and all restrooms walls have ceramic tile surfaces. The interior wall finishes were visibly scuffed and had surface damage common to their age. The interior walls were observed to be in average condition.	Average
	Interior Floor Finishes	The interior floors are predominantly vinyl tile with a 4-inch base throughout the building. Carpet is found in administration and the library. Classroom, restrooms, and common restrooms have ceramic tile floors. The flooring in the kitchen is quarry tile. The vinyl tile flooring appeared to be in poor condition with general wear and tear. The vinyl flooring in the 200-wing had small blisters and discoloration, evidence of slab moisture problems. The vinyl tile in the cafeteria was covered with tiny indents, presumably from chair legs, which made cleaning the floor difficult. The carpet	Poor

1. Refinish the wood stage's flooring and steps.
2. Replace aged and damaged vinyl flooring throughout the main building.
3. Regrout or replace ceramic tile floors in restrooms throughout the main building.
4. Replace damaged ceiling tiles in corridor C1 once the cause of the leak is identified and repaired.

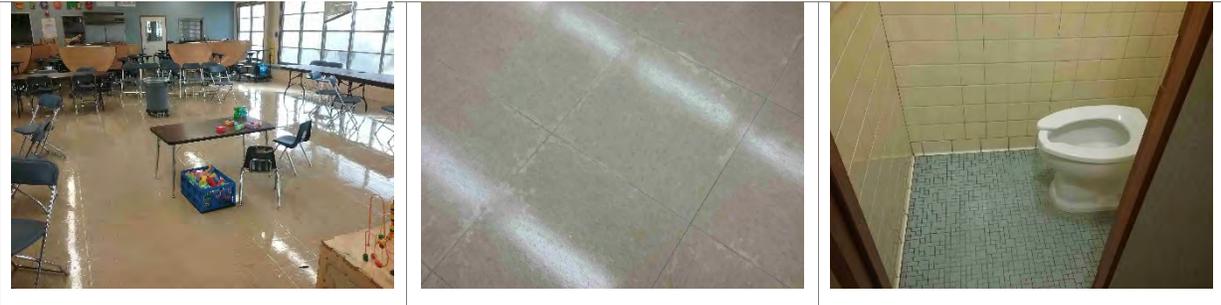
Interior Floor Finishes

System	Subsystem	Condition and Deficiency Overview	System Condition Rating
		<p>in the library appeared to be relatively new. The carpet in administration appeared to be in average condition. The ceramic tile and vinyl flooring throughout the building was at the end of its service life. The wood stage floor was visibly scratched, and the finish was deteriorated.</p>	
	Interior Ceiling Finishes	<p>The interior ceilings are the exposed underside of the building's structure and cement-fiber roof deck. The administration spaces and main corridor have a suspended acoustical tile ceiling. Restroom ceilings have gypsum board surfaces. The kitchen has a lay-in ceiling with a non-porous washable finish.</p> <p>The exposed structure and deck were observed to be in good condition. There were numerous stained ceiling tiles from roof leaks or mechanical equipment in corridor C1. The interior ceilings were observed to be in average condition.</p>	Average

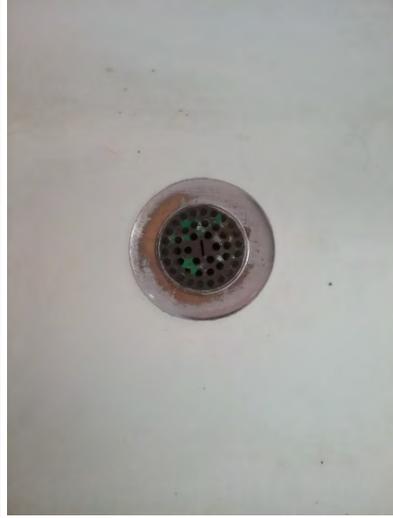
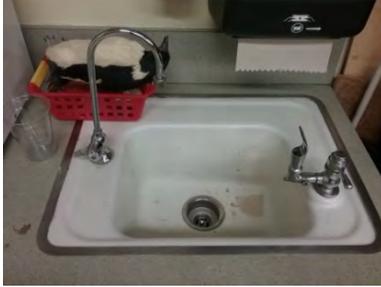
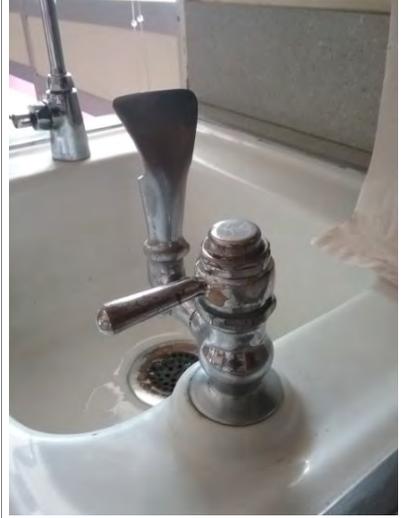
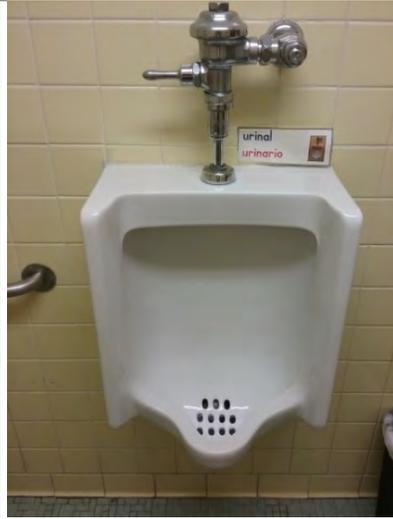
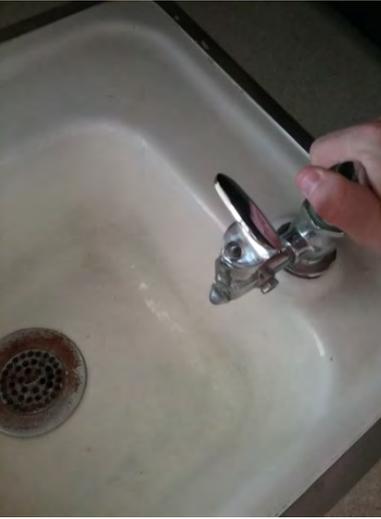
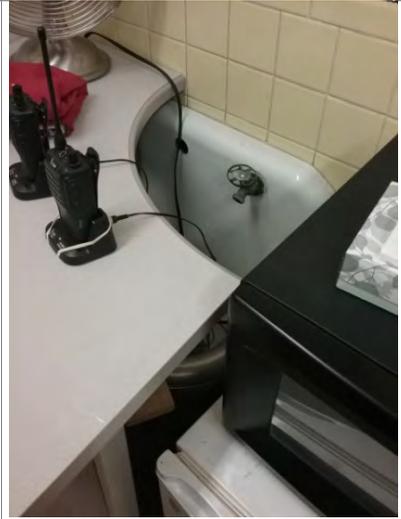
Conveying	System not present.		N/A
Plumbing	Plumbing Fixtures	<p>The building has public male and female restrooms for students between each classroom located throughout the facility and separate staff restrooms located near the cafeteria. These restrooms typically have vitreous china hand sinks with manual faucets, along with vitreous china floor-mount toilets with manual flushing mechanisms, and vitreous china wall-hung urinals in the male restrooms with manual flushing mechanisms. There are no service sinks in the janitorial closets. Water coolers are located in the corridors. There are no staff restrooms in the kitchen.</p> <p>Rust and corrosion were noticed on select fixtures, primarily classroom sinks and bubblers. Select water coolers did not appear to be cooling at the time of the assessment. Building staff reported that the water fountain lines would clog and water did not flow. This was observed at several fountains at the time of assessment. The trough-style fixture in the cafeteria had a hose bib as a faucet. Building staff reported that RR321 clogged frequently. Building staff requested hose bibs at the front of the facility.</p> <p>The restroom plumbing fixtures were observed to be in poor condition, primarily due to the age of the fixtures and the deficiencies mentioned above.</p>	Poor

1. Replace fixtures where corrosion or rust exists.
2. Replace water coolers that are not cooling properly.
3. Invest and correct reported clogged water fountain lines.

4. Replace the faucet on the trough-style fixture in the cafeteria.
5. Address reported clogging of RR321.
6. Consider staff's request to install hose bibs at the front of the building.

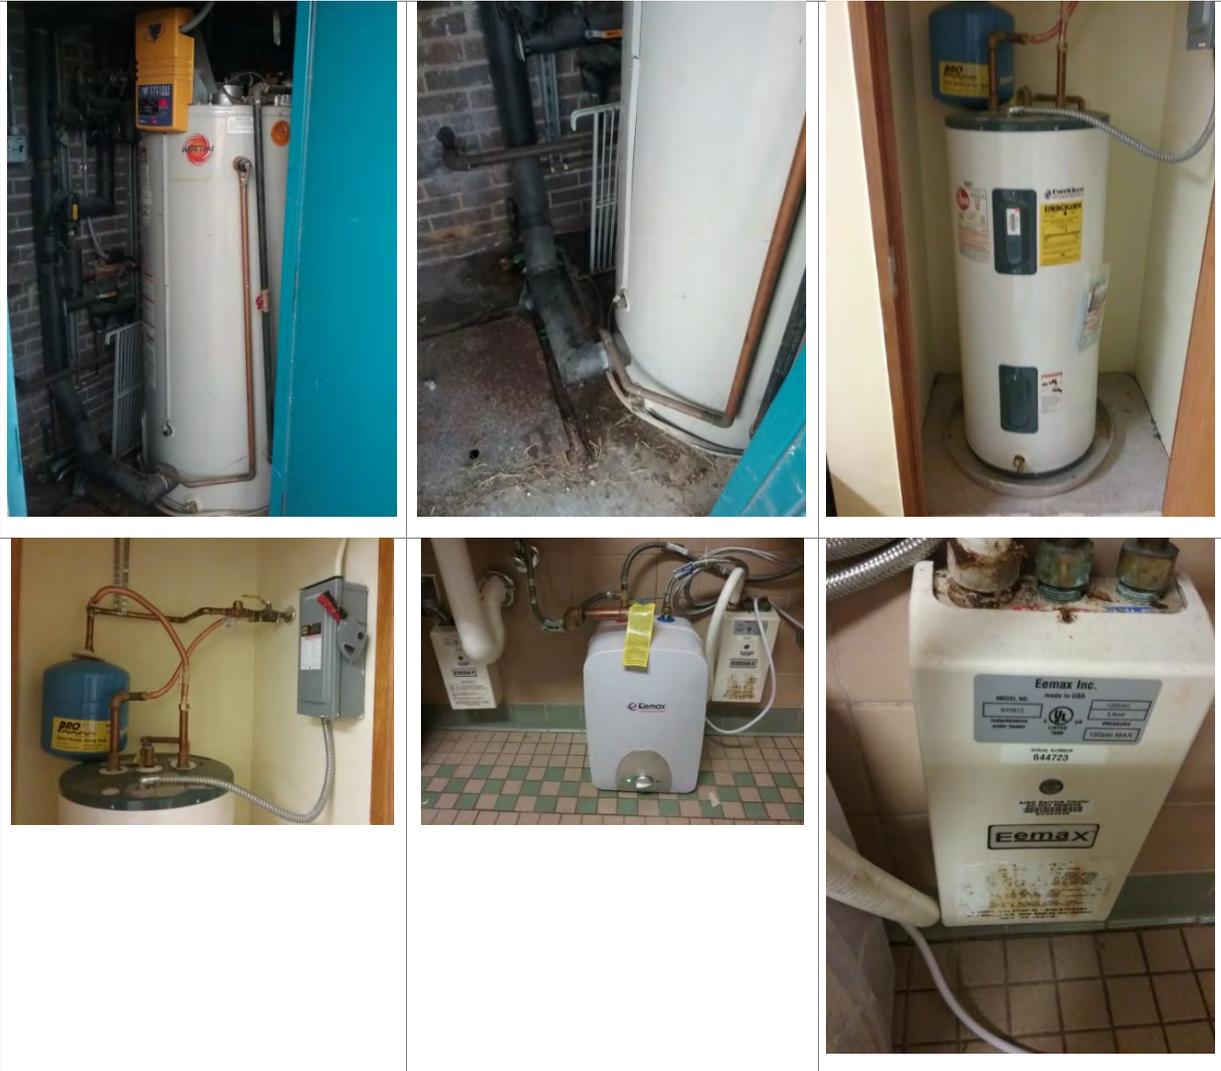
Domestic Water Distribution	The sinks located throughout the facility are not equipped with hot water with the exception of the	Poor

System	Subsystem	Condition and Deficiency Overview	System Condition Rating
		<p>kitchen, nurse's office, and staff restrooms. The primary hot water service for the building is provided by GWH (gas water heater)-1 located in the kitchen mechanical room. The hot water in the nurse's office is provided by EWH (electric water heater)-1. The hot water in the staff restrooms is provided by two small infrared water heaters, both labeled IFEWH-1.</p> <p>Rust and corrosion were observed at the piping connections to the water heaters. Building staff requested hot water service to the teacher's workroom sink.</p> <p>The water heaters serving the building were observed to be in poor condition. They appeared aged and past their service life. The piping insulation associated with EWH-1 was missing.</p> <p>The plumbing distribution equipment serving the facility appeared to be in poor condition, primarily due to the age of the equipment.</p>

7. [Install a janitorial mop sink \(requested by AISD Construction Management\).](#)
8. Track the installation year of the water heater and plan for replacement as the typical design service life for a water heater is 10 to 15 years.

9. Insulate the piping associated with the water heaters.
10. Clear partially blocked floor drains.
11. Replace floor drain covers where rust and corrosion exists.

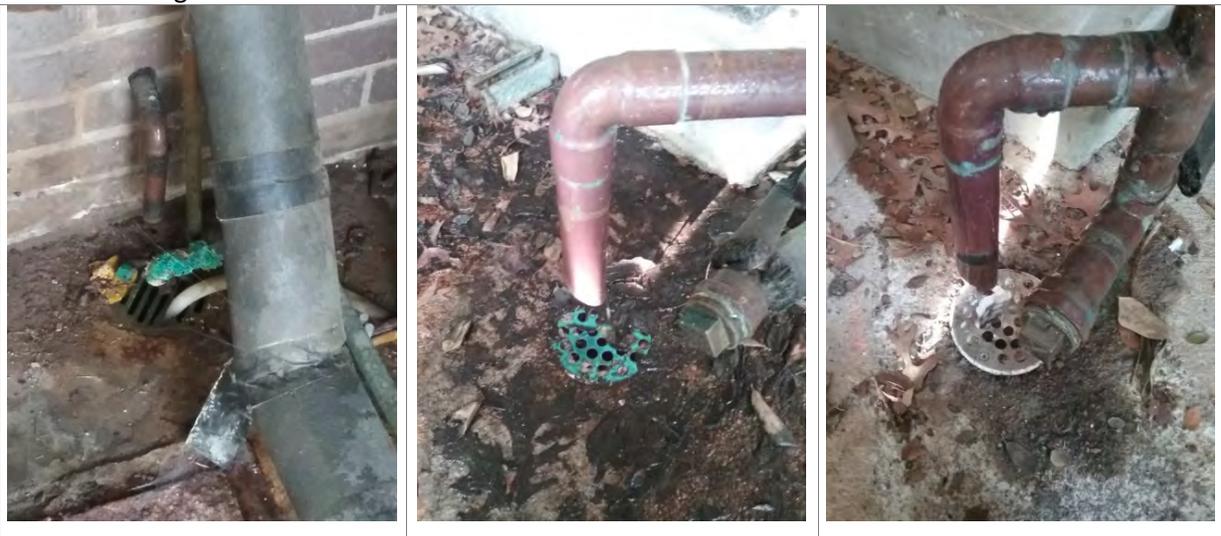
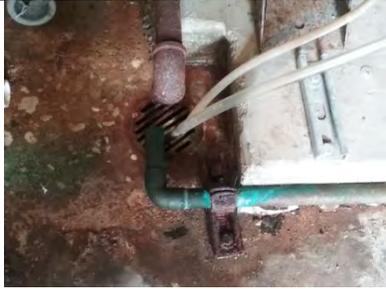
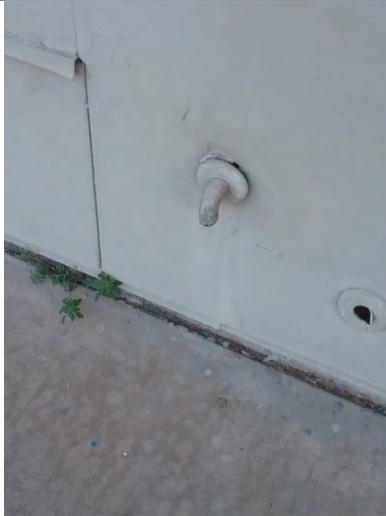
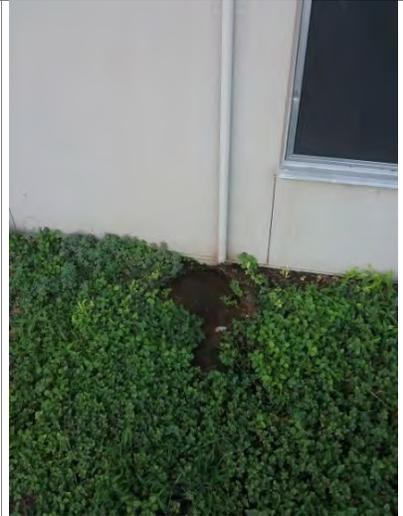
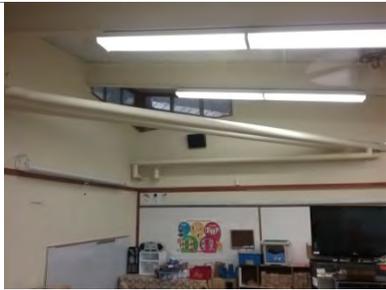
Other Plumbing	<p>The roof is equipped with gutters and downspouts (see Roofing for condition). The roof is not equipped with roof drains.</p> <p>The floor drains associated with the AHUs (air handling units) located on the northern side of the 200-wing were partially blocked, rusted and corroded in some areas. Condensate drain piping near the floor drains was corroded in several areas. Several condensate drains were observed to terminate through the exterior wall onto walkways and grassy areas, creating ponding issues. Piping was observed to penetrate through the classroom ceilings in many classrooms. The plumbing system was equipped with a backflow preventer. Building staff reported grease trap odors outside of RR321 and room 324.</p> <p>The plumbing equipment serving the facility appeared to be in poor condition, primarily due to the age of the equipment and the deficiencies mentioned above.</p>	Poor

12. Replace corroded condensate drain piping.
13. Reroute the condensate drain piping to eliminate discharge onto walkways or grassy areas and avoid ponding.

14. Consider rerouting plumbing so that it does not penetrate through classroom walls and is not visible to classroom occupants.
15. Investigate and correct grease trap odors occurring outside of RR321 and room 324.

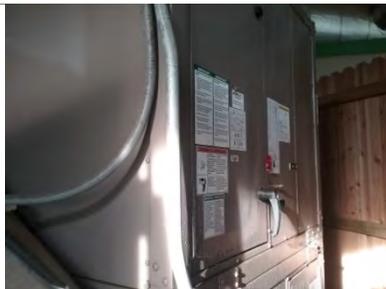
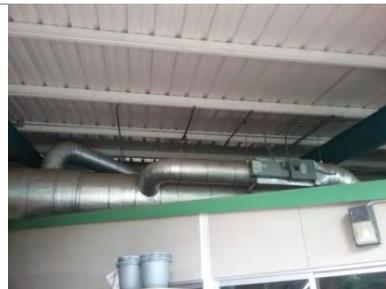
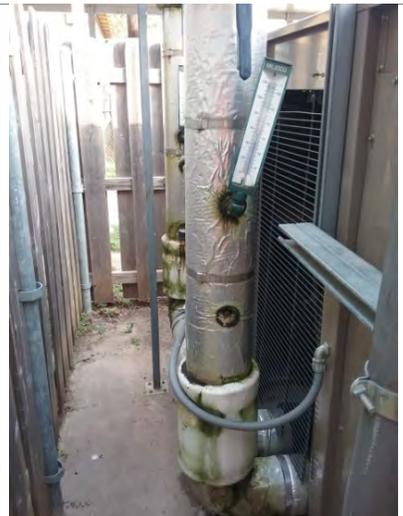
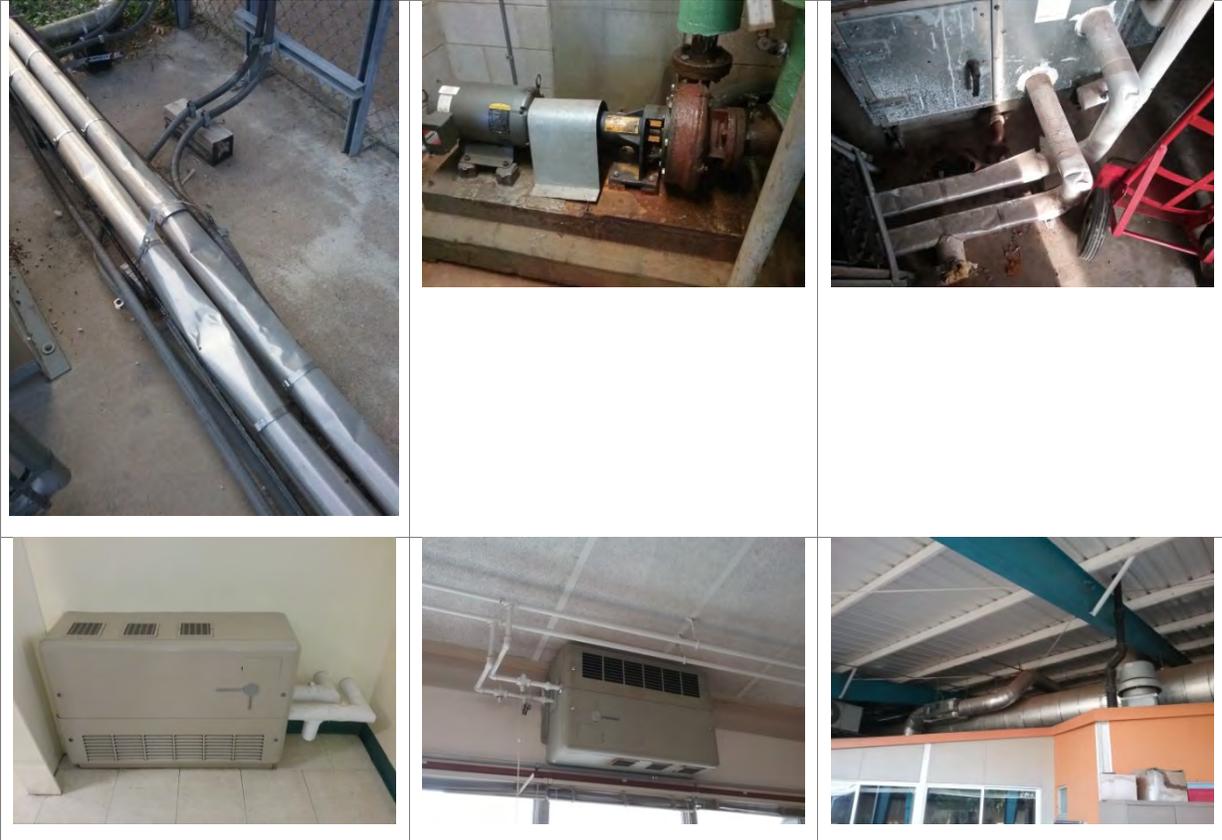
Mechanical/HVAC System Deficiency Examples

Mechanical/ HVAC		<p>The major mechanical equipment consists of exterior ground-mounted chilled water AHUs with associated VAV (variable air volume) terminal units, packaged RTUs (roof top units), interior central station AHUs, split system AHUs with associated air-cooled condensers, scroll chillers with air-cooled condensers, the boiler with associated the distribution pump, and radiators located within the administration areas and corridors. These serve the HVAC (heating, ventilating, and air conditioning) system along with roof-mounted EFs (exhaust fans).</p> <p>The exterior ground-mounted AHUs were observed to be aged and in average</p>	Poor

System	Subsystem	Condition and Deficiency Overview	System Condition Rating
		<p>condition. The roof was inaccessible at the time of assessment, but the associated VAVs were observed to be in average condition based on inspection from the ground. Building staff reported that AHUs and VAVs were undersized for the building and that changes in the temperature set point within classrooms served by these units affected the temperature of other classrooms associated with the system, indicating the possibility of an undersized system.</p> <p>The RTUs were observed by inspection from the ground to be in average condition. Building staff indicated that classrooms served by these units also had temperature control issues. Building staff reported that the RTUs froze during the winter and had to be manually restarted.</p> <p>The interior ground-mounted AHUs were observed to be aged and in average condition. The interior split system AHUs were observed to be aged and in average condition. The associated air-cooled condensers were observed to be aged and in average condition with damage to the refrigerant piping insulation. Condensate piping insulation was damaged or missing throughout the facility. The scroll chillers were observed to be aged and in average condition. The chilled water piping insulation was stained and discolored. Building staff reported that the AISD Service Center had determined that the chillers were undersized. The boiler appeared to be in good condition, while the associated distribution pump was aged and in poor condition. The radiators within the space appeared to be original to the building and were aged and in poor condition.</p> <p>Supplemental mechanical equipment for the HVAC system includes EFs serving the kitchen and restroom exhaust. Roof top EFs appeared to be aged and in poor condition. The classroom student restrooms were not equipped with EFs.</p> <p>The HVAC system appeared to be in poor condition, primarily due to the deficiencies mentioned above and the age of the equipment.</p>

1. Plan for replacement of the RTUs as they appeared to be past or near the end of their design service life.
2. Plan for replacement of the AHUs as they appeared to be past or near the end of their design service life.
3. Plan for replacement of the chillers as they appeared to be past or near the end of their design service life.
4. Plan for replacement of the distribution pumps as they appeared to be past or near the end of their design service life.
5. Address any rust or corrosion observed on the equipment, its associated piping, or any other sub-asset by cleaning, repainting, or repairing to prevent further deterioration.

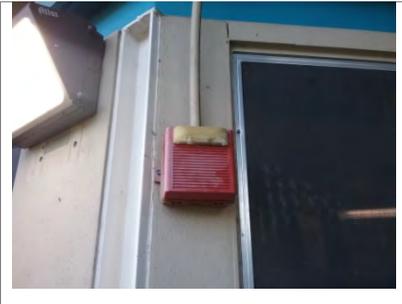
Fire Protection	Fire Alarm	<p>The building has a fire alarm system that consists of alarm and signaling devices such as horns/annunciators, strobes, horn/strobe combos, pull stations, and detectors. The fire alarm control panel is manufactured by Silent Knight.</p> <p>In the interview notes, the facility reported that the fire alarm system periodically goes off.</p> <p>The fire alarm system appeared to be in average condition with exterior devices showing deterioration due to exposure to outdoor elements.</p>	Average
	Fire Protection/Suppression	<p>The building is protected by portable fire extinguishers placed throughout the facility.</p> <p>All observed portable fire extinguishers had inspection tags dated within the last year with the exception of one located in the mechanical room containing AHU-3 and another located in the cafeteria.</p> <p>A fire suppression system associated with the kitchen exhaust hoods is present.</p>	Average

1. Continue annual assessments of the portable fire extinguishers.
2. Continue annual assessments of the fire alarm system.
3. Replace all damaged fire alarm devices.

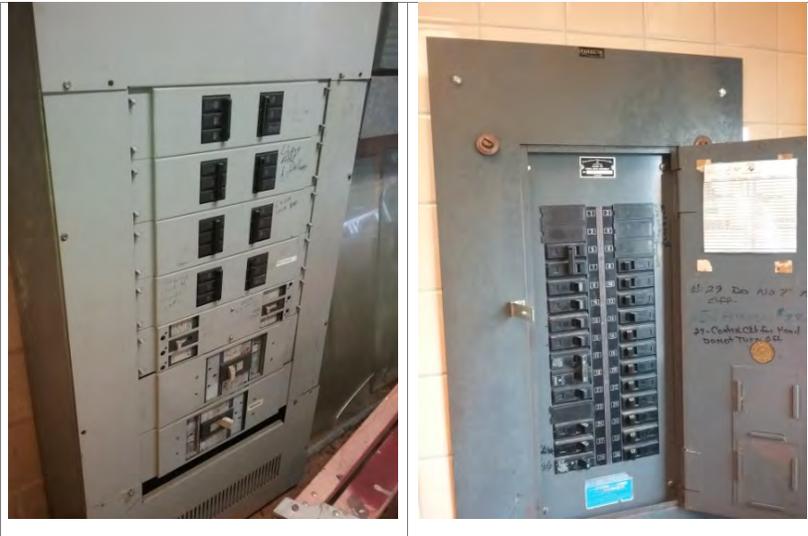
System	Subsystem	Condition and Deficiency Overview	System Condition Rating
		The building's fire protection systems were observed to be in average condition.	
Electrical	Electrical Distribution	<p>The electrical service enters the building at the 120/240-volt 1600-amp main exterior switchboard. The service feeds panelboards located in various electrical rooms throughout the building. The building does not have a lightning protection system.</p> <p>The electrical distribution equipment appeared to be in average condition. The exterior housing door to the main switchboard was deteriorating due to exposure to outdoor elements. Panel PA in the main electrical equipment room and Panel K in the kitchen appeared to be aged and past their design life.</p>	Average
	Lighting	<p>The building's exterior lighting consists of HID (high-intensity discharge) light fixtures located along the entire perimeter and canopies.</p> <p>Observed deficiencies included discolored lenses and deteriorating light fixture housings. Lighting for the exterior of the building appeared to be in average condition.</p> <p>The interior lighting consists primarily of T8 fluorescent light fixtures.</p> <p>About 80% of the interior lights appeared to be aged and past their design life. Observed deficiencies included inconsistent lamp color temperatures, non-functional fixtures, and broken light fixture lenses. Lighting for the interior of the building appeared to be in poor condition.</p> <p>There are exit light signs present in the building, secured to the ceiling, but they appeared to be aged.</p>	Poor

1. Replace all electrical panels affected by age.
2. Install emergency light fixtures/emergency bug eyes throughout the building.
3. Per interview notes, staff requested cameras at the cafeteria and at the south and north parking lots for viewing student drop-off and pick-up by parents.

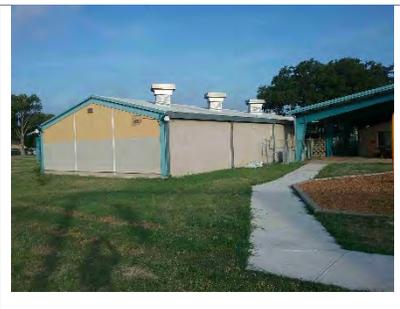
System	Subsystem	Condition and Deficiency Overview	System Condition Rating
Exterior	Exterior Walls	<p>The stand-alone gymnasium has an exposed painted steel structure, and the building's exterior walls are painted cement stucco. A small area of decorative masonry is found near the south entrance.</p> <p>The exterior walls were observed to be in average condition. Leaking was reported to occur through either the wall or roof, at the east end of the building. No defects were visible, nor were they evident from the interior. Sealants joints between the steel structure and the stucco wall panels were aged and created potential for water intrusion.</p>	Average
	Exterior Windows	<p>There are two metal-framed windows with single-pane glazing in the stand-alone gymnasium building.</p> <p>The exterior windows were observed to be in average condition. Sealants around the windows appeared aged and were visibly dry and cracked.</p>	Average

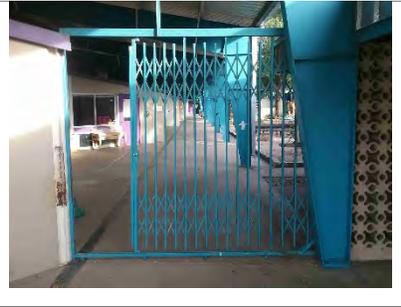
Exterior Doors	<p>The building's exterior doors are steel with hollow metal frames. The building entry doors have vision panels and panic hardware.</p> <p>The exterior doors were observed to be in average condition. The door hardware was aged and reported to be a frequent maintenance issue.</p>	Average
Roofing	<p>The roof is steep-sloped with a modified bitumen membrane. There are continuous gutters and downspouts along the north and south roof edge.</p> <p>The roof was not accessible and was viewed by the assessor from the ground. There was no evidence of roof leaks and no visible staining on the ceiling. The roof, gutters, and downspouts appeared to be in good condition.</p>		Good

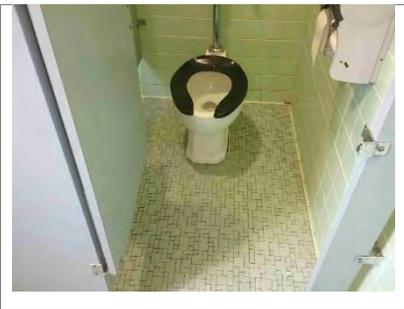
System	Subsystem	Condition and Deficiency Overview	System Condition Rating
Interior Construction	Interior Walls	The interior walls are framed with cement plaster finish. There are no interior windows or movable partitions. The interior wall finishes were observed to be in good condition.	Good
	Interior Doors	The interior doors are steel with hollow-metal frames. The interior doors were observed to be in good condition.	Good
	Interior Specialties	System not present.	N/A
Stairs	Exterior Stairs	System not present.	N/A
	Interior Stairs	System not present.	N/A
Interior Finishes	Interior Wall Finishes	The interior walls have a cement plaster finish. The gymnasium walls have a painted plywood wainscot on the lower 6-feet for safety. The restrooms have ceramic tile wainscoting with painted surfaces above. The interior wall finishes were observed to be in good condition.	Good
	Interior Floor Finishes	The building has vinyl tile with a 4-inch base. There is an athletic play surface in the gymnasium and ceramic tile flooring in the restrooms. The interior flooring appeared to be in average condition. The vinyl and ceramic tile flooring was aged and visibly worn.	Average

1. Further study the cause of reported water intrusion at the east end of the gymnasium, and repair.
2. Regrout ceramic tile floors in restrooms.

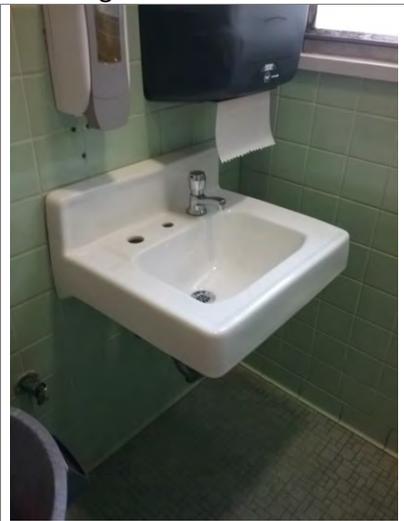
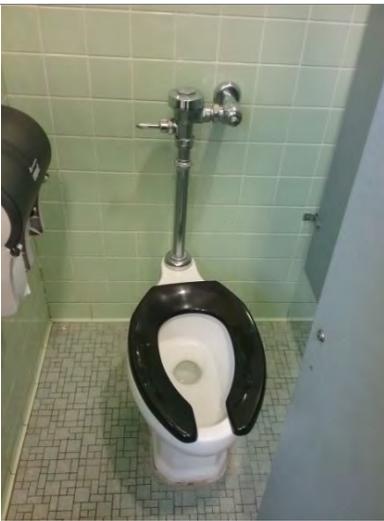
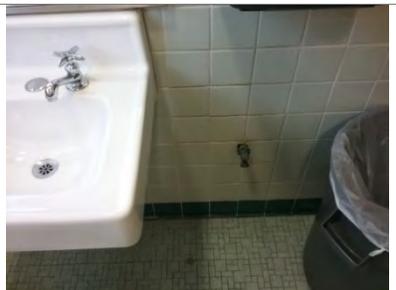
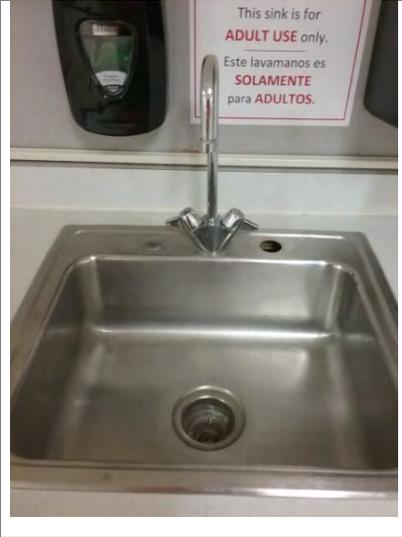
Interior Ceiling Finishes	The building's interior ceiling is a painted metal structure with its cement-fiber roof deck exposed to view. The restrooms have a painted gypsum board ceiling finish. The interior ceiling finishes were observed to be in good condition.	Good
Conveying	System not present		N/A
Plumbing	Plumbing Fixtures	The building has public male and female restrooms for students. These restrooms have vitreous china hand sinks with manual faucets, along with vitreous china floor-mount toilets with manual flushing mechanisms, and a vitreous china wall-hung urinal in the male restroom with manual flushing mechanism. There are no service sinks in the janitorial closet. A water cooler is located in the corridor. The fixtures appeared to be aged and in average condition. Hose bibs were observed in the male and female restrooms. The restroom plumbing fixtures were observed to be in average condition, primarily due to the age of the fixtures.	Average

1. Remove hose bibs from male and female restrooms.

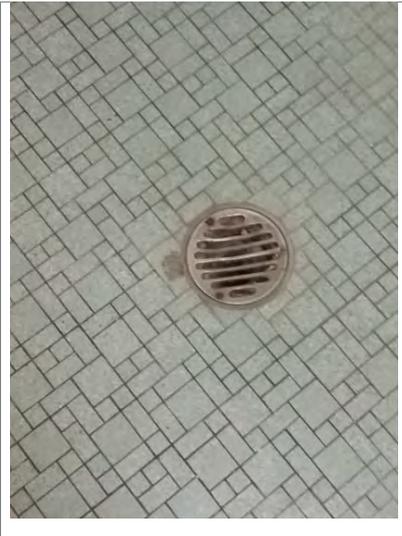
System	Subsystem	Condition and Deficiency Overview	System Condition Rating
	Domestic Water Distribution	System not present.	N/A
	Other Plumbing	<p>The roof is equipped with gutters and downspouts (see Roofing for condition). The roof is not equipped with roof drains.</p> <p>The floor drains located in the restrooms were observed to be in average condition.</p> <p>The plumbing equipment serving the facility appeared to be in average condition, primarily due to the age of the equipment.</p>	Average
Mechanical/ HVAC	<p>The major mechanical equipment consists of split system AHUs with associated air-cooled condensers, a through-wall air conditioning unit, and a roof-mounted EF. These serve the HVAC system.</p> <p>The interior split system AHUs were observed to be aged and in poor condition. The condensate piping was not insulated. A garden hose was serving as the condensate drain piping for one of the units. Condensate piping insulation was damaged or missing for each unit. The associated air-cooled condensing units were observed to be aged and in poor condition. The through-wall air conditioning unit appeared to be aged and in poor condition.</p> <p>Supplemental mechanical equipment for the HVAC system includes an EF serving the restroom. The EF appeared to be aged and in poor condition.</p> <p>The HVAC system appeared to be in poor condition, primarily due to the deficiencies mentioned above and the age of the equipment.</p>		Poor

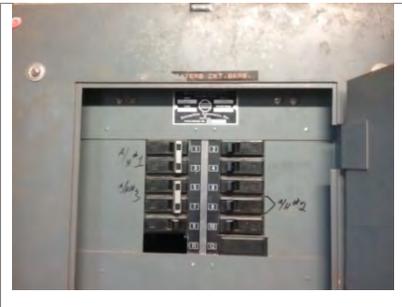
Fire Protection	Fire Alarm	<p>The building has a fire alarm system that consists of alarm and signaling devices such as horns/annunciators, strobes, horn/strobe combos, pull stations, and detectors. The fire alarm control panel is manufactured by Silent Knight.</p> <p>The fire alarm system appeared to be in good condition.</p>	Good
	Fire Protection/Suppression	<p>The building is protected by a portable fire extinguisher placed near the exit door.</p> <p>The portable fire extinguisher had an inspection tag dated within the last year. The building's fire protection system appeared to be in good condition.</p>	Good
Electrical	Electrical Distribution	<p>The electrical service enters the building at the 120/240-volt 400-amp switchboard. The service feeds panelboards located in the electrical equipment room.</p> <p>The electrical distribution equipment appeared to be in poor condition. About 80% of the assets had out-of-date panels, and a panel labeled "Heater" had missing circuit breaker covers, which is considered a life safety hazard.</p>	Poor

1. Replace all electrical equipment affected by age.
2. Remove and provide blank cover for any floor receptacles as they are being phased out of use district-wide.
3. Replace all outdated light fixtures with LED and dimming capabilities.
4. Replace all existing exit signs with battery powered LED fixtures.
5. Lightning Protection.

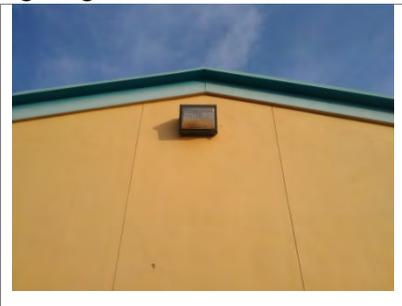
System	Subsystem	Condition and Deficiency Overview	System Condition Rating
	Lighting	<p>The building's exterior lighting consists of HID light fixtures located along the entire perimeter.</p> <p>Observed deficiencies included discolored lenses. Lighting for the exterior of the building appeared to be in average condition.</p> <p>The interior lighting consists primarily of T8 fluorescent light fixtures.</p> <p>Lighting for the interior of the building appeared to be in average condition.</p>	Average
	Security & Communications	<p>There is a Gemini security system including surveillance cameras in the building's interior and exterior.</p> <p>The system appears to be in average condition.</p> <p>There is a public address system in the building, and it appeared to be in average condition.</p>	Average
