Mathews Elementary School Site Summary

Main School Building – BLDG-123A

Boiler House – BLDG-123B

Storage Building (CMU) – BLDG-123C

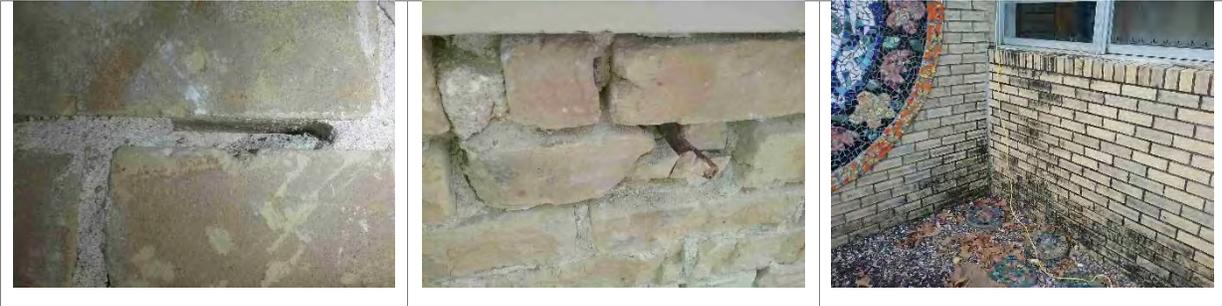
| System | Subsystem | Condition and Deficiency Overview | System Condition Rating |
|---|---|---|---|
| Exterior | Exterior Walls | <p>The original exterior walls are faced with tumbled brick both interior and exterior. The addition to the school is face with sharp edged brick.</p> <p>On the original portion of the building, the mortar was observed to be worn on the interior side of the exterior walls. Some of the classroom walls were so worn that rebar was observed protruding into the classroom. The newer walls were observed to be in good condition with some discoloration.</p> | Average |

1. Infill deteriorated grout on interior of building.
2. Trim exposed rebar.
3. Clean discolored areas of walls.
4. Sand and paint chipped wood window frames. Repair wood where necessary.
5. Investigate reported failures of feature window in south stairwell. Repair if necessary.
6. Replace deteriorated FRP panels located beneath windows.
7. Clean exterior windows and frames.
8. Recondition wood doors and frames. Replace where necessary.

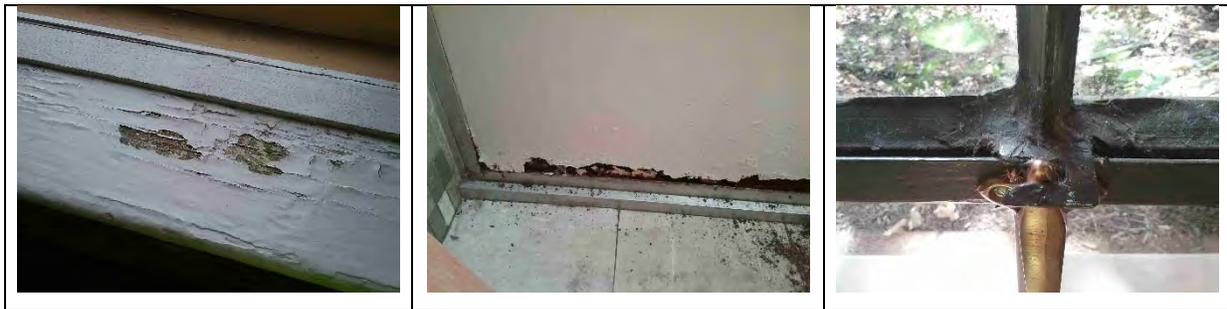
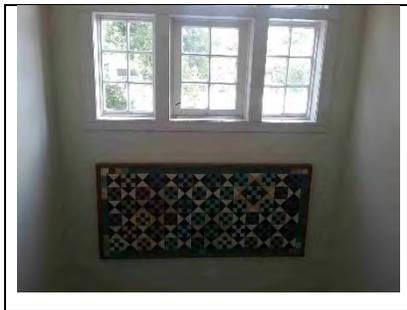
| System | Subsystem | Condition and Deficiency Overview | System Condition Rating |
|---|---|---|---|
| | Exterior Windows | <p>The exterior windows include wood framed, single-hung windows and metal framed, single-hung windows. The single-pane wood windows are original to the building. Some of the first floor windows are updated double-pane windows in matching wood frames.</p> <p>The windows were observed to be in average condition with worn, damaged finishes expected of their age. No broken panes or screens were observed, nor did the wood of the frames appear excessively damaged. Any damage was confined to the window sills and paint of the frames. The FRP (fiber-reinforced plastic) panels at the bottoms of many of the metal frame windows were observed to be deteriorating. The painted metal window frames in the cafeteria were observed to be excessively dirty. It was reported that the feature window in the south stairwell of the building is in need of repair. The bottom of the window frame was observed to have splintered wood and possible water damage.</p> | Average |

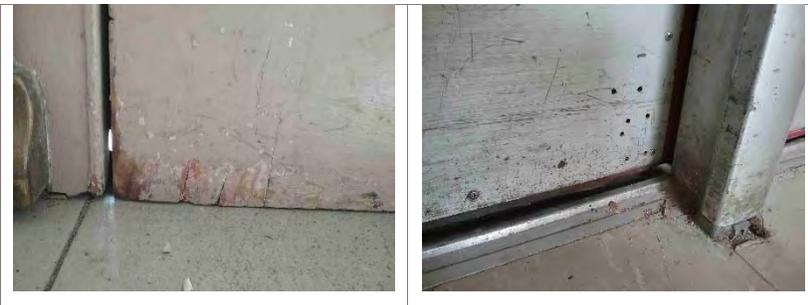
| System | Subsystem | Condition and Deficiency Overview | System Condition Rating |
|---|--|---|---|
| | Exterior Doors | <p>There is one main public entryway located at the southeast side of the building; these doors are wood French doors with divided side lites. The remaining service doors around the facility are wood or metal.</p> <p>The exterior doors were observed to be in average condition due to age and use. The main entry exterior doors were observed to have worn door bases, and the metal doors and frames were observed to be scratched.</p> | Average |

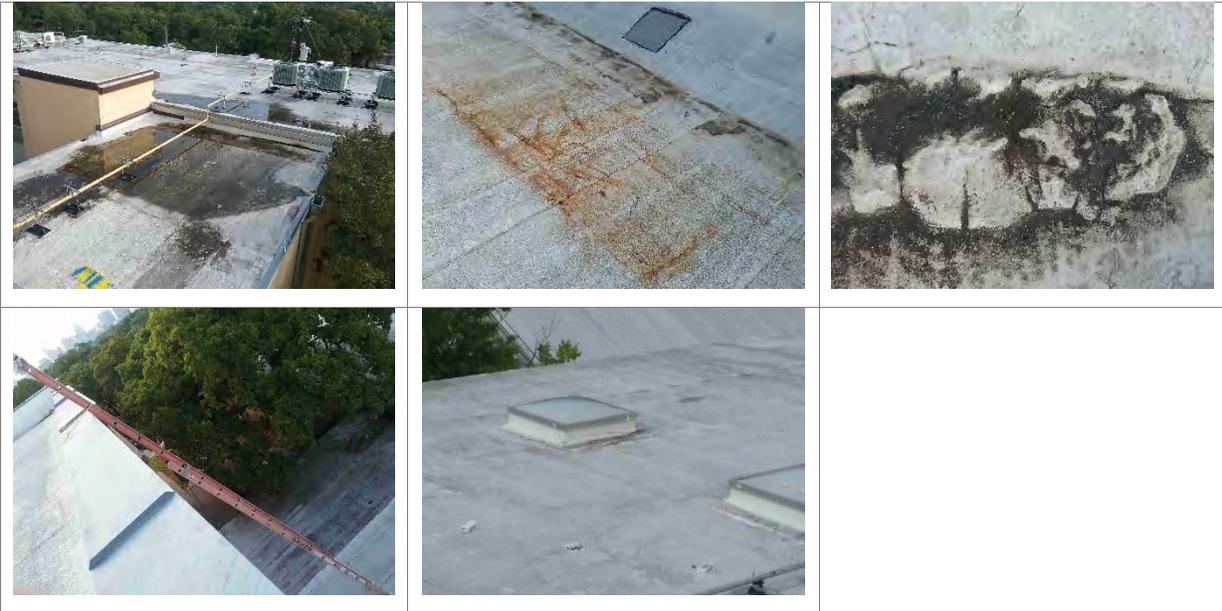
Roofing Deficiency Examples

| System | Subsystem | Condition and Deficiency Overview | System Condition Rating |
|---|--|---|---|
| Roofing | <p>The entirety of the building is covered with a modified bitumen roof system with a white reflective coating. There are four skylights over the gymnasium area.</p> <p>It was reported that the roof leaks at the seams, and much ponding was observed on the roof. Spots of rusty discoloration were also observed. The membrane was observed to be cracking and spotting as typical for its age, and portions were observed to be thickened. The roof appeared to be in poor condition as water damage was observed on the original ceiling of the building. Access ladders were insufficient to reach most portions of the roof. It was reported that the sky lights above the gymnasium were deteriorating, and from a distance, the skylights appeared to be in average condition due to the observable aging membrane.</p> | | Poor |

1. Install access ladders from roof to roof where necessary.
2. Further investigate all roof areas observed with standing water in order to re-slope to proper drainage points. Replace water-damaged areas of roof membrane.
3. Further investigate membrane around skylights and repair where necessary.

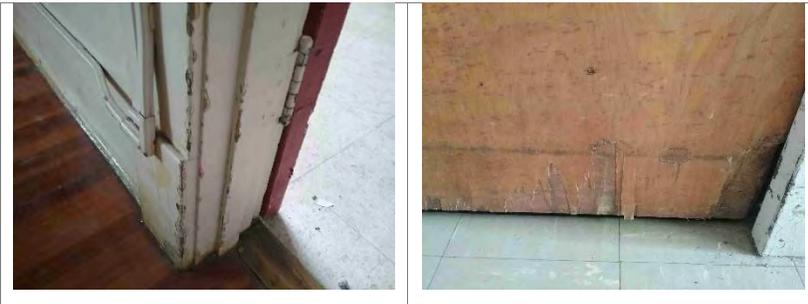
| System | Subsystem | Condition and Deficiency Overview | System Condition Rating |
|---|--|---|---|
| | Interior Doors | <p>The interior doors are wood in wood frames with narrow lites.</p> <p>The interior doors were observed to be in average condition due to age and use. The wood frames and doors were observed to be damaged and worn with chipped paint, dented frames and splitting wood.</p> | Average |

1. Recondition and repaint wood doors and frames.
2. Remove folding partitions and replace with permanent partition.

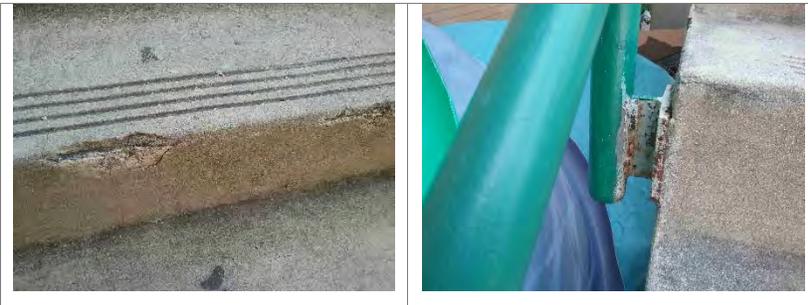
| System | Subsystem | Condition and Deficiency Overview | System Condition Rating |
|---|--|---|---|
| Stairs | Exterior Stairs | <p>There is one exterior stair on the northwest side of the building. It is a concrete stair with metal handrails.</p> <p>The stair was observed to be in good condition with isolated areas of deficiency. Small corners of chipped concrete and rusting handrail connections were observed.</p> | Good |

1. Patch areas of chipped concrete on exterior stairs.
2. Remove rusted segments of handrails on exterior stair.
3. Replace linoleum membrane on the interior stair in the south wing of the building.
4. Repaint handrails of interior stairs.

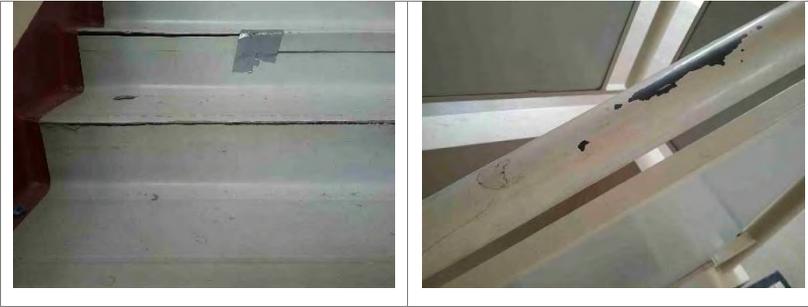
| System | Subsystem | Condition and Deficiency Overview | System Condition Rating |
|---|--|---|---|
| | Interior Stairs | <p>There are two interior stairs in the building, both covered in linoleum flooring with metal handrails.</p> <p>The stairs were observed to be in average condition structurally, but the finishes were in poor condition. The stair at the south side of the building was observed to have cracked and broken linoleum, bandaged with duct tape. The handrails on both stairs were observed to have worn paint.</p> | Average |

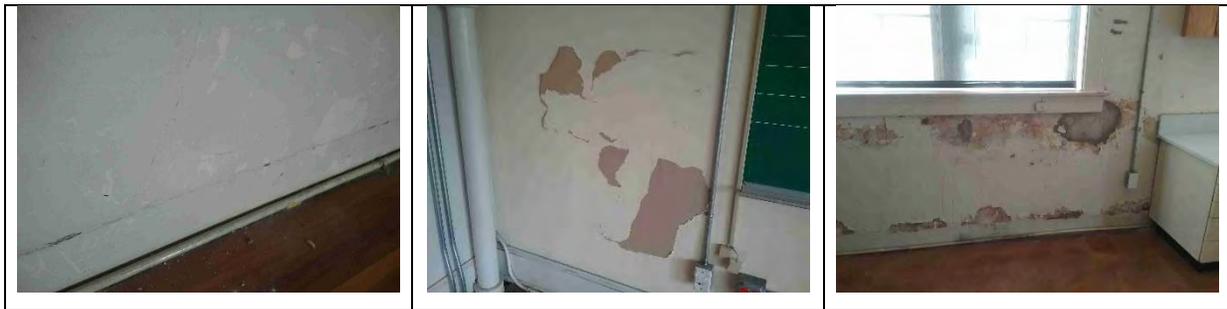
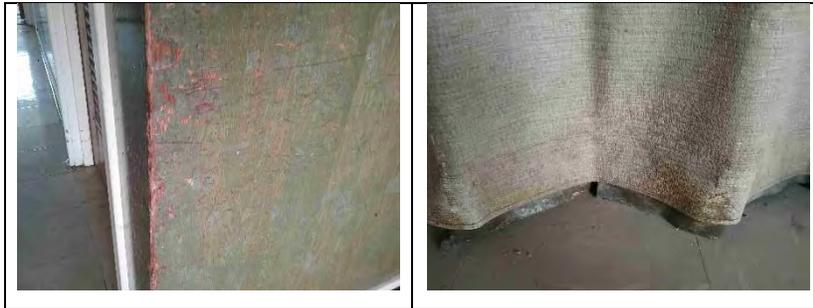
| System | Subsystem | Condition and Deficiency Overview | System Condition Rating |
|---|---|---|---|
| Interior Finishes | Interior Wall Finishes | <p>Most of the walls, except the exterior brick walls, are finished with paint. The cafeteria has painted concrete masonry units and ceramic faced masonry units. There are classrooms that are divided by folding partitions.</p> <p>Finish damage was observed where the base board had been ripped from the wall. Deteriorating plaster was also observed throughout the building. Holes were reported in the walls of room 107, and the exterior wall of room 107 was furred out with drywall and was extremely water-damaged. Excessive wear and tear was observed on the wood walls near room 213. The folding partitions were observed to be discolored and were reported to be inoperable. Wall in room 107 has been repaired. Water leak from adjacent exterior downspout was corrected.</p> | Average |

1. Repair damaged wall base, and install base board where it has been removed.
2. Refinish walls with peeling paint.
3. Recondition wood paneling near room 213.
4. Repair damaged linoleum flooring.
5. Install complete flooring in janitorial office.
6. Investigate further the cause of the damaged wall in room 107. Mitigate cause and repair wall. [Wall in room 107 has been repaired. Water leak from adjacent exterior downspout was corrected.](#)
7. Consider removing lay-in ceiling and restoring original dry wall ceiling. If that is cost prohibitive, replace all damaged and buckling ceiling tiles.
8. Investigate further water-damaged portions of original ceiling to ensure they are not enduring active leaks. Restore damaged ceiling.

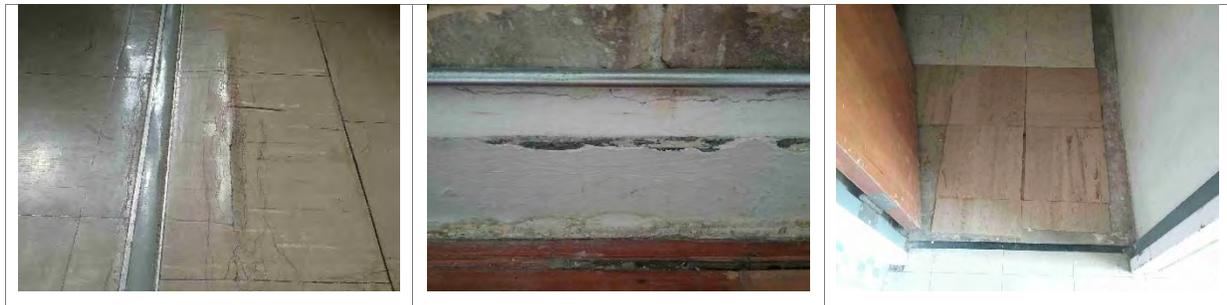
| System | Subsystem | Condition and Deficiency Overview | System Condition Rating |
|---|---|---|---|
| | Interior Floor Finishes | <p>The floors are finished in linoleum tile and wood. There is a six inch wood base around the perimeter of the classrooms and corridors. The main office is finished with carpet and linoleum flooring. One classroom has stained concrete. The library is finished with carpet.</p> <p>Some of the linoleum was observed to have ridges or dents. Some of the wood wall bases were observed to be very damaged, and some were missing from the classroom walls. The main office flooring was observed to be in good condition. The floor of the janitorial office was observed to be only partially covered with aged linoleum tile. The carpet in the library was observed to be in good condition.</p> | Average |

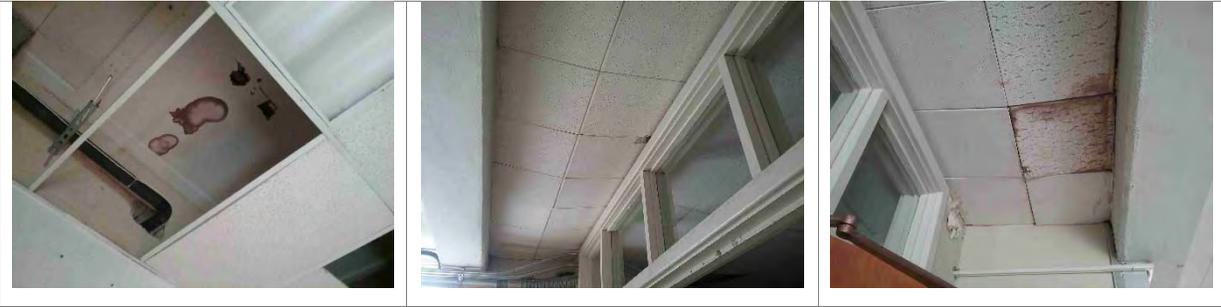
| System | Subsystem | Condition and Deficiency Overview | System Condition Rating |
|---|---|---|---|
| | Interior Ceiling Finishes | <p>The majority of the school is ceiled with lay in ACT (acoustical ceiling tile), which is covering the original dry wall ceiling. The restrooms are ceiled with dry wall. The library is ceiled with ACT. The ceiling in and by the gymnasium is wood wool panels.</p> <p>The ceiling tiles appeared to be in average condition with very little water damage, but in the areas where ACT was removed for construction, water damage was observed on much of the original ceiling. One portion of the ceiling on the second floor was observed to be buckling and water damaged. The library ceiling was observed to be in good condition. No damage was observed on the wood wool ceilings.</p> | Average |

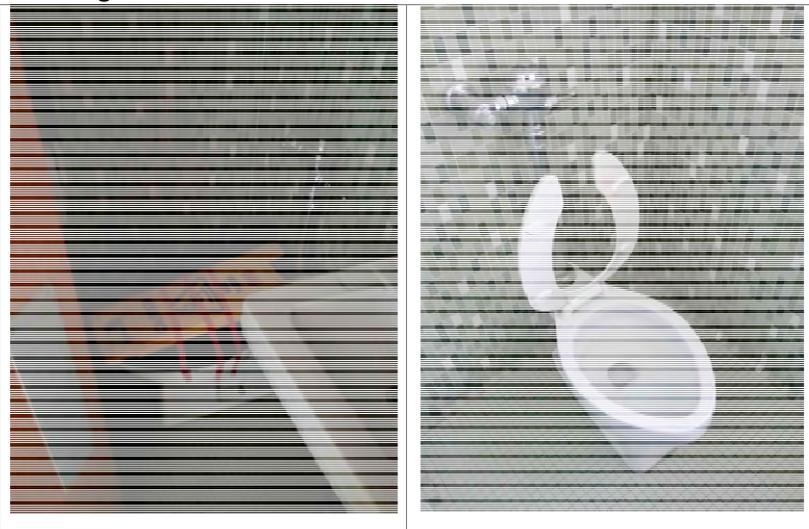
| System | Subsystem | Condition and Deficiency Overview | System Condition Rating |
|---|---|--|---|
| Plumbing | Plumbing Fixtures | <p>This building has a male and female public restroom as well as private restrooms located in the classrooms. There is a separate faculty restroom outside of the library. The plumbing fixtures in this building are vitreous china with floor-mounted toilets and manual hand sinks. The urinals in this building are hung on the wall.</p> <p>Many of the toilets were not functioning at the time of the assessment. One of the urinals in the male public restroom on the first floor did not flush. The toilets on the second floor between classrooms 211 and 213 did not flush properly. The toilet adjacent to room 214 was out of order.</p> <p>Water would spray from the bubblers after being initially pressed down. Some of the classroom sinks and bubblers were not functioning and there was not any hot water flow in the health clinic.</p> | Poor |

1. The water pressure issues in 100-wing need to be addressed.
2. Address hot water issues for the faculty restrooms. It was reported that FRR, FHRR100, and FRR200 restrooms do not have hot water.
3. Secure vent pipes so they do not fall over per the facility interview notes.
4. Repair toilets on the second floor between classrooms 211 and 213.
5. Repair toilet adjacent to room 214 on the second floor.
6. Repair the urinal in the male public restroom on the first floor.
7. Replace the gas water heater outside of the kitchen area.

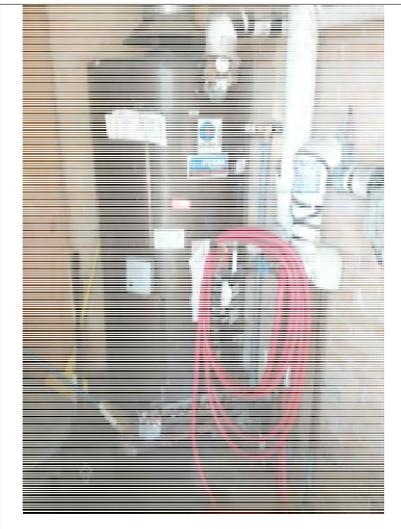
| System | Subsystem | Condition and Deficiency Overview | System Condition Rating |
|---|---|--|---|
| | Domestic Water Distribution | This water heater was aged and observed to be in poor condition. It was obstructed by other objects in the same area and did not look like it was being maintained properly. | Poor |

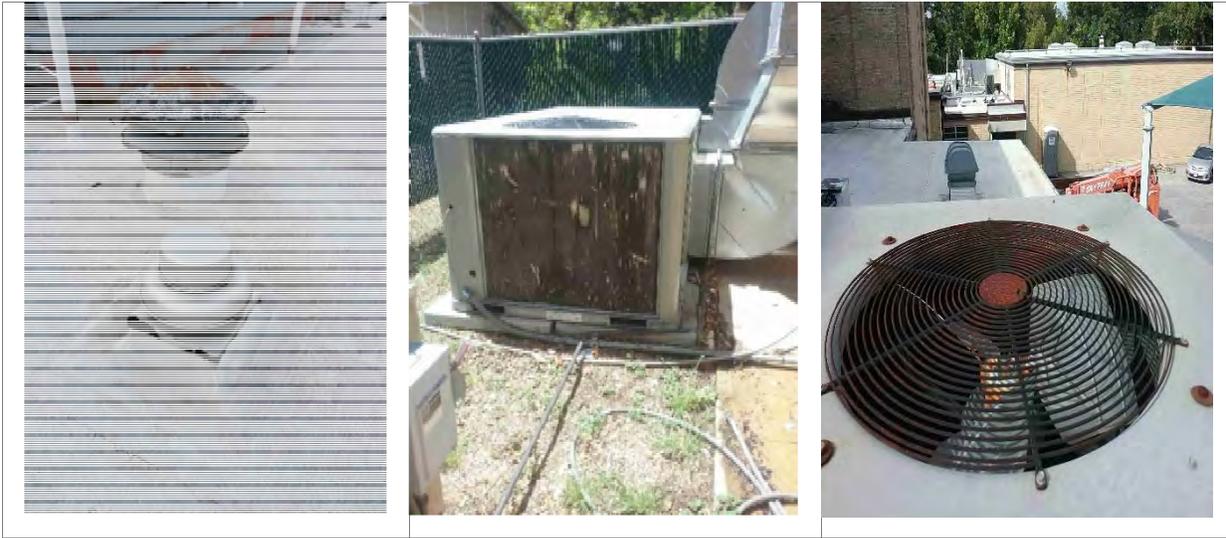
Mechanical/HVAC System Deficiency Examples

| System | Subsystem | Condition and Deficiency Overview | System Condition Rating |
|---|---|--|---|
| Mechanical/ HVAC | | <p>The major mechanical equipment in this building consists of split system vertical fan coils located in each classroom and roof top air handlers. The air handlers for this school are not new. The new units that are being installed are the split system vertical fan coils for the classrooms.</p> <p>There was one air handler located on the ground level of the exterior of the building that was not new and had obvious signs of wear and tear on the condenser section of the unit. There were also initial signs of corrosion on the condenser fan. Several exhaust fans on the roof looked to be abandoned, while others were new.</p> <p>The roof top unit above the gymnasium had some corrosion on the exterior and slight damage on the exterior grate. There were condensers above the library that were corroded and appeared to be past their service date. There were only a few</p> | Good |

| System | Subsystem | Condition and Deficiency Overview | System Condition Rating |
|---|---|--|---|
| | | condensers on the roof that were not recently installed. These were observed to be in average condition. | |

1. Address any rust or corrosion observed to the outdoor air handlers by cleaning, re-painting, and/or repairing by any other means to prevent further deterioration.
2. Repair or replace any damaged or missing piping insulation as needed.

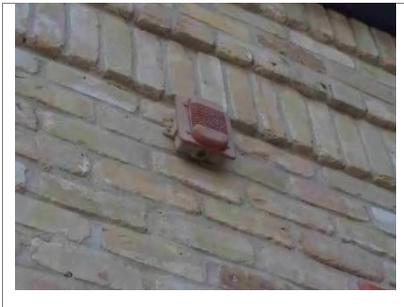
| System | Subsystem | Condition and Deficiency Overview | System Condition Rating |
|---|---|--|---|
| Fire Protection | Fire Alarm | <p>The building has a fire alarm system that consists of alarm and signaling devices such as horns/annunciators, strobes, horn/strobe combinations, pull stations, and detectors. The fire alarm system is controlled by the Silent Knight IFP-1000 addressable control panel.</p> <p>The fire alarm system was observed to be in good condition, but the exterior fire alarm devices were observed to have corrosion and rust. It was also reported that dust trips the detectors in the gymnasium.</p> | Good |

1. Conduct a detailed assessment to determine the cause for the gymnasium smoke detectors being set off in error to ensure it is not a result of defective controls.

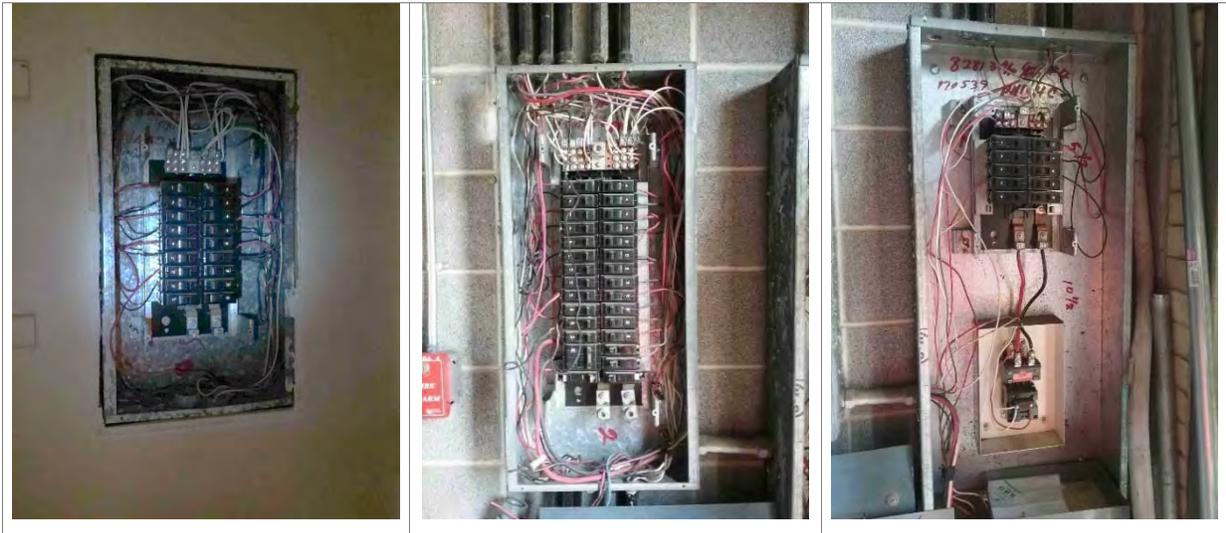
| System | Subsystem | Condition and Deficiency Overview | System Condition Rating |
|---|---|--|---|
| Electrical | Electrical Distribution | <p>At the time of this assessment, the entire electrical distribution system voltage was being changed from 120/240V delta to 120/208Y. A new 1600A 120V/208Y switchboard, several new distribution panels and branch panels, and two new transformers were being installed. 85% of the existing 120/240V delta panels were scheduled to remain and be back-fed at the new 120/208Y system voltage. The new main switchboard is located in the Boiler House Building and feeds the entire facility. Approximately 10% of the electrical panels are from the original construction and are still active. The facility does not have a lightning protection system</p> <p>The electrical distribution equipment was observed to be in average condition, with the exception of the new equipment that was being installed at the time of our visit. The outdated older panels/equipment were observed with corrosion and rust and should be replaced soon.</p> <p>95% of the disconnect switches on the roof are in excellent condition, 5% are older and are corroded/rusted out.</p> | Average |

1. Replace all outdated panelboards in the building as they appear original to construction, have rust and corrosion, and are severely aged past typical design life.
2. Verify the condition of telecommunications systems equipment in the building, as it was inaccessible.

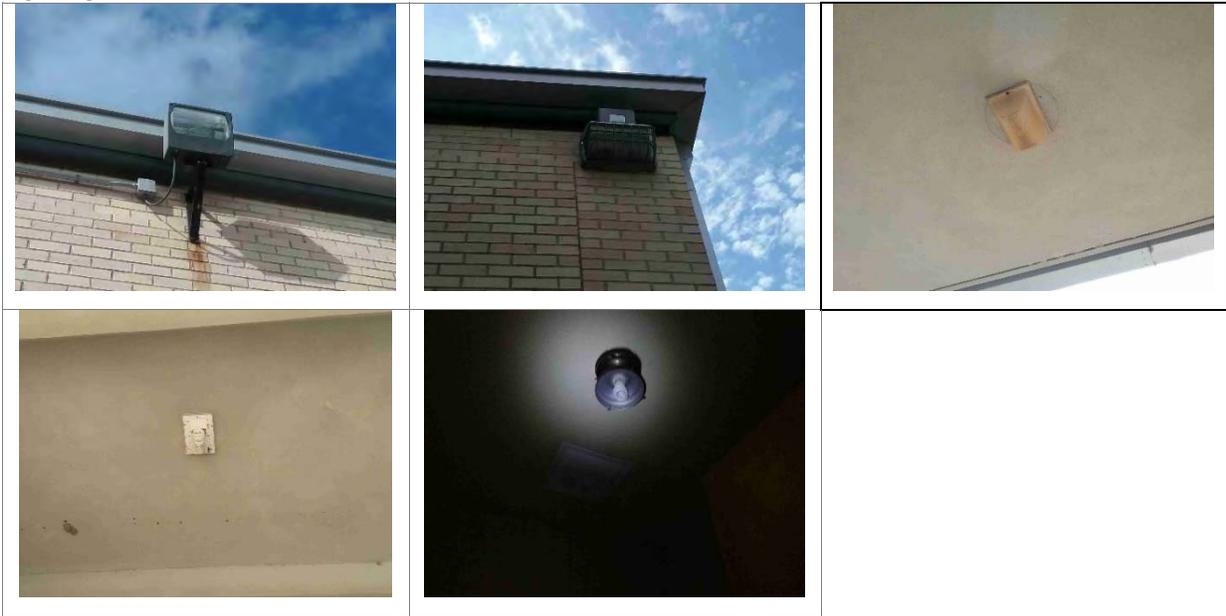
| System | Subsystem | Condition and Deficiency Overview | System Condition Rating |
|---|---|--|---|
| | Lighting | <p>95% of the interior lighting at the facility consists of 2x4 fluorescent fixtures. 5% of the fixtures are outdated fixtures from 1940s. All switching and lighting controls are manual.</p> <p>Life Safety: All exit lighting appears to be outdated, worn out, and nonfunctional. There appears to be no</p> | Average |

| System | Subsystem | Condition and Deficiency Overview | System Condition Rating |
|---|---|--|---|
| | | <p>emergency lighting in the facility.</p> <p>All exterior light fixtures are outdated, worn-out, and/or non-functional.</p> <p>The interior lighting for the building appeared to be in average condition. All exterior light fixtures appeared to be aged past their design life. Observed deficiencies include: broken lenses, inconsistent color temperatures, and non-functional fixtures.</p> | |

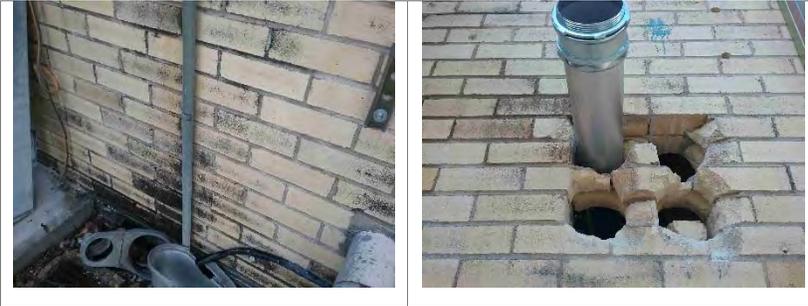
| System | Subsystem | Condition and Deficiency Overview | System Condition Rating |
|---|---|--|---|
| Exterior | Exterior Walls | The exterior of the building consists of a brick façade. The exterior walls were observed to be in average condition; discoloration and unsealed penetrations were observed. | Average |

1. Clean the discolored portions of the walls.
2. Seal all penetrations.
3. Replace windows with a rust-resistant assembly.
4. Replace the entry door with a prefinished hollow metal assembly.

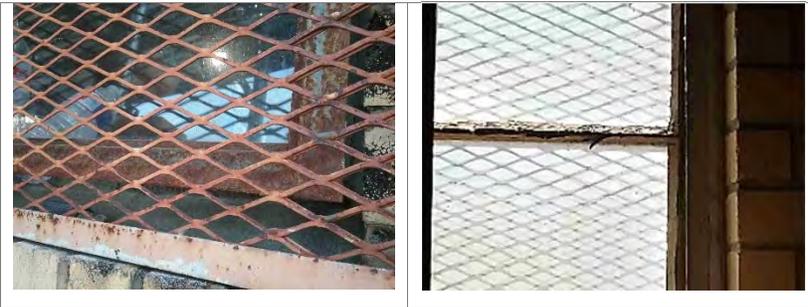
| System | Subsystem | Condition and Deficiency Overview | System Condition Rating |
|---|---|--|---|
| | Exterior Windows | There are two steel frame windows on opposite sides of the building. They have single pane glazing with metal safety screens. The exterior windows were observed to be in poor condition. The window frames and screens were observed to be rusted, and the sealant was observed to be deteriorated on the interior of the building. | Poor |

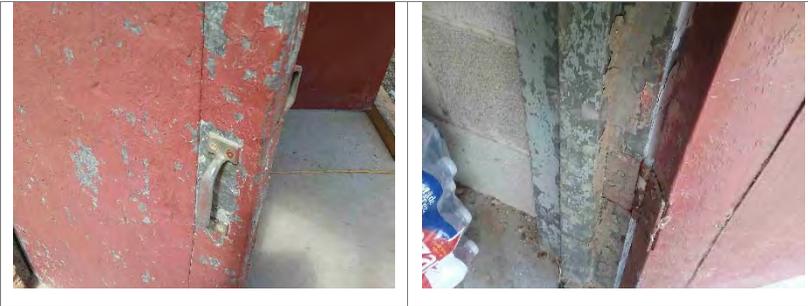
| System | Subsystem | Condition and Deficiency Overview | System Condition Rating |
|---|---|--|---|
| | Exterior Doors | There is one set of exterior double doors located at the northeast side of the building; these doors are painted metal with a painted metal frame. The exterior doors were observed to be in poor condition due to age. The paint was observed to be thick and peeling, and the hinges were observed to be bent and rusting. | Poor |

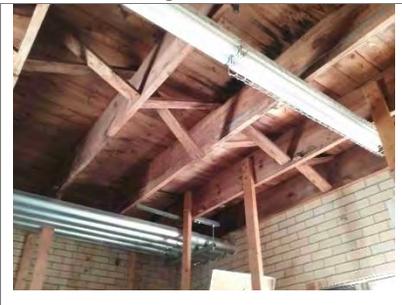
| System | Subsystem | Condition and Deficiency Overview | System Condition Rating |
|---|---|--|---|
| | Interior Ceiling Finishes | The interior ceiling consists of exposed wood roof sheathing and rafters. The wood was observed to be in good condition with one disconnected bracing member. | Good |

1. Nail loose bracing member back into proper position.

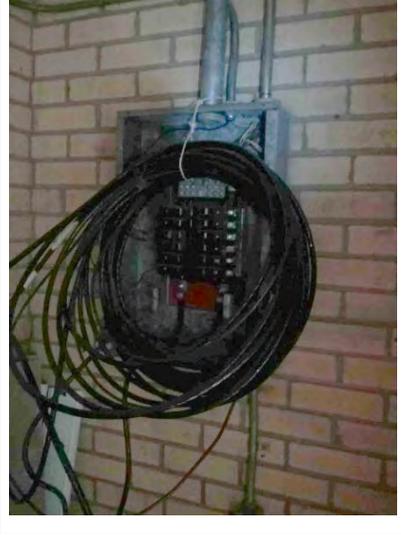
| System | Subsystem | Condition and Deficiency Overview | System Condition Rating |
|---|---|--|---|
| Electrical | Electrical Distribution | At the time of the assessment, the entire electrical distribution system voltage was being changed from 120/240V delta to 120/208Y. The new 1600A 120V/208Y switchboard was being installed in the Boiler House Building. There is one branch circuit panel 'F' present in this building and it is active and appears to be from the original building construction. There is a 75KVAR power factor correction capacitor bank installed outside this building. The electrical distribution equipment in this building was observed to be in excellent condition, with the exception of panel 'F' which was observed to be in poor condition. Panel 'F' was observed to be outdated and with lot of corrosion and rust and should be replaced immediately. | Good |

1. Replace outdated Panel 'F'.

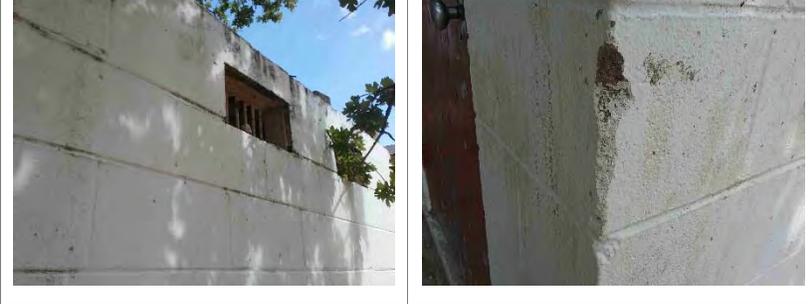
| System | Subsystem | Condition and Deficiency Overview | System Condition Rating |
|---|---|---|---|
| Exterior | Exterior Walls | The exterior walls of the building consist of CMU walls, painted on the exterior and unfinished on the interior. There are two grated openings in the wall for ventilation. The walls were observed to be in average condition with prevalent discoloration and chipped pieces of CMU observed on the exterior. | Average |

1. Clean discolored areas of exterior walls.
2. Patch areas of chipped CMU on exterior walls.
3. Replace the entry door with a prefinished hollow metal assembly.

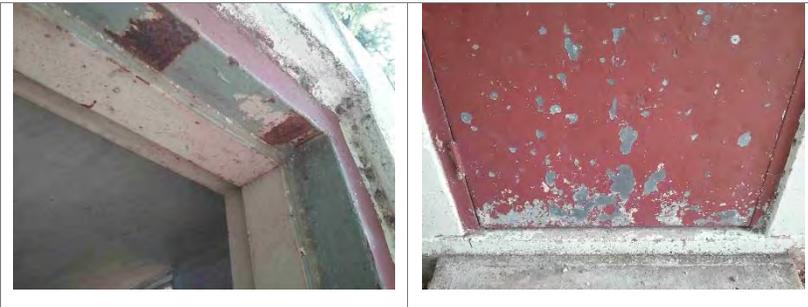
| System | Subsystem | Condition and Deficiency Overview | System Condition Rating |
|---|---|---|---|
| | Exterior Doors | There is one exterior door located on the southwest side of the building. The door is painted hollow metal in a painted metal frame. The door and frame were observed to be in poor condition. Rust was observed on the doorframe, and excessively chipped paint was observed on the door itself. | Poor |

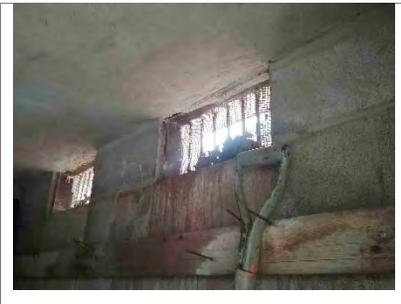
| System | Subsystem | Condition and Deficiency Overview | System Condition Rating |
|---|---|---|---|
| Interior Finishes | Interior Wall Finishes | The interiors of the CMU walls are clear-coated. The finish was observed to be in poor condition with excessive streaking from rust and water runoff. | N/A |

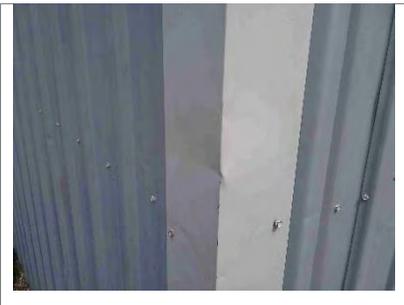
| System | Subsystem | Condition and Deficiency Overview | System Condition Rating |
|---|---|--|---|
| Exterior | Exterior Walls | The exterior of the building is constructed with prefinished corrugated sheet metal overlain on interior wood sheathing. The exterior walls were observed to be in good condition with only small dents expected of use. | Good |

1. Monitor metal for further denting.
2. Replace the entry door with a prefinished hollow metal assembly.

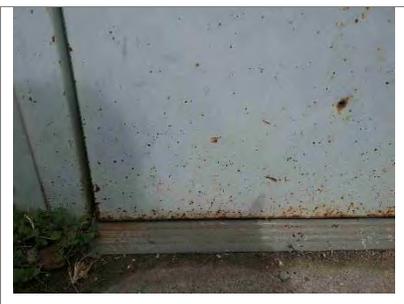
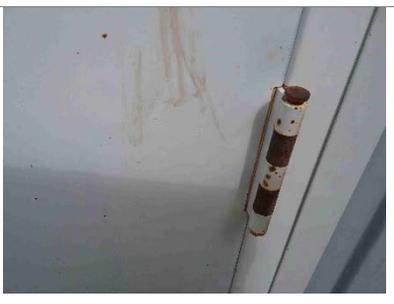
| System | Subsystem | Condition and Deficiency Overview | System Condition Rating |
|---|---|--|---|
| | Exterior Doors | There is one exterior door located at the southeast side of the building; this door is hollow metal with a metal frame. The exterior doors were observed to be in average condition with some rust spots observed on the door. The hinges were also observed to be rusting. | Average |

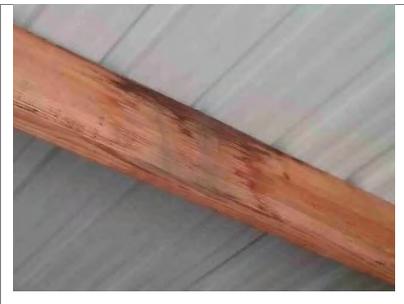
Roofing Deficiency Examples

| System | Subsystem | Condition and Deficiency Overview | System Condition Rating |
|---|---|--|---|
| Roofing | The roof is constructed of standing seam metal supported by interior wood framing. The exterior of the roof was observed to be in good condition, but some water damage was observed on the interior wood framing. | | Good |

1. Investigate further the integrity of the roof. Repair where necessary.
