Metz Elementary School Site Summary

Address	84 Robert Martinez Jr. Austin, TX 78702
Number of Permanent Campus Facilities	1
Original Year of Construction	1993
Total Campus Building Area (combined)	61,905 SF

Main School Building – BLDG-124A

Building Purpose	Administrative, Classrooms, Cafeteria and Gymnasium
Building Area	61,905 SF
Inspection Date	June 28-29, 2016
Inspection Conditions	June 28 - 80° sunny and hot June 29 - 80° sunny and hot
Facility Condition Index

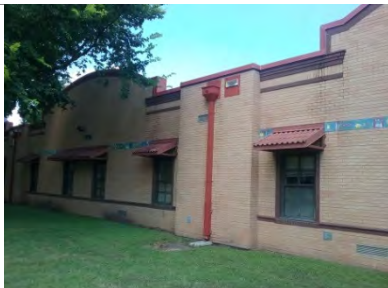
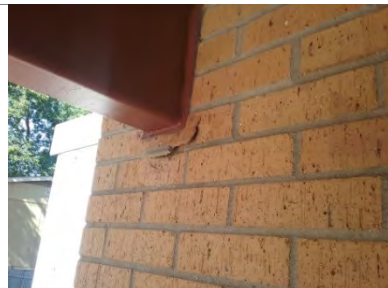
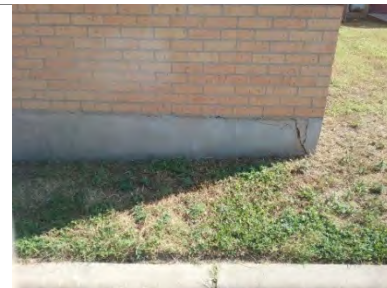
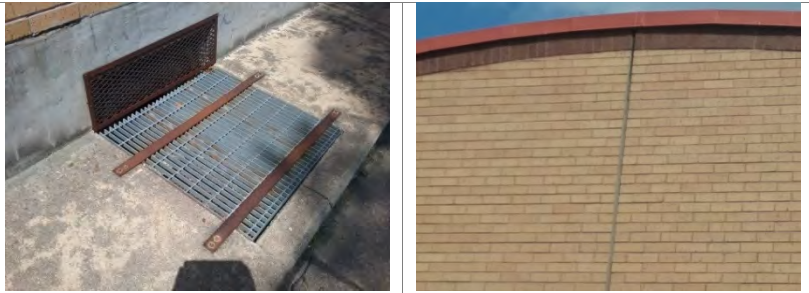
System	Subsystem	Condition and Deficiency Overview	System Condition Rating
Exterior	Exterior Walls	The exterior of the building consists of a brick and tile façade over a steel structure. The wall between the cafeteria and gymnasium is EIFS (Exterior Insulating Finishing System) construction over the same structure. The exterior walls were observed to be in good condition, with isolated areas in need of cleaning due to organic growth. A foundation crack was observed near the corner of the Main Building near the kitchen. It was reported that this area also has a cracked interior kitchen wall in the same location. Expansion joint sealant was deteriorated or missing in places but was in average condition. Masonry spalling was observed at a structural beam near the kitchen loading dock roof. Also, the crawlspace access grate may allow rodents to enter between the grate in the concrete and the expanded metal on the wall opening.	Good

2. Repair the leaking concrete block wall and damage to adjacent finishes in the kitchen after the structural issue in this area is addressed.
3. Investigate and seal penetration points for rodents at the crawlspace access grate below the building. Continue pest management program with district exterminators.

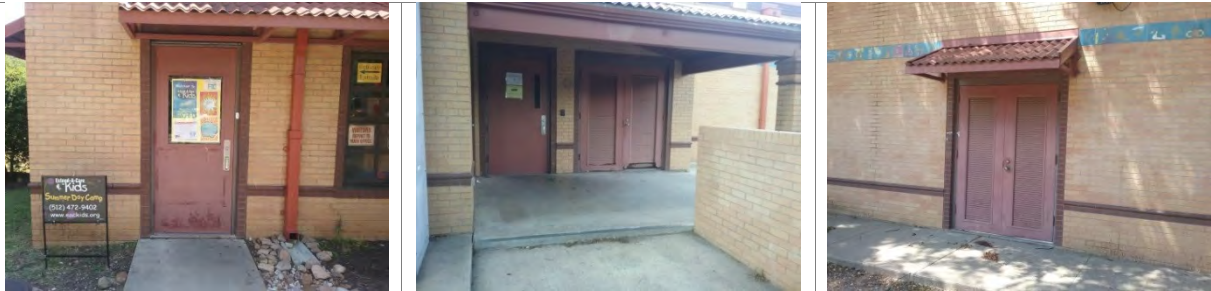
Exterior Windows	The exterior windows consist of single-pane glazing units with bronze aluminum window frames. All windows appear to be original to building and in good condition with no reported issues.	Good
	Exterior Doors	There is one main public entryway located at the east side of the building. All exterior doors are hollow metal with original hollow metal frames. The exterior doors were observed to be in good condition with minor paint issues, primarily on those facing the sun. The kitchen door and doorframe showed signs of rust and deterioration.	Good
Roofing	The roof material covering the majority of the building appears to be PVC/TPO (polyvinyl chloride/thermoplastic membrane). There is a connecting covered walkway with a metal sloped roof between the Main Building's B-wing and C-wing.		Average

4. Paint the stair railing with hard architectural coating to minimize future repainting or replace with galvanized rail.
5. Repaint/replace damaged exterior doors.

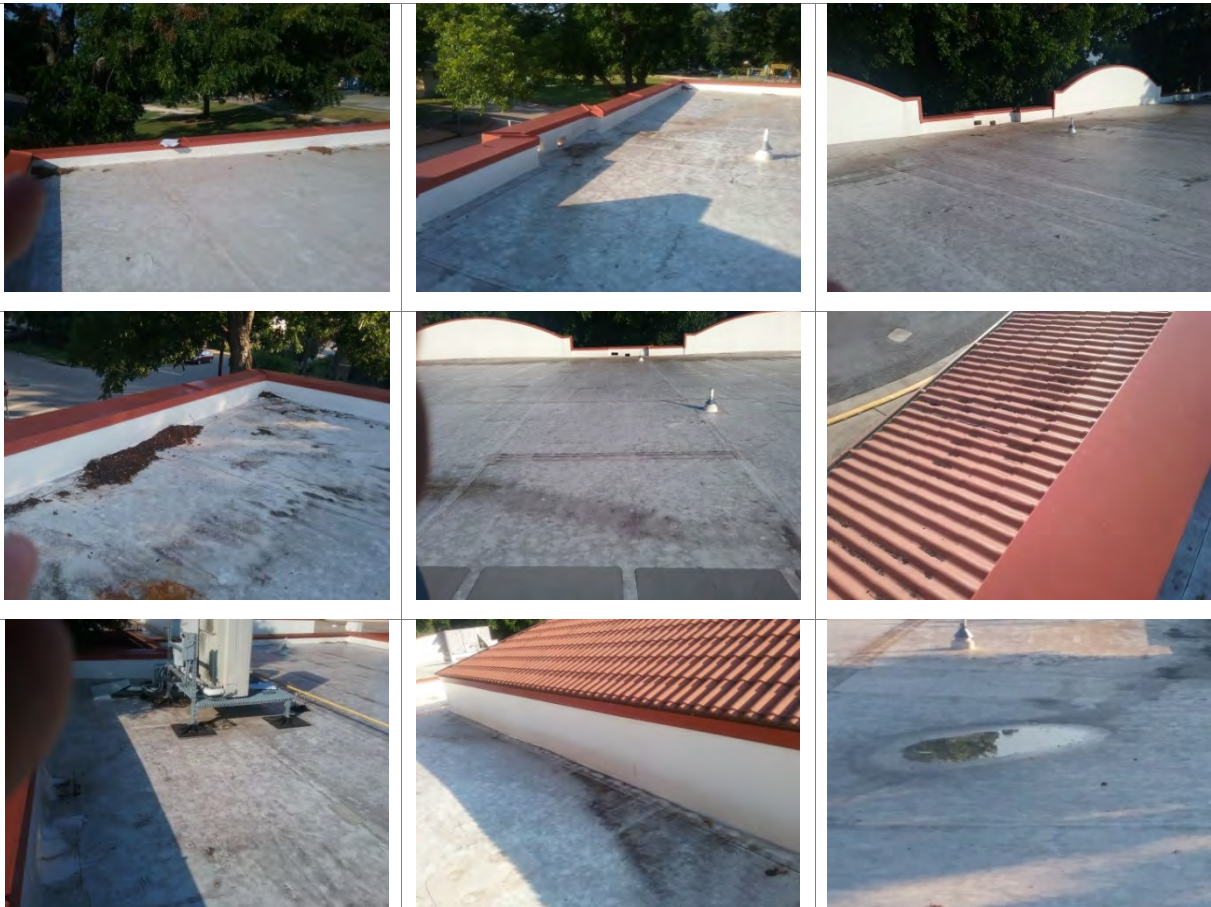
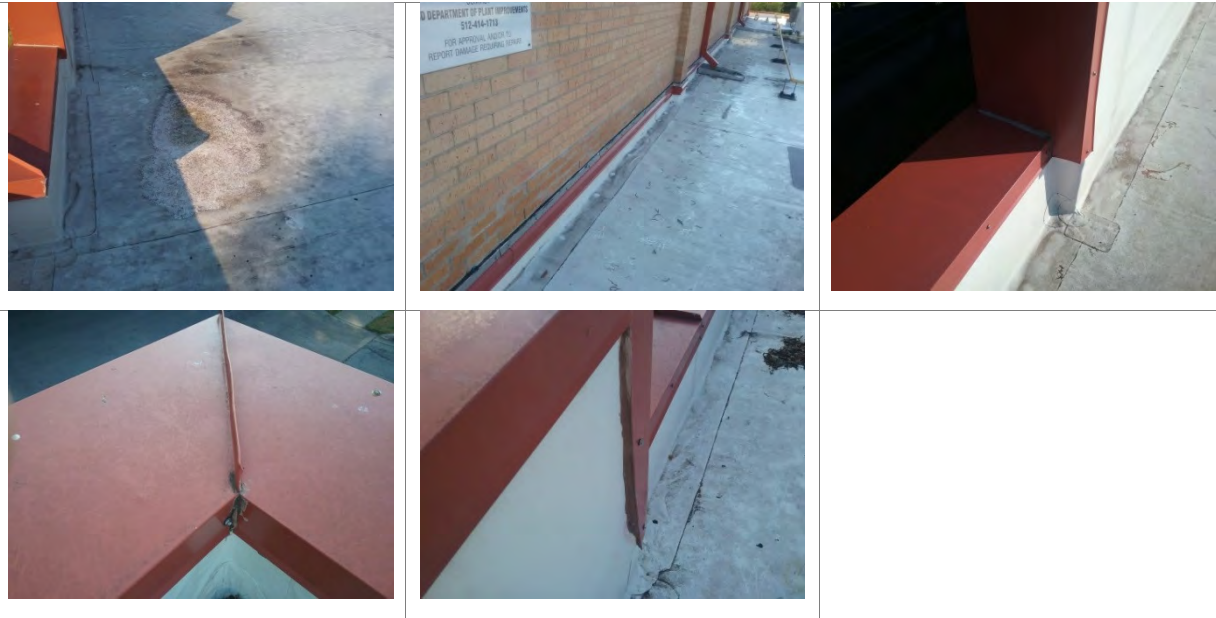
Roofing Deficiency Examples

System	Subsystem	Condition and Deficiency Overview	System Condition Rating
		<p>There is also a sloped metal roof along the north and east facades. There is a sloped metal roof at the bus canopy along the east side of the parking lot connecting to the building canopy.</p> <p>The majority of roof surfaces appear to be in average condition with the exception of isolated areas where ponding and blistering were observed on the A- and B-wings (roofs A30, A31, A01) and C-wing (roof A107). The west side of the building (B-wing) was in poor condition. Leaks were reported in B122, C100 and COR5, and ceiling damage was visible in these areas. Building staff indicated that leaks had occurred mainly in the north and west of the building. Many areas of blistering, ponding, debris and staining were observed in these areas. The membrane flashings around the metal hip roofing elements showed signs of blistering and darkening as well. The areas above the cafeteria and gymnasium were at two different heights from the rest of the roofs, but in average condition. Little staining was noted in these areas. The base flashing sealant along these higher walls was deteriorating. Water damage was reported near this area.</p> <p>The metal sloped canopy roof over the walkway appeared to be in good condition, although the front canopy had dark staining and debris buildup. Many of the sealants used on the metal copings were deteriorated and pulling away from the membrane flashings throughout the roofing system.</p>

1. Investigate areas of roofing which appear to be leaking into classrooms below A-, B-, and C-wings and COR5.
2. Repair flashings that may be causing leaks near the cafeteria outside COR5 and in the middle of B-wing. Verify that membrane flashings at hip roof above the library are water proof.

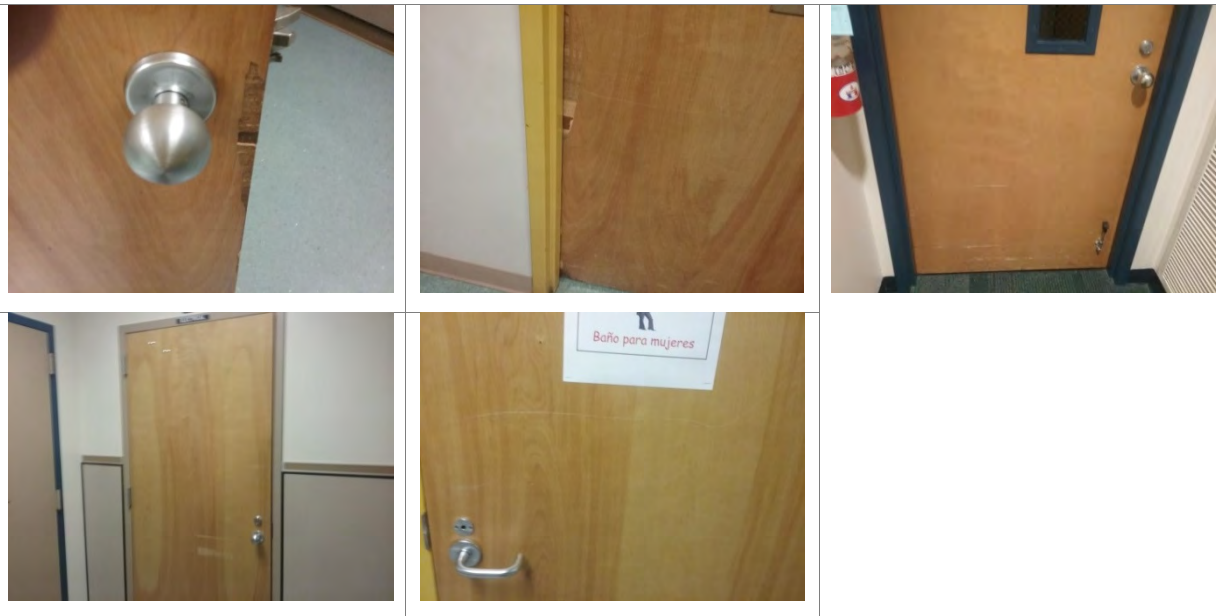
Interior Construction	Interior Walls	<p>The administrative offices, classrooms and library have painted gypsum board construction. The gymnasium, kitchen and cafeteria are constructed of a combination of gypsum and CMU (concrete masonry unit) systems.</p> <p>There are hollow metal framed interior windows located throughout the building. Most of the classroom partitions have had small spots of the gypsum board paper layer torn away. This damage was typically around tack boards, doors and windows. The administrative offices, Nurse's office, stage and library were in good condition.</p>	Good
	Interior Doors	<p>The building contains solid core wood doors, hardware, and hollow metal doorframes.</p> <p>The interior doors and frames were observed to be in good condition. There were scratches and finish damage observed on the wood doors. A few doors had severe gouges. The hardware throughout was showing signs of wear, but appeared to be in good condition.</p>	Good

6. Replace damaged ceiling tiles with new matching ceiling tiles.
7. Replace damaged floor tiles with matching product.
8. Replace five damaged wood doors. Refurbish 30% of wood door surfaces. Provide kick plates.

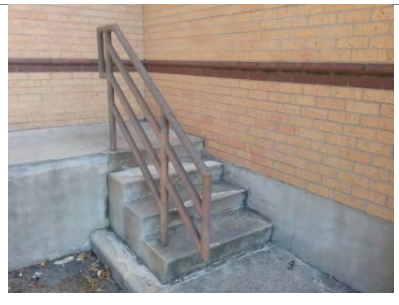
Interior Specialties	System not present.	N/A
Stairs	Exterior Stairs	Concrete stairs with steel nosings were only noted at the loading dock and were observed to be in average condition. The stair railing observed was unpainted steel and in poor condition showing signs of rust and corrosion.	Average
	Interior Stairs	The ramp and stairs at the back of the stage are concrete with steel railings. The stage steps are wood and were observed to be in good condition.	Good

1. Repaint stair handrails with a very hard architectural coating to minimize the need for repainting as often.

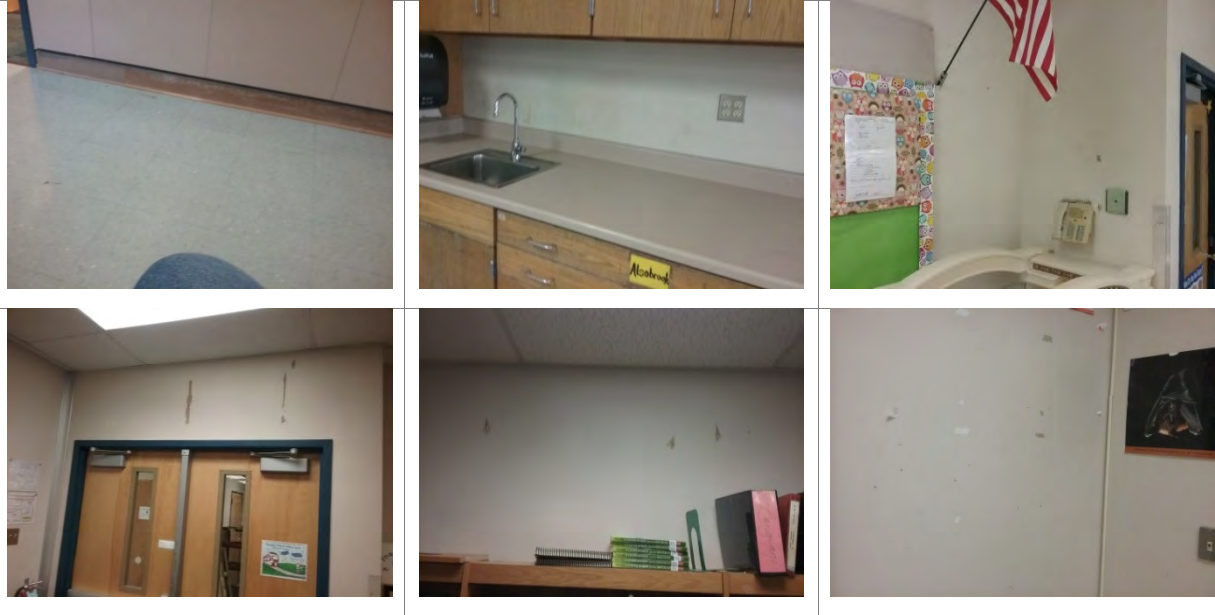
System	Subsystem	Condition and Deficiency Overview	System Condition Rating
Interior Finishes	Interior Wall Finishes	<p>The building has undergone renovations since its original construction in 1993. The library, administration and Nurse's office spaces were recently updated and appear to be in good condition. The corridor walls are plastic laminate wainscot with gypsum construction above and appeared to be in good condition. The walls in most classrooms have areas of missing gypsum paper and paint. This occurs around tack/chalkboards, doors, windows and above millwork in approximately 90% of classrooms. Painted gypsum walls inside the stage and cafeteria are also in good condition.</p> <p>A few staff restrooms were observed. These were finished with 4"x4" wainscot ceramic tile with painted gypsum construction above. The public restrooms are full height ceramic tile. Both were observed to be in average condition.</p> <p>The gymnasium is painted acoustical block construction and in good condition. The cafeteria and kitchen are painted concrete block and in good condition, except for an area reported to have a leak above the sink.</p>	Good

9. Touchup texture and paint classroom walls.

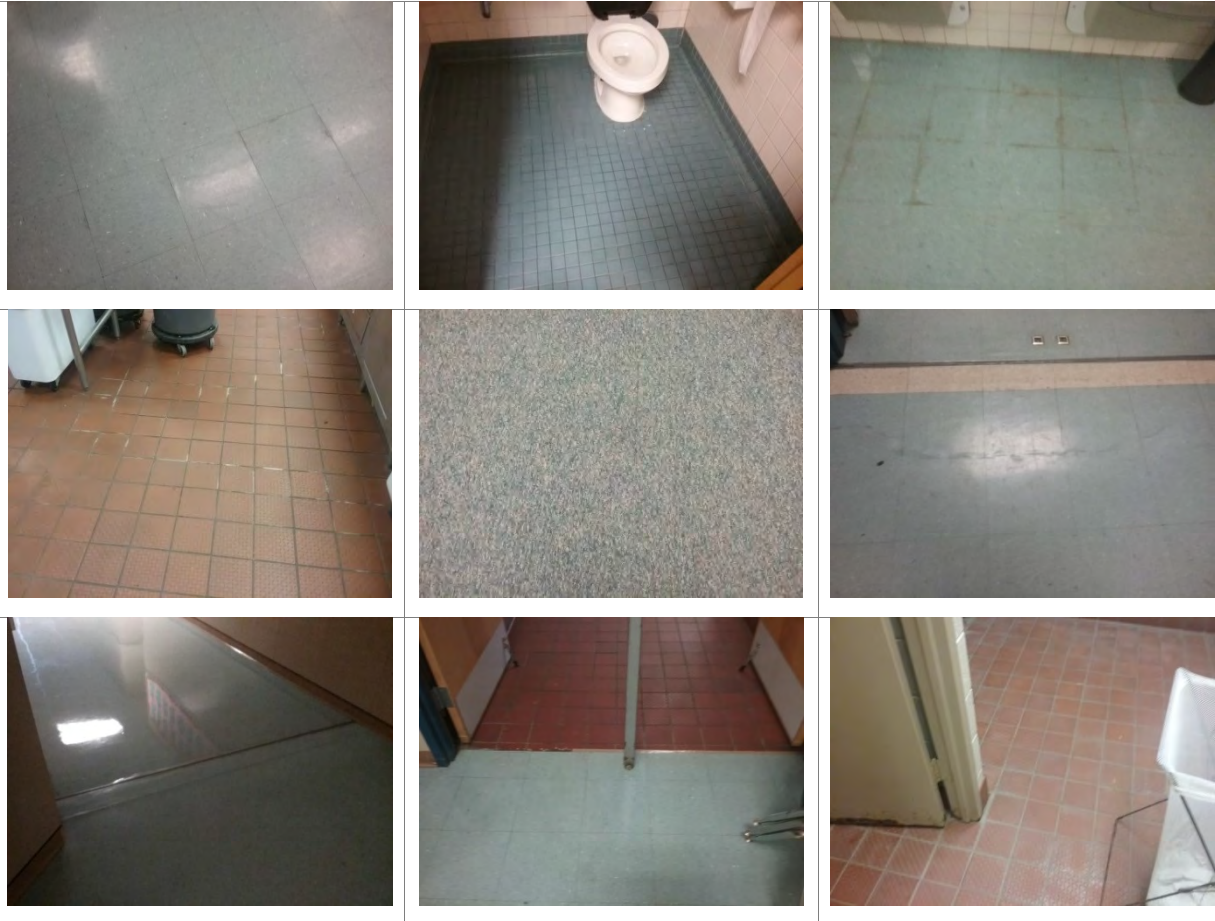
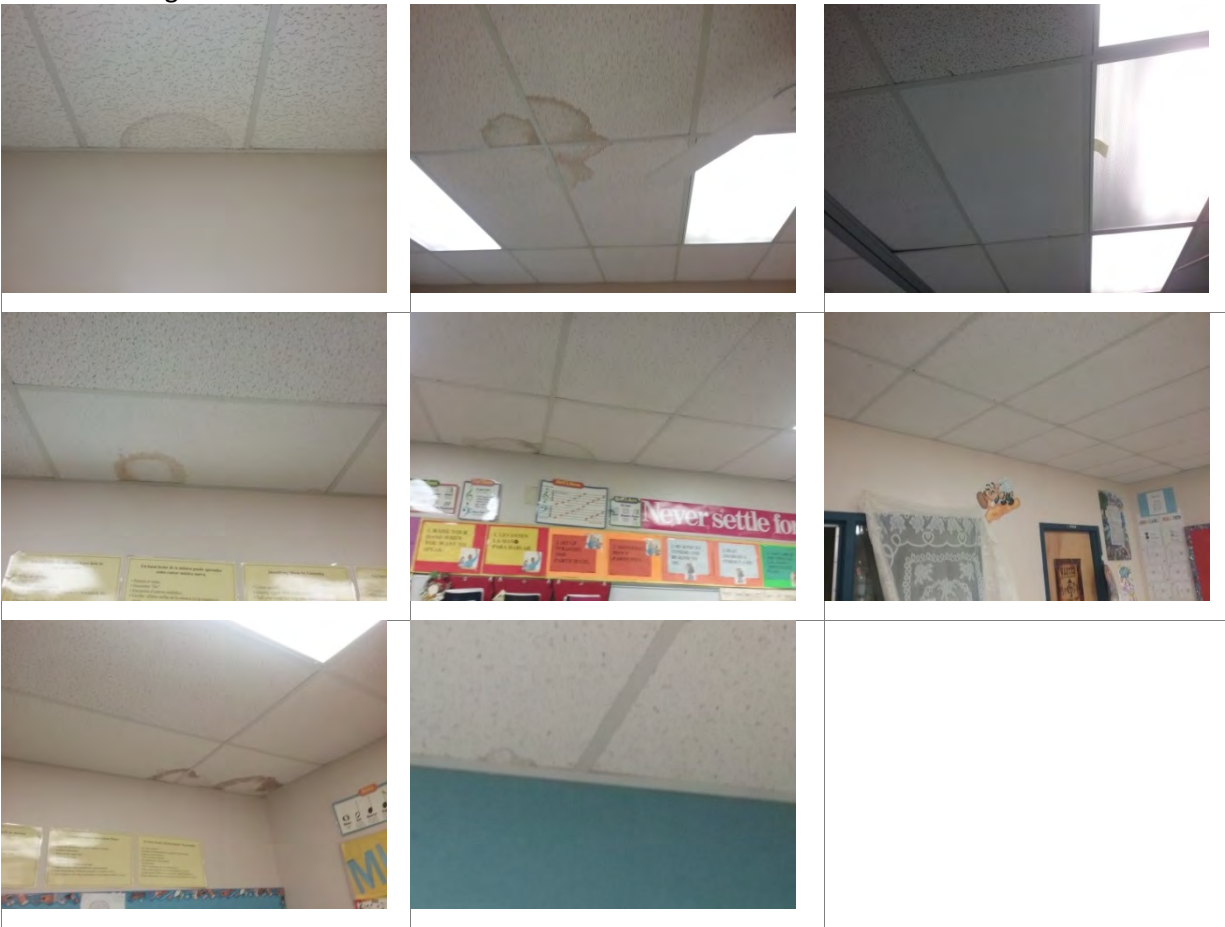
Interior Floor Finishes	<p>Resilient 12"x12" floor tile is found throughout the building and is original construction. Original ceramic tile floor is present in the restrooms. The administrative offices and library are finished with carpet and in good condition.</p> <p>In room 122, vinyl tile has been patched.. Carpet in the music room had a pull in the pile material. In one staff restroom, the grout was discolored around the toilet. In the cafeteria, some tiles appeared to be darkened below the hand sink. The transition strips between quarry tile and vinyl tile were deteriorated in the serving line. It was observed in the kitchen that there are several areas with water marks in the grout.</p>	Good
	Interior Ceiling Finishes	<p>Acoustical 2x4 lay-in tile was predominantly used throughout the building. Reports of leaks in B-wing and C-wing was confirmed by water-damaged tiles observed in these areas. The ceiling in the gymnasium consisted of exposed joists and decking that was observed to be in good condition.</p> <p>No damaged ceiling tiles were observed in COR5, though this area has been reported to have roof leaks. All other areas with reported leaks have water-damaged ceiling tiles. A few damaged ceiling tiles with holes and miscellaneous scratches appeared in about 20% of the classrooms.</p>	Good

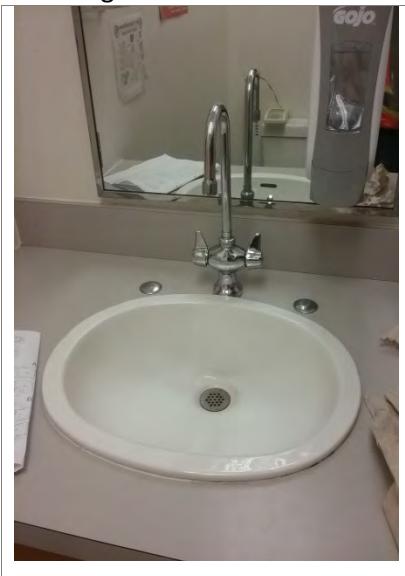
System	Subsystem	Condition and Deficiency Overview	System Condition Rating
Plumbing	Plumbing Fixtures	<p>The building has shared male and female restrooms for students between classrooms, and separate staff restrooms located throughout the facility. The restrooms have vitreous china hand sinks in counters with manual faucets, along with vitreous china toilets with manual flushing mechanisms. There are service sinks found in the janitorial closets and water fountains located throughout the facility, typically near the public restrooms.</p> <p>The restroom plumbing fixtures are in average condition as the fixtures are typically aged but still operational with noticeable wear due to their age.</p> <p>The kitchen includes additional plumbing fixtures such as stainless steel wash sinks. These plumbing fixtures were observed to be in average condition.</p>	Average
	Domestic Water Distribution	<p>The sinks located throughout the facility, with the exception of the kitchen, are not equipped with hot water. The sinks located in the kitchen are serviced with hot water from a gas water heater (GWH-1) that is located in the kitchen mechanical room.</p> <p>The water heater was observed to be in poor condition and appears to be at the end of its useful life. An additional water heater is present in the room and appeared to be abandoned. An abandoned recirculation pump was also observed in the mechanical room.</p> <p>The plumbing distribution equipment was observed to be in poor condition based upon the deficiencies of the water heater mentioned above and the age of the system.</p>	Poor

1. Continue preventive maintenance on aged plumbing fixtures or plan for replacement in the future as fixtures continue to age.
2. Repair or replace any damaged or missing piping insulation as needed.
3. Paint/protect gas lines on the roof from further rusting as needed.
4. Track the installation date of the water heater and plan for replacement as the typical design service life for a water heater is 10 to 15 years.
5. Remove the abandoned water heater, circulation pump and associated piping from the kitchen mechanical room.

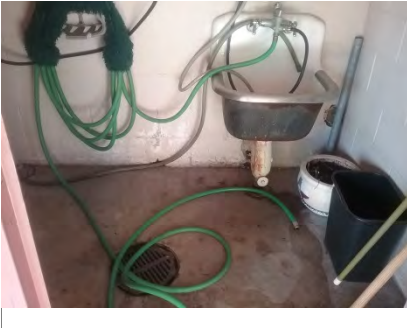
Other Plumbing	<p>The roof drainage system consists of gutters that drain water off the roof as well as roof drains located within the roof perimeter. The interior floor drains were observed to be aged and in average condition.</p>	Average
Mechanical/ HVAC	<p>The major mechanical equipment consists of package RTUs on the roof and floor-mounted units within the classrooms and corridors that appeared to be ground source heat pumps to provide cooling in the building. Additional ducted ground source heat pumps are located within the interior spaces in the facility, presumably to provide cooling to the corridors and select interior portions of the building. These serve the HVAC (heating, ventilating, and air conditioning) system along with roof-mounted and plenum-mounted exhaust fans.</p> <p>Eight rooftop units (RTU)s, ranging in capacity from an estimated 10 to 25 tons, are located on the roof. There are floor-mounted units that appeared to be ground source heat pumps located in the classrooms and select other areas, including the corridors. Approximately six additional ground source heat pumps are located within mechanical closets and were observed to be past their service life. The RTUs and ground-mounted units within the facility appear to be aged and need replacement. Split system AHUs (air handling units) were observed to serve the</p>		Poor

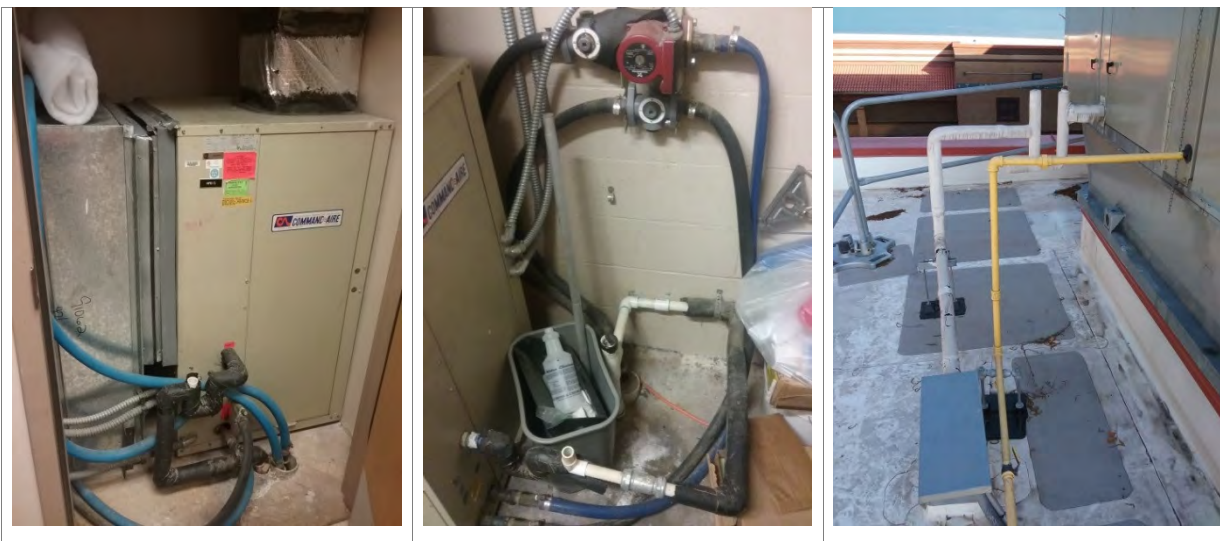
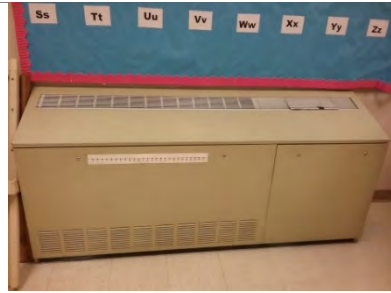
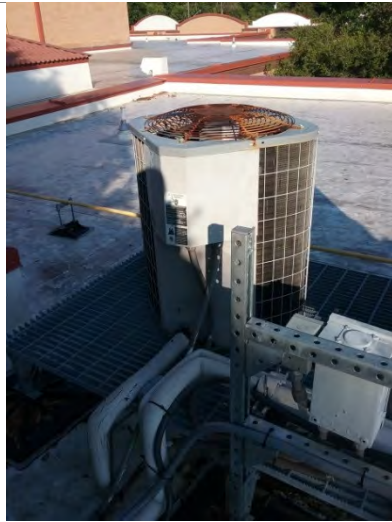
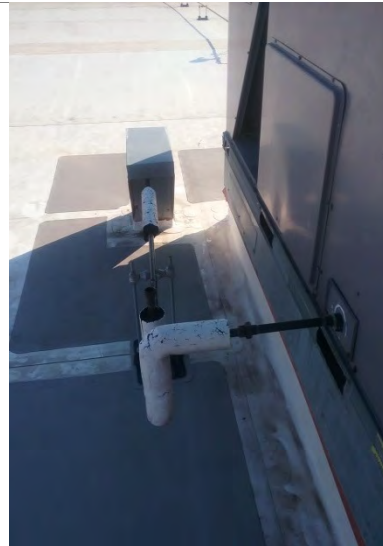
Mechanical/HVAC System Deficiency Examples

System	Subsystem	Condition and Deficiency Overview	System Condition Rating
	<p>MDF (main distribution frame) room as well as the administration area. The split system units serving the administration area were observed to be in good condition. The split system serving the MDF room was inaccessible at the time of assessment. Corrosion was observed on several pieces of equipment and piping. The condensate lines associated with the RTUs appeared to be aged and damaged in some areas. The condensate drain piping insulation was observed to be deteriorated or missing in areas. Corrosion was beginning to form on the gas piping associated with the RTUs.</p> <p>Supplemental mechanical equipment for the HVAC system also includes roof-mounted and plenum-mounted exhaust fans. The roof-mounted and wall-mounted exhaust fans appeared to be outdated and need replacement. The plenum-mounted exhaust fans appear to serve bathroom exhaust. The rooftop exhaust fans located on the kitchen roof are much larger and appear to serve the dishwasher, kitchen exhaust hood and general kitchen exhaust. The makeup air unit appears to be in good condition.</p> <p>The HVAC system was observed to be in poor condition due primarily to its age.</p>

1. Plan for replacement of the ground source fan coil units as these units appear to be past their design service life.
2. Plan for replacement of the RTUs as these units appear to be past or near the end of their design service life.
3. Address any rust or corrosion observed to the equipment, its associated piping, or any other sub-asset in all facilities by cleaning, repainting, or repairing to prevent further deterioration.
4. Repair or replace any damaged or missing piping insulation as needed at all facilities.

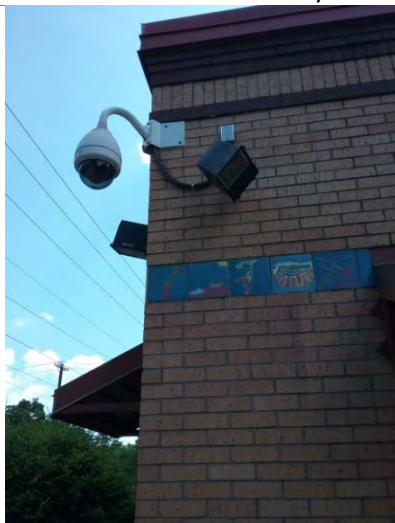
Communications & Security	There is a Gemini security system including surveillance cameras covering the interior and exterior of the building. Facilities reported that the exterior cameras are not fully functional, there are blind spots throughout the corridors, and the quality of video in the kitchen area is poor. There is a public address system in the building, and it was observed to be in good condition. The building is equipped with tele/data systems, but the main backbone equipment is located in an inaccessible room.	Average

5. Replace non-functional cameras, and add more cameras where required for all areas identified by the staff, particularly in the corridors and play areas.
6. Identify and repair the issue with the kitchen panel reported by the staff.
7. Inform Facilities that electrical rooms are not to be used for janitorial storage.
