Mills Elementary School Site Summary

Address	6201 Davis Lane Austin, TX 78749
Number of Permanent Campus Facilities	1
Original Year of Construction	1998
Total Campus Building Area (combined)	81,368 SF

Main School Building – BLDG-181A

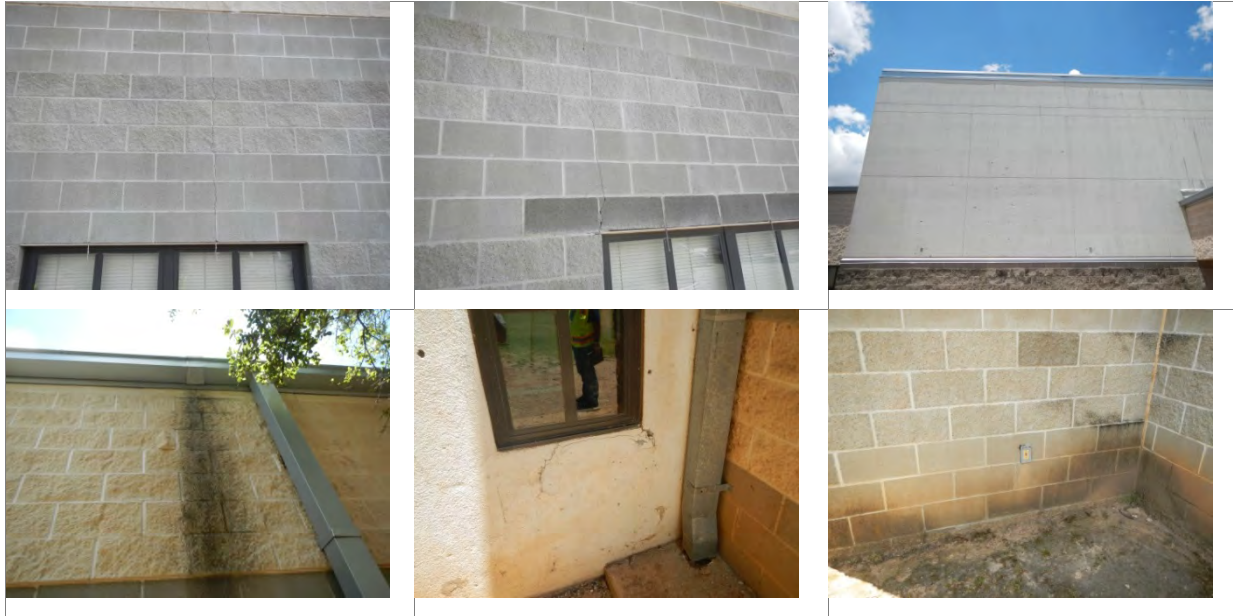
System	Subsystem	Condition and Deficiency Overview	System Condition Rating
Exterior	Exterior Walls	<p>The exterior of the building consists primarily of a concrete masonry unit (CMU) façade with areas of gunite present.</p> <p>The CMU walls had areas with minor water staining caused by leaking gutters and ponding water due to poor site drainage. It was reported that rooms 104 and 106 have had water intrusion through the base of the wall during heavy rain events, likely caused by poor site drainage. A significant amount of vertical and step cracks were observed in the CMU around the exterior of the building. Dents and holes caused by thrown rocks and balls were also observed in the areas of gunite façade. It was reported that the gunite façade acts “sponge like” during rain events and tends to absorb water.</p> <p>Despite having multiple minor wall deficiencies, the overall condition of the exterior walls was average.</p>	Average

1. Investigate site drainage issues that are causing leakage through exterior walls and doors and take corrective action
2. Investigate a solution to control all of the cracking in CMU walls and take corrective action.

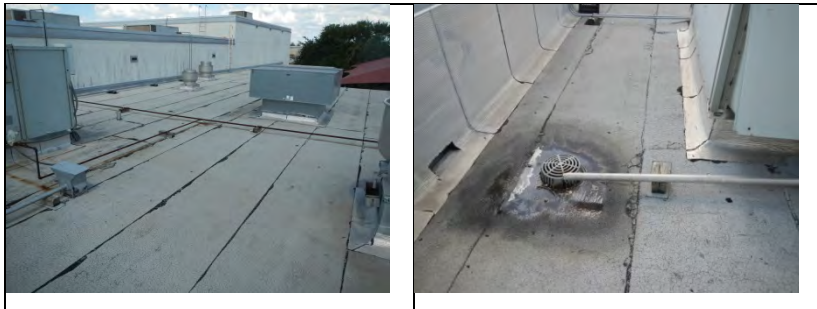
Roofing Deficiency Examples

System	Subsystem	Condition and Deficiency Overview	System Condition Rating
		the doors on the south end of the C6 corridor and floods the corridor during heavy rain events. This is caused by poor site drainage outside of the doors. The exterior doors were in average condition with typical wear and tear.	
Roofing	The roof material covering the building is asphalt shingle roll roofing. There are covered walkways near the building entryways with metal roofing. The asphalt roof surfaces had cracks and bubbling and appeared aged. It was reported that minor water penetration occurs on the roof, which has required the replacement of ceiling tiles. The asphalt roofing is nearing the end of its service life and was in poor condition.		Poor
Interior Construction	Interior Walls	The interior partitions original to the building are predominantly painted gypsum board construction with painted CMU. The interior partitions appeared to be in good condition as no instances of significant cracking or chipping were observed on any of the wall surfaces.	Good

1. Consider repairing or replacing the existing roof as it was in poor condition and is near the end of its service life.
2. Investigate the roof for leaks that are causing staining on the interior ceiling tiles and take corrective action.

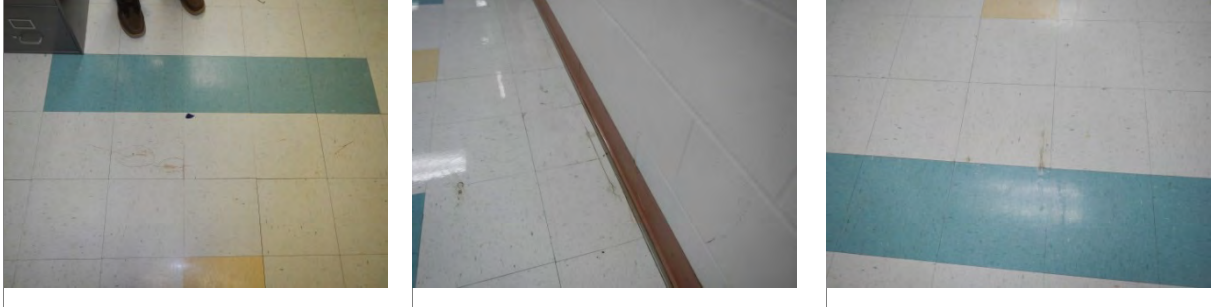
Interior Floor Finishes	Vinyl floor tile is found in most areas throughout the building and is original to the facility. Ceramic tile floor is present in the restrooms and the kitchen. The administrative offices and library as well as some	Good

System	Subsystem	Condition and Deficiency Overview	System Condition Rating
		<p>classrooms are finished with carpet.</p> <p>It was reported that the carpet in the admin offices and 100-wing classrooms was replaced this past year. Visual observation of these classrooms confirmed that the carpet was in excellent condition.</p> <p>Minor cracking was observed in some of the vinyl floor tiles in the corridors. Apart from this deficiency, interior floors appeared to be in good condition.</p>	
	Interior Ceiling Finishes	<p>The ceilings in the building are predominantly finished with 2x2 and 2x4 suspended lay-in acoustic tiles.</p> <p>It was reported that stained ceiling tiles are visible on occasion because of reported water intrusion from the degraded roof. Stains in the ceiling tiles were located at various locations throughout the school.</p> <p>The ceiling tiles were in average condition, apart from the stained ceiling tiles.</p>	Average

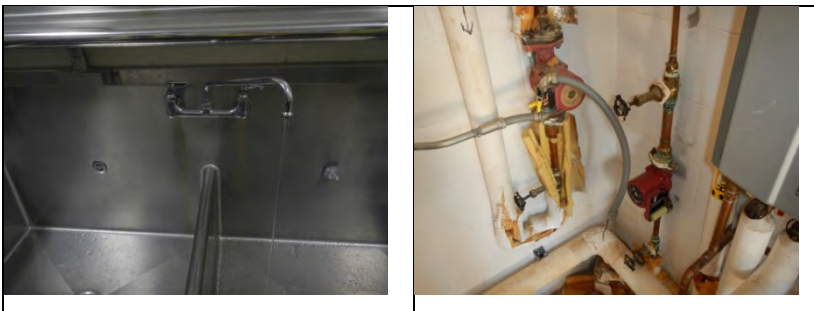
Domestic Water Distribution	<p>The only plumbing fixtures that are serviced with hot water from gas and electric water heaters are located in the kitchen and in the janitorial closets.</p> <p>The tankless water heater located in the KITMECH room was reported as having a circulating pump that was not operating properly. The multi-basin stainless steel sink in the KITDWRM does not receive adequate</p>	Poor

System	Subsystem	Condition and Deficiency Overview	System Condition Rating
		<p>hot water pressure to the right-hand fixture of the sink.</p> <p>The plumbing distribution equipment appeared to be in average condition, but with the reported deficiencies the domestic water distribution system, is rated as poor.</p>	
	Other Plumbing	<p>Roof drains are not present at the facility apart from one drain for HVAC (heating, ventilating, and air conditioning) condensation. Gutters and downspouts are present at the facility to drain water from the roof.</p> <p>The condensate roof drain appeared unclogged and in average condition despite the amount of water pooled around the drain caused by improper plumbing of the condensate line. The floor drains in KITDWRM for draining the dishwashing sinks were reported as being undersized. It was reported that it takes nearly 40 minutes for staff to completely drain the sinks, and water will typically pool on the floor around the drain. It was also reported that the floor drain in front of the ovens potentially has a severe clog or blockage that causes poor and slow drainage.</p> <p>The drains throughout the facility were observed to be in average condition, but with the reported issues, the system rating of other plumbing is in poor condition.</p>	Poor

1. Repair the non-operational water heater circulating pump.
2. Investigate repair options for the inadequate water pressure in the dishwashing sink.

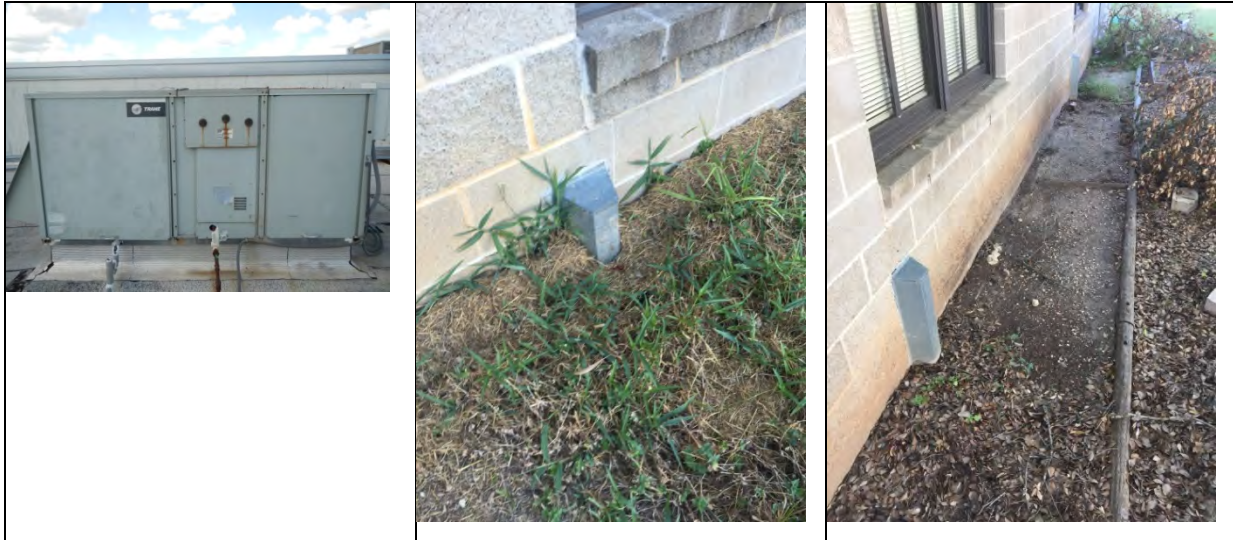
Mechanical/HVAC System Deficiency Examples

Mechanical/ HVAC	<p>The HVAC system for the building is composed primarily of package rooftop units (RTUs) ranging in size from 10- to 15-TON and split system individual heat pump consoles located in classrooms.</p> <p>It was reported that the console units function properly for their age but are almost at the end of their service life. It was reported that some of the console units in classrooms have had excessive condensation on high humidity days, and the drip pans will overflow and leak onto the classroom floor. It was also reported that the condensate lines drain to the exterior of the classrooms, and the exterior drainage for units located primarily in the 100-wing will clog up. It was reported that variable air volume (VAV) units have tripped in the past during storms, but none of the faculty was certain if the problem had been addressed.</p> <p>The HVAC system for the building was observed as being in average condition with the only major deficiencies being the age of the units and the excessive condensation on some units. These units are all reaching the end of their recommended service life and will need replacement in the next few years.</p>		Average

1. Consider replacement of all HVAC units that are original to the facility as they are nearing the end of their recommended service life.
2. Improve the exterior drainage for classroom heat pump console condensate lines to prevent water leakage onto classroom floors.
3. Repair the condensate drain lines for the RTUs to reduce the amount of ponding water on the roof.
