## Norman Elementary School Site Summary

## Main School Building – BLDG-150A

## CRAWL SPACE – Norman ES – Main School Building (150-A)

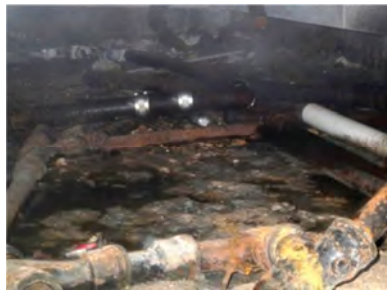
Damp soil, Small areas with standing water

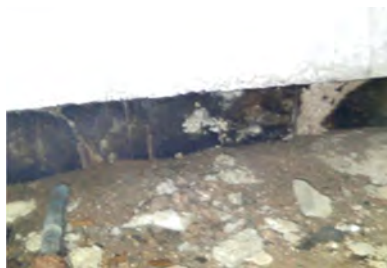
Cracked soil retainers

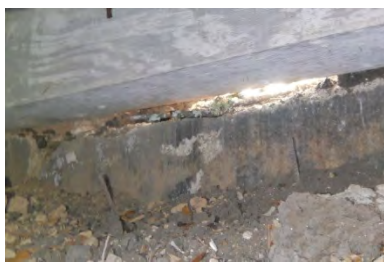
Failed soil retainers

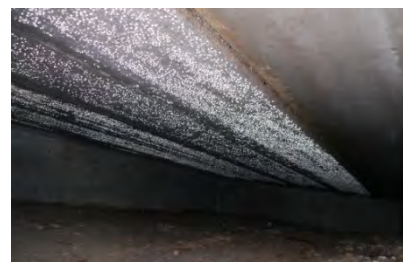
Poor ventilation, Condensation under slab

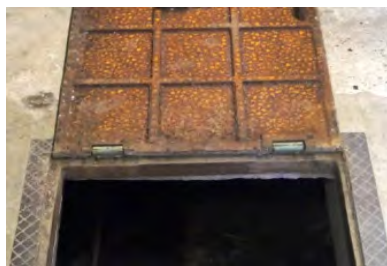
Corroded floor access hatch frame & door

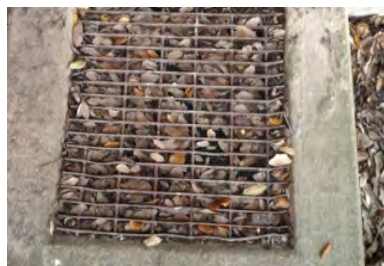
Foliage partially clogging areaway

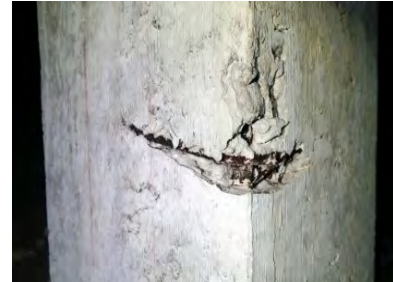
Spalling at column corner,  
Exposed/corroded column reinforcement

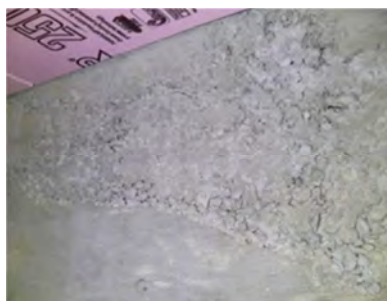
Honeycombing on face of perimeter  
beam

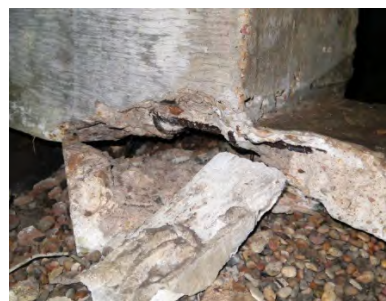
Large spall under former perimeter beam  
(adjacent to library addition)

1. Repair large spall at interior beam adjacent to library addition. Clean exposed reinforcing beforehand.
2. Clean corrosion from exposed reinforcement and remove unsound concrete along bottoms of cracked/spalled channel legs. Patch damaged areas with a repair mortar. Enlarge leg section as needed to establish adequate clear cover to the channel rebar.
3. Clean corrosion from exposed slab & column reinforcement and paint with a rust-inhibitive coating to protect from further corrosion

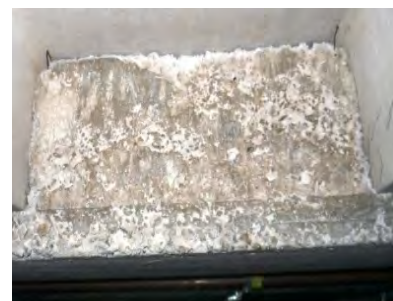
Honeycombing on interior beam

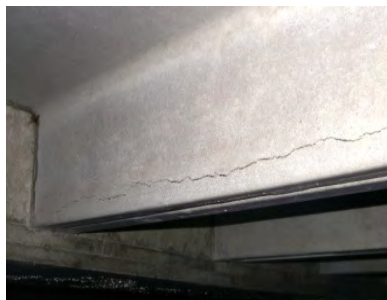
Longitudinal cracking along bottom of  
precast channel leg

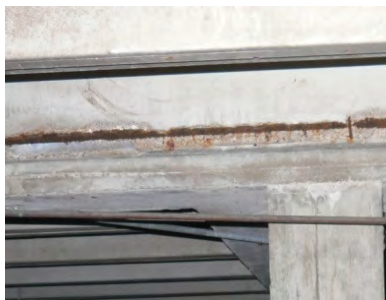
Exposed/corroded longitudinal rebar at  
bottom of precast channel leg

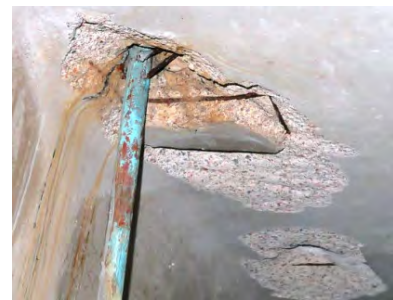
Channel slab spalling & corroded reinf at  
pipe penetration

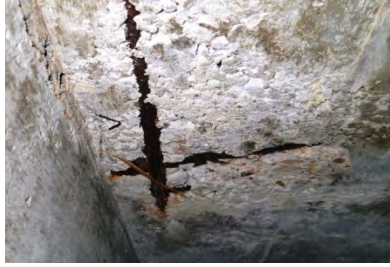
Exposed/corroded rebar and  
honeycombing under flat slab

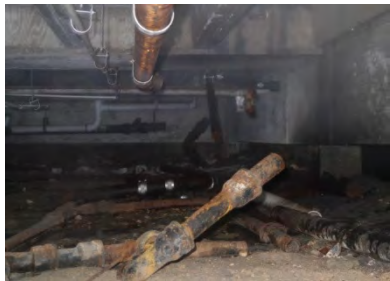
Pipe leak in slab, broken pipe, and  
broken pipe hanger. Mistiness of picture  
is due to steam in the air.

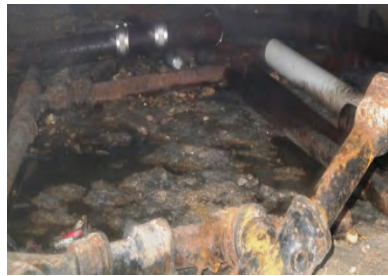
Water under kitchen pipe leak

1. Repair kitchen pipe leak immediately.
2. Clean corrosion from pipes and paint to prevent further corrosion.
3. Replace heavily corroded pipe hangers.
4. Replace degraded pipe insulation.
5. Replace torn/degraded duct insulation.
6. Reattach or replace fallen rigid insulation boards.

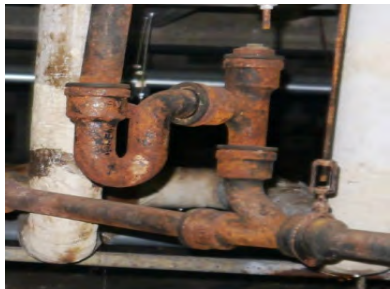
Rusted pipes & pipe supports

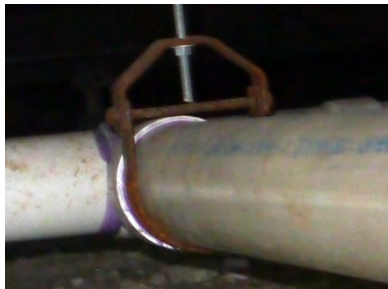
Rusted pipe hangers

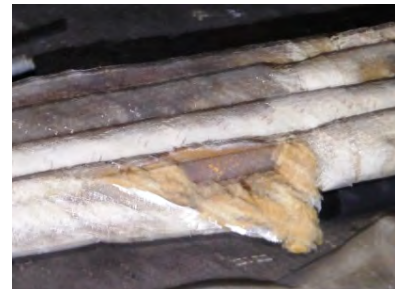
Torn/degraded pipe insulation

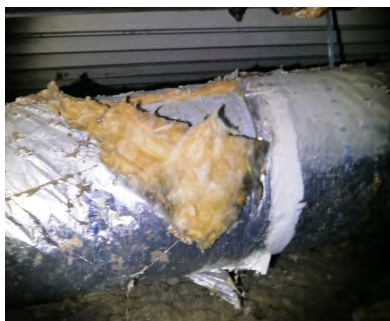
Torn/degraded duct insulation

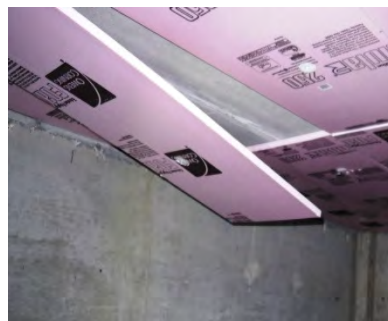
Falling rigid board insulation

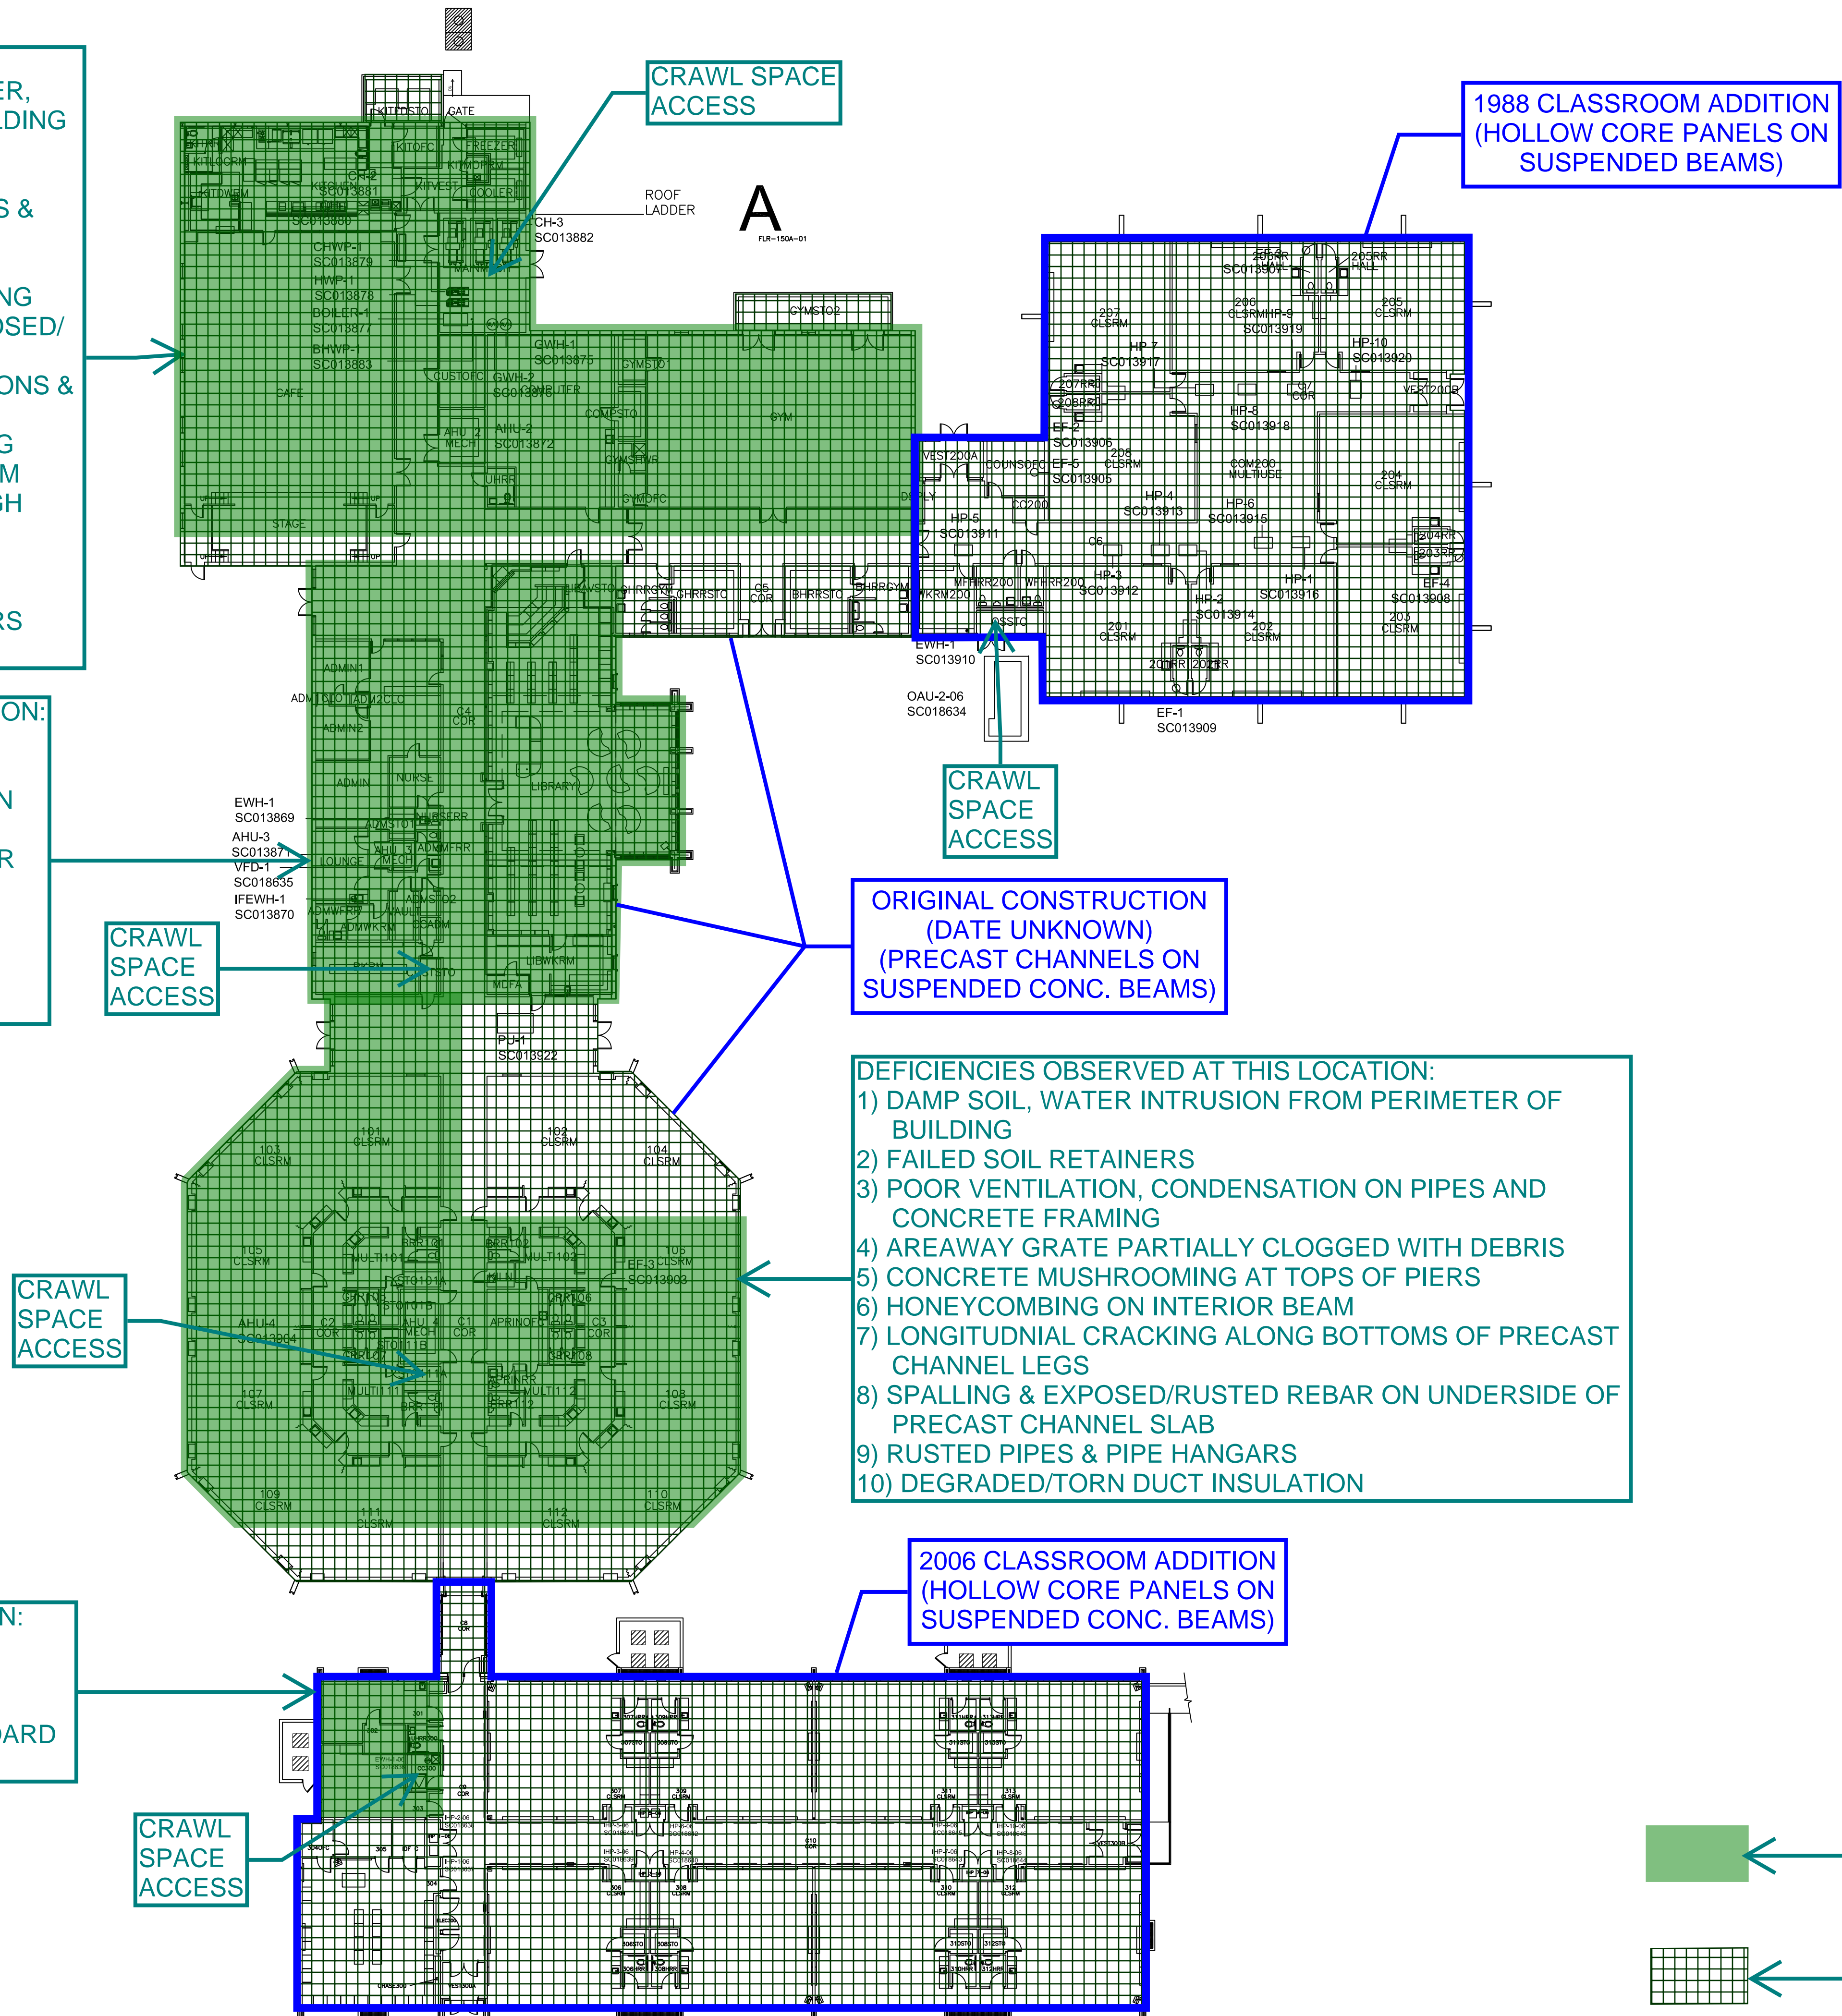
- DEFICIENCIES OBSERVED AT THIS LOCATION:
- 1) DAMP SOIL, SMALL AREAS OF STANDING WATER, WATER INTRUSION FROM PERIMETER OF BUILDING
  - 2) PARTIALLY CLOGGED DRAIN
  - 3) DAMAGED SOIL RETAINERS
  - 4) POOR VENTILATION, CONDENSATION ON PIPES & CONCRETE FRAMING
  - 5) CORRODED ACCESS HATCH FRAME & DOOR
  - 6) LONGITUDINAL CRACKING AND SPALLING ALONG BOTTOMS OF PRECAST CHANNEL LEGS, EXPOSED/CORRODED BOTTOM REBAR
  - 7) CHANNEL SLAB SPALLING AT PIPE PENETRATIONS & HANGER CONNECTIONS
  - 8) MILD HONEYCOMBING ON CONCRETE FRAMING
  - 9) LARGE AMOUNT OF HOT WATER LEAKING FROM KITCHEN ABOVE INTO CRAWL SPACE THROUGH PIPE IN FLOOR
  - 10) POSSIBLE FAILED/BROKEN PIPE CAUSING CONDITION LISTED IN DEFICIENCY #9 ABOVE
  - 11) SEVERELY CORRODED PIPES & PIPE HANGERS
  - 12) DEGRADED PIPE INSULATION

- DEFICIENCIES OBSERVED AT THIS LOCATION:
- 1) DAMP SOIL
  - 2) FAILED SOIL RETAINERS
  - 3) POOR VENTILATION, CONDENSATION ON CONCRETE FRAMING
  - 4) RUSTED ACCESS HATCH FRAME & DOOR
  - 5) COLUMN HONEYCOMBING & SPALLING, EXPOSED/CORRODED REBAR
  - 6) SPALLS AT INTERIOR BEAM
  - 7) RUSTED PIPES & PIPE HANGERS
  - 8) TORN/DEGRADED PIPE INSULATION

- DEFICIENCIES OBSERVED AT THIS LOCATION:
- 1) HONEYCOMBING ON COLUMN
  - 2) HONEYCOMBING ON PERIMETER BEAM
  - 3) RUSTED PIPE HANGERS
  - 4) DETACHED/FALLEN RIGID INSULATION BOARD
