Odom Elementary School Site Summary

Main School Building – BLDG-156A

Odom Elementary School Campus Summary of Recommendations

CRAWL SPACE – Odom ES – Main School Building (BLDG-156A)

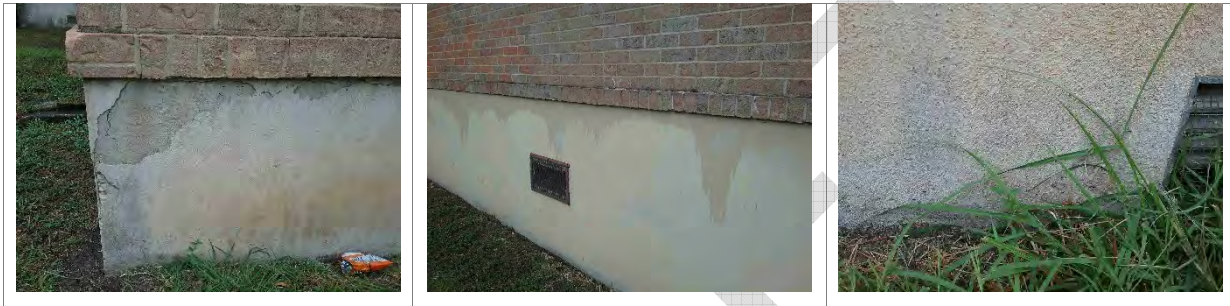
System	Subsystem	Condition and Deficiency Overview	System Condition Rating
Exterior	Exterior Walls	The exterior of the building is finished with brick with prefinished metal downspouts and coping. The concrete foundation wall is finished with a painted plaster coating. The plaster finish on the concrete portions of the exterior walls was peeling and cracking. Water was leaking through one concrete wall of the building. Streams of insects were entering the building through various openings.	Good
	Exterior Windows	The exterior windows consist of single-pane glazing set in metal frames. Some windows are covered with mesh insect and metal safety screens. The metal and insect screens were broken on the windows facing the playground. Condensation was present on a few of the windows, namely those near the bus drop-off door. Peeling paint was observed on many window and awning frames. The windows to classroom 114 were reported to be leaking, but no evidence of water was observed. Windows in the primary-wing were operational, but unclean and missing an insect screen.	Average

1. Patch cracking plaster on exterior stairs.
2. Refinish the metal handrails on the exterior stairs.
3. Apply perimeter treatment to the building and seal holes and cracks to prevent further insect intrusion.
4. Clean exterior windows.
5. Refinish aged exterior doors.
6. Replace damaged door lites.
7. Investigate cause of water seepage through concrete and mitigate.
8. Patch peeling and cracking plaster finish.
9. Monitor windows in room 114 for water intrusion.
10. Reinstall windows showing condensation.
11. Refinish peeling window frames.
12. Install insect screens on all operable windows.

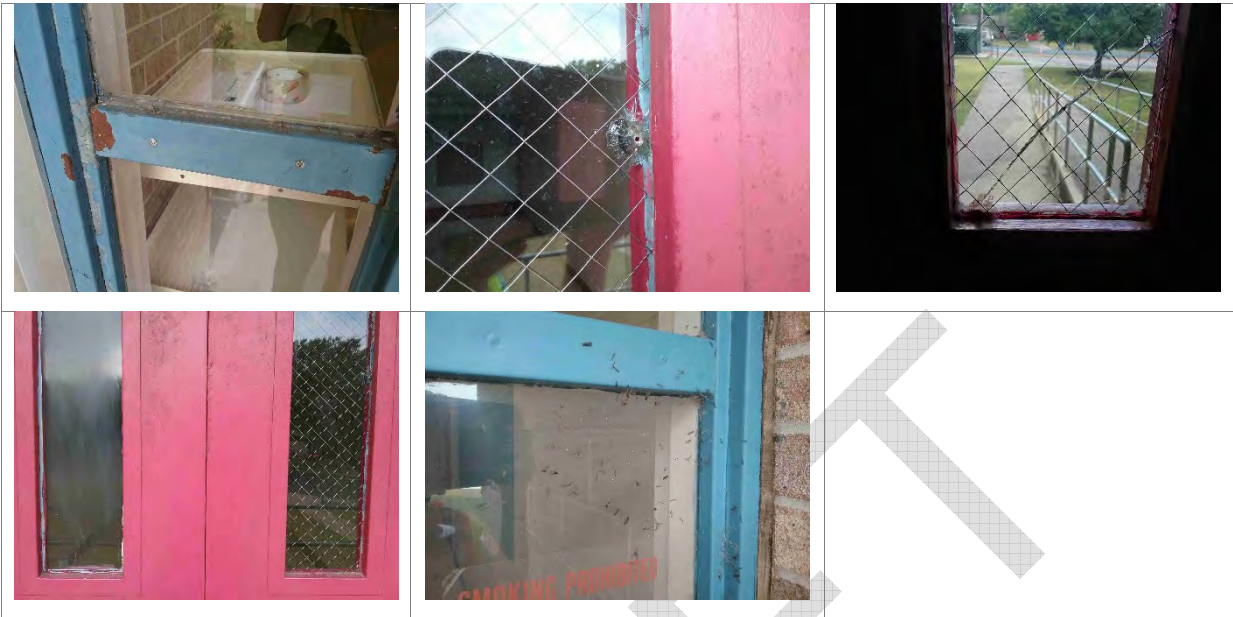
Exterior Doors	The exterior doors are glazed metal doors set into metal storefront systems. The exterior doors were observed to be in average condition due to the appearance of the finishes. Peeling paint was observed on many of the doors and frames. A few lites were damaged, either due to holes or cracks in the glazing. One lite had been replaced with acrylic.	Average

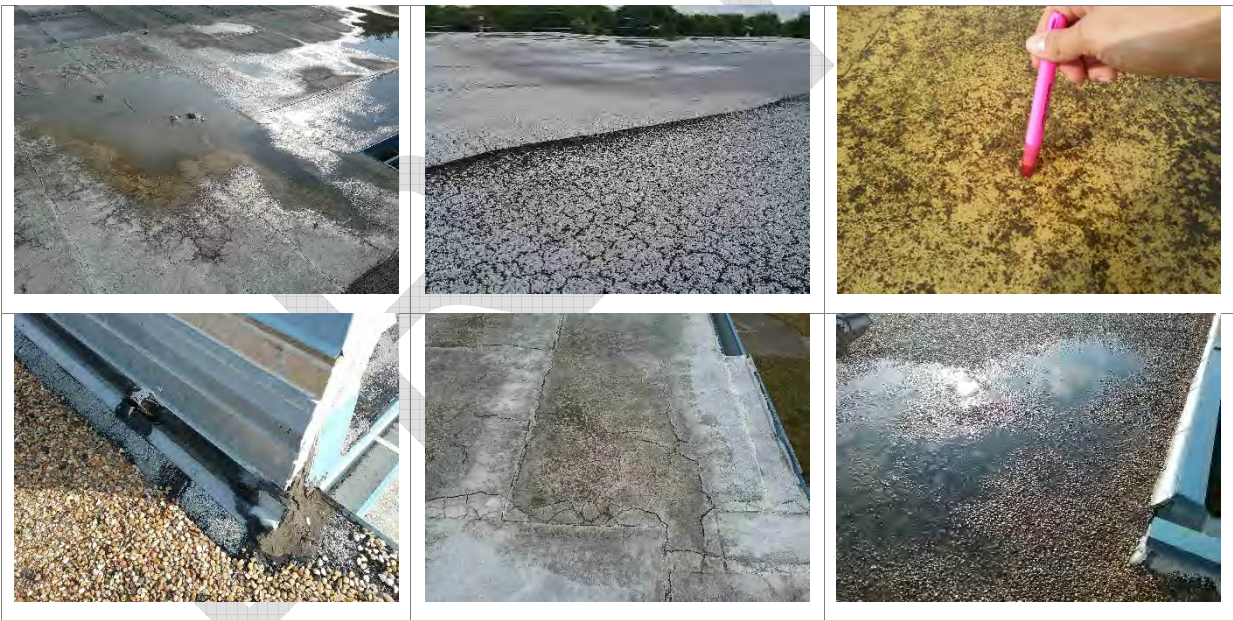
Roofing Deficiency Examples

System	Subsystem	Condition and Deficiency Overview	System Condition Rating
		Many of the doors were hosting swarms of insects. The logbook in the main office states that the last pest treatment was on 6/21/2016 in rooms 110 and 112, and the main office, gymnasium, and cafeteria for ants.	
Roofing		<p>The roof systems consist of built up with a granular topping and modified bitumen. Some of the modified bitumen membrane is covered with a white reflective coating. There are eight skylights over the gymnasium.</p> <p>Not only was excessive ponding observed on the modified bitumen roof, the material was undulating. Some standing water was observed to be 1.5 inches deep. The sealant material at the edges of the sheets was cracked and worn away. The portions of the modified bitumen roof finished with a white reflective coating were the most damaged, exhibiting extreme cracking, ponding, and discoloration. Ponding was also observed on the built-up roof near the gutter feeds. The skylights were observed to be in good condition.</p>	Poor

1. Further investigate all roof areas observed with ponding to reslope to proper drainage points. Include areas around roof drains.
2. Replace all deteriorated roofing.

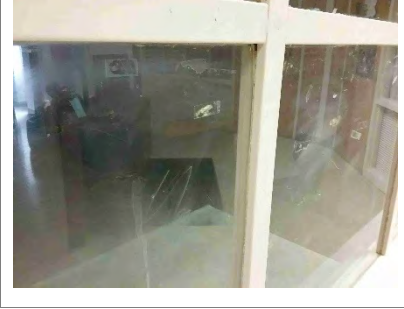
Interior Construction	Interior Walls	<p>The interior walls are varied in composition. In the classroom wings of the building, metal window systems are set into drywall. In the primary-wing of the building, the classroom walls are drywall on metal studs and terminate below the ceiling.</p> <p>The walls were observed to be in good condition, except for the acrylic in the classroom windows; it was scratched and scuffed.</p>	Good
	Interior Doors	<p>The interior doors are wood doors in metal frames with narrow lites and fixed transom windows. Some transom windows are covered with plastic paneling. The service doors are metal in metal frames.</p> <p>The interior doors were observed to be in average condition with splitting wood and worn door frames. The male restroom door in the 100-wing would only shut from the inside as the closer is either too strong or too tight. Many of the door closers are either too strong or not engaged; for example, the janitorial closet next to room 207 swings shut strongly and could pose a safety hazard. Many of the equipment closets were observed to have missing or inoperable hardware/locksets.</p>	Average

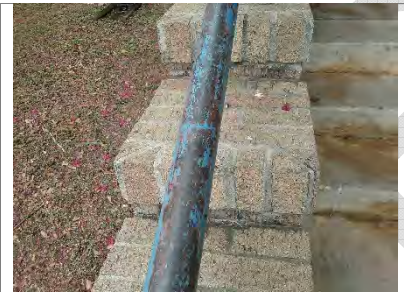
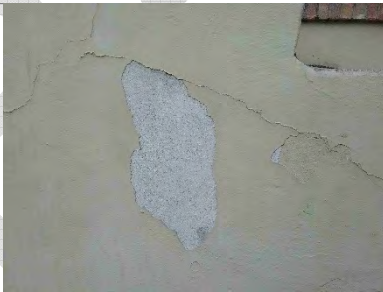
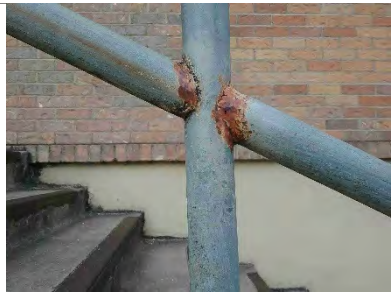
Interior Specialties	System not present.	N/A
Stairs	Exterior Stairs	<p>There are multiple exterior stairs leading to building entrances around the school. They are all cast-in-place concrete with metal handrails. One stair has metal anti-slip nosings.</p> <p>The stairs were observed to be in good condition, though many of the stairs did not have an adjacent access ramp. The metal handrails were worn, and the plaster finish on one exterior stair was cracking and</p>	Good

System	Subsystem	Condition and Deficiency Overview	System Condition Rating
		peeling. The handrails were also rusting at the connection points.	
	Interior Stairs	System not present.	N/A
Interior Finishes	Interior Wall Finishes	<p>The interior wall finishes in the school consist of paint, wood paneling, and ceramic tile. Some brick is left exposed as well.</p> <p>The acoustical wall panels in the gymnasium and music room were observed to be in good condition. The janitorial closet in the primary-wing showed signs of water damage behind the wall. The wood paneling in the corridors appeared to be in good condition. The toilet partitions were observed to be in poor condition; some are rusted, and some are missing segments.</p>	Average
	Interior Floor Finishes	<p>The majority of the school is finished with vinyl composition tile (VCT) tile, with a layer of rubber athletic tile in the gymnasium. The library is finished with carpet, as is a portion of the administration space. The restrooms are finished with ceramic tile. The kitchen floor is finished with ceramic tile.</p> <p>The VCT appeared to be in good condition throughout the school. The restroom finishes were observed to be in poor condition. The restroom floors and grout were deteriorating at the wall base. Ants were prevalent in the 200-wing. The rubber base in the art-wing corridor was very aged and dried. The carpet in the primary-wing was very stained in the classrooms and in the open space. It was reported that overflow from the toilets caused the staining. The rubber base in this wing was also messily painted.</p>	Average

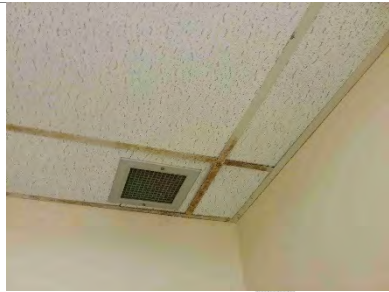
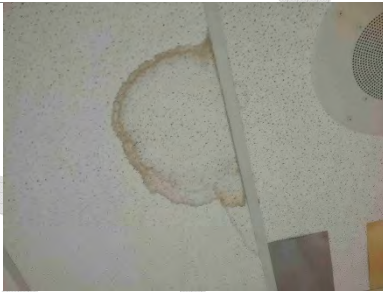
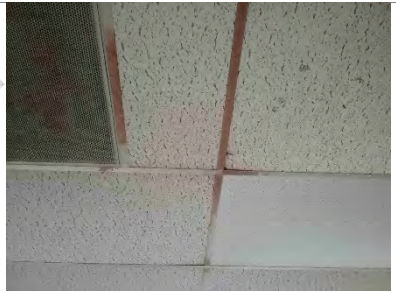
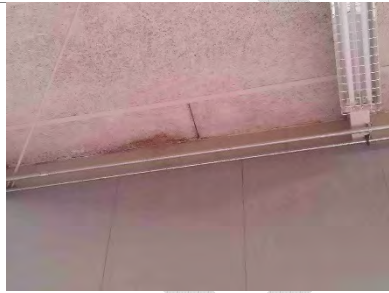
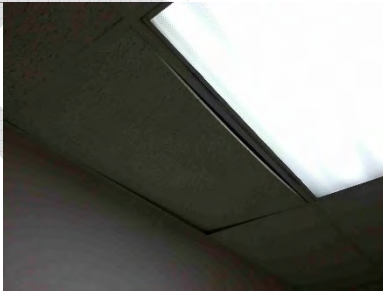
Interior Ceiling Finishes	<p>The majority of the building is ceiled with 2x4 lay-in ACT (acoustical ceiling tile), including the restrooms. The library, classrooms, gymnasium, and cafeteria are ceiled with painted wood wool panels. The library has a perimeter drywall soffit. The kitchen ceiling consists of lay-in FRP (fiber-reinforced plastic) tiles.</p> <p>The library ceiling exhibited negligible spots of water damage, though ponding was observed on the roof. The same condition was observed in the classrooms. The ACT ceiling finishes were damaged in the interior rooms of the 100-wing, such as the restrooms and offices, but not in the classrooms themselves. The ACT ceiling in the administration office was observed to be in poor condition, appearing aged and dingy with more water stains and broken tiles than the rest of the school.</p>	Average

System	Subsystem	Condition and Deficiency Overview	System Condition Rating
		Water damage was observed on the gymnasium ceiling. The ceilings in the primary wing were more aged than other parts of the school. Many tiles were askew.	
Conveying	System not present.		N/A
Plumbing	Plumbing Fixtures	<p>The building has public restrooms for males and females as well as separate staff restrooms located throughout the facility. These restrooms have vitreous china hand sinks, floor-mounted toilets, and wall-hung urinals. The urinals and toilets have manual flush valves, and the sinks have manual faucets. Service sinks are located in janitorial closets throughout the building.</p> <p>Most of the plumbing fixtures for this building were functioning well. The 100-wing exhibited the most deficiencies. The urinal in BRR104 next to MLTCLS2 did not flush properly. There was low water pressure for the faucet in room 104 and the faucet located in the corridor across from room 104. The urinal in BRR106 had a leaking flush valve. The urinal in the male restroom next to MLTCLS4 was falling off the wall. As a whole, the urinals in the 100-wing did not flush well, and the faucets had low water pressure. Water for the faculty restroom in the administration area was warm when the cold water valve was open and the hot water valve was closed. There was low water pressure for the faucet in room 209.</p>	Average

1. Repair the water-damaged wall in the janitorial closet in the primary-wing.
2. Refinish the restrooms, and replace the damaged toilet partitions.
3. Replace the rubber base in the art-wing.
4. Replace the carpet in the primary-wing "open space" with carpet tile.
5. Remove the excess paint from rubber base in the primary-wing.
6. Install moisture-proof ceiling in the restrooms.
7. Replace all damaged ceiling tiles and tees.

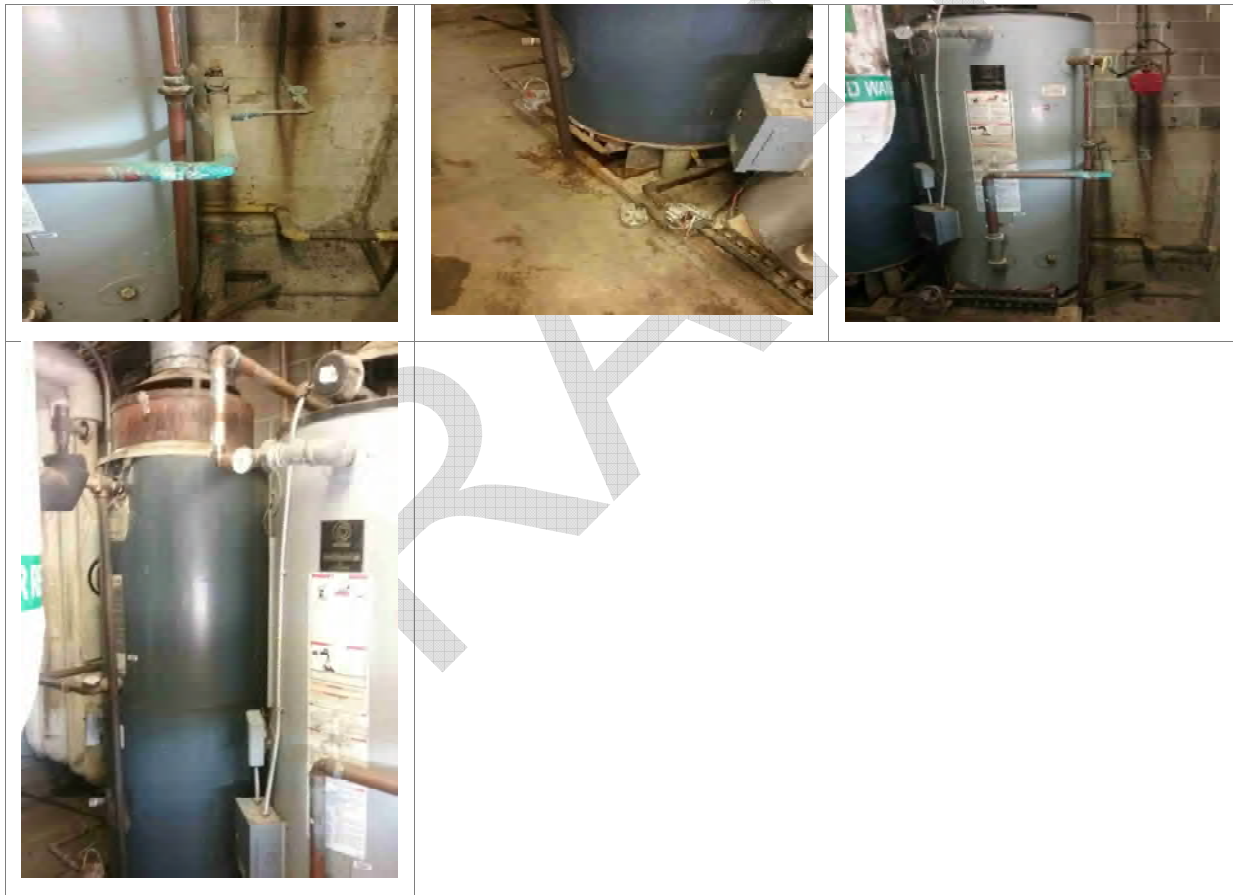
Domestic Water Distribution	The staff and kitchen areas are serviced with hot water, while the classrooms only have cold water. Two electric water heaters in this building were not accessible for assessment. The two GWHs (gas water heaters) that were observed appeared to be in poor condition. The units and distribution piping appeared aged and corroded.	Poor
	Other Plumbing	The roof drains were observed to be in good condition, although water had collected on the roof due to the rainfall from the night prior to the assessment.	Average
Mechanical/ HVAC	<p>The major mechanical equipment in this building consists of two chillers, central air handlers, heat pumps located in classrooms, and packaged RTUs (roof top units). Some of the air handlers are located in the interior of the building.</p> <p>An exhaust grille was falling out of the ceiling in one of the male restrooms next to MLTCLS4. Some of the exhaust grilles on the roof appeared to be abandoned, while others were new. The make-up air unit on the roof appeared to be in good condition, except for the metal grate on the air intake. This metal grate needed to be replaced. The air conditioners in rooms 204 and 209 were observed to be in</p>		Average

1. Continue preventive maintenance on aged plumbing fixtures and plan for replacement in the future as fixtures continue to age.
2. Plan to replace GWs in the main mechanical room.
3. Address the water pressure issues in the 100-wing and room 209.
4. Repair the leaking flush valve in BRR106.
5. Repair the urinal that is falling off the wall in the male restroom next to MLTCLS4.
6. Repair the urinal in BRR104 for flushing issues.

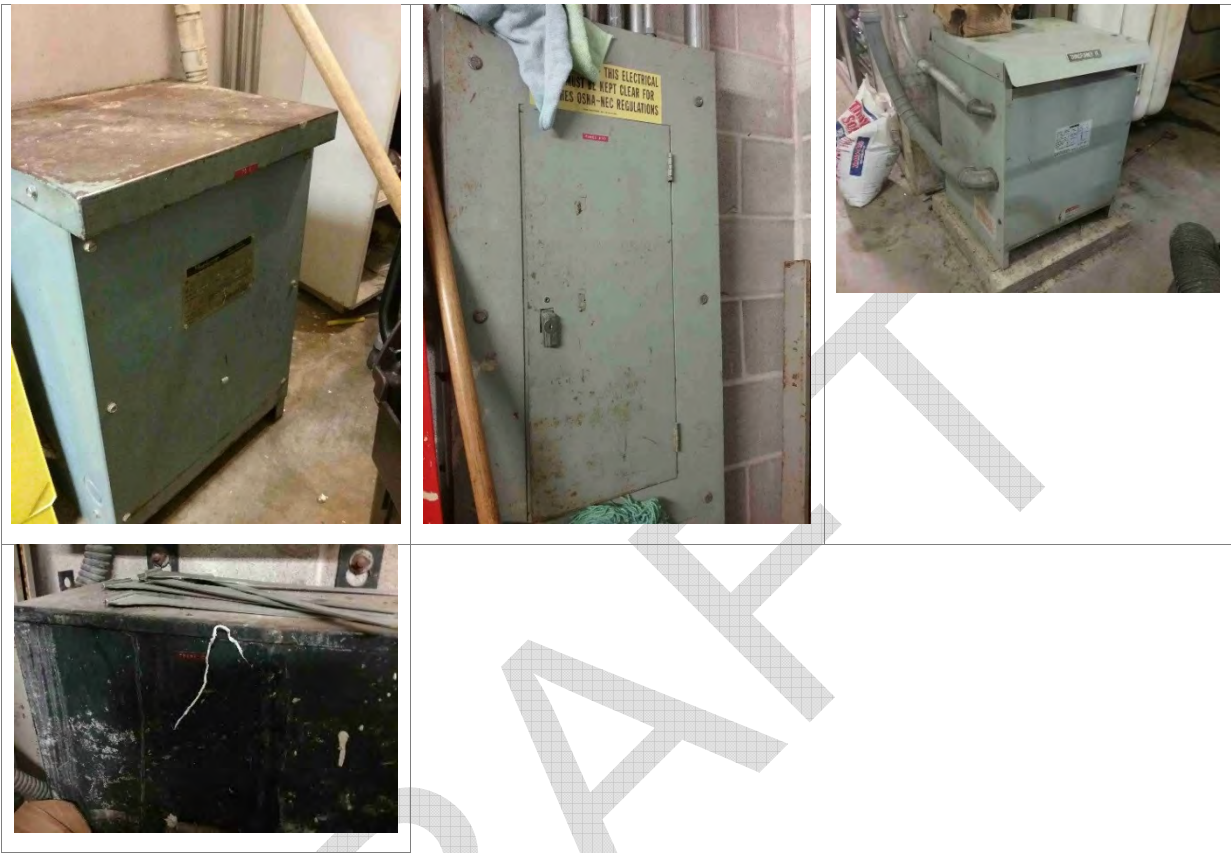
Fire Protection/Suppression	<p>This building does not have a sprinkler system. Fire extinguishers are placed throughout the building for protection in the event of a fire.</p> <p>The equipment looked to be in good condition, and the tags were signed by an inspector.</p>	N/A
Electrical	Electrical Distribution	<p>There is a 750KVA pad-mounted utility transformer that serves a 480/277V 1600A MSB located in the main mechanical room. There is also a 250KVAR PF correction bank. MSB serves panels and transformers located throughout the facility. There are several transformers and panels from the original 1970 construction that are still active. Approximately 90% of the electrical distribution equipment appeared to be in average condition. The electrical service appears to have been upgraded in 1998. The remaining 10% of the electrical distribution equipment appeared to be in poor condition, severely corroded and worn out. The disconnect switches on the roof appeared to be severely corroded. It was reported that several panels in the facility have breakers that are permanently in the "tripped" state. It was also reported that the electrical outlets on the cafeteria wall opposite the kitchen have issues. Plugging in more than one item causes frequent electrical breaker trips. The electrical outlet on the front side of the stage closest to the kitchen was reported to</p>	Poor

System	Subsystem	Condition and Deficiency Overview	System Condition Rating
		be unusable, as anything plugged into it trips the circuit. Existing Panel 'LVK2' (that is in the main mechanical room) appeared to to not have adequate code-required working clearance.	
	Lighting	<p>The administration area has 2x4 fluorescent fixtures. Approximately 30% of the light fixtures appear to be worn out, with deficiencies such as bent lenses, yellowed lenses, and burned-out lamps. Approximately 20% of the areas have occupancy sensors, and they appear to be functioning. Lighting in all janitorial closets consist of incandescent sockets with compact fluorescent lamps.</p> <p>The 100-wing classrooms have pendant-mounted 1x4 fluorescent fixtures. Approximately 30% of the light fixtures appear to have lamps that are burned out, cracked, or with yellowed lenses. The corridor areas have surface-mounted 2x4 fixtures that appear worn out. A small percentage of classrooms have occupancy sensors. The corridors do not have occupancy sensors.</p> <p>Lighting and lighting controls are similar throughout the remaining wings. The 200-wing mostly consists of 2x4 recessed lay-in fixtures. Corridor areas have recessed 2x4 fixtures with no occupancy sensors.</p> <p>The classrooms in the 300-wing have occupancy sensors.</p> <p>The library has pendant-mounted fluorescent light fixtures. About 10% of these fixtures have lenses falling off, and some have lamps out. There are no occupancy sensors in the general library area, but the librarian's office has a wall-mounted occupancy sensor switch. The teacher's lounge in the library has an occupancy sensor.</p> <p>The gymnasium has fluorescent lowbay fixtures with wire guard. The gymnasium has occupancy sensors that appear to be tampered with.</p> <p>Cafeteria space has surface-mounted fluorescent fixtures. The cafeteria has occupancy sensors.</p> <p>The staff parking lot has one pole with two HID (high-intensity discharge) flood light fixtures, and the visitors parking lot has no lighting at all. The playground and basketball court area have no lighting.</p> <p>The lighting for the building appeared to be in poor condition. Many interior and exterior light fixtures appeared to be aged past their design life. Observed</p>	Poor

1. Immediately provide missing break cover plates for all electrical equipment that were noted, as these instances should be considered life safety hazards.

2. Repair or replace all electrical equipment affected by corrosion or rust. If the corrosion/rust is beyond the enclosure, then replacement is suggested.

9. Provide additional security cameras in the corridor areas.
10. Replace outdated Panels HVG, HVC, HVE, LVDA, LVD, and LVE.
11. Replace outdated Transformers D, C, and E.

12. Replace the electrical panel (located in janitorial closet CC120) and the circuits that serve the 100-wing. This is a panel that was reported with breakers that remain permanently "tripped."

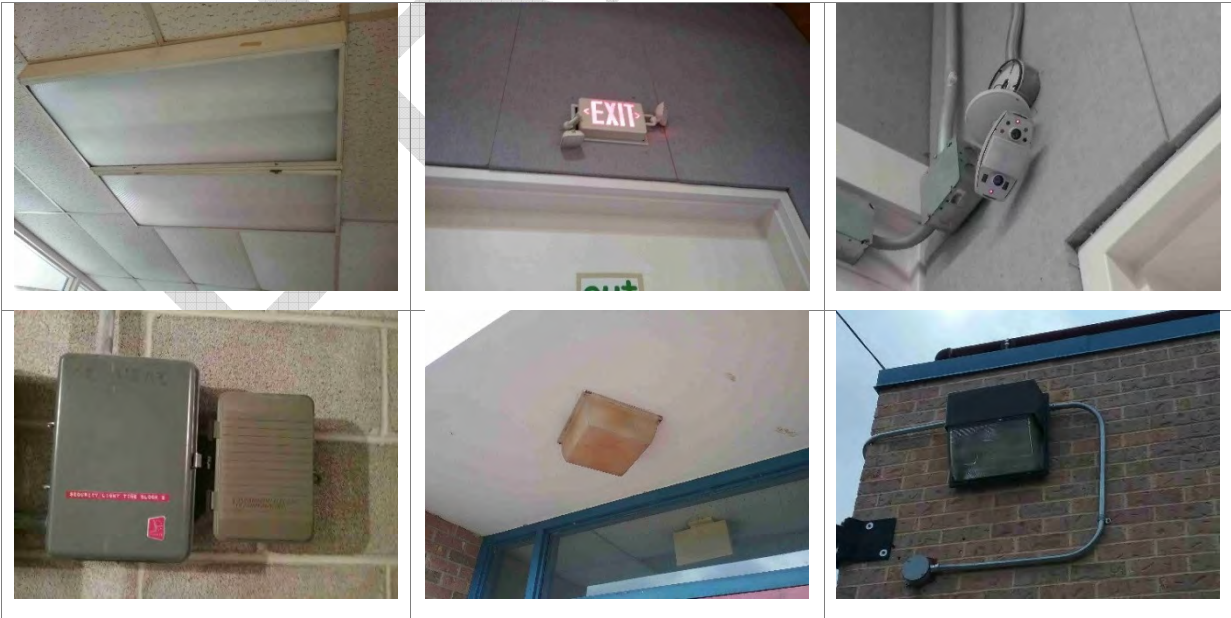
Lighting

System	Subsystem	Condition and Deficiency Overview	System Condition Rating
		<p>deficiencies included broken lenses, inconsistent color temperatures, and non-functional fixtures. There are exit signs present in the building; however, approximately 95% appeared to be from the original construction and were non-functional in the emergency mode. About 95% of the exterior building-mounted lights are worn out and outdated. Around 5% of the exterior lighting consists of LED (light-emitting diode) building-mounted light fixtures that appeared to be in good condition and appear to be installed recently. The lighting timeclocks are mechanical type and appeared to be in poor condition and likely non-functional. There were several areas in the 200 and 300 Wings that appeared to have issues with occupancy sensor not functioning properly. After closer observation, it appeared the likely cause was due to location of the sensor. The gymnasium and cafeteria occupancy sensors appeared to have been tampered with and due to this did not exhibit proper operation.</p> <p>The school has very limited emergency lighting in most areas of the facility. It was reported that during a power outage in the spring, the cafeteria emergency back-up lights did not come on. Specifically, maintenance staff reported lack of emergency lighting and lack of general lighting in the main mechanical room and in the crawlspace.</p>

3. Remove any floor receptacles as they are being phased out of use district-wide.
4. Replace all interior and exterior outdated light fixtures with LED light fixtures with dimming capabilities.

5. Provide additional exterior LED light fixtures as required.
6. Replace all existing exit signs with LED fixtures, and add more exit signs where required for all buildings.

7. Provide all new LED egress lighting as required for the entire facility.
8. Relocate the secured buzzer/lock to the door that is directly outside of the administration area.

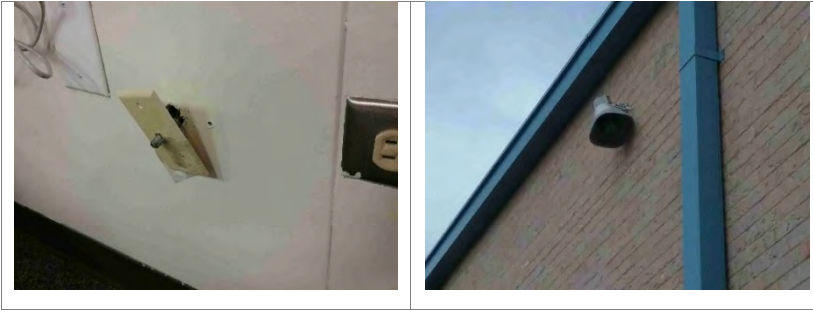
Communications & Security	<p>There is a Gemini security system including surveillance cameras in the building and on the exterior of the building.</p> <p>The security system appeared to be in good condition; however, it was reported that the secured door buzzer is located on the door furthest from the administration offices, which creates a safety issue because it allows guests access to the cafeteria and other areas of the school before arriving at the administration offices.</p> <p>There is a public address (PA) system in the building.</p> <p>The PA system appeared to be in poor condition, as it was reported to not be functioning correctly in the cafeteria, kitchen, and administration offices. Exterior speakers are worn out and at the end of their design life.</p> <p>The school bell system is controlled via the school's phone system and appeared to be functioning well, with no reported issues.</p> <p>The building is equipped with telecommunications</p>	Average

System	Subsystem	Condition and Deficiency Overview	System Condition Rating
		systems, but the main backbone equipment is located in an inaccessible room. Wi-Fi hubs throughout the facility appeared to be working and in good condition. Some coaxial cable outlets in the 200-wing were falling out from the wall.

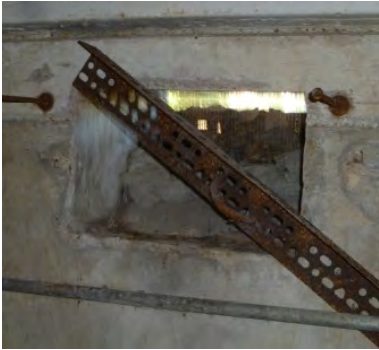
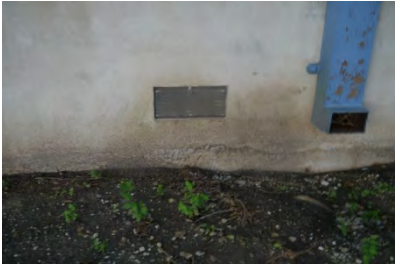
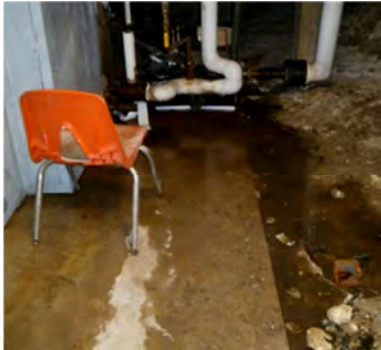
Partially blocked vent	Small vents / poor ventilation	Standing water under pipe leak

1. Clear blocked vents
2. Investigate need for additional ventilation
3. Investigate source of soil saturation in the vicinity of rooms 102 and 104
4. Repair damaged access hatch doors, clean hatch frames/doors & protect from further corrosion

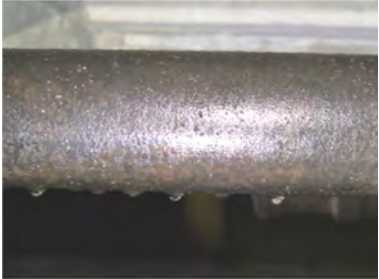
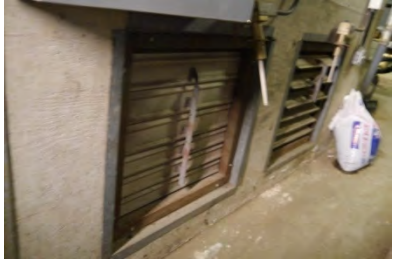
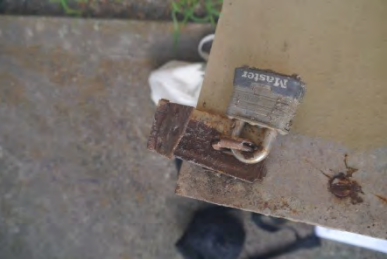
Condensation on pipes	Mechanical fan off, louvers closed	Broken hinge on access hatch door

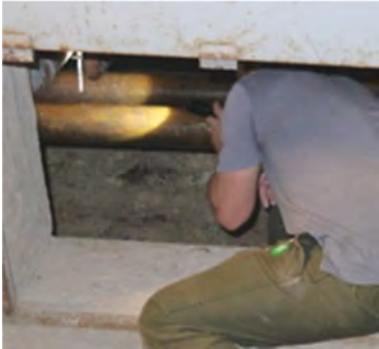
Pipe congestion at access door

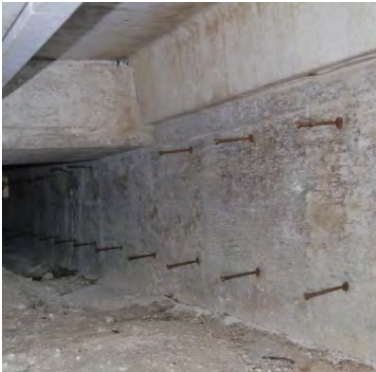
Corroded form ties at perimeter beams

1. Repair badly spalled/honeycombed concrete elements
2. Clean exposed reinforcement and protect from further corrosion

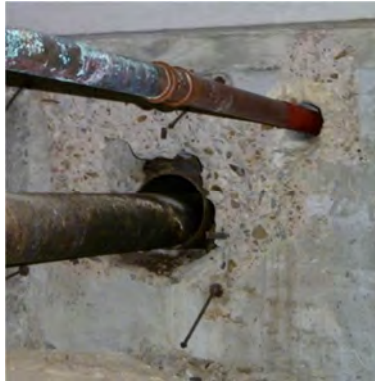
Honeycombing/spalling in perimeter beam
at pipe penetration

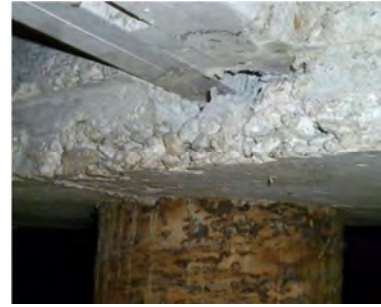
Beam honeycombing

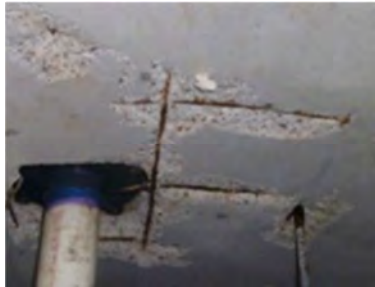
Spalling & exposed/corroded
reinforcement at underside of precast pan
joist flange

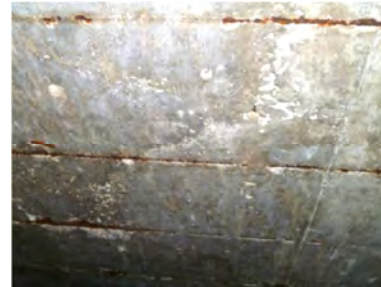
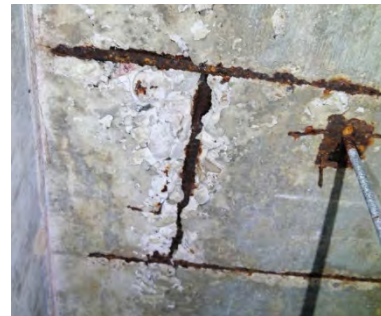
Exposed/corroded reinforcement in
bottom of slab due to insufficient clear
cover

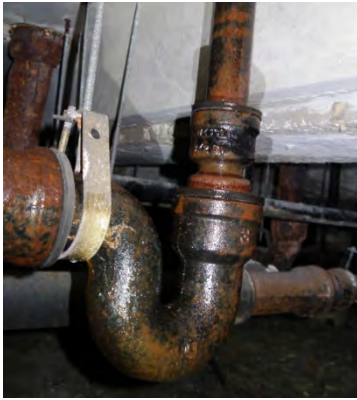
Wet/leaking pipe, corrosion

1. Repair corroded cast iron pipes & protect from further corrosion or replace
2. Replace heavily corroded hangers/supports
3. Repair leaking pipes
4. Repair degraded/missing pipe and duct insulation

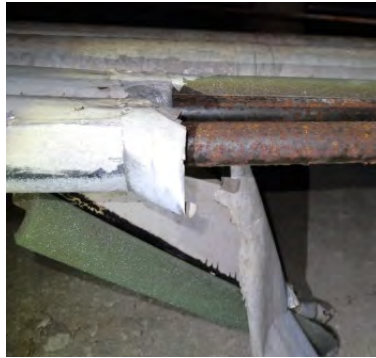
Failed pipe insulation

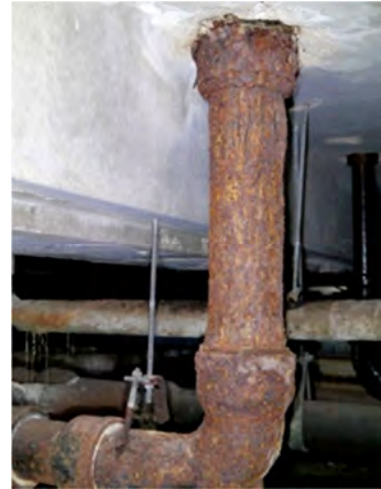
Rusted cast iron pipe

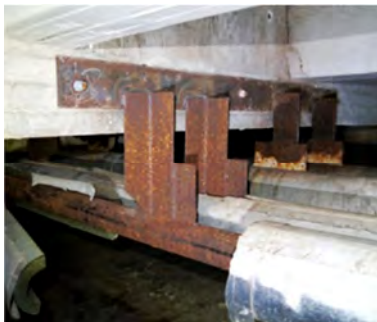
Corroded pipe supports

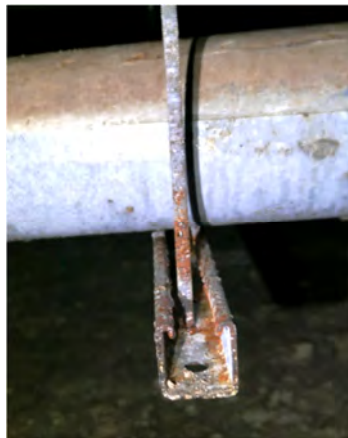
Corroded pipe hangers

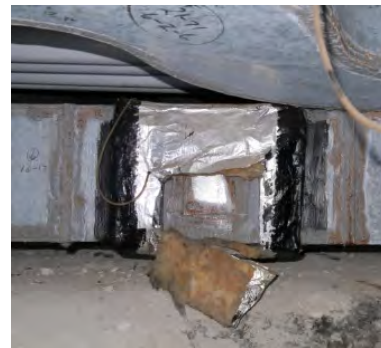
Degraded duct insulation

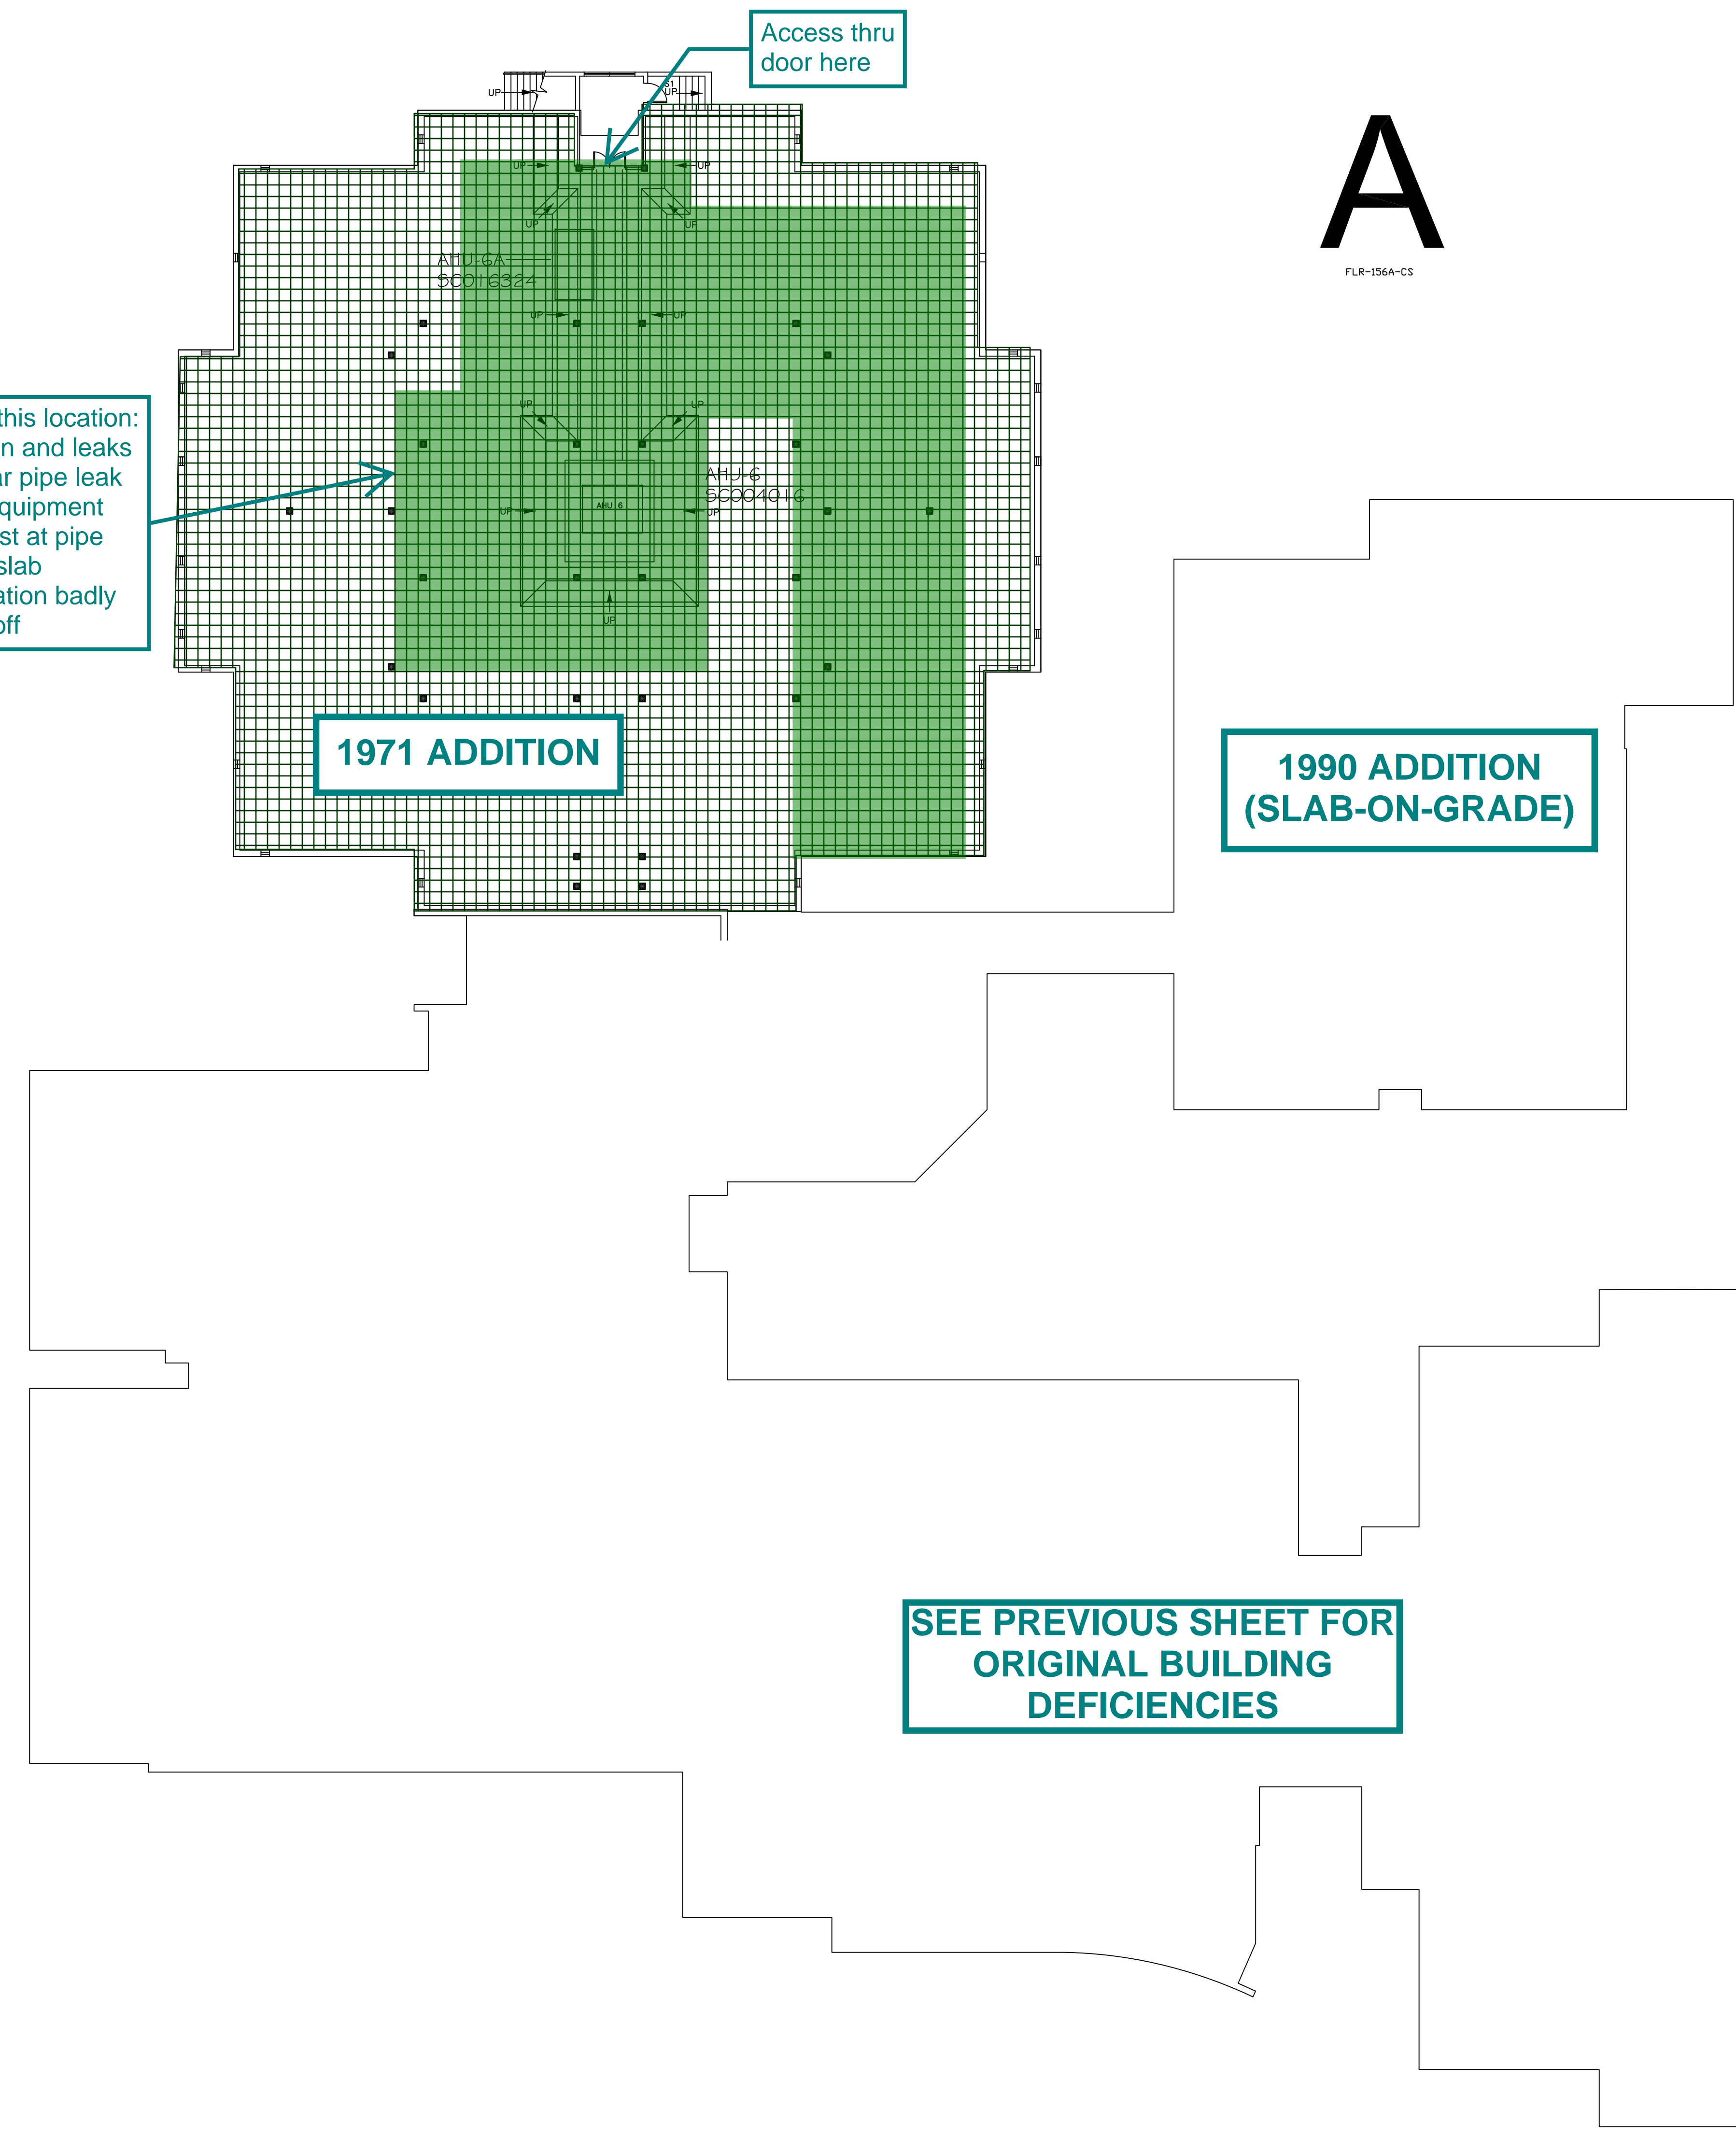
DWG:156-FLR-01

- Deficiencies found in this location:
- 1) Some vent louvers closed
 - 2) Access limited due to large number of pipes at crawl space entrance
 - 3) Some pan joists with exposed corroded reinforcement
 - 4) Wet soil from pipe leak

- Deficiencies found in this location:
- 1) Saturated soil at NW corner; damp soil elsewhere
 - 2) Vents partially blocked
 - 3) Exposed and corroded reinforcement in perimeter beams
 - 4) Minor to heavy corrosion and spalling in floor slab and beams
 - 5) Significant corrosion in cast iron pipes
 - 6) Degraded of pipe insulation
 - 7) Possible pipe leaks
