## Overton Elementary School Site Summary

## Main School Building – BLDG189A

Building Purpose	Administration, Classrooms, Cafeteria/Gymnasium
Building Area	83,405 SF
Inspection Date	July 14, 2016
Inspection Conditions	100°F - Sunny
Facility Condition Index

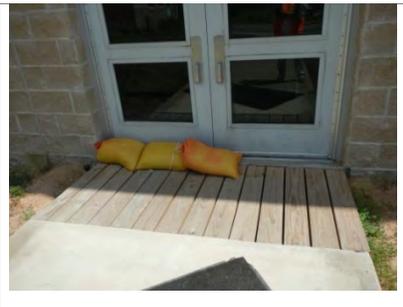
System	Subsystem	Condition and Deficiency Overview	System Condition Rating
<b>Exterior</b>	Exterior Walls	The exterior of the building consists of a CMU (concrete masonry unit) façade.  The exterior walls were in good condition. The masonry was clean and in good repair.	Good
	Exterior Windows	The exterior windows consist of single-pane glazing units with aluminum frames.  It was reported that the windows in rooms C204 and 206, on the south side, of the building and all the windows on the north wall of the administration area are all leaking. The frames were in good condition.	Good
	Exterior Doors	There is one main entryway located at the northeast side of the building. This entryway consists of two pairs of aluminum storefront doors with glazing lites. These doors were in average condition.  There are nine pairs of doors and six single-leaf exterior hollow metal doors with steel frames. These doors and frames are painted. The doors showed normal wear and tear, such as scratched paint and chipping due to use.  It was reported and observed that four exterior doors were sandbagged due to water intrusion during high-intensity storm events. On the northwest face leading to room B107 and the west face leading into the exterior stair tower, there were sandbags in place at these doors. There were also sandbags at the southerly most pair of doors leading into the cafeteria and the pair of doors on the east side of corridor 1-1. It was also	Average

System	Subsystem	Condition and Deficiency Overview	System Condition Rating
		observed that the finish on the majority of the doors was in average condition due to normal wear.	
<b>Roofing</b>		The roofing material on this structure is of the membrane type. Very little damage was visible on the entire roof area. Drainage for the roof is provided by a system of scuppers and downspouts that flow into an underground drainage system.  It was reported by facility staff that roof leaks have occurred previously, but recent repairs have fixed them. The roof overall is in good condition.	Good
<b>Interior Construction</b>	Interior Walls	The interior construction consists of drywall with various panel-type treatments used as accents.  Mold was reported in the mechanical closet C1-3. The interior walls were in average condition. In the main corridor on the south wall, one of the panels above the 9-foot level had a vertical crack in the finish. The southeast corner of room B102 had mold in the corner closest to the floor.	Average

1. Perform a roof leak test to determine the source of ceiling damage. Consider damage due to a leaking sprinkler line or migration through the walls in driving rain. Replace stained tile.
2. Leak test exterior windows, and apply caulking to remediate the leaking.
3. Adjust doors to eliminate sticking and dragging. Adjust hardware on affected doors.

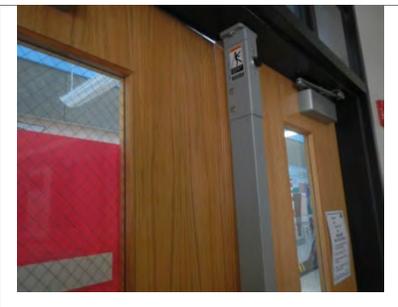
Interior Doors	The interior of the building contains hollow metal frames with natural finished wood doors.  It was reported the interior lobby doors do not close properly. The interior doors and frames were in average condition given the age of the building. The pair of doors at mechanical closet C1-3 did not close and latch, the door in the kitchen restroom dragged on the floor, the doors into the admin area did not close properly, and the restroom door in the learning lab did not close completely.	Average
	Interior Specialties	System not present.	N/A
<b>Stairs</b>	Exterior Stairs	System not present.	N/A
	Interior Stairs	The interior stairs are a steel stair system. The underside of the stairs is exposed and painted. The treads and landings have formed sheet vinyl, and the landing has vinyl tile in a raised coin pattern.  The tile on the landings was worn but in good condition as was the vinyl on the stairs.	Good

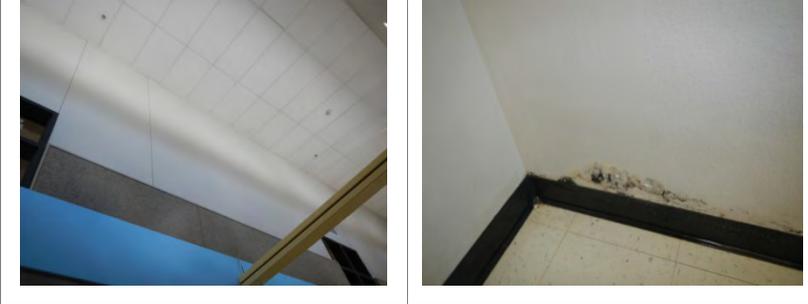
<b>Interior Finishes</b>	Interior Wall Finishes	The interior wall finish is generally a painted surface with some accent panels.  The interior wall finishes were in average condition but were showing signs of age with wear and use. There was chipping in most classrooms throughout the facility.	Average
	Interior Floor Finishes	The corridor and classroom floors are finished with vinyl tile. The music room, rooms 104, 105, 106, and the administration offices are carpeted.  The tile and carpet were in average condition.	Average

1. Repair the damaged wall in the main corridor. Monitor for reoccurring cracks that may indicate building settlement.
2. Cut out all drywall that is exhibiting mold. Find the source of the water, and repair the drywall to its original condition. Engage an industrial hygienist to determine the extent of the mold and identify the appropriate remediation method. Implement the remediation recommended.

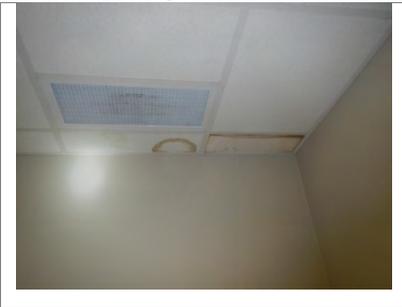
System	Subsystem	Condition and Deficiency Overview	System Condition Rating
	Interior Ceiling Finishes	<p>The classrooms and support rooms have a suspended acoustical ceiling system. The library, cafeteria, and main corridors have vaulted ceilings with acoustical tile that has been affixed directly to the underlayment with no suspension system.</p> <p>It was reported there is leakage and ceiling damage in the library above the second column near the ceiling. It was also reported there is leakage in the music rooms and multipurpose rooms.</p> <p>Along the north wall in classrooms on the second floor, the ceiling tile had water damage in the majority of classrooms. There was wet ceiling tile in the southwest corner of room 103.</p>	Poor
<b>Conveying</b>		<p>The building is equipped with a hydraulic passenger elevator to service two levels. No operational issues were reported by the facility staff. The elevator was in good condition and had a current inspection certificate issued September 18, 2015. Capacity of the elevator is unknown.</p>	Good

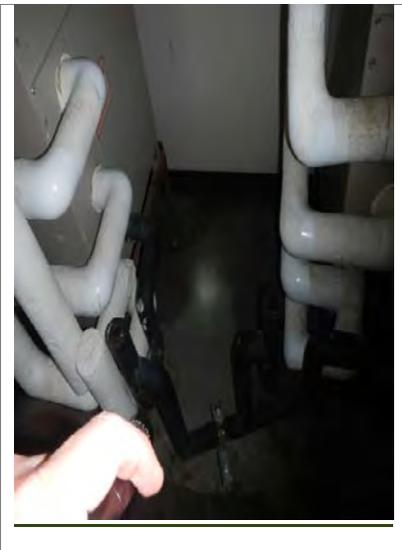
**Mechanical/HVAC System Deficiency Examples**

<b>Mechanical/ HVAC</b>	<p>The major mechanical equipment consists of a boiler and chiller located on the first floor in the vicinity of the kitchen. Four AHUs (air handling units) are located on the roof, and 46 FCUs (fan coil units) are located throughout the building in mechanical closets. There is a cooling tower located at the rear exterior of the building near the docks.</p> <p>It was reported by staff that the HVAC (heating, ventilating, and air conditioning) system in the past has shut off during storms. Additionally, the second floor was not as cool as the first floor, nor consistently cooled throughout the second floor areas. Generally, the north wing experiences more problems than the south wing. It was also reported that a significant amount of maintenance has been required due to motor failures.</p> <p>The HVAC system was observed to be in average condition. All areas were cool, although some areas were cooler than others, despite the outside air temperature being in excess of 100°F.</p> <p>Water was observed on the floor under the mechanical FCUs in the mechanical closet C2-2.</p>		Average

1. Work with the fire alarm vendor and HVAC vendor to find the source of the HVAC shut offs during storm events. Determine source of regular shut downs occurring at times other than storm events. Implement recommended changes or replace faulty equipment. Consider lightning protection for the facility.
2. Make recommendations regarding HVAC system shutting off, motor failures and 2<sup>nd</sup> floor cooling issues. Work with the HVAC vendor to identify the source of frequent motor failures. Implement vendor recommendation or replace faulty equipment.
3. Rebalance the second floor cooling system to determine if poor balance is the cause of the cooling issues. If rebalancing does not correct the problem, consider replacing the equipment.

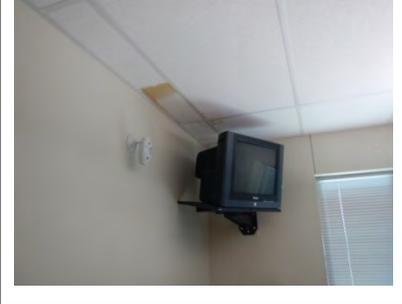
Fire Protection/Suppression

System	Subsystem	Condition and Deficiency Overview	System Condition Rating
	Suppression	<p>extinguishers placed strategically throughout the building.</p> <p>A fire sprinkler escutcheon in the main corridor had fallen out of the ceiling. The music room and the multipurpose room had water-stained ceiling tiles directly below the sprinkler water line.</p>	
Electrical	Electrical Distribution	<p>The electrical distribution has a 2500-amp service. Voltage information for the service was not provided. The system was functioning well.</p> <p>It was reported that the GFI (ground fault interrupter) outlets frequently trip when load is applied and the floor plug circuits trip when custodial staff is mopping.</p> <p>There is no lightning protection system.</p>	Average
	Lighting	<p>The lighting system primarily utilizes fluorescent 2x4 troffer fixtures in the grid ceiling. There are various types of architectural fixtures in the library and the corridor.</p> <p>It was reported that the exterior lighting which consists of exterior wall packs and pole type lighting in the parking areas was generally good. However, there was one exterior power pole that had fallen down and was not reinstalled.</p> <p>The lighting systems in classrooms were working properly. There was a rusted fixture in the restroom in room B105 and a rust-stained fixture lens in the restroom for room C101.</p>	Good

1. Conduct a detailed inspection to determine the source of ceiling damage. Repair or replace defective sprinkler lines.
2. Contact the fire alarm vendor to diagnose constant alarms at the annunciator and to determine the best method to modify the system to alleviate shutting down of HVAC during false alarms.
3. Replace and secure the escutcheon that has fallen in the main corridor.
