Pease Elementary School Site Summary

Address	1106 Rio Grande Street Austin, Texas 78701
Number of Permanent Campus Facilities	2
Original Year of Construction	1876
Total Campus Building Area (combined)	35,705 SF

Main School Building – BLDG-128A

Gymnasium – BLDG-128B

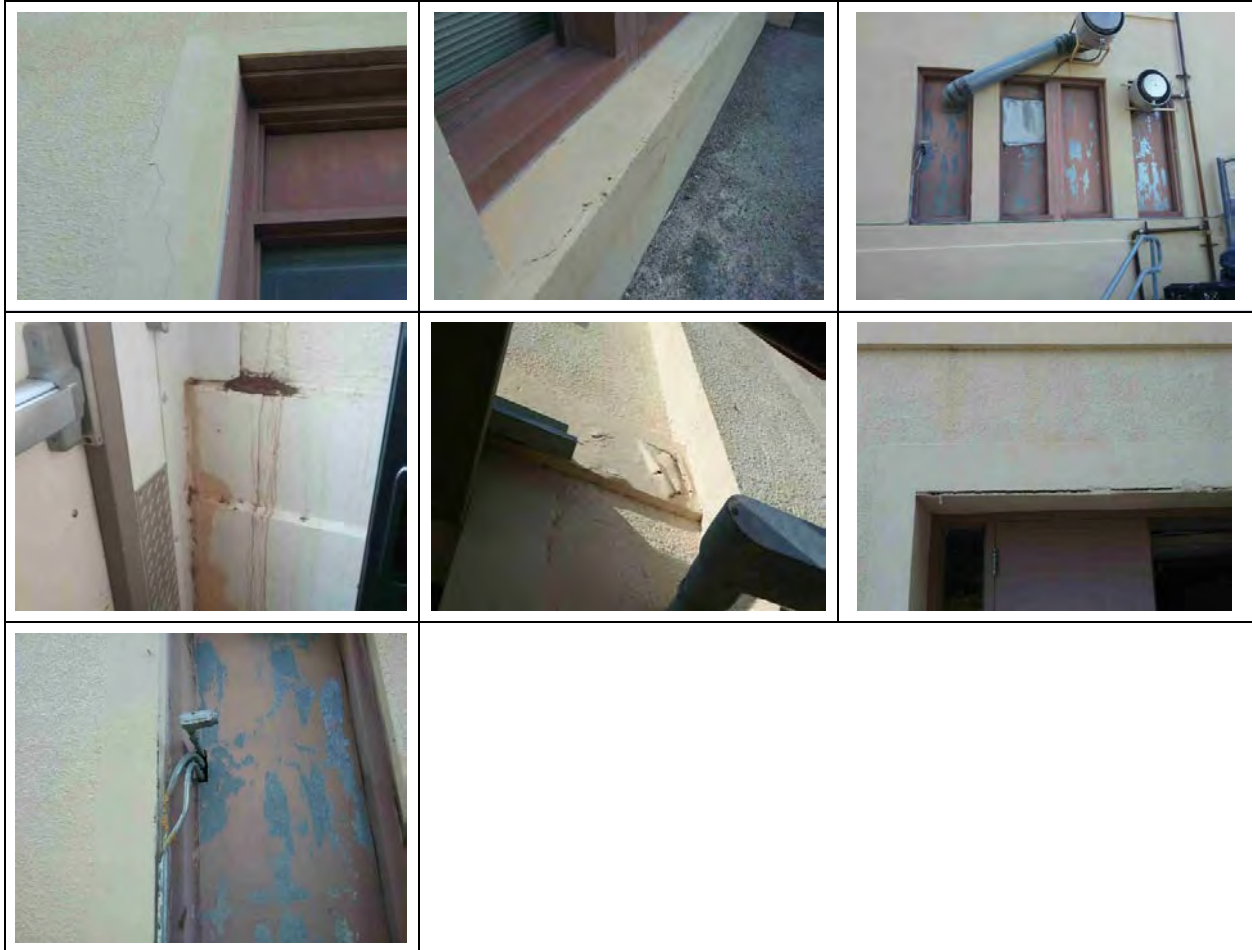
System	Subsystem	Condition and Deficiency Overview	System Condition Rating
Exterior	Exterior Walls	<p>The exterior walls are comprised of load bearing masonry with stucco coating the outside face and plaster on the inside face.</p> <p>The exterior wall is in average condition. The stucco in areas was observed to be cracking in locations and steel lintels were observed to be separated or rusting in locations. The paint system appeared to be blistered and peeling in places. This may be the result of moisture issues in the envelope or a buildup of coatings that are delaminating. One window sill was spalling. At the kitchen, the connection between the main building and the freezer addition showed evidence of continuous water infiltration in corridor C4, and pest activity while other areas of the kitchen had unsealed openings in the metal infill panel at the windows. It was reported that the wall system on the first floor in rooms 108 and 109 which is partially below grade leaks during rain events. It was also reported that termites are present in these rooms along with 110.</p>	Average

1. Patch and repair stucco systems where cracking.
2. Assess condition of lintels, address separation from masonry and rusting.
3. Repair spalling masonry sill.
4. Investigate connection between freezer addition and main building.
5. Address degradation of building envelope.
6. Remove old sealant and apply new sealant to all windows.
7. Remove exterior window finish and apply new.

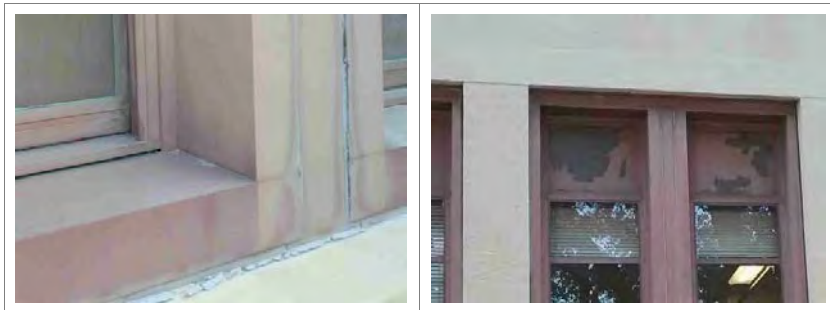
Exterior Windows	<p>The exterior windows are single hung metal framed units with single pane glazing with metal panel transoms.</p> <p>The window systems are in average condition. The window systems appeared to have been painted. The paint system was observed to be faded and was peeling in places. Throughout the building, the sealants</p>	Average

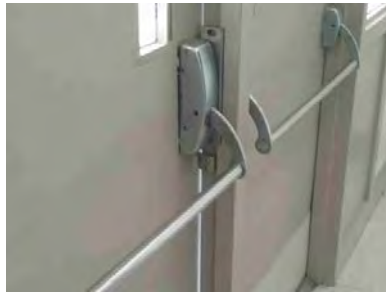
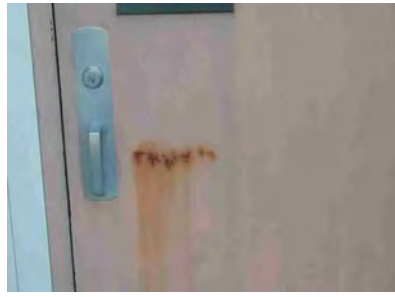
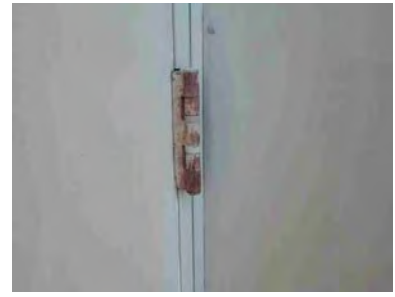
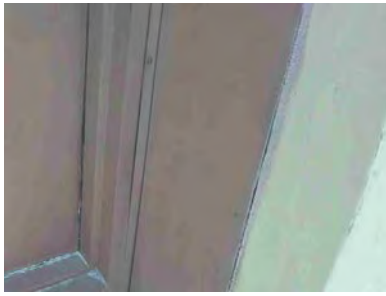
System	Subsystem	Condition and Deficiency Overview	System Condition Rating
		appeared aged and cracking. This was typical for all windows in the building.	
	Exterior Doors	<p>The exterior doors are hollow metal door panels hung in hollow metal frames.</p> <p>The exterior doors are in average condition. All of the hinges observed had minor corrosion developing on them. Sealants applied to door systems and jamb extensions appeared cracked and faded. Corrosion was observed on multiple door panels or frames. Gaskets and seals at the exterior doors were observed to be inadequate or missing.</p>	Average
Roofing	<p>The roofing system is a modified bitumen type roof that was installed approximately a year for the main structure. There are smaller sections of roofing that are over the freezer and over a vestibule on the east side of the building. Access to the roof is via an interior fixed ladder located in the corridor on the third floor that is interrupted by the ceiling finish system.</p> <p>The roofing system was observed to be in good condition it was recently installed. However, several deficiencies were noted during the assessment. Minor ponding was evident in or two areas, other areas had debris left on the roof surface. The cap sheet of the northwest corner of the roof area was observed to be blistered. The interior roof access ladder was installed in a manner that created an unsafe condition when climbing the ladder itself as the ladder sections were inconsistently mounted. The roofing section over the freezer and cooler addition was in poor condition due to the degradation of the membrane do to aging.</p>		Good

8. Seal holes in exterior systems at Kitchen.
9. Replace rusted hinges and other rusting elements at exterior doors.
10. Survey exterior doors for missing gaskets and seals. Install as required.
11. Investigate subgrade water infiltration in rooms 108 and 109.

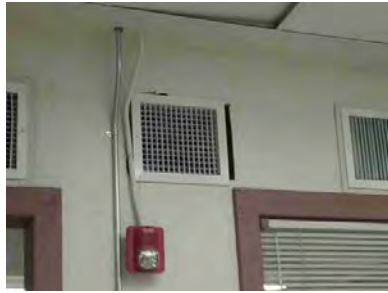
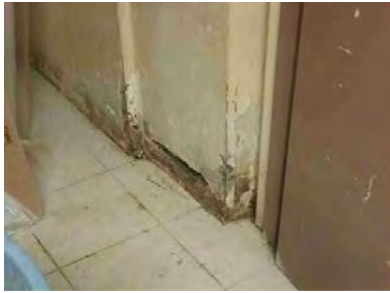
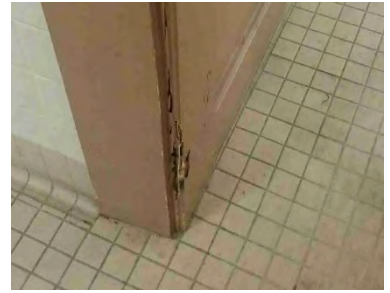
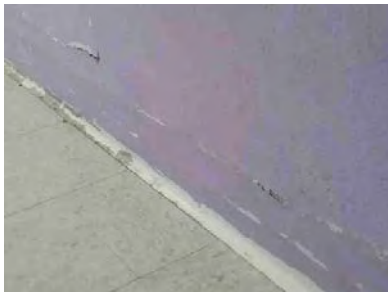
Interior Construction	Interior Walls	<p>The interior walls are a combination of masonry construction and gypsum board partitions finished with plaster, stucco, paint, or wood paneling. The walls were observed to be in average condition with several deficiencies noted. Termite damage was observed on the first floor in the wood paneling and also reported by facility staff in rooms 108-110, BRR100 and GRR100. Ants were also reported to be present in this area. Moisture damage was observed on the bottom portion of wall surfaces throughout the entire building. The damage could be from moisture penetration through the wall construction or from prolonged exposure to water due to mopping and cleaning procedures. A poorly fitted wall diffuser was observed in the Kitchen resulting in a large gap or opening at the wall penetration. In a closet on the first floor, CC100B the bottom portion of the gypsum board partition was completely degraded and open.</p>	Average

1. Close wall around the HVAC register in the kitchen.
2. Survey interior walls for loose and damaged plaster or stucco systems. Repair as required.
3. Remove and replace termite damage wood construction.
4. Replace partition in CC100B.
5. Strip doors of multiple layers of paint. Refinish and reinstall.
6. Survey millwork in classrooms for repair or replacement.

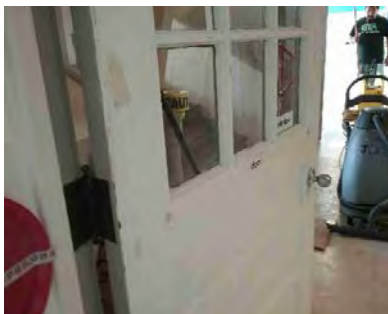
Interior Doors	<p>The interior doors are solid wood doors hung in wood frames.</p>	Average

System	Subsystem	Condition and Deficiency Overview	System Condition Rating
		The interior doors were observed to be in average condition. All doors observed had finish issues as a result of the application of multiple coats of paint. Paint was observed to be peeling and chipping.	
	Interior Specialties	System not present.	N/A
Stairs	Exterior Stairs	Three stairways are present on the south side of the building and one is located on the north side. The exterior stairs providing access to the second floor of the building are metal. The exterior stairs located at grade around the facility are constructed of concrete with metal tube railings. All exterior stairs were observed to be in average condition. The exterior metal stairs were observed to be corroded in various places.	Average
	Interior Stairs	The interior stairs are constructed of cast-in-place concrete with anti-slip nosing. The interior stairs were observed to be in average condition. The anti-slip nosing appeared deteriorated and no longer able to provide sufficient friction to reduce slipping hazards.	Average

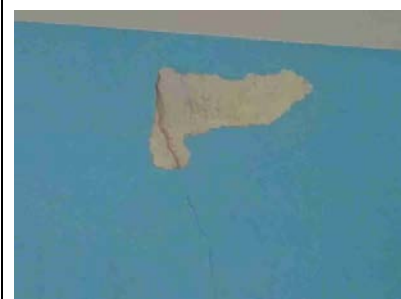
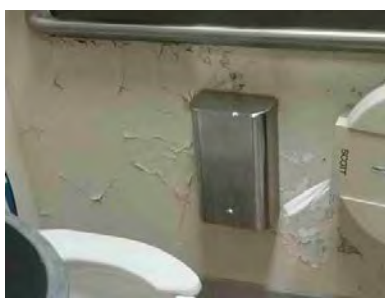
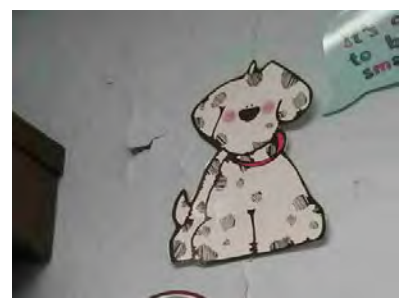
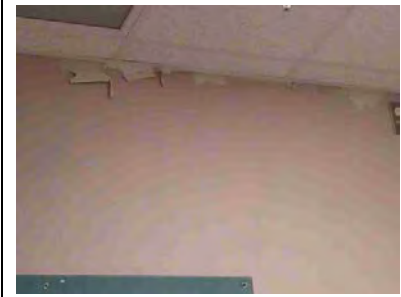
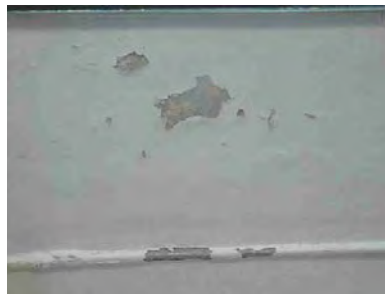
Interior Finishes	Interior Wall Finishes	The interior walls have a painted finish over various substrates. The restroom walls are finished with a combination of ceramic tile and paint. The interior paint finish throughout the entire building was observed to be in poor condition. Blistering, peeling, and cracked paint was observed on many wall surfaces. The cause of the peeling and blistering paint could possibly be a result of moisture intrusion through the wall construction, age, or poor surface preparation prior to repainting the surfaces in previous years. In the administration area, the paper of the gypsum board appeared to be torn at the head condition and unfinished. The campus staff has requested specifically that the painted base boards be refinished.	Poor
	Interior Floor Finishes	The interior floor finishes consist of ceramic tile in the restrooms, and VCT (vinyl composition tile) in most other spaces. The kitchen is finished with quarry tile while the library is finished with carpet. The interior floor finishes were observed to be in average condition with several deficiencies noted. At all of the exterior exits on the first floor, the VCT appeared cracked, blistered, or buckling away from the substrate. At several other locations throughout the building, the VCT was observed to be cracked or separating from the	Average

1. Investigate appropriate paint for wall system in place.
2. Remove excess layers of paint, repair substrate, and repaint interior of school.
3. Repair gypsum board in ADMIN.
4. Replace VCT on the first floor.
5. Install expansion joint cover at first floor where tile is damaged at substrate joint.
6. Seal floor around piping in ADMIN.
7. Remove VCT on wood flooring substrate. Refinish wood floors and maintain or remove wood floor and replace with substrate appropriate for VCT flooring.
8. Diagnose and repair water leak or intrusion issue at water-damaged tiles. Replace ceiling tiles.
9. Replace ceiling tiles on the first floor.

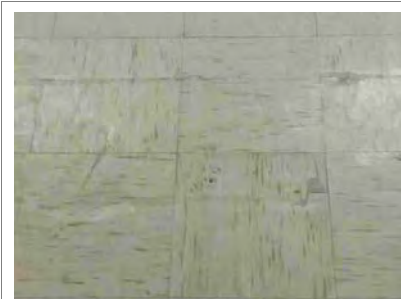
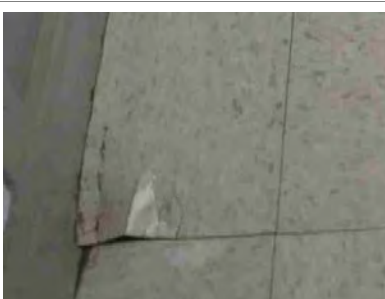
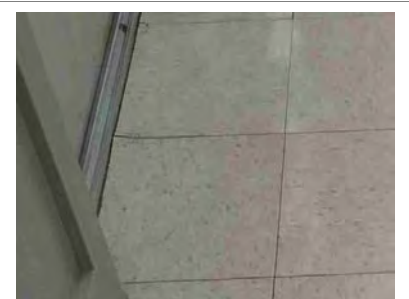
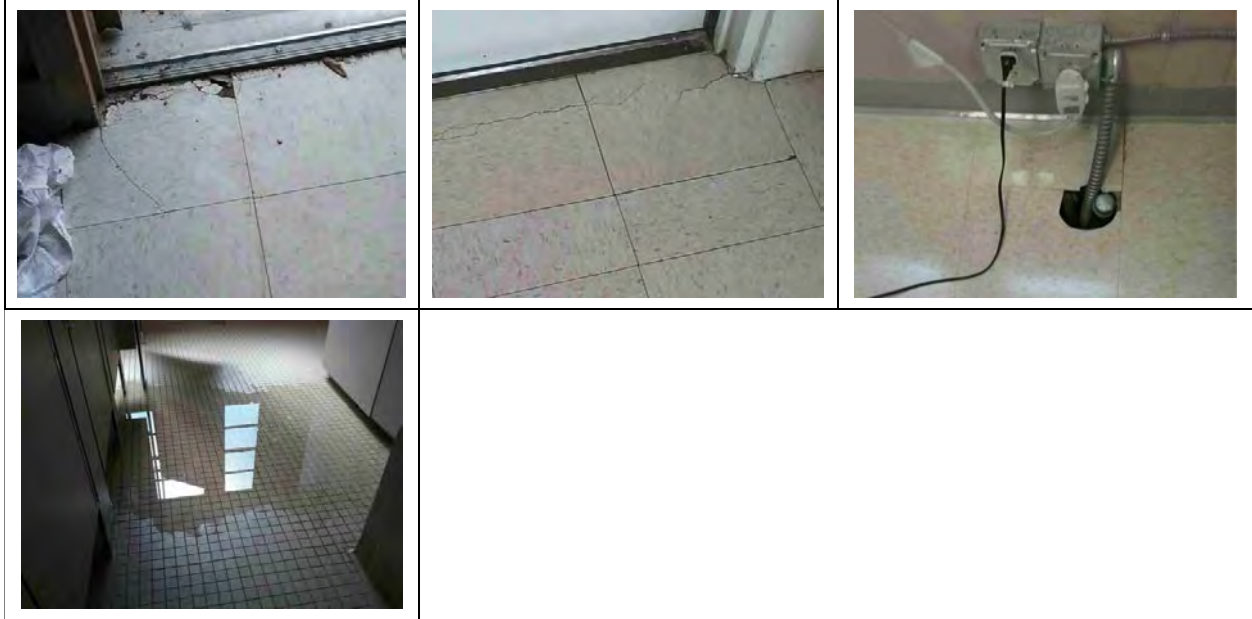
Interior Floor Finishes

System	Subsystem	Condition and Deficiency Overview	System Condition Rating
		substrate. The third floor female's restroom was noted as not sloped to drain to the floor drain. Softness in the flooring was reported by staff. Staff also requested that the carpet in the library be replaced.	
	Interior Ceiling Finishes	<p>The interior ceiling finishes at the facility consists of a 2'x4' suspended ceiling system in most areas. The exception is a 2'x2' suspended ceiling system, installed in the kitchen.</p> <p>The interior ceiling finishes were observed to be in average condition with several deficiencies noted. The first floor tile observed had humidity and physical damage. Water damage was noted on ceiling tiles on all three floors. The kitchen ceiling system had physical damage that detracted from its ability to function as a washable and maintainable surface as required. Staff requested that the ceiling tile on the third floor be replaced, as well.</p>	Average

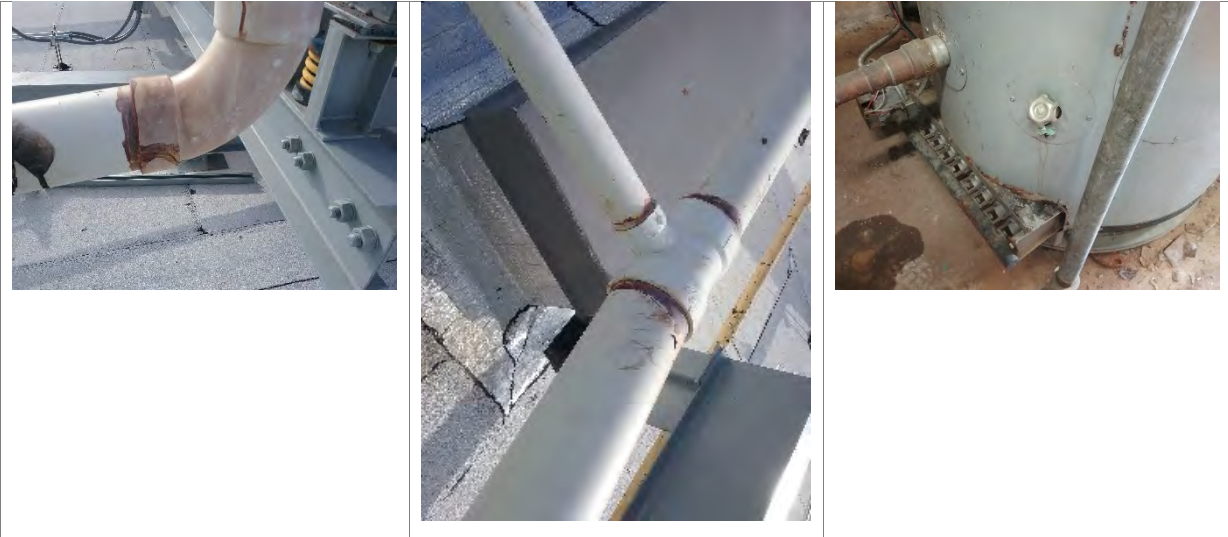
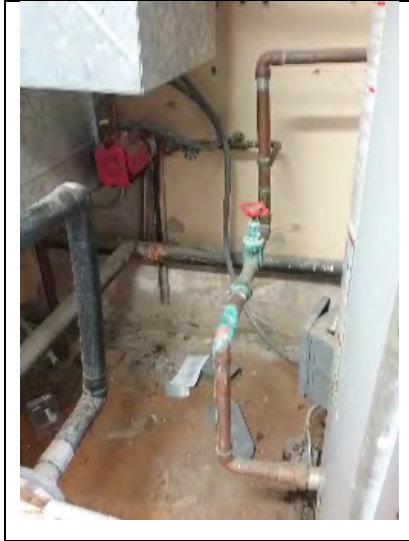
System	Subsystem	Condition and Deficiency Overview	System Condition Rating
	Domestic Water Distribution	<p>All of the plumbing fixtures are serviced with domestic cold water. There is a GWH (gas water heater) located in a mechanical room near the cafeteria.</p> <p>The GWH is in excess of 20 years old and is showing signs of aging and corrosion.</p> <p>Due to the identified corrosion issues and age of equipment, the system is rated as average.</p>	Average
	Other Plumbing	<p>The roof drains are equipped with metal grate covers to prevent debris from entering the drainage system. Vent piping is re-routed to the roof to accommodate outside air clearances.</p> <p>The roof drains appeared to be in good condition. The re-routed vent piping was not supported correctly and was degrading due to solar exposure.</p>	Poor
Mechanical/ HVAC	<p>The major mechanical equipment consists of indoor water source heat pumps (WSHPs), one RTU (roof top unit), and several DX (direct-expansion) split systems. The loop water temperature is controlled with a cooling tower and boiler located at the central plant. The outside air for the classrooms is understood to be served from a DX RTU.</p> <p>The mechanical system was undergoing a major renovation that did not include the replacement of the WSHPs. The WSHPs in the classrooms were observed to be in excess of their service dates. Several of the WSHPs were located in mechanical rooms accessible from the exterior. The WSHPs in these rooms were also in excess of their service dates. Due the age of the WSHPs, the system was rated average.</p>		Average

1. Replace GWH and associated corroded piping.

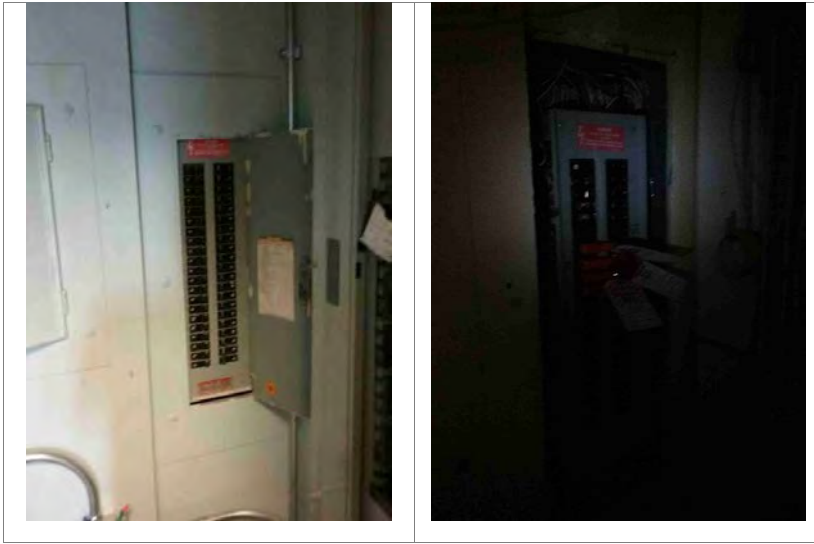
Electrical System Deficiency Examples

Fire Protection	Fire Alarm	<p>The building has a fire alarm system that consists of alarm and signaling devices, such as horns/annunciators, strobes, horn/strobe combinations, pull stations, and detectors.</p> <p>The fire alarm system appeared to be in good condition.</p>	Good
	Fire Protection/ Suppression	<p>The building has a sprinkler system with zone valves located at each floor. In addition to the sprinkler system, there are portable fire extinguishers placed throughout the facility.</p> <p>All observed portable fire extinguishers had inspection tags dated within the last year as required.</p>	Good
Electrical	Electrical Distribution	<p>The electrical service enters the building from the 120/208-volt 1600-amp main switchboard "MSB" located on the exterior near the service transformer. The service then feeds a 1600-amp distribution switchboard "SWBD" in the "MECH BOILER" room that distributes service to branch panelboards which are located in various electrical rooms throughout the</p>	Poor

System	Subsystem	Condition and Deficiency Overview	System Condition Rating
		<p>building.</p> <p>The electrical distribution equipment appeared to be in poor condition. The AISD Service Center staff reported that conduits are not properly secured and abandoned wiring is present. They also reported that the original cloth insulated wiring is in use and is not grounded. The Interview Notes reported that panelboards next to room "CC200A" and electrical room "ELEC300" need to be replaced. The Campus staff requested additional convenience outlets throughout the facility.</p> <p>The building does not have a lightning protection system although the AISD Service Center has requested that it be installed.</p>	
	Lighting	<p>The building's exterior lighting consists of HID (high intensity discharge) light fixtures that are located along the entire perimeter. The interior lighting consists of 2'x4' fluorescent recessed troffers.</p> <p>The interior and exterior lighting appeared to be in good condition. There were exit signs present in the building that appeared to be in good working condition. The Interview Notes reported that the interior light fixtures need to be replaced due to age and the lenses were falling out. It was also reported that the emergency lighting needs to be replaced.</p>	Good

1. Replace old panelboards with new in room next to "CC200A" and "ELEC300" room.

2. Secure all conduits that are not properly secured in place.
3. Remove all abandoned conduits and wiring throughout BLDG-054A.
4. Replace old or exposed wiring as necessary to be installed in conduit for a complete and grounded system.

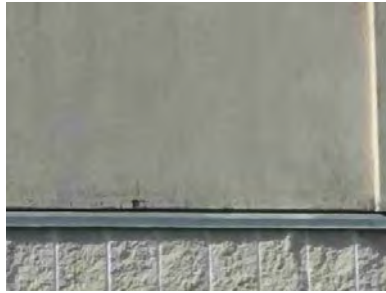
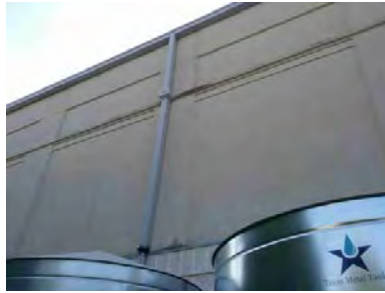
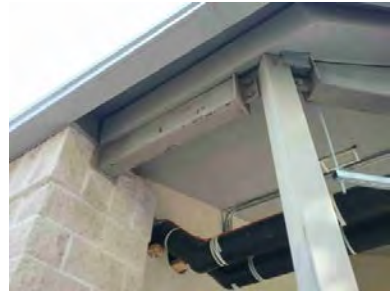
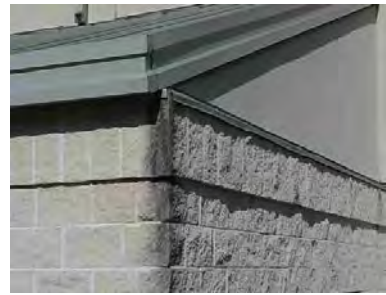
System	Subsystem	Condition and Deficiency Overview	System Condition Rating
Exterior	Exterior Walls	<p>The exterior wall systems include CMU (concrete masonry unit) and an EIFS (exterior insulated finish system) or, possibly, stucco installed on upper portions of the wall. At the main entry, there are exposed metal beams supporting the southeast corner of the lower roof section.</p> <p>The exterior walls are in good condition. Conditions of concern on the exterior wall were the failing of the paint system, staining on the exterior wall surfaces, and damage at the EIFS/Stucco system. The paint system on the exposed steel structure was observed to be peeling. In various locations uncontrolled run-off from the roof and water ejecting from the rain water collection system were noted to be staining the exterior wall. At the joint between the EIFS/Stucco and the CMU, the sill of the EIFS/Stucco was observed to be damaged. Given the height of this joint, it was unclear what might be the cause of the damage.</p>	Good

1. Investigate damage of EIFS/Stucco system at joint between system and CMU.
2. Strip and repaint exposed steel structure at main entry.
3. Rework rain water collection system with correctly sized intake and overflow piping.
4. Install continuous drip edge at CMU corner on the east side of the building.
5. Investigate damage at sill in GYMOFC.
6. Clean rust of the bottom of the rollup door and apply appropriate finish system.
7. Investigate water infiltration at rollup door, repair are required.
8. Repair panic hardware at GYMVEST.

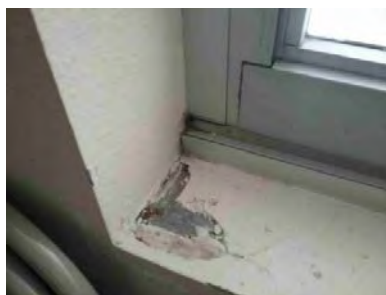
Exterior Windows	<p>The exterior windows are fixed and single hung with the fixed units installed in the gymnasium while the single hung unit is in the office.</p> <p>The exterior windows are in good condition. The window sill at the single hung window in the office showed signs of water damage suggesting the wall or window unit is leaking.</p>	Good

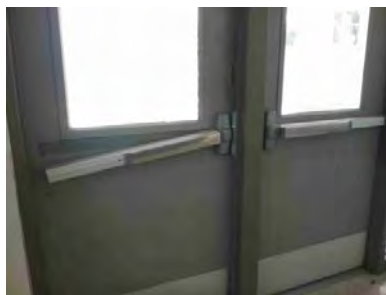
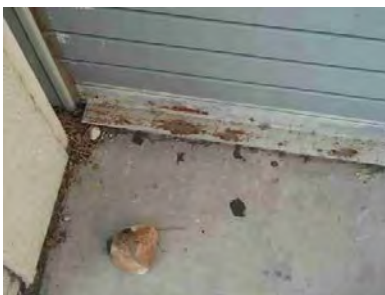
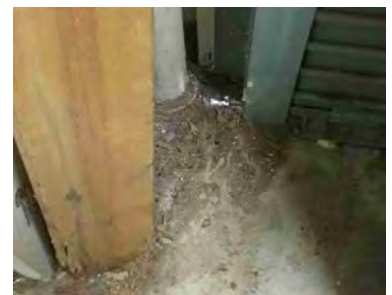
System	Subsystem	Condition and Deficiency Overview	System Condition Rating
	Exterior Doors	<p>The exterior doors are hollow metal units hung in hollow metal frames and one roll-up door at the outside storage room.</p> <p>The exterior doors are in average condition. During the assessment the panic hardware at the main entrance was observed to be damaged and hanging from the door. The rollup door had rust developing on the bottom angle of the unit and the unit did not appear to be water tight.</p>	Average
Roofing		<p>The roof area is inaccessible due to the lack of a roof ladder. Observed from the adjacent building's roof, the roof system on the building appeared to be standing seam metal. The other roof surfaces associated with this building make up the covered walkway between the two buildings. This is a formed metal panel that spans between supporting beams.</p> <p>The roofing appeared to be in good condition. The edge of the panels at the gutter on the east side of section B02 appeared discolored which might indicate rust developing. One panel on the same roof section appeared damaged. Gutters on the walkway canopy appeared to have leaves and debris in them.</p>	Good

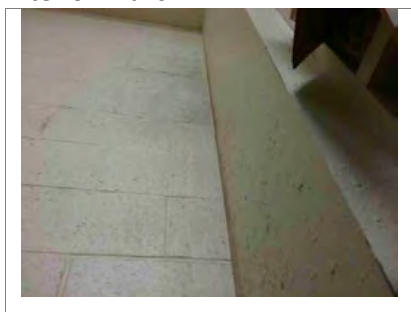
Interior Construction	Interior Walls	<p>The interior walls are construction of gypsum wall board systems or exposed CMU.</p> <p>The interior walls are in good condition. In GYMOSTO there appeared to be a growth on the wall system.</p>	Good
	Interior Doors	<p>The interior doors are hollow metal or solid core wood door units hung in hollow metal frames.</p> <p>The interior doors are in good condition. A door stop was noted as missing at the doors between the GYM and GYMVEST.</p>	Good
	Interior Specialties	System not present.	N/A
Stairs	Exterior Stairs	<p>The exterior stairs consist of cast-in-place concrete stairs with pipe railings on site between the two buildings.</p> <p>The exterior stairs are in good condition and no deficiencies were noted.</p>	Good
	Interior Stairs	System not present.	N/A
Interior Finishes	Interior Wall Finishes	<p>The interior walls finishes were paint systems applied to gypsum board wall or CMU construction.</p> <p>The interior wall finishes are in good condition. Two deficiencies were noted during the assessment: Damage to the wall finishes as a result of the missing door stop noted above and the gypsum board window sill in the office. Gypsum board wall systems are not a durable material for horizontal surfaces where constant contact with objects or people is highly likely. This is</p>	Good

1. Investigate growth on wall of GYMOSTO. Address underlying cause.
2. Install durable material at window sill.
3. Install a door stop in GYMVEST at the double doors leading into the GYM.

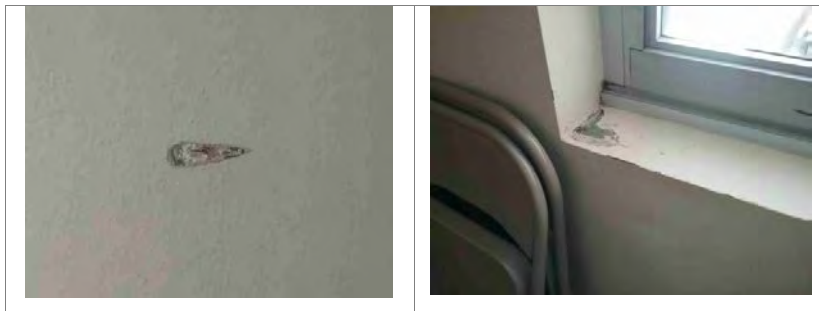
Interior Wall Finishes

System	Subsystem	Condition and Deficiency Overview	System Condition Rating
		likely to lead to continuous maintenance the surface of the window sill.	
	Interior Floor Finishes	The building contains a variety of floor finishes, including sheet vinyl flooring in the gymnasium area, ceramic tile in the restrooms, and VCT or exposed concrete in other areas. The interior floor finishes are in average condition. One deficiency noted was a damage tile in the vestibule.	Average
	Interior Ceiling Finishes	The ceilings are painted gypsum board, 2'x2' suspended ceiling tiles, or vinyl faced insulation batts, used in the gymnasium. The interior ceilings are in average condition. Paint system deficiencies were noted in the outside storage room, a water-damaged ceiling tile was noted in the office, and damage was observed to the insulation system in the gymnasium. At least one area of the physical damage to the insulation in the gymnasium appeared to have staining suggestive of water infiltration.	Average

1. Repair gypsum board and paint in GYMVEST
2. Repair window sill at GYMOFC and install a durable window sill material.
3. Repaint the ceiling in GYMOSTO.
4. Replace damaged tile in GYMVEST
5. Replace damaged insulation and investigate possible roof leak.
