Pecan Springs Elementary School Site Summary

Address	3100 Rogge Lane Austin, TX 78723
Number of Permanent Campus Facilities	2
Original Year of Construction	1957
Total Campus Building Area (combined)	56,992 SF

Main School Building – BLDG-129A

Classrooms and Library – BLDG-129B

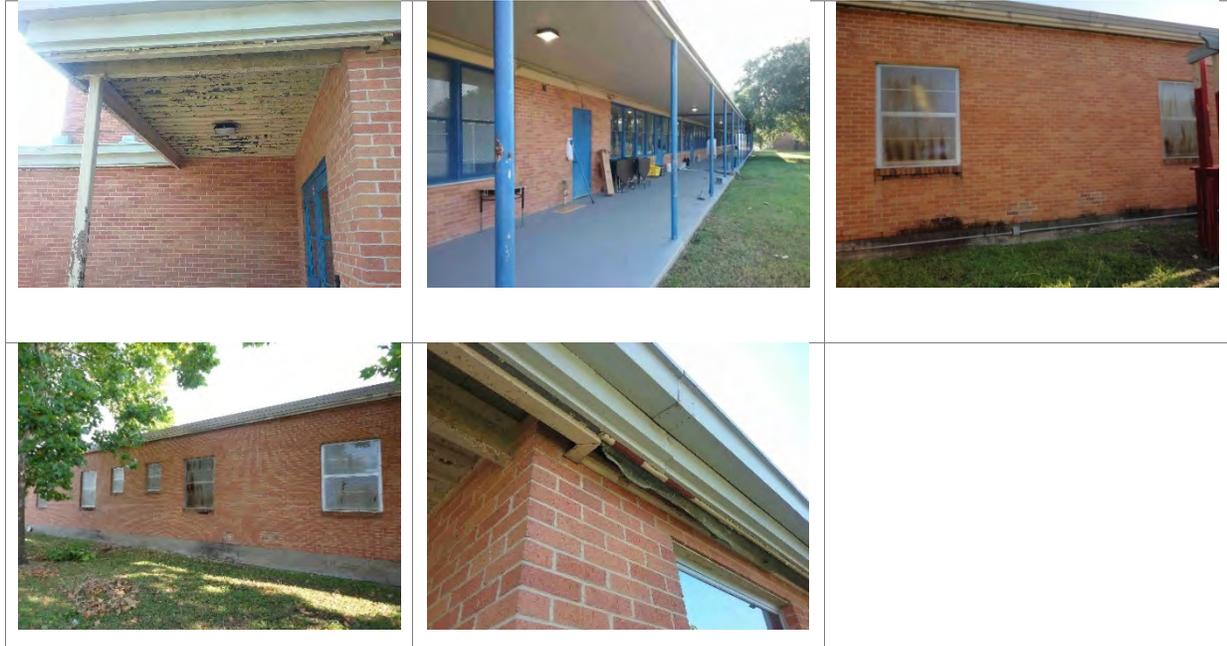
System	Subsystem	Condition and Deficiency Overview	System Condition Rating
Exterior	Exterior Walls	<p>The exterior of the building consists of a brick façade.</p> <p>The exterior walls were observed to be in average condition due to age with isolated areas in need of cleaning due to organic growth, specifically on the brick window sills. There are a few areas where mortar has been previously repaired and isolated cracks were observed in the mortar on the south side of the 300-wing. It was reported that water infiltrates the exterior wall at the foundation on the west side of corridor C2 during rain events due to parking lot flooding.</p> <p>The painted metal soffits at the entrances and painted steel columns supporting the walkways were peeling significantly.</p>	Average
	Exterior Windows	<p>The exterior windows along corridor C2 and the 300-wing are aluminum framed single-pane glazing units. The remaining windows appear to be original to the building and consist of single-pane glazing units with painted metal frames.</p> <p>The aluminum windows were observed to be in good condition. The original painted metal frame windows were in poor condition as the multiple layers of paint were peeling, and the weather seals have deteriorated. The original windows were inoperable and have visible air gaps in the office area and kitchen.</p> <p>Several screens were damaged, and the metal guards on the windows have peeling paint, rust and damaged in isolated areas.</p>	Average

1. Refinish and repaint all painted metal railings, columns, awnings and window covers.
2. Clean organic material from brick window sills and surrounding areas.

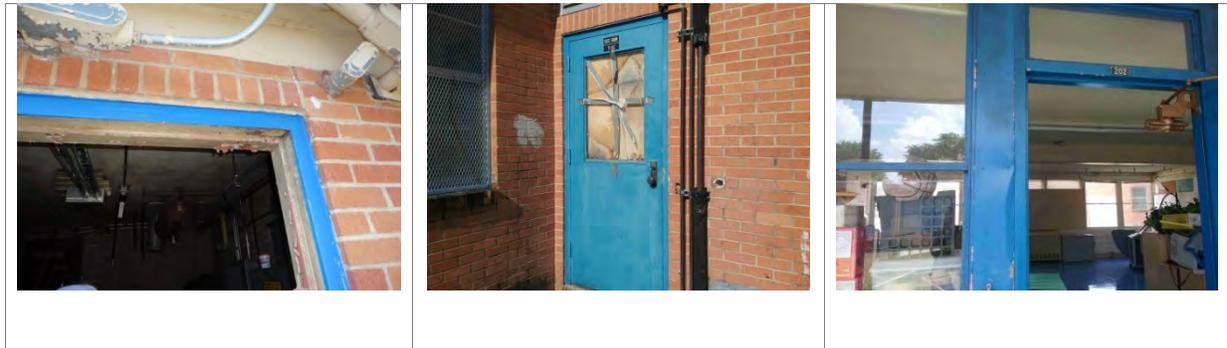
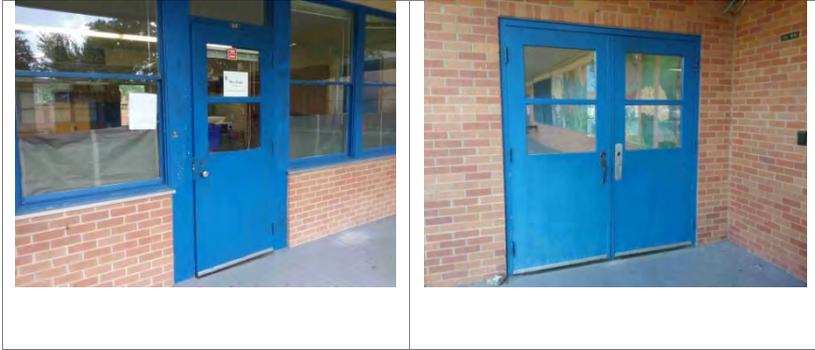
System	Subsystem	Condition and Deficiency Overview	System Condition Rating
	Exterior Doors	<p>There is one main public entryway located at the south side of the building; these doors are painted metal with a metal frame. The 100- and 200-wing classrooms are accessed by doors directly from an exterior covered walkway. The remaining service doors around the facility are painted metal.</p> <p>The exterior doors were observed to be in poor condition due to age, high usage, weather exposure, and layers of peeling paint. Various exterior doors did not open and close properly and had gaps at the weather stripping. The paint on the doors and frames was peeling, and some areas were dented or damaged. The door hardware was mismatched and antiquated. The glazing in the door to HPD1 was broken and was being held together with tape.</p>	Poor
Roofing		<p>The roof material covering the building is a modified bitumen roof system. There is a covered walkway connecting BLDG-129A and BLDG-129B with a corrugated metal roof.</p> <p>The roof surfaces were observed to be in poor condition. There were areas of ponding water over the kitchen, administration, and gymnasium. The roof material has begun to separate at the seams and roof edges, and the metal fascia has peeling paint. Facility staff reported pests entering the facility through an unknown point on the roof. Staff also reported various spot leaks in the 100-, 200-, and 300-wings. The gutters that exist at administration, kitchen, cafeteria, corridor C2, and gymnasium were in good condition. The classroom wings did not have gutters, and water appears to sheet off of the edge to grade. The low side of the classroom wings appears to remain damp after rain events as slope is insufficient. The roofing walkway access pavers do not extend to all mechanical equipment, and various areas are slick. The corrugated metal over the walkway was in average condition due to age.</p>	Poor

1. Replace the remaining original painted metal windows. Replace screens and window guards.
2. Replace exterior doors and frames.

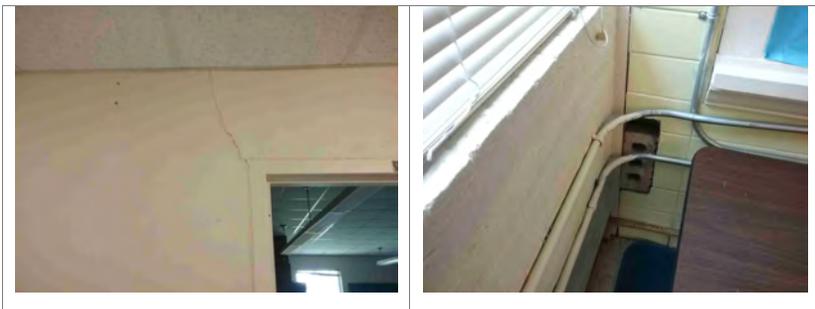
Interior Construction	Interior Walls	<p>The interior partitions in the 100- and 200-wings are predominantly constructed of glazed brick on the lower portion of the wall and painted above. The corridors have exposed and painted brick. The 300-wing has a mixture of exposed brick and stud and gypsum board walls.</p> <p>The interior walls appear to be in average condition due to age and minor areas that required repair. There were multiple cracks at the upper door corners in the 300-wing in the gypsum board walls, possibly due to building movement or high usage. There were missing or removed bricks in the north corner of the wall between rooms 104 and 105. It was reported that the louvered windows between the office and corridor were</p>	Average

1. Repair gypsum board and repaint at upper door corners in the 300-wing. Consider installing control joints at door corners to prevent future cracking.
2. Replace missing bricks in wall at rooms 104 and 105.

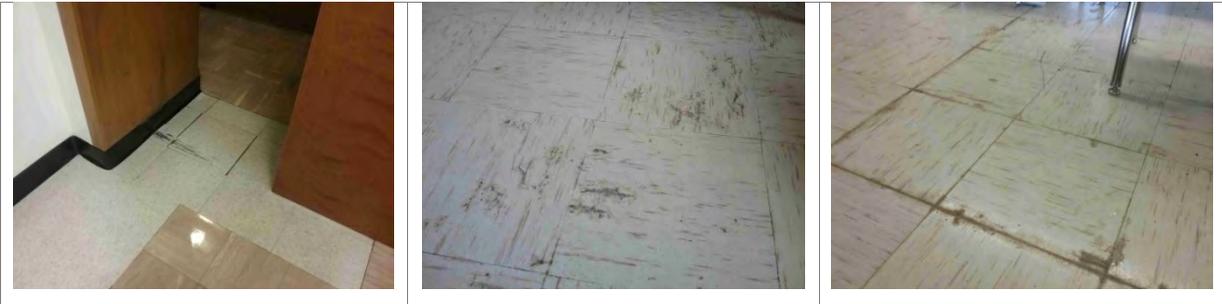
Interior Floor Finishes	VCT (vinyl composition tile) is found throughout the building that appears to be original construction. There is ceramic tile in the restrooms and kitchen. The administration areas are a mixture of vinyl composition tile and carpet. The stage is wood. The flooring appears to be in poor condition as the vinyl composition tile in the 100-, 200-, and 300-wings and adjacent to the office area has deteriorated due to age, specifically at the tile seams. There were reports of asbestos being present.	Poor
	Interior Ceiling Finishes	Acoustic ceiling tile is found throughout the building. An acoustic spray finish is present in the classrooms in the 100- and 200-wings. Vinyl ceiling tile is in the kitchen. The high ceiling tile in the cafeteria appears to be original. It was reported that the ceilings in corridors C1 and C2 and in the 100- and 200-wings are original and contain asbestos.	Poor

1. Repaint classrooms in 100- and 200-wings.
2. Replace wood paneling in 300-wing with a more durable surface.
3. Further investigation is required of the moisture issues in 300-wing. Building staff reported mold and odors.
4. Replace discolored ceiling tile in 300-wing and further investigate cause of water damage.
5. Replace vinyl composition tile throughout classroom wings.

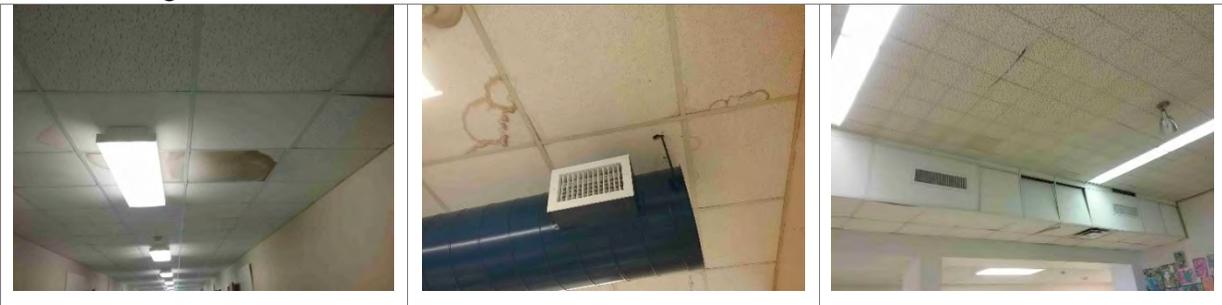
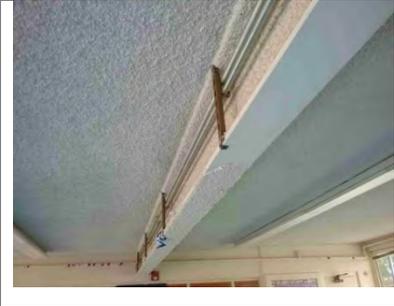
Interior Ceiling Finishes

System	Subsystem	Condition and Deficiency Overview	System Condition Rating
		<p>The interior ceiling finish appears to be in poor condition. There were multiple leaks causing discolored tiles in the 300-wing due to condensation from equipment or possibly roof leaks. The acoustic spray finish in the classrooms of the 100- and 200-wings was damaged and peeling at various locations. The lowered acoustical tile ceiling in the cafeteria was damaged and out of alignment, possibly due to the reported pest issue at this area. Pests were visible in the corridors and administration areas.</p>	
Conveying	System not present.		N/A
Plumbing	Plumbing Fixtures	<p>BLDG-129A contains predominantly single-use restrooms throughout the facility, with multi-use restrooms outside the gymnasium. Typical restrooms have floor-mounted vitreous china water closets with manual flush valves. Additionally, wall-hung vitreous china urinals with manual flush valves are located in the dedicated multi-use male restrooms. Typical classrooms contain a single-basin stainless steel or vitreous china sink with a drinking fountain attached. Stainless steel drinking fountains can be found in the corridors throughout the building.</p> <p>The majority of plumbing fixtures are in average working condition but are aged and show minor signs of deterioration. room 104 was observed to have a leaking faucet on the sink. room 202 was observed to have a loose faucet on the sink. rooms 101 and 313 were observed to have little or no flow to the drinking fountains. The female restroom in room 103 was marked with a "Do Not Use" sign, but there was no visual evidence of any deficiency.</p> <p>A commercial kitchen is located in the school's cafeteria in BLDG-129A. The kitchen contains stainless steel kitchen equipment, including a three-basin prep sink. It also has various wall-mounted vitreous china and stainless sinks for personal use. The building also has service sinks located in various janitorial closets. These were in average to poor condition, with signs of leaks and corrosion around the base.</p>	Average

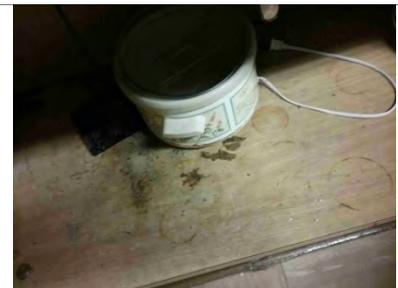
Domestic Water Distribution	<p>Domestic hot water to the kitchen is provided by a 99-gallon, 0.199 MBH gas water heater stored in the mechanical room (KITMECH) located on the outside of the building just outside the kitchen. Various smaller electric hot water heaters are located throughout the</p>	Average

System	Subsystem	Condition and Deficiency Overview	System Condition Rating
		<p>building to provide heated domestic water to specific locations in the school (i.e., the Nurse's office and gymnasium shower). Domestic hot water is not supplied to the classroom plumbing fixtures.</p> <p>The plumbing distribution equipment was observed to be in average condition with damaged insulation and corrosion and rust observed on piping throughout the building. Several sinks in the 100-wing were observed to have corrosion and rust in the connecting piping to the sink. The sinks in rooms 101, 203, 206, 302, 313 and 310 were observed to have a musty smell coming from beneath them and signs of leaks. room 303 was observed to be missing the connecting piping from the drain on the sink. It was reported in the facility interview that this classroom recently had a pipe burst, but repairs had already been completed.</p> <p>The EWH (electric water heater) in CC300 Unit shows signs of fire damage and smells charred. The building staff later noted that the unit caught fire earlier in the day. The unit has been disconnected and is not operational. Smaller EWHs in the administration office and nurse's office are aged and out of date. Corrosion was noticed on piping running along the ceiling in the kitchen storage. The domestic water system is in average condition with typical wear and tear associated with the system's age and general daily use.</p>

1. Replace EWHs that are beyond their expected design life need to be replaced before failure occurs.
2. Clean out storm and condensate exterior drains to avoid plugging and backup.
3. Inspect, clean and repair plumbing in multiple bathrooms that are emitting an unpleasant odor.
4. Address any rust or corrosion observed on the equipment, its associated piping, or any other sub-asset in all facilities by cleaning, re-painting, or repairing to prevent further deterioration.

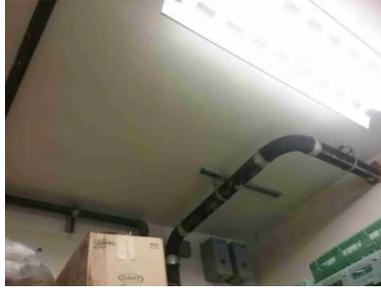
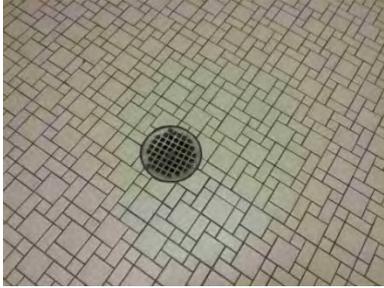
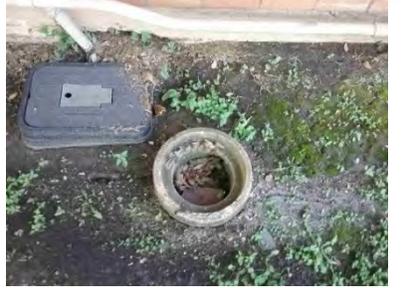
Other Plumbing	<p>The male restrooms off the gymnasium as well as multiple classrooms in the 300-wing, male restrooms in rooms 101, 201, and 205, and the female restroom in room 101 were observed to be emitting an unpleasant odor. The floor drains were observed to be in average condition. Visual assessment did not show any obvious clogs. Corrosion was noticed on piping running along the ceiling in the kitchen storage.</p>	Poor
Mechanical/ HVAC		<p>The building's HVAC (heating, ventilating, and air conditioning) system is composed of geothermal water pump units, RTUs (roof top units), roof top AHUs (air handling units), heat pump systems and in-wall package units for individual zone temperature controls. The original building containing the administration office, gymnasium, and cafeteria and 300-wing classrooms is controlled using RTUs that distribute air through in-ceiling source vents. Classrooms in the 100- and 200-wings are temperature controlled using a geothermal water pump system designated for each classroom. Water source heat pumps in each classroom were not accessible, but assumed to be stored within the unit and working properly. Multiple roof top exhaust fans ranging in size serve the building.</p>	Poor

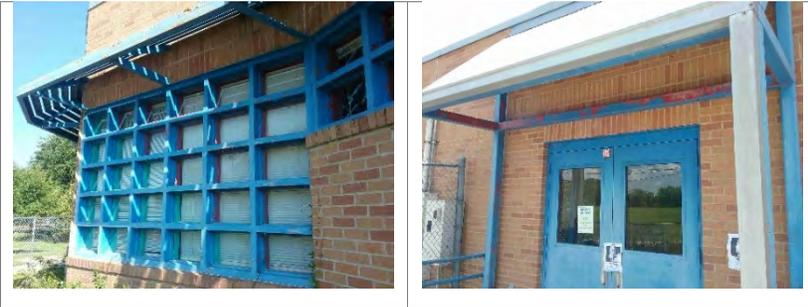
System	Subsystem	Condition and Deficiency Overview	System Condition Rating
Exterior	Exterior Walls	The exterior of BLDG-129B consists of a brick façade with painted metal sun shades over windows and doors. The exterior walls were observed to be in good condition, with isolated areas in need of cleaning due to organic growth, specifically on the brick at window sills on the north side. The painted awnings and painted steel columns supporting the door cover were peeling significantly.	Good
	Exterior Windows	The exterior windows consist of single-pane glazing units with painted metal frames. The classroom windows have frosted glazing panels on the lower portion of the double-hung windows. The classroom windows were observed to be in average condition. Water damage was evident on the interior and exterior sills of the windows in the classrooms. The wood sills and surrounding painted gypsum walls were deteriorating, possibly due to issues with installation or failed sealant.	Average

1. Replace classroom windows on the north side to prevent further moisture damage to interior finishes and discoloration of exterior brick. Consider installing awnings similar to the south side.
2. Repaint exterior doors.

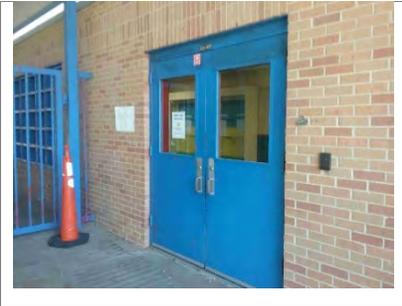
Exterior Doors	The main entrance to the building has a card reader on the exterior. The doors around the exterior are painted metal with half glazing lites in metal frames. The doors appear to be in good working condition with a few areas of peeling paint on the exterior.	Good
Roofing	The roof of BLDG-129B does not have a roof access ladder or roof hatch. This area was not assessed as it was inaccessible. The building has a parapet wall at the perimeter and clerestory windows in the library. There is no mechanical		N/A

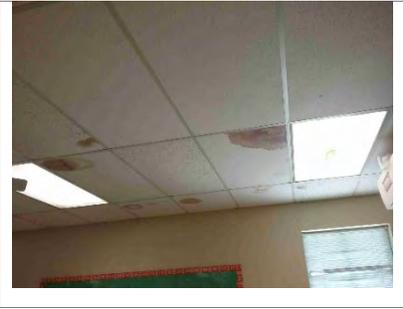
Interior Ceiling Finishes	The interior ceiling finish is acoustic ceiling tile throughout the corridors and classrooms. The library ceiling is painted gypsum board. The ceiling finishes appear to be in good condition with the exception of the acoustic ceiling tile in room 404. There were numerous discolored ceiling tiles, possibly due to condensation from equipment or roof leaks.	Good

1. Patch gypsum board and repaint at window sills.
2. Replace wood window sills in classrooms with new sills.
3. Replace damaged or discolored ceiling tile in room 404.

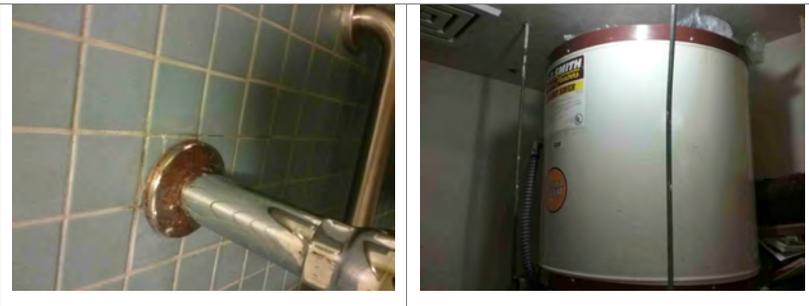
Domestic Water Distribution	<p>A small EWH, approximately 19 gallons, was found in the janitorial closet (CC400). The heater was mounted above head, making it difficult to inspect. It is estimated to be original to this building (1990) and showed signs of being aged and out of date.</p> <p>The plumbing distribution equipment was observed to be in average condition with minor corrosion and rust observed on piping throughout the building. The domestic water system is in average condition with typical wear and tear associated with the system's age and general daily use.</p>	Average
	Other Plumbing	<p>Exterior rain water drains appeared to have minor debris that could cause blockage. The male restroom in room 404 and the female restroom in room 401 were observed to be emitting a foul smell. Other plumbing was observed to be in average condition.</p>	Average
Mechanical/ HVAC	<p>BLDG-129B's HVAC system is composed of geothermal water pump units in the individual classrooms and heat pump systems to feed the library. The restrooms also contained exhaust fans.</p> <p>The HVAC system is in average condition; however, the majority of the equipment is original to the building and is past its expected design life. Some units show signs of degradation and signs of rust and corrosion. The geothermal water pump units are approaching end of useful life and have been reported to leak. Heat pump systems for the library are aged and out of date. Multiple HVAC units were</p>		Average

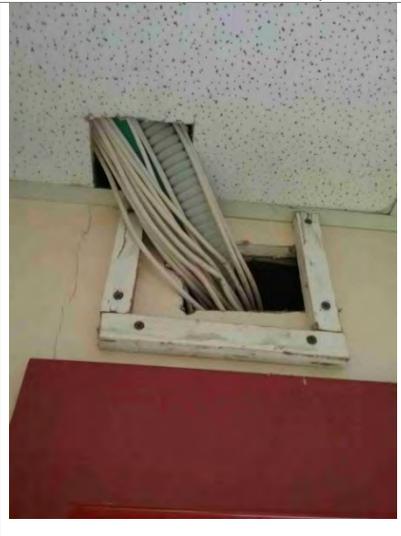
Lighting	The building's exterior lighting consists of metal-halide and LED luminaires. The interior lighting primarily consists of fluorescent luminaires flush mounted in the ceiling. The building has battery-operated emergency lighting luminaires throughout which were found to be in good condition. BLDG-129B's lighting system was found to be in good condition. One deficiency was noted due to a strobing luminaire in the female restroom that connects rooms 400 and 401. The building exit luminaires were found to be dim and appeared discolored. No deficiencies were found with the branch wiring.	Good
	Communications & Security	BLDG-129B is equipped with telecommunication systems. room LIBAVSTO houses server equipment for building distribution. The classrooms and library also have Wi-Fi modules present. Each classroom has a hardwired telephone fixture and receptacle. Interior security cameras are located in the building corridors, and the classrooms have motion detectors. The timeclock system appears to be in good condition. BLDG-129B's communications and security system was found to be in good condition. The north entrance that connects to the C5 corridor was found to have networking cable (assumed) running through a hole in	Good

System	Subsystem	Condition and Deficiency Overview	System Condition Rating
		the wall. Although this is not a communications deficiency, it should be corrected for aesthetic reasons.

1. Replace the female restroom luminaire for room 400/401.
2. Consider rerouting cabling at the north entrance to BLDG-129B or repairing the damaged wall.
