Pillow Elementary School Site Summary

Main School Building – BLDG-151A

CRAWL SPACE – Pillow ES – Main School Building (BLDG-151A)

PILLOW ELEMENTARY SCHOOL

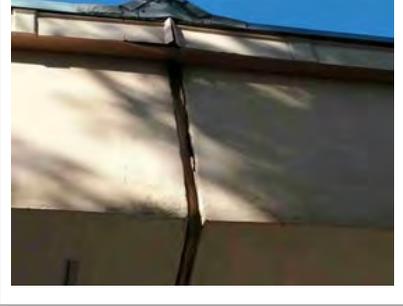
System	Subsystem	Condition and Deficiency Overview	System Condition Rating
Exterior	Exterior Walls	The exterior of the building consists of a brick façade. The building is one story built in 1969. The exterior walls were observed to be in good condition. The expansion joints at soffit of the north entrances were deteriorated.	Good
	Exterior Windows	The windows are single-paned, aluminum metal-framed inset into the brick façade. The windows appeared to be in average condition. Windows on the south side of the building were faded and discolored from the sun.	Average
	Exterior Doors	There are many double exterior metal doors with glazing throughout the building. Most doors were in average condition and working order, but were chipped and scratched. The glazing was scratched and filmed. There was also paint chipping on the interior face.	Average
Roofing	The main building roof has a modified bitumen roof system. Only roof A-10 is a single-ply roof and has been re-covered in recent years. The roof system was viewed in poor condition. With the exception of A-10, the roof system showed evidence of ponding, cracking, splitting, and bubbling. Roof A-02 had two broken skylights, repaired with duct tape, and showed cracking and loose edge flashing.		Poor

1. Repair expansion joints on exit door overhangs.
2. [Repair or replace damaged exterior doors and glazing \(requested by the CAC and Principal Brian Hill\).](#)

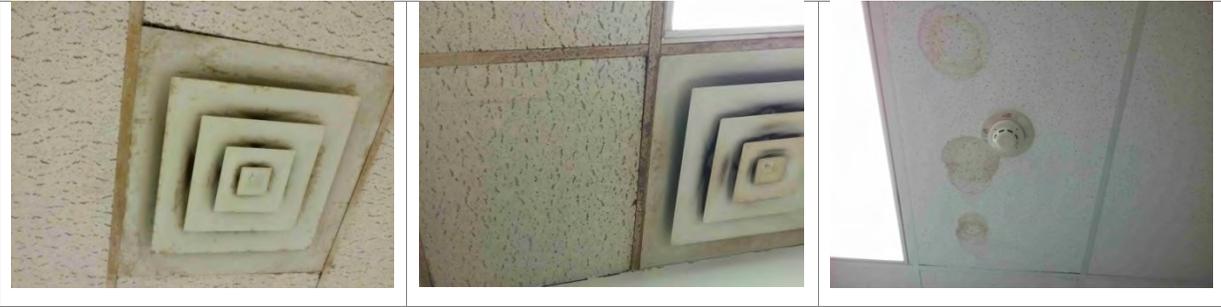
System	Subsystem	Condition and Deficiency Overview	System Condition Rating
	Interior Ceiling Finishes	<p>The interior ceilings are acoustical ceiling tile in a metal grid in the classrooms, library, and cafeteria and administration areas. There are 12x12" perforated tiles on the ceiling in the music classroom and the male and female restrooms across from the gymnasium area. There are gypsum board ceilings in the restrooms. The gymnasium has Tecktum acoustical panels in a metal grid.</p> <p>The ceiling systems were observed to be in average condition. The grid and nearby AC registers in the faculty restroom, gym, and main corridor were pitted with rust. There were stained ceiling tiles.</p>	Average
Conveying		A vertical lift was not observed at this facility. However, the facility reports that there is a mobile lift, which is old and has to be hand cranked, posing problems for students with mobility issues.	Poor

1. Replace stained ceiling tile as needed.
2. Replace AC registers and grid that are rusted.
3. Replace missing floor tile.

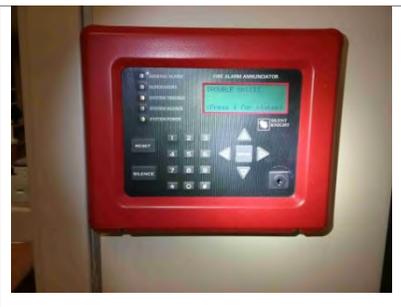
Fire Protection	Fire Alarm	<p>The building has a fire alarm system that consists of alarm and signaling devices such as horns/annunciators, strobes, horn/strobe combos, pull stations, and detectors. The fire alarm system is controlled by the Silent Knight control panelboard.</p> <p>The fire alarm system equipment was observed to be in average condition. The remote annunciator indicated system trouble.</p>	Average
	Fire Protection/Suppression	<p>The building is not equipped with a fire sprinkler/suppression system; however, it is protected by portable fire extinguishers that are stationed throughout the building.</p> <p>All portable fire extinguishers observed were inspected within the last year.</p>	N/A
Electrical	Electrical Distribution	<p>The electrical service (utility transformer for the facility) appears to be located on the southwest corner of the campus. The main mechanical room houses a 480-volt 800-amp main switchboard that feeds power to transformers, panelboards, and mechanical equipment. Numerous electrical rooms and storage closets house transformers and sub panelboards to supply power to the buildings end devices and additional mechanical equipment.</p> <p>The electrical distribution equipment was in average condition. The main switchboard, a 45-kVA transformer, and a 30-kVA transformer located in the main mechanical room appeared to be nearing the end of their life expectancy.</p> <p>Panelboard K, located in the kitchen adjacent the serving line, appeared to be nearing the end of its life expectancy and had considerable corrosion on its</p>	Average

1. Identify the cause of the remote annunciator indicating system trouble and implement repair.

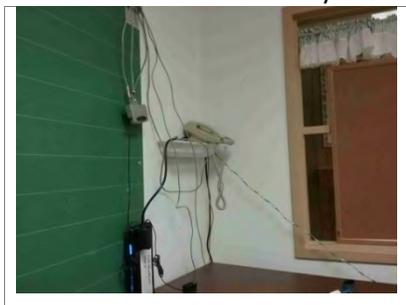
Communications & Security

System	Subsystem	Condition and Deficiency Overview	System Condition Rating
		The equipment was observed to be in average condition. Networking cabling in various locations throughout the building routed along walls and floor ways presented tripping and tangling hazards.

3. Assess the facility needs for additional power requirements in the administration area.
4. Consider relocating the electrical panel in the MDF room to a more accessible location.
5. Assess lighting in hallways and classroom bathrooms for increasing illumination.
6. Reroute and install communication cabling in a manner that does not cause trip hazards.
7. [Replace interior lighting fixtures \(requested by CM Randall Sakai\).](#)

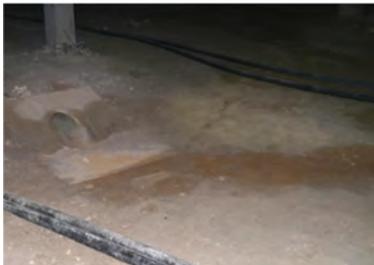
<p>Damp soil leading to drainage inlet</p>	<p>Puddle below leaking pipe</p>	<p>Cracked soil retainer, Damp soil</p>

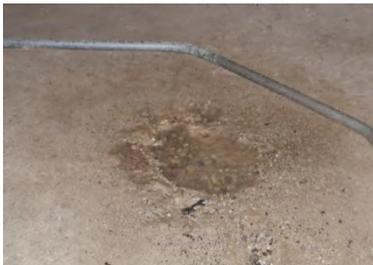
Pipes, Ducts, Equipment & Fireproofing	Suspended Pipes & Hangers	<p>All pipes observed were suspended. Few pipes had detached and/or degraded insulation and mild rusting and one pipe was leaking and had formed a puddle in the soil below. Failed and rusted hangers were observed in the classroom addition crawl space.</p> <p>Pipe deficiencies:</p> <ul style="list-style-type: none"> • Leaking pipe • Rusted pipes & hangers • Failed hangers • Degraded/detached insulation 	Average
	Exposed Ductwork	N/A – No exposed ductwork was present in the crawl space areas observed.	N/A
	MEP Equipment	N/A – No MEP equipment was present in the crawl space areas observed.	N/A
	Spray Fireproofing/ Insulation	N/A – No spray fireproofing or insulation was present in the crawl space areas observed.	N/A

1. Repair leaking pipes
2. Repair or replace rusted pipes and pipe supports
3. Replace failed hangers
4. Replace detached/degraded pipe insulation

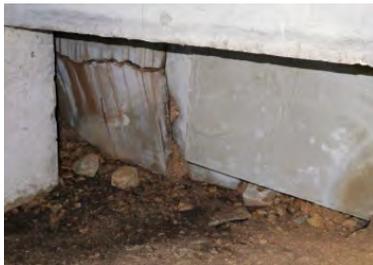
System	Subsystem	Condition and Deficiency Overview	System Condition Rating
Soil, Drainage, Ventilation & Access	Soil Below Building, Site Drainage in Crawl Space	<p>The soil beneath the building was generally dry and appeared in good condition. A drainage pipe was observed under the cafeteria and also appeared in good condition. Soil was slightly damp around and lead to the drainage pipe, below a leaking pipe, below broken soil retainers and near various penetrations in perimeter beams. No significant soil deficiencies observed.</p> <p>Soil/drainage deficiencies.</p> <ul style="list-style-type: none"> Mildly damp soils 	Good
	Soil Retainers	<p>Observed soil retainers were generally in good condition. Cracks were observed on a few retainers on the west side of the main building. Perimeter beams in the classroom addition were built on trapezoidal carton forms and did not have soil retainers.</p> <p>Soil retainer deficiencies.</p> <ul style="list-style-type: none"> Cracked concrete soil retainers 	Average

1. Replace cracked/broken soil retainers
2. Investigate need for additional ventilation
3. Verify adequate security at access points

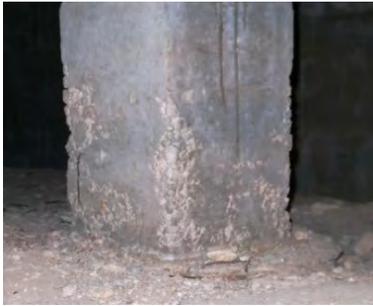
Access Hatches	<p>Access hatches inside the building were located in the admin storage room, the electrical room, and a custodian closet on the southeast classroom wing. All interior access hatches were locked and could not be unlocked with available tools. The southeast classroom addition was accessed through a loose vent on the east wall of the school. The original construction crawl space was accessed through an exterior access door on the south wall near the gym. This access hatch was loosely placed and could be opened easily by anyone.</p> <p>Access hatch deficiencies:</p> <ul style="list-style-type: none"> • Loose vent on east side of school may not be safe for children • Loose access hatch on south wall near gym may not be safe for children 	Good
Exposed Structure	Exposed Columns & Tops of Foundations	<p>Observed exposed columns and tops of foundations appeared generally in good condition. Honeycombing was observed in a few isolated locations.</p> <p>Column/Foundation deficiencies:</p> <ul style="list-style-type: none"> • Mild column honeycombing 	Good

<p>Honeycombing on column</p>

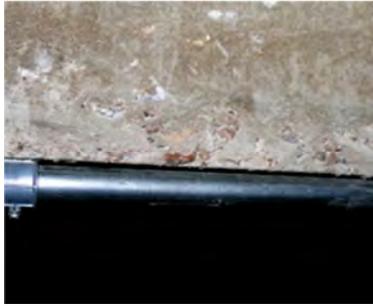
<p>Mild honeycombing in interior beam</p>

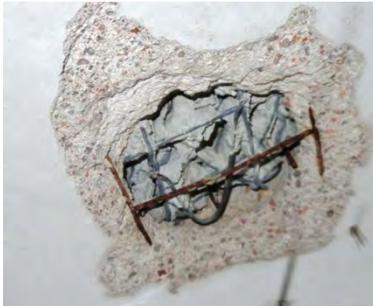
Exposed Faces of Perimeter Walls / Beams	<p>Perimeter beams were cast-in-place and suspended. All perimeter beams observed were in good condition. No deficiencies were observed</p>	Good
	Exposed Portions of Interior Floor Beams Above	<p>Suspended floor beams spanned between columns and supported a flat slab in the new classroom addition and precast pan joists in the original construction. Minor honeycombing was observed on few beams in the original construction.</p> <p>Beam deficiencies:</p> <ul style="list-style-type: none"> • Minor honeycombing 	Good
	Underside of Suspended Floor Slabs Above	<p>The new classroom addition floor system consists of a flat slab supported by floor beams. The original construction floor system consists of precast pan joists. Spalling in the deck was observed on the precast pan joists. There was also a spall at a pipe penetration.</p> <p>Slab deficiencies:</p> <ul style="list-style-type: none"> • Spalls with exposed reinforcement in deck • Spalls at pipe penetrations 	Average

<p>Spall and exposed/corroded reinforcement on underside of deck</p>

1. Repair significantly damaged areas in concrete deck by cleaning exposed reinforcement and patching spalled concrete.
2. Patch holes in slab and repair slab damage at pipe penetrations

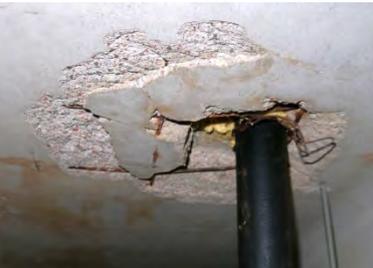
<p>Spalls and exposed/corroded reinforcement at deck pipe penetration</p>

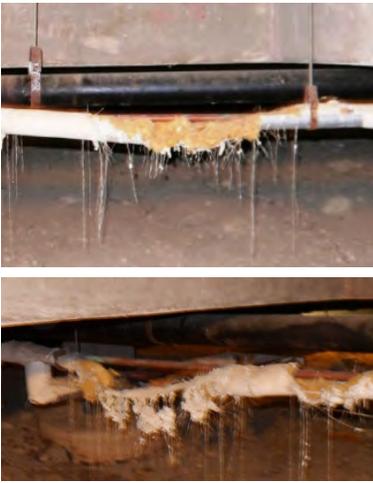
<p>Detached/degraded pipe insulation</p>

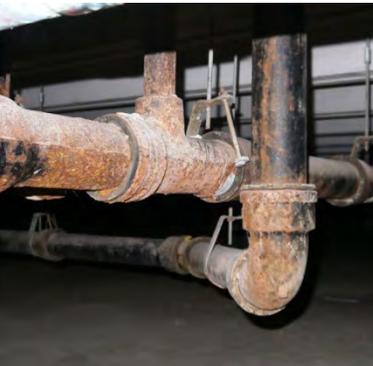
<p>Rusted pipes</p>

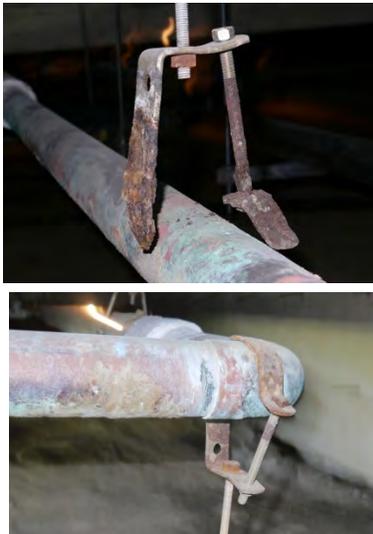
<p>Rusted, failed pipe hangers</p>
--	---	--

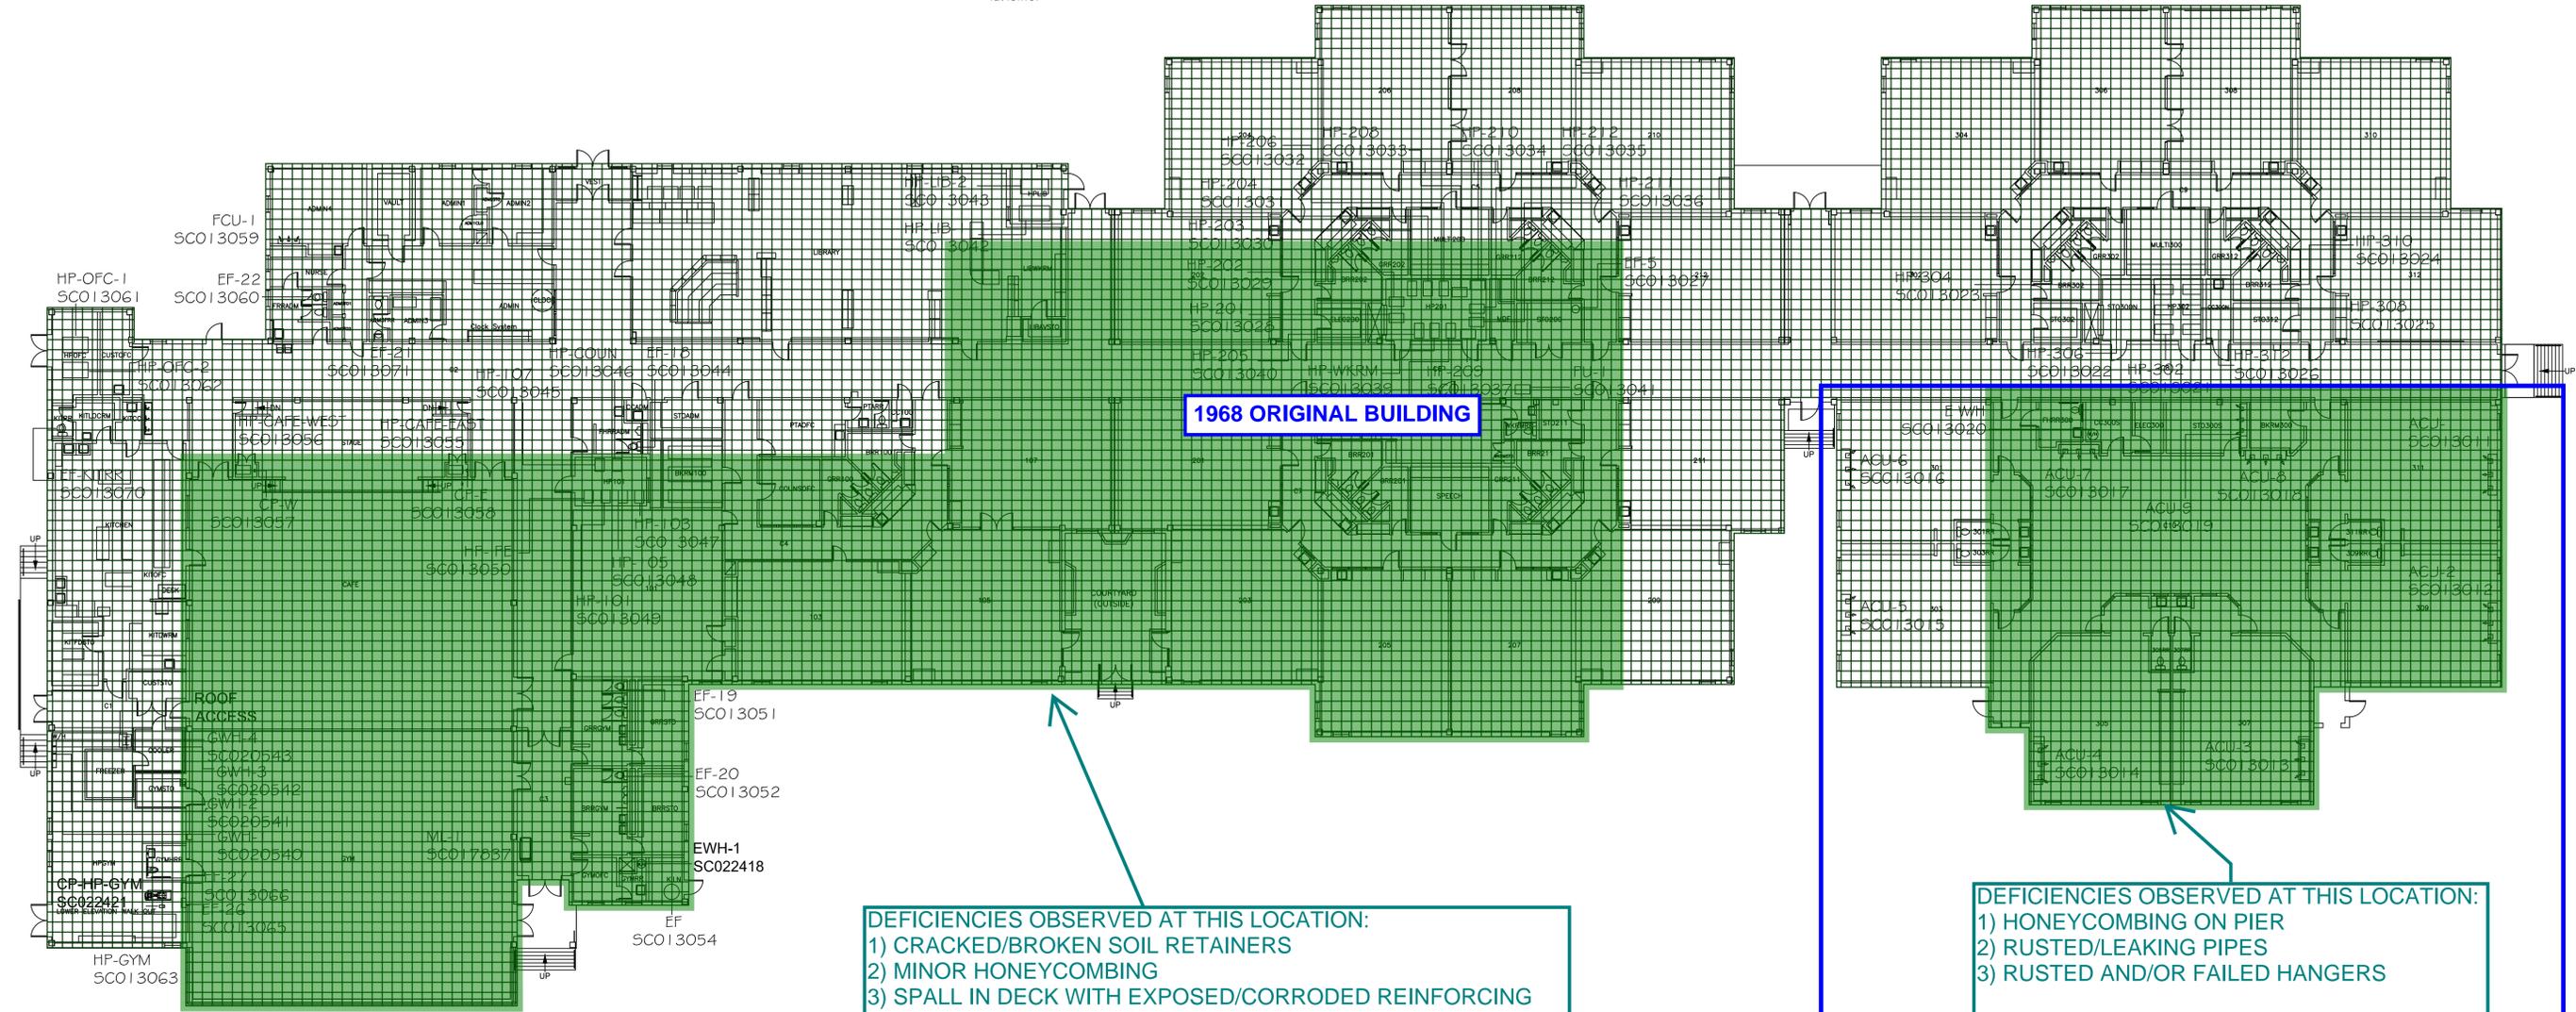
FLR-151A-01

- 1) CRACKED/BROKEN SOIL RETAINERS
- 2) MINOR HONEYCOMBING
- 3) SPALL IN DECK WITH EXPOSED/CORRODED REINFORCING
- 4) SPALLS AT PIPE PENETRATIONS
- 5) RUSTED PIPES
- 6) RUSTED AND/OR FAILED HANGERS
- 7) LEAKING PIPES
- 8) DEGRADED PIPE INSULATION

- 1) HONEYCOMBING ON PIER
- 2) RUSTED/LEAKING PIPES
- 3) RUSTED AND/OR FAILED HANGERS
