## Pleasant Hill Elementary School Site Summary

## Main School Building – BLDG-130A

Building Purpose	Administration Offices, Classrooms, Cafeteria, and Gymnasium
Building Area	65,298 SF
Inspection Date	July 28, 2016
Inspection Conditions	90°F - Sunny and hot
Facility Condition Index

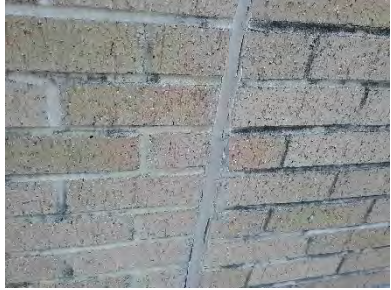
### Exterior Walls

System	Subsystem	Condition and Deficiency Overview	System Condition Rating
Exterior	Exterior Walls	<p>The building exterior walls are brick veneer over CMU (concrete masonry unit) structural backup. There is a nine-course decorative band of glazed brick in the brick façade.</p> <p>The brick veneer façade appeared to be in good condition. Sealant joints appeared to be dry, cracked and generally at end of life. It was reported that pests were able to enter the building through mechanical piping penetrations through exterior walls around the building perimeter.</p>	Good
	Exterior Windows	<p>The exterior windows are metal framed with operable sash and single-pane glazing. At the classroom wings, many of the windows are residential-grade, anodized aluminum, single-hung windows set into a hollow metal storefront system. These pre-finished windows have been field painted to match the storefront system.</p> <p>The horizontal factory-finished exterior windows appeared to be in average condition. Sealants were dry and cracked. The aluminum windows that were modified to fit into the storefront system were observed to be in poor condition and were reported to leak. These windows were observed to have missing PVC (polyvinyl chloride) glazing strips with glass edges visible, resulting in air infiltration. The aluminum windows and hollow metal frames were not compatible as a system.</p>	Poor

1. Replace the aluminum windows within the hollow metal frames. Consider fixed glazing that is more compatible with hollow metal frames, unless there is a requirement for ventilation through the window system.
2. Replace sealants at masonry joints and around windows.
3. Paint all exterior doors and hollow metal frames.
4. Further study the cause for security breaches at exterior doors.
5. Investigate and block access points for pests at mechanical piping penetrations.

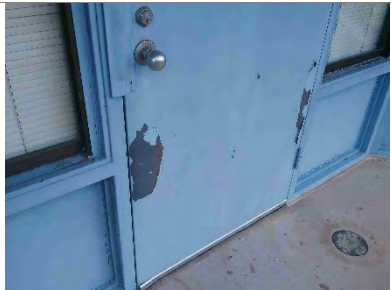
### Exterior Doors

System	Subsystem	Condition and Deficiency Overview	System Condition Rating
	Exterior Doors	<p>The exterior doors are steel in individual hollow metal frames or within a storefront system. The exterior doors have large vision panels and/or side-lites at major building entrances.</p> <p>The building exterior doors were observed to be in average condition. Many of the exterior doors had peeling paint and heavy oxidation. It was reported that 50% of the doors could be breached, but nothing unusual about the hardware was observed.</p>	Average
<b>Roofing</b>		<p>The primary building roof is built-up and is likely original to the 1985 construction. The low-sloped roof drainage is to internal roof drains. There are steep-sloped, formed metal roofs at major building entrances and a low-slope metal canopy at the bus loading area.</p> <p>The roof appeared to be in average condition; however, the built-up roof had aged beyond its expected service life. The steep-sloped metal roofs appeared to be in good condition. The bus loading metal canopy appeared to be in good condition.</p>	Average

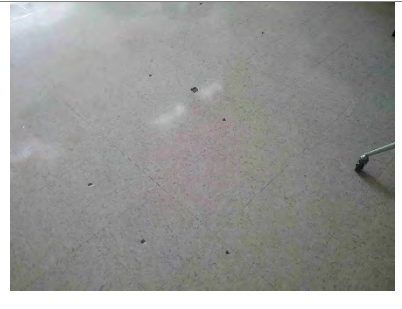
### **Interior Floor Finishes**

System	Subsystem	Condition and Deficiency Overview	System Condition Rating
		has wood steps for access. The concrete ramps and the wood steps at the stage were observed to be in good condition.	
<b>Interior Finishes</b>	Interior Wall Finishes	The building interior wall finishes are mostly painted surfaces. The building's restrooms have ceramic tile on walls. The walls in the kitchen are painted CMU. The interior wall finishes were observed to be in good condition despite some visible scuffing in high-traffic areas.	Good
	Interior Floor Finishes	The interior floors throughout most of the building are vinyl tile with a 4-inch base. Carpet is found in the library, administration spaces, and the PTA workroom. The kitchen has a quarry tile floor. Restrooms throughout the building have ceramic tile flooring. The vinyl flooring appeared to be in good condition relative to its age. However, the vinyl floor at COR 5 had been replaced and was still reported to have problems with adherence due to moisture coming up through the slab. Loose tiles are reported in COR1, the K classroom wing, and in other areas of the facility. The carpet, quarry tile, and ceramic tile floors were observed to be in good condition.	Good

1. Determine the cause of water infiltration in the floor in COR5. Replace vinyl floor tiles as needed.
2. Determine the cause and extent of deterioration of the folding partition in the cafeteria/gymnasium, and repair or replace the partition as needed.
3. Determine the cause of rust in the COR5 ceiling grid hangers, and replace hangers as needed.

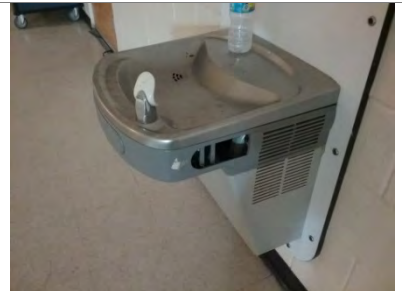
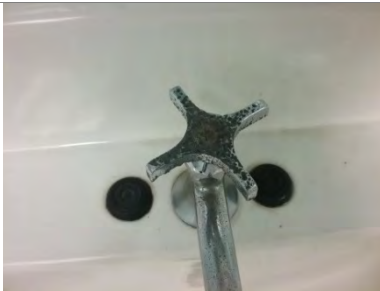
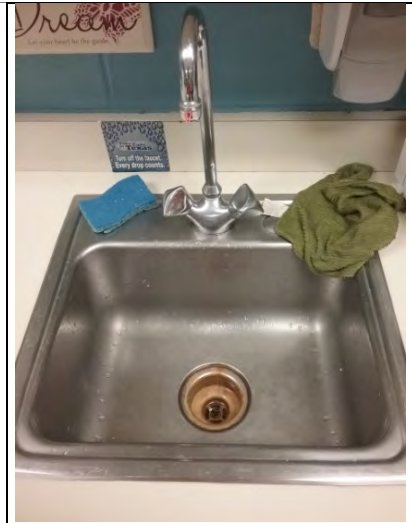
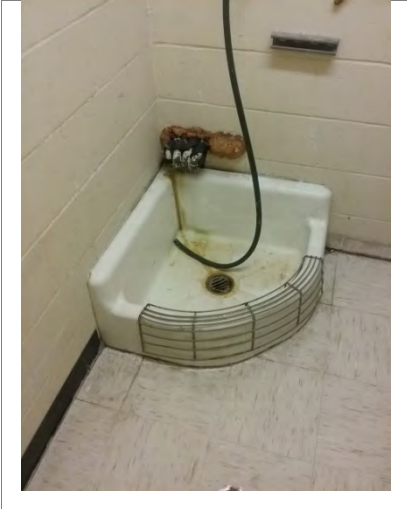
### **Plumbing Fixtures**

Interior Ceiling Finishes	The interior ceilings are primarily suspended acoustical tiles. Restroom ceilings have painted gypsum board surfaces. The acoustical tile in the kitchen is vinyl covered. The interior ceilings were observed to be in good condition. However, it was reported that the grid hangers in COR 5 were rusting.	Good
<b>Conveying</b>	System not present.		N/A
<b>Plumbing</b>	Plumbing Fixtures	The building has public restrooms for students and separate staff restrooms located throughout the facility. These restrooms typically have vitreous china hand sinks with manual faucets, along with vitreous china toilets with manual flushing mechanisms. There are service sinks in the janitorial closets, trough-style vitreous china handwashing sinks located near the gymnasium, and water coolers located throughout the facility, typically near the public restrooms. The kitchen includes additional plumbing fixtures such as stainless steel wash sinks and a small restroom equipped with a vitreous china wall toilet and sink. The restroom plumbing fixtures were observed to be in poor condition as the fixtures were aged and had	Poor

System	Subsystem	Condition and Deficiency Overview	System Condition Rating
		noticeable wear. Several water coolers were nonfunctioning or damaged. Numerous plumbing fixtures were damaged or leaking. It was reported that numerous toilet seals and flanges were failing. Rust was observed on select sinks and janitorial service sinks. The plumbing fixtures were observed to be in poor condition.	
	Domestic Water Distribution	The sinks located throughout the facility, with the exception of the kitchen, lounge, PTA workroom, library and gymnasium office are not equipped with hot water. The sinks located in the kitchen are serviced with hot water from a GWH (gas water heater)-3, located in the kitchen mechanical room. The remaining areas are served by local, small EWHs (electric water heaters). The mechanical drawings indicate a small EWH was in the administration area, but the area was under construction and was inaccessible at the time of assessment.  The domestic water distribution equipment appeared to be in average condition. The kitchen water heater was observed to be functioning, but nearing the end of its useful life due to age and use. Damaged piping insulation was observed in some areas.	Average

1. Continue preventive maintenance on aged plumbing fixtures and plan for replacement in the future as fixtures continue to age.
2. Repair water coolers that are nonfunctional.
3. Repair or replace leaking plumbing fixtures.
4. Replace toilet seals and flanges where needed.
5. Replace rusted plumbing fixtures.
6. Track the installed years of water heaters, and plan for replacement as the typical design service life for a water heater is 10 to 15 years.
7. Repair damaged piping insulation.
8. Clean out roof drains to eliminate standing water on the roof.
9. Remove gravel and debris covering roof drain entry points.
10. Reroute condensate drain lines into an approved sanitary sewer drain.

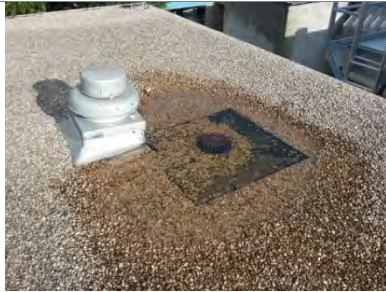
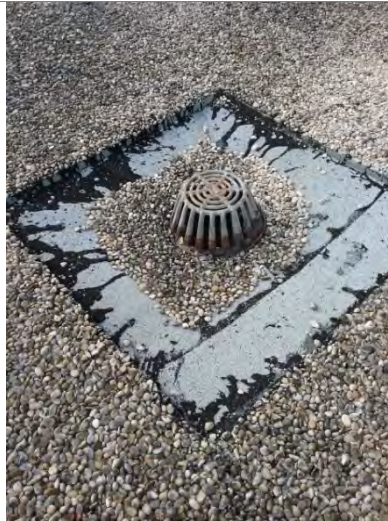
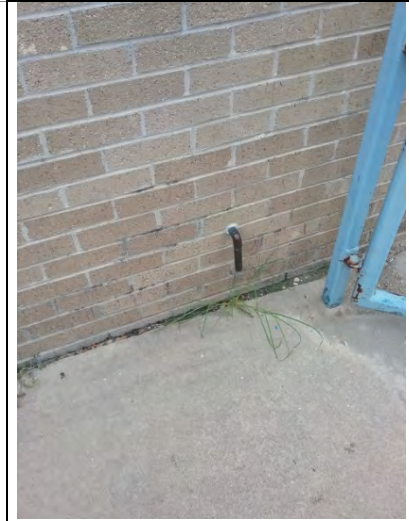
Other Plumbing	The roof is equipped with roof drains. Floor drains are located in the interior portion of the building.  The other plumbing appeared to be in poor condition due to age. The roof drains were rusty and need replacement. The roof drain located nearest the cooling tower was partially clogged. Standing water covering the top of the roof drain cover was observed after rainfall the previous day. It was reported that during the last roofing project, tar flowed into the roof drains and has caused problems in the past. It was also reported that there were no overflow drains on the roof. Roof gravel was partially blocking several roof drains. Condensate drain lines were discharging onto the ground and walkways.	Poor
<b>Mechanical/ HVAC</b>	The major mechanical equipment consists of ceiling-mounted WSHPs (water source heat pumps), a cooling tower and heat exchanger for heat rejection, a boiler for building heating, and a RTU (roof top unit) for kitchen make-up air. These serve the HVAC (heating, ventilating, and air conditioning) system along with roof-mounted EFs (exhaust fans).  The HVAC system appeared to be in poor condition. Seventy WSHPs, ranging in capacity from an estimated 3- to 6-TON, were located in the ceiling plenum throughout the facility and were unavailable for individual assessment. It was		Poor

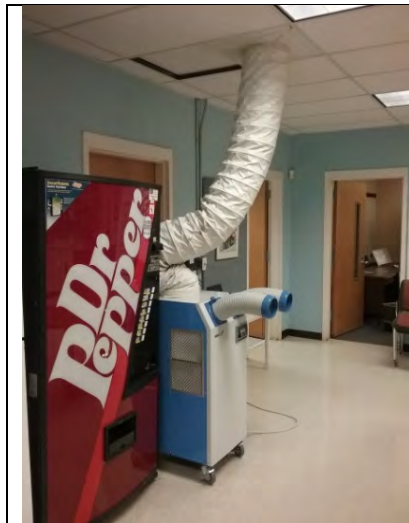
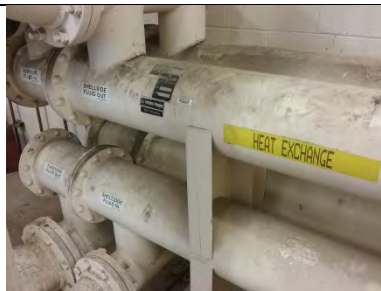
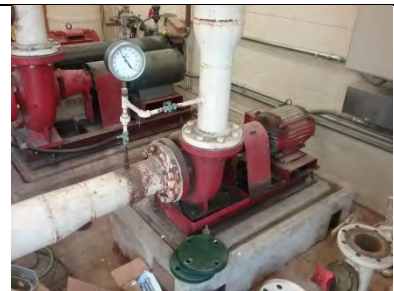
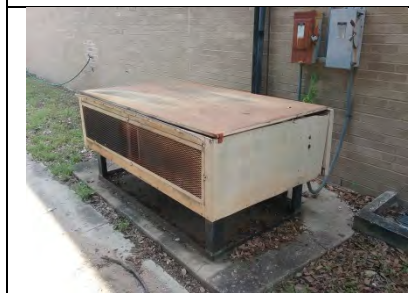
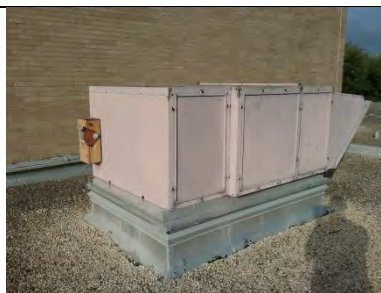
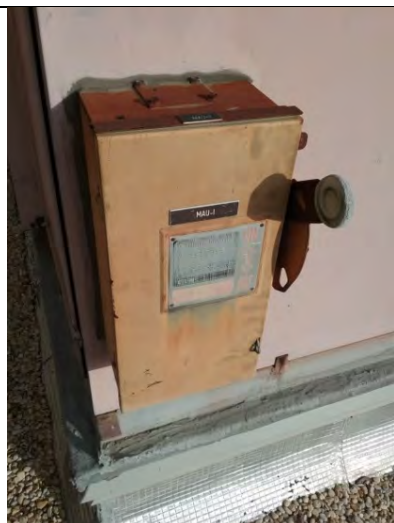
Mechanical/HVAC System Deficiency Examples

System	Subsystem	Condition and Deficiency Overview	System Condition Rating
		<p>reported that 15 WSHPs were being replaced this summer and that the remaining 55 WSHPs need replacement as well. Portable coolers were observed in select areas of the building at the time of assessment. The cooling tower appeared to have been installed within the last three years and appeared to be in good condition. The heat exchanger and distribution pumps appeared aged and need replacement. A new boiler was being installed at the time of assessment. A condensing unit located on the exterior of the building was aged and appeared to be in poor condition. The RTU located above the kitchen for the kitchen exhaust hood make-up air appeared to be in poor condition due to age. The electrical disconnect was rusted and needed replacement. Electrical conduit was penetrating the ductwork located in the kitchen.</p> <p>The EFs serving restroom exhaust appeared to be in average condition. The kitchen EF and nearby EFs appeared to be in poor condition due to their age. A nonfunctioning EF was observed on the roof near the kitchen. It was reported that the electrical rooms and janitorial closets throughout the building need EFs.</p> <p>It was reported that the mechanical units in the K-wing were unique to the building. The outside air is ducted to each unit through the exterior wall of each classroom. This requires that the maintenance staff change more filters than a typical combined outside air unit, and the additional building penetrations lead to pest management issues.</p> <p>It was also reported that the HVAC controls run on a Microsoft XP operating system that is no longer supported for security upgrades by Microsoft. The AISD Service Center staff is concerned that this situation can become a security threat.</p>

1. Ensure routine preventive maintenance is conducted for cleaning ductwork to promote efficient and clean air flows to all of the facilities' spaces.
2. Address any rust or corrosion observed on the equipment, its associated piping, or any other sub-asset in all facilities by cleaning, repainting, or repairing to prevent further deterioration.
3. Repair or replace any damaged or missing piping insulation as needed.
4. Replace the heat exchanger.
5. Replace distribution pumps.
6. Replace the remaining 55 WSHPs.
7. Replace the outdoor condensing unit.

8. Replace the RTU and electrical disconnect above the kitchen.
9. Reroute electrical conduit in kitchen ductwork and seal duct penetrations.
10. Replace aged EFs.
11. Consider installing a dedicated outside air unit in the K-wing.
12. Upgrade HVAC controls system to improve security.

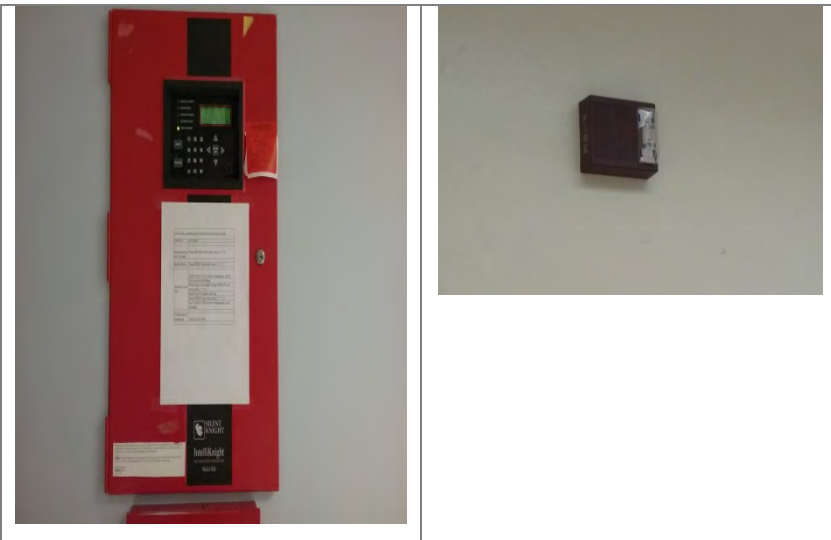
**Fire Alarm**

Fire Protection	Fire Alarm	<p>The building has a fire alarm control panel by Silent Knight. The system consists of alarms and signaling devices such as horns/annunciators, strobes, horn/strobe combinations, pull stations, and detectors.</p> <p>The fire alarm devices appeared to be aged and past their design life.</p> <p>The facility staff reported that the system was old, and that the alarm sounded off on a regular basis.</p>	Poor
	Fire Protection/Suppression	<p>There are fire sprinklers located in the janitorial closets and above the auditorium stage. A fire suppression system is located in the kitchen. Additionally, fire extinguishers are located throughout the building</p> <p>The fire protection/suppression systems were observed to be in average condition. It was reported that the galvanized pipe to the sprinkler head in CCCafe janitorial closet needs replacement.</p> <p>Fire extinguishers were observed to have been inspected within the last year with the exception of the extinguishers located in the PTA workroom and art room.</p>	Average

1. Inspect outdated fire extinguishers and replace as needed.
2. Consider replacing the galvanized pipe leading to the fire sprinkler in the CCCafe janitorial closet.
3. Continue annual inspections of the fire alarm system and replace any aged fire alarm devices throughout the building along with inspection of the fire alarm panel to verify its functionality.

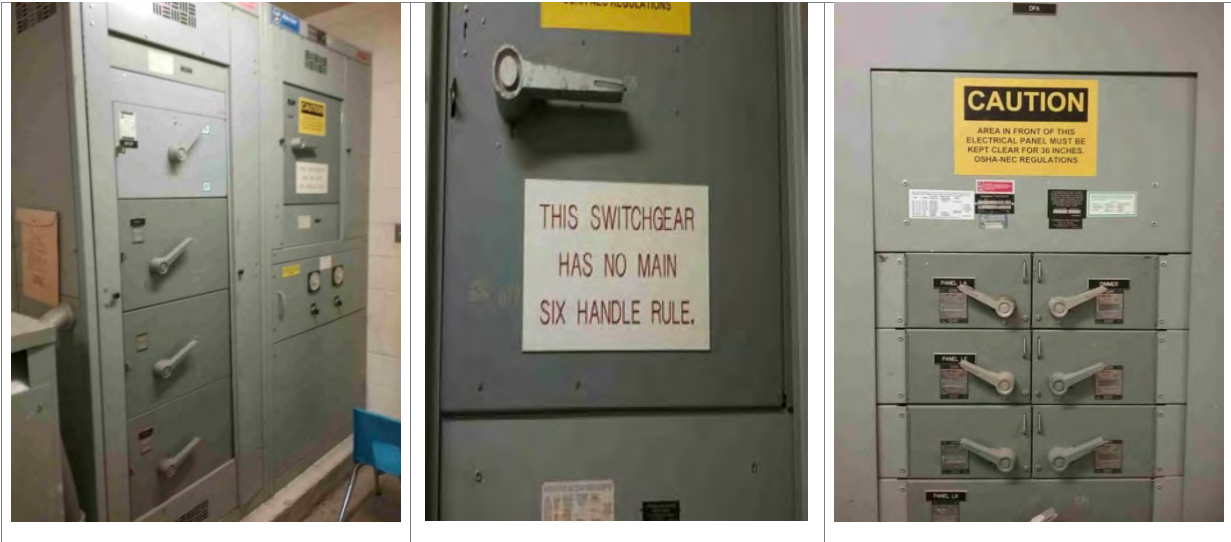
System	Subsystem	Condition and Deficiency Overview	System Condition Rating
Electrical	Electrical Distribution	<p>The electrical service enters the building at the 277480-volt 2000-amp main switchboards located in the Main Electrical room near the gymnasium/cafeteria. The service feeds transformers and high-voltage panelboards are located in various electrical rooms throughout the building. There are six transformers rated at 480-volt primary that step-down to 120/208-volt secondary.</p> <p>The 2000-amp main switchgear and distribution panel equipment appeared to be in poor condition. A majority of the assets appeared to be aged, and the main switchgear was identified as having no main circuit breaker within the panel. Facility staff reported that the conduit to the main panel was routed along the floor and had deteriorated from the recently replaced cooling tower, and the wire was exposed. The building does not have a lightning protection system. <a href="#">PM Andrew Miller reported the MCC (motor control panel in the mechanical room is obsolete and requires replacement.</a></p>	Poor

1. Remove any floor receptacles as they are being phased out of use district-wide.
2. Replace all outdated light fixtures with LED fixtures and dimming capabilities.
3. Replace all exit signs with LED fixtures, and add more exit signs where required.
4. Replace all aged and outdated electrical switchgear and panels within the building that were noted.
5. Replace outdated exterior light fixtures with LED light fixtures, and add new ones as needed.
6. Inspect all card readers for functionality. Replace defective card readers, including all associated appurtenances as necessary.
7. [Replace MCC in mechanical room \(requested by PM Andrew Miller\).](#)

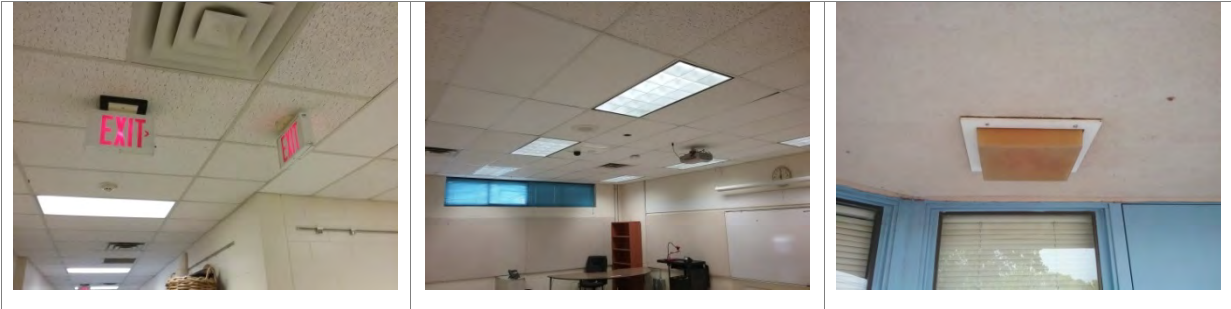
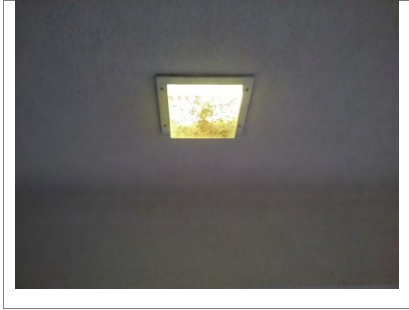
Lighting	<p>The building's exterior lighting consists of downlights, HID (high-intensity discharge), and LED (light-emitting diode) fixtures that are located along the entire perimeter.</p> <p>The interior lighting consists primarily of T8 light fixtures and high-bay HID lights in the gymnasium.</p> <p>The lighting for the building appeared to be in poor condition.</p> <p>There are exit signs present in the building that appeared to be functioning at the time of assessment; however, many of the exit lights appeared to be aged.</p> <p>Many interior and exterior light fixtures appeared to have aged past their design life. Observed deficiencies included broken lenses, inconsistent color temperatures, and non-functional fixtures. In the interview notes, facility staff reported that the glass within the parabolic light had fallen out and broken on the floor.</p> <p>Facility staff reported that there was inadequate exterior lighting throughout the grounds and building perimeter, and new lights should be added to the courtyard near the main mechanical room.</p>	Poor
