## Reilly Elementary School Site Summary

## Main School Building – BLDG-132A

| Inspection Date | July 25, 2016 |

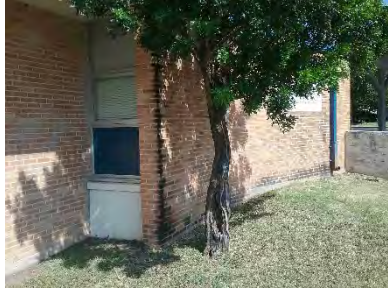
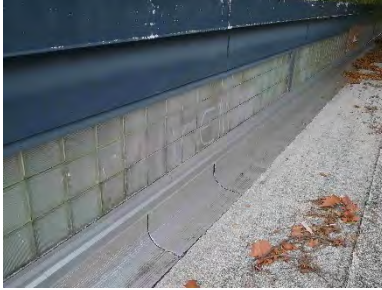
### Exterior Walls

| System | Subsystem | Condition and Deficiency Overview | System Condition Rating |
|---|---|---|---|
| Exterior | Exterior Walls | <p>The exterior facade is brick with the exposed structural frame (both steel and concrete) painted. The 100- and 200-wings have a glass block clerestory above corridor roofs. The 300-wing has an exposed concrete structural frame with exposed aggregate concrete panels incorporated into the corridor wall.</p> <p>The brick facade was observed to be in good condition, but there are areas of exterior wall with organic growth that has discolored the brick. Paint on metal flashings, gutters, downspouts, and the steel structure has oxidized and is peeling. The glass block grout on 100- and 200-wings is deteriorated and likely leaking.</p> | Average |

1. Clean organic growth from brick façade.
2. Replace deteriorated grout from glass block at 100- and 200-wings.
3. Further investigate reported leaks at windows in corridor 7 and along the northern wall of the 200-wing.
4. Replace existing wood door at kitchen entry with steel exterior door and hollow metal frame.

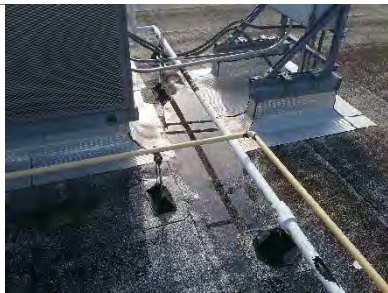
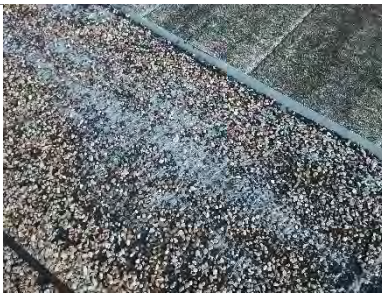
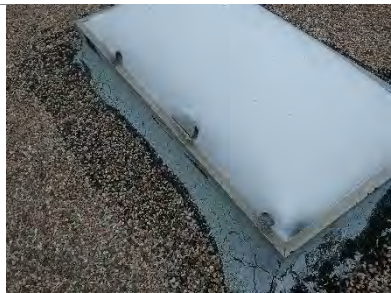
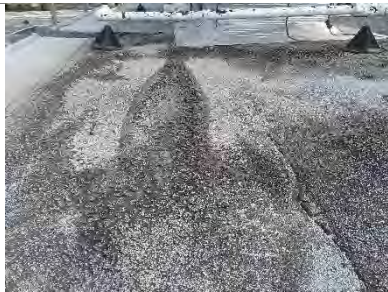
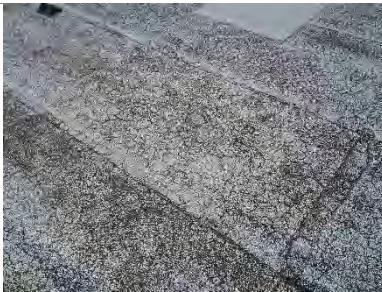
## Roofing Deficiency Examples

| System | Subsystem | Condition and Deficiency Overview | System Condition Rating |
|---|---|--|---|
| <b>Roofing</b> | | <p>Roof surfaces are comprised of both built-up and modified bitumen. There is a new metal canopy at the school's main entrance.</p> <p>The roof was observed to be in poor condition, depending on age. The roof over the cafeteria has failed. Significant erosion of granular surface, patching and large areas where membrane has detached from deck were observed. Built-up roofs with steeper slopes (over 100- and 200-wings) have areas where fiberglass strands are exposed. Both modified bitumen and built-up roofs systems have aged past their expected life. Evidence of ponding was observed. The roof over the gymnasium was reported to leak. Counter flashings in some areas appeared to have been replaced recently and in good condition.</p> | Poor |

1. Further investigate all roof areas observed with deteriorated membrane surface, standing water, and roof membrane appropriateness for roof slope. Replace roof as needed.

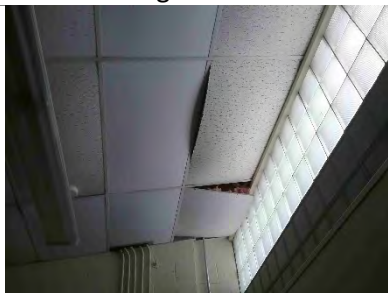
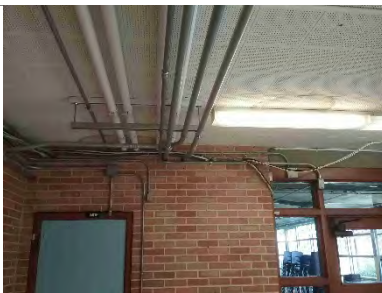
### Interior Ceiling Finishes

| System | Subsystem | Condition and Deficiency Overview | System Condition Rating |
|---|---|--|---|
| | Interior Ceiling Finishes | <p>Ceilings throughout much of the building are suspended acoustical tile. Exposed structure and roof deck are found in corridors C1, C2, C3, C4, and C7, classrooms in the 400-wing, and the gymnasium. The kitchen ceiling tiles are vinyl covered. The ceiling in corridor C5 is 12-inch attached acoustical tiles.</p> <p>The tiles in corridor C5 are showing age and stains, likely from roof leaks. The suspended acoustical tiles in the 100- and 200-wing classrooms were bowed, most likely from excessive humidity.</p> | Average |

1. Conduct further investigation into the suitability of 9"x9" floor tiles from an environmental concern.
2. Repair the damaged ceiling grid in room 204. Monitor and repair roof leaks as needed to prevent further damage.
3. Evaluate potential humidity concerns in 100- and 200-wing classrooms and damage to ceiling tiles.

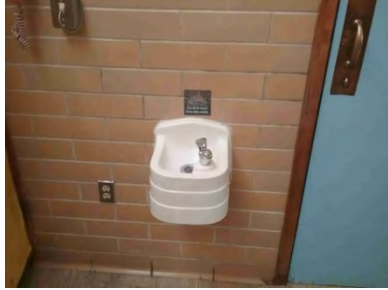
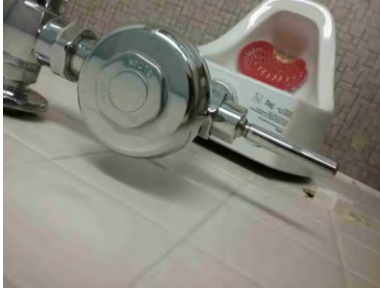
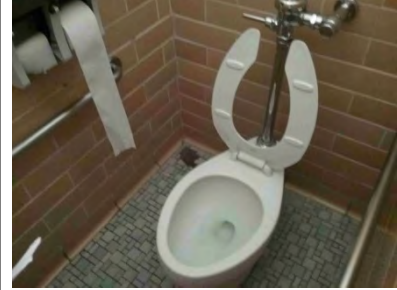
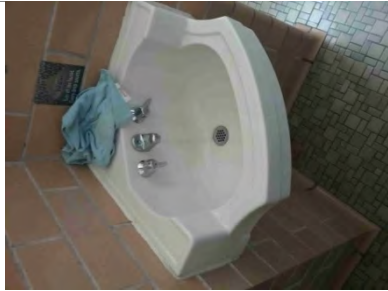
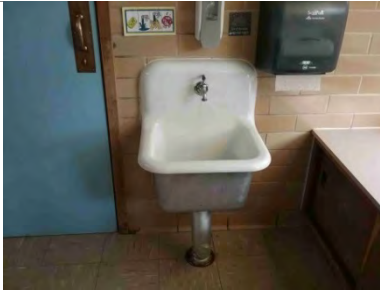
### Plumbing Fixtures

| System | Subsystem | Condition and Deficiency Overview | System Condition Rating |
|---|---|---|---|
| Plumbing | Plumbing Fixtures | <p>The building has public restrooms for male and female students and separate staff restrooms located throughout the facility. These restrooms have wall-hung vitreous china hand sinks with manual faucets, along with vitreous china, floor-mount toilets with manual flushing mechanisms, and vitreous china, wall-hung urinals in the male restrooms with manual flushing mechanisms. There are stainless steel sinks located in the kitchen and employee break areas. There are service sinks located in the janitorial closets, and water fountains located throughout the facility, typically near the public restrooms.</p> <p>The drinking fountains appear to be original to the building, and many did not function.</p> <p>The restroom plumbing fixtures were observed to be in poor condition as the fixtures were typically aged and appeared to be original to the building. The sink serving the male restroom between rooms 101 and 102 did not have water service.</p> <p>The male restroom near the gymnasium had one urinal with a leaking flush valve and another urinal that had separated from the carrier. It was reported that the urinals frequently fall off the wall.</p> <p>The hand sinks in the classrooms were observed to be in poor condition due to age and the deficiencies indicated above.</p> <p>The three-compartment sink in the kitchen was observed to flood the hub drain if all three compartments were drained at the same time.</p> <p>The 300-wing consisted of four classrooms with a male and female student restroom shared by every two classrooms; however, the wing was not accessible at the time of the assessment.</p> | Poor |

1. Replace drinking fountains throughout the building.
2. Replace water closets, sinks, and urinals throughout the building.
3. Correct the flow issue at the sink serving the male restroom between rooms 101 and 102.
4. Replace hand sinks in classrooms.
5. Increase the size of the hub drain serving the three-compartment sink in the kitchen to allow draining of all three basins at the same time.
6. Replace the GWH-1.
7. Provide pipe insulation at kitchen water heaters, and remove corrosion on piping connections.
8. Replace all domestic cold and hot water piping throughout the facility.
9. Repair or replace any damaged or missing condensation drain pipe insulation as needed.
10. Remove rust from gas piping on the roof, and paint/protect piping from further rust and corrosion.

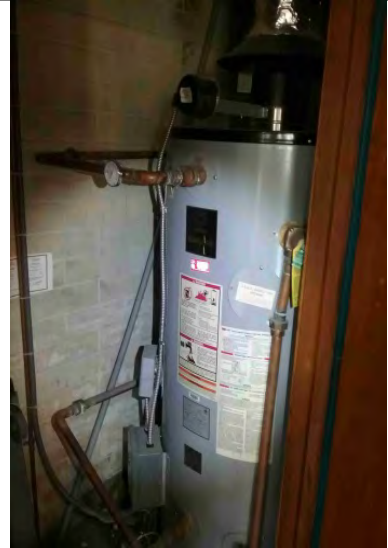
### Domestic Water Distribution

| System | Subsystem | Condition and Deficiency Overview | System Condition Rating |
|---|---|---|---|
| | Domestic Water Distribution | <p>The sinks located throughout the facility, with the exception of the kitchen, lounge, and nurse's restroom, are not equipped with hot water. The sinks located in the kitchen are serviced with hot water from GWH-1 (gas water heater-1), located in the kitchen mechanical room. Under-counter EWHs (electric water heaters) serve the sinks in the lounge and the nurse's restroom. Both EWHs were identified as EWH-1 on the plans.</p> <p>The GWH appeared to be in poor condition. It was reported that the water heater is over 15 years old. The hot water piping associated with the water heater was</p> | Poor |

| System | Subsystem | Condition and Deficiency Overview | System Condition Rating |
|---|---|---|---|
| | | <p>not insulated. Corrosion was observed at the hot water piping connections.</p> <p>The EWHs located under the counters in the lounge and the nurse's restroom appeared to be in good condition.</p> <p>The domestic water distribution piping that was visible appeared to be in poor condition.</p> | |

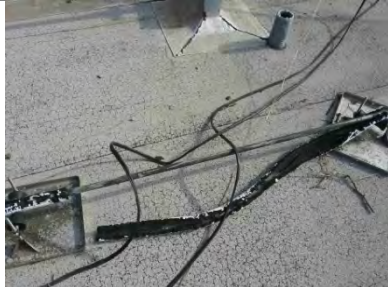
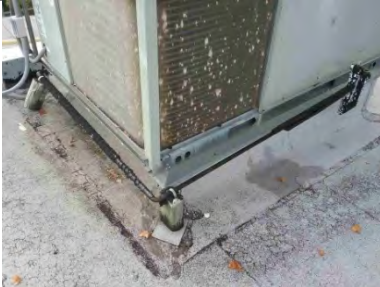
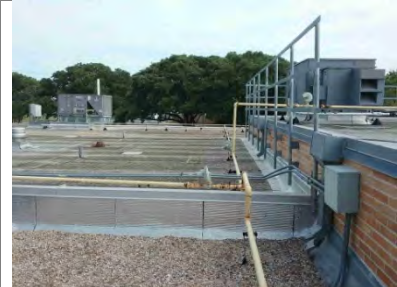
### Other Plumbing

| System | Subsystem | Condition and Deficiency Overview | System Condition Rating |
|---|---|---|---|
| | Other Plumbing | <p>The roof drainage system consists primarily of scuppers and gutters with downspouts. See the architectural assessment for condition of gutters and downspouts. The few roof drains present were observed to be in good condition.</p> <p>Condensate drain piping insulation appeared to be damaged or missing in places and in poor condition.</p> <p>The gas piping on the roof had chipped paint, which has led to surface rust on portions of the pipe.</p> <p>A grease trap was present to serve the kitchen.</p> <p>It was reported that the 100/200/300-wings needed new drain lines.</p> <p>It was reported that the water lines have gate valves installed that are getting stuck and are not up to code.</p> <p>It was reported that the drain lines under the kitchen are original cast iron pipe that has cracks causing water back-ups and foul odors.</p> | Poor |

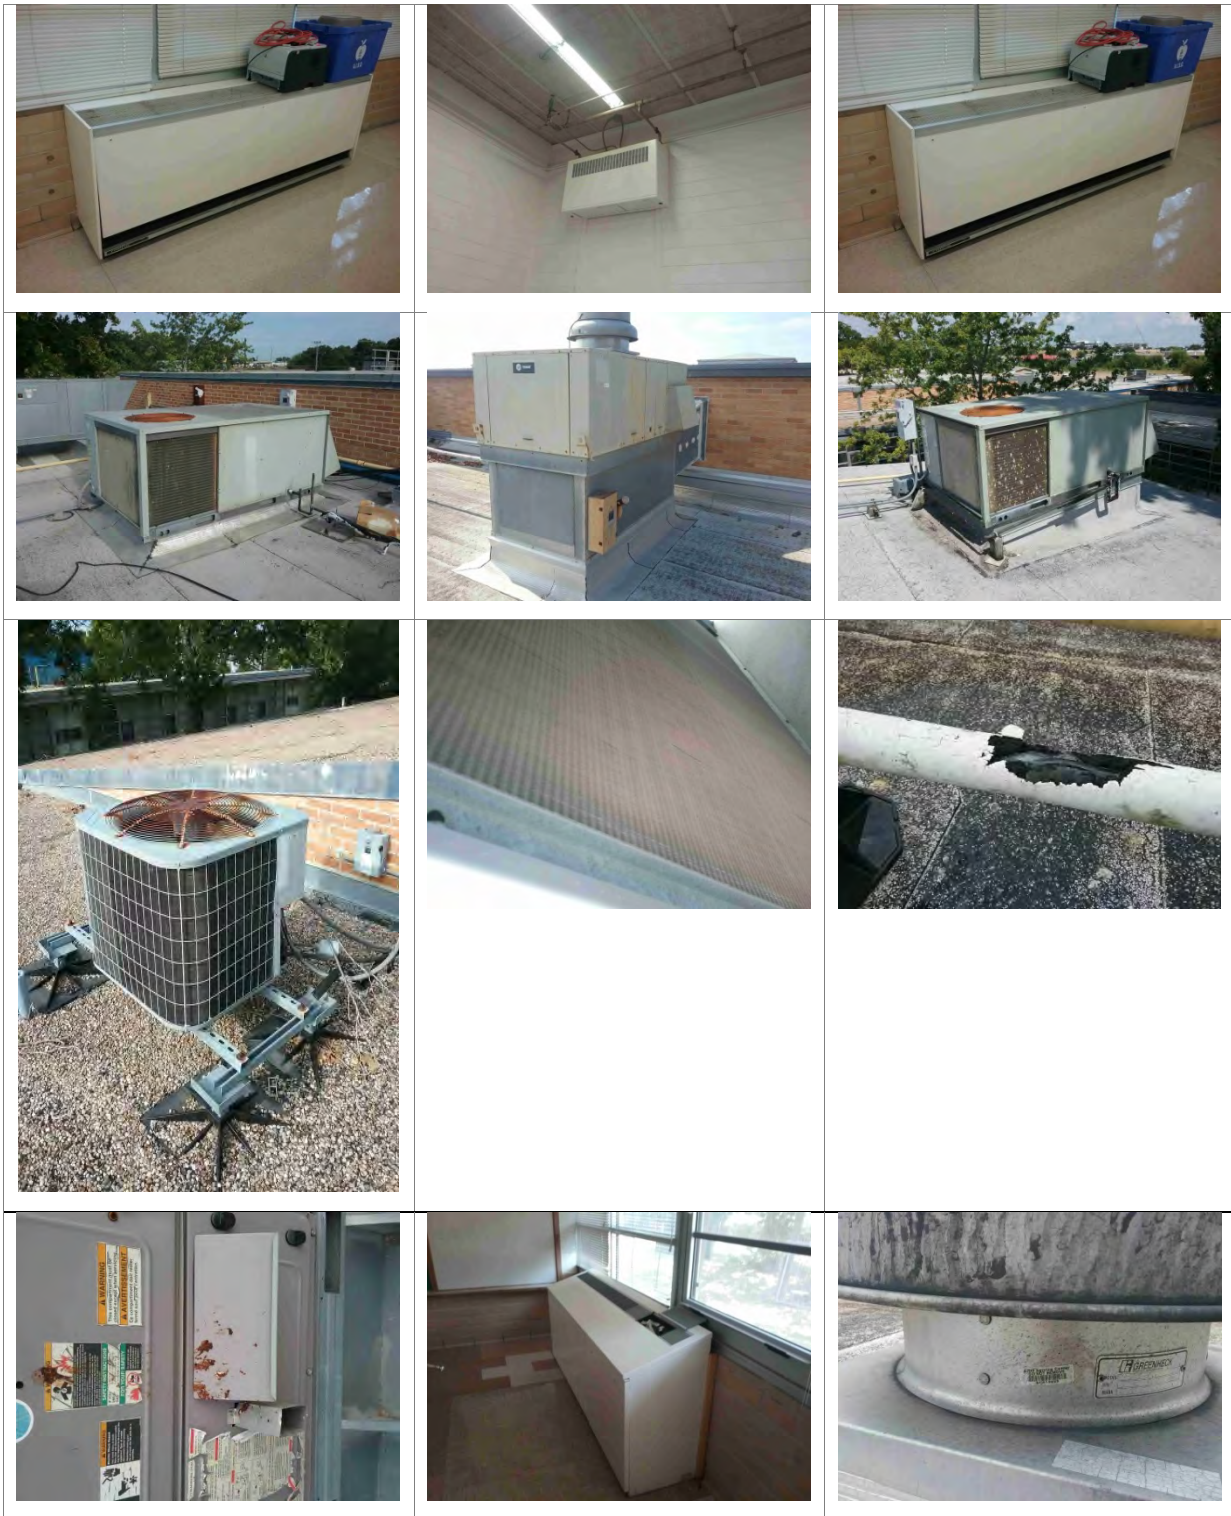
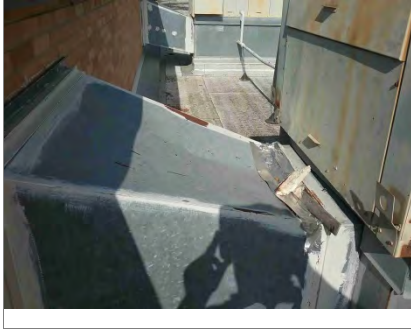
**Mechanical/HVAC System Deficiency Examples**

| System | Subsystem | Condition and Deficiency Overview | System Condition Rating |
|---|---|---|---|
| <b>Mechanical/<br/>HVAC</b> | | <p>The building is served by a combination of package RTUs (roof top units); some with ERVs (energy recovery ventilators), floor-mounted ground-source heat pumps, and roof-mounted EFs (exhaust fans). These serve the HVAC (heating, ventilating, and air conditioning) system. Nine RTUs, with an approximate capacity range of 5,000 to 15,000 CFM (cubic feet per minute), are located on the roof. These RTUs serve non-classroom functions throughout the facility. WSHP (water-source heat pumps) serve each of the classrooms. The classrooms in the 200-wing contain abandoned vertical fan coil units. Classrooms 102, 103 and 104 also contain abandoned vertical fan coil units. There are nine abandoned fan coil units in the corridors, and six abandoned fan coil units in the gymnasium. Roof-mounted EFs serve the kitchen hoods and the restrooms.</p> <p>RTU-KIT, RTU-11, RTU-12, and RTU-LIB appeared to be in poor condition. The units appeared aged, and rust was observed. Condenser coil fin damage was observed on several RTUs. Air-cooled CU (condensing unit) was aged and at the end of its service life. The condenser coils on RTU-1 and RTU-2 are plugged with dust and the condensation drain piping on RTU-3 is cracked and leaking. There appears to be birds nesting on the burner of RTU-4.</p> <p>The WSHPs serving the classrooms appeared to be past their design service and it was reported that WSHPs HP-8 and HP-35 were malfunctioning. It was also reported that numerous WSHPs frequently leak into the classrooms due to</p> | Poor |

| System | Subsystem | Condition and Deficiency Overview | System Condition Rating |
|---|---|--|---|
| | | <p>clogged condensate drain piping.</p> <p>Roof top EFs appeared to be aged and in poor condition. Several EFs were observed to operate with excessive noise.</p> <p>The HVAC system appeared to be in poor condition, primarily due to the age of the equipment and the deficiencies indicated above.</p> | |

1. Remove abandoned fan coil units in rooms 201, 202, 203, 204, 102, 103, and 104.
2. Remove nine abandoned fan coil units in the corridors.
3. Remove six abandoned fan coil units in the gymnasium.
4. Replace RTU-KIT, RTU-11, RTU-12, and RTU-LIB.
5. Replace CU.
6. Clean condenser coils on RTU-1 and RTU-2.
7. Repair cracked condensation drain pipe associated with RTU-3.
8. Ensure bird nesting material and bird waste is removed from the burner on RTU-4.
9. Replace WSHPs and associated condensate piping serving the classrooms.
10. Replace aged and noisy EF.
11. Replace collapsed duct at RTU-12.

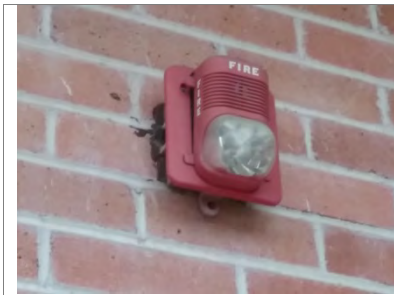
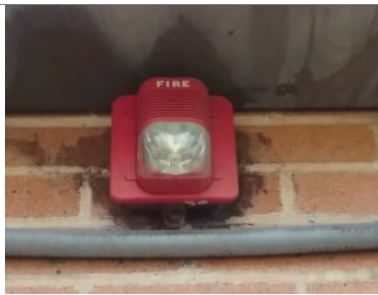
#### Fire Alarm

| System | Subsystem | Condition and Deficiency Overview | System Condition Rating |
|---|---|--|---|
| <b>Fire Protection</b> | Fire Alarm | <p>The building has a Silent Knight fire alarm control panel and it appears to be in good condition.</p> <p>The system consists of alarm and signaling devices such as, horn and strobe combination devices, pull stations, and detectors. This system appeared to be in poor condition.</p> <p>Approximately 50% of the devices appeared to be in average condition and have aged past their design life.</p> | Average |

1. Continue annual inspections of the portable fire extinguishers.
2. Continue annual inspections of the Fire Alarm System, and replace any aged fire alarm devices throughout the building.

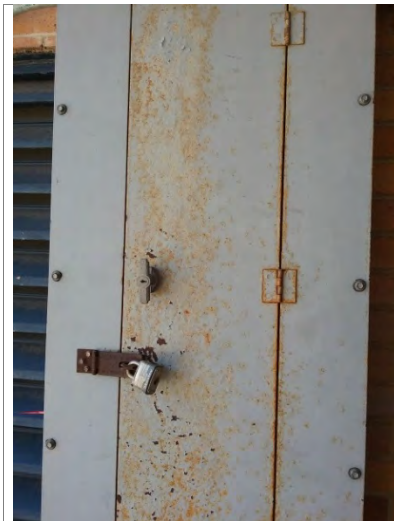
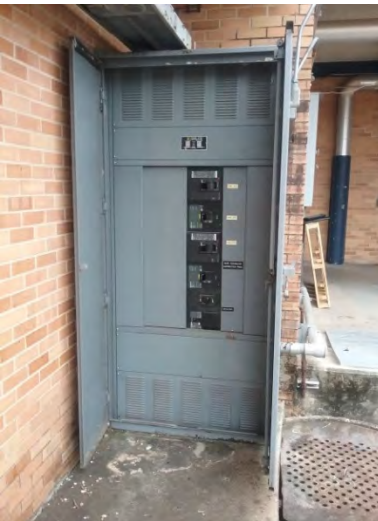
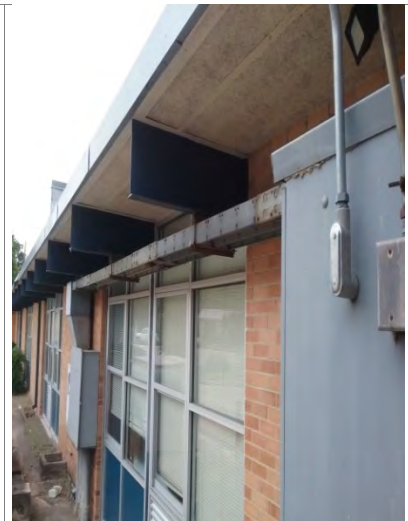
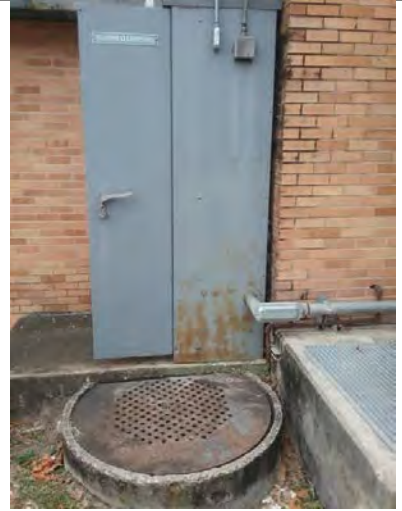
#### Electrical Distribution

| System | Subsystem | Condition and Deficiency Overview | System Condition Rating |
|---|---|--|---|
| <b>Electrical</b> | Electrical Distribution | <p>The electrical service enters the building at a 120/208-volt, 2000-amp, 3-phase, 4-wire main switchboard located in the Main Electrical room near the Kitchen. The service switchboard feeds various 120/208-volt panelboards located in electrical rooms throughout the building.</p> <p>The electrical distribution equipment appeared to be in poor condition. A majority of the assets appear to be corroded and have aged.</p> <p>The building does not have a lightning protection system.</p> | Poor |

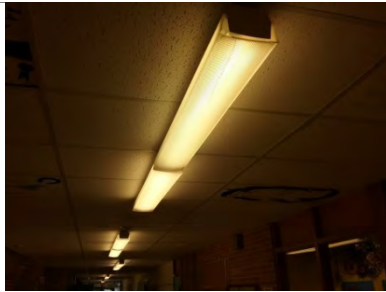
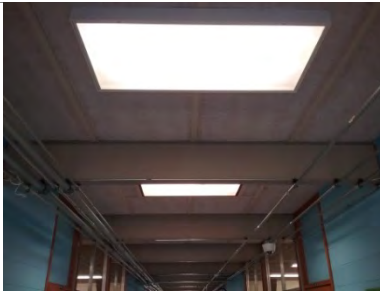
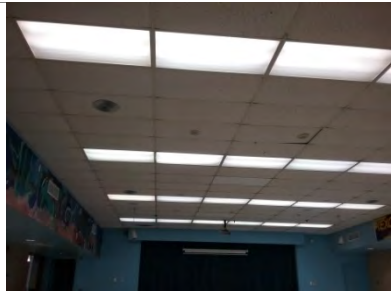
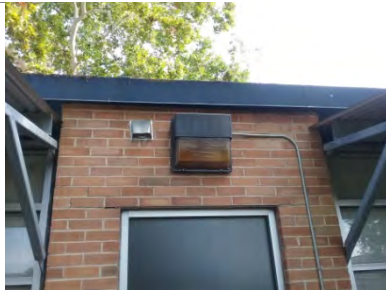
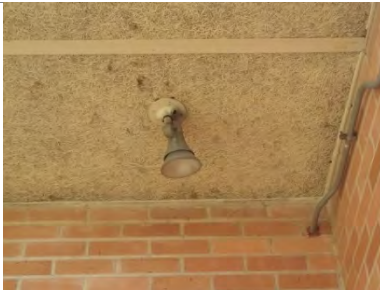
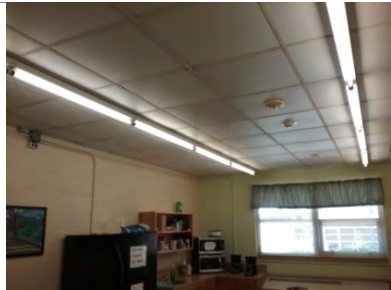
### Lighting

| System | Subsystem | Condition and Deficiency Overview | System Condition Rating |
|---|---|--|---|
| | Lighting | <p>The building exterior lighting consists of recessed downlights, surface mounted HID (high-intensity discharge) and LED (light-emitting diode) light fixtures that are located along the entire perimeter and controlled by the buildings time clock. The interior lighting consists of 2x4 recessed and pendant mounted light fixtures along with surface mounted 1x4 fluorescent. The lighting for the corridors and classrooms are controlled by wall-mounted wall switches.</p> <p>The lighting for the building appeared to be in average condition. Many interior and exterior light fixtures appeared to have aged past their design life. Observed deficiencies included broken lenses, inconsistent color</p> | Average |

| System | Subsystem | Condition and Deficiency Overview | System Condition Rating |
|---|---|---|---|
| | | <p>temperatures, and non-functional fixtures.</p> <p>Per the interview notes, it was reported that the lighting in the gymnasium office and the adjacent corridor (C2) are on the same circuit, and the lights cannot be turned off in the office without turning off the lights in the corridor. This situation was observed during the assessment. There are exit signs present in the building that appeared to be functioning at the time of assessment and in average condition.</p> | |

1. Replace non-functioning exit signs with LED fixtures.
2. Replace aged light fixtures with LED fixtures with dimming capabilities.
