## Rodriguez Elementary School Site Summary

## Main School Building – BLDG-174A

## Stand-Alone Classroom Building – BLDG-174B

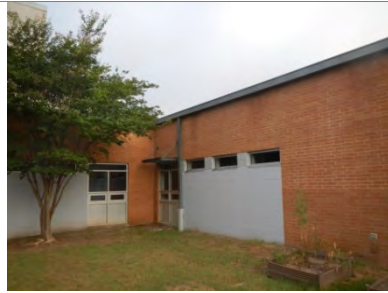
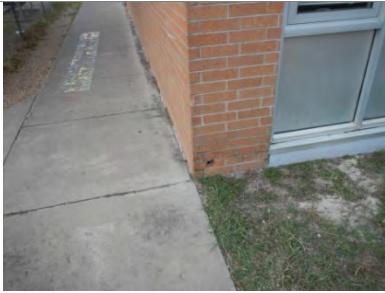
#### Exterior Walls

System	Subsystem	Condition and Deficiency Overview	System Condition Rating
Exterior	Exterior Walls	The exterior of the building consists of a brick façade. The brick walls had areas with minor water staining, caused by leaking gutters. A small hole in the brickwork was observed on the exterior of classroom 101.  The exterior walls were in average condition with typical wear and tear.	Average
	Exterior Windows	The exterior windows consist of single-pane units with metal frames. Water leaks were reported at the windows in the library, indicating that the windows were inadequately sealed. Sand bags were observed at the base of these windows to prevent water from leaking through them.  Paint was observed on windows around the 300-wing due to overspray from painting the exterior walls. The windows were observed to be in average condition, with the exception of locations where water intrusion was reported.	Average

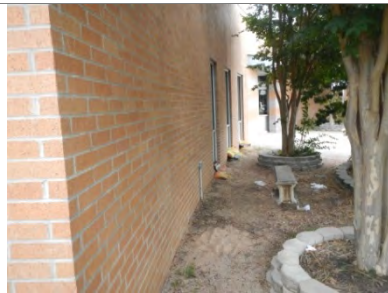
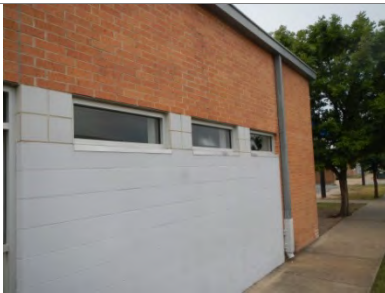
#### Exterior Windows

Exterior Doors	There is one main public entryway located at the south side of the building; these doors are metal with metal frame. The remaining service doors around the facility are also made of metal. It was reported that water leaks through the bottom of the doors to the library during heavy rain events. This is caused by poor site drainage outside of the library.  The exterior doors were in average condition due to weathering and high usage.	Average

1. Repair or replace leaking exterior windows and resolve water intrusion outside the library.
2. Investigate adding additional grate inlets outside the library to help with exterior drainage.

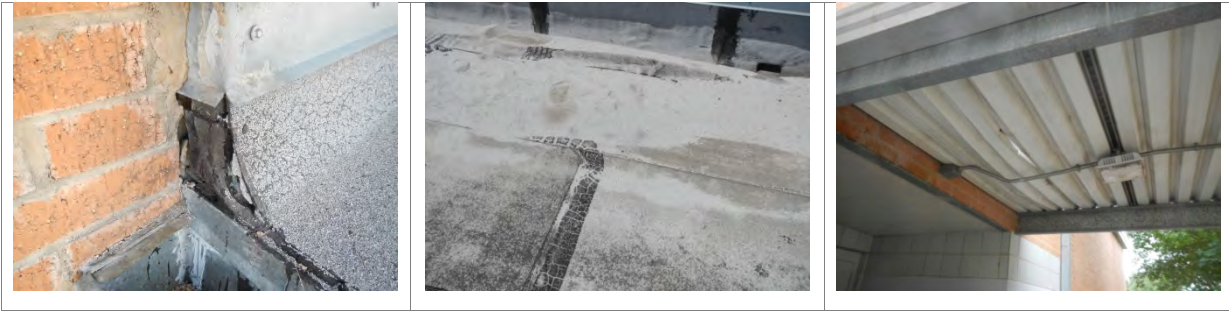
### Roofing Deficiency Examples

System	Subsystem	Condition and Deficiency Overview	System Condition Rating
<b>Roofing</b>	<p>The roof material covering the building is asphalt shingle roll roofing. There are covered walkways near the building entryways with a corrugated metal roof.</p> <p>The asphalt roof surfaces were in poor condition due to weathering and are nearing the end of their service life. The corrugated metal roof over the walkways had many large dents and holes due to people walking on it and appeared to be in poor condition.</p>		Poor
<b>Interior Construction</b>	Interior Walls	<p>The interior partitions original to the building are predominantly constructed of CMU (concrete masonry unit) that are painted.</p> <p>The interior partitions appeared to be in average condition as only a couple of instances of minor cracking and chipping were observed throughout all wall surfaces. In the cafeteria and one of the restrooms, the walls were observed to have vertical cracks about ¼" wide up the majority height of the wall.</p>	Average

1. Consider repairing or replacing the existing asphalt roof as it was in poor condition and is near the end of its service life. Repair the holes and dents in the corrugated roof to prevent accelerated degradation.
2. Investigate the roof for potential leaks that are staining the interior ceiling tiles.

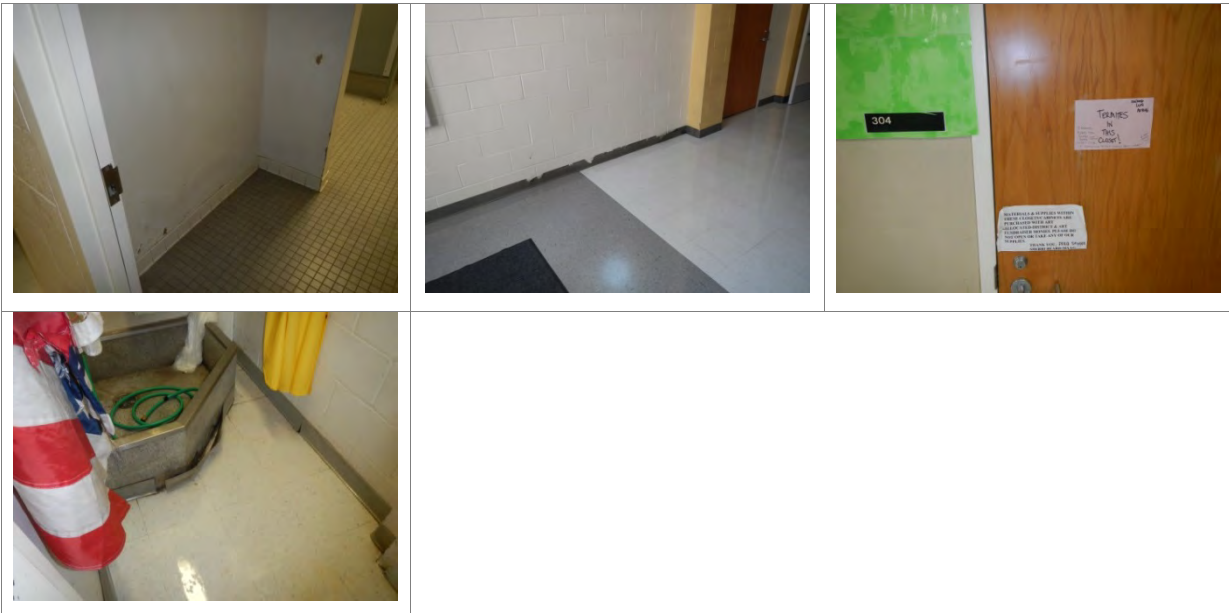
#### Interior Wall Finishes

Interior Doors	<p>The building consists primarily of wood doors and metal frames. The kitchen has a metal overhead roll-up door.</p> <p>The interior doors and frames were in average condition given the age of the system and typical signs of wear and use. The overhead doors in the kitchen appeared to be in good operational condition.</p>	Average
	Interior Specialties	System not present.	N/A
<b>Stairs</b>	Exterior Stairs	System not present.	N/A
	Interior Stairs	System not present.	N/A
<b>Interior Finishes</b>	Interior Wall Finishes	<p>The interior walls are painted gypsum board. The wall that separates room CC200 from GHRR200 appeared to have water damage toward the bottom. Flexible rubber baseboards were also observed in the building and run along the bottom of all of the walls. The rubber baseboards were peeling off the walls in some locations around the building. It was reported that termites are damaging walls in the principal's office as well as room 304.</p> <p>Apart from the minor damage to the baseboards and the water damage in the female restroom, all of the interior walls appeared to be in average condition.</p>	Average

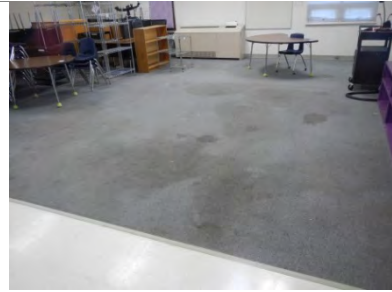
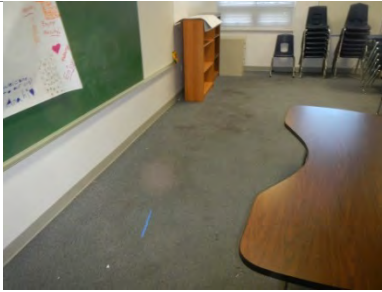
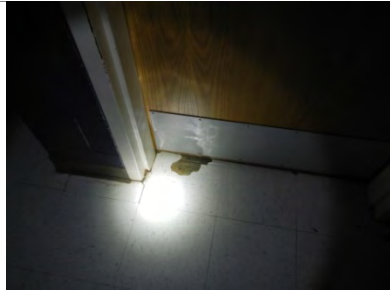
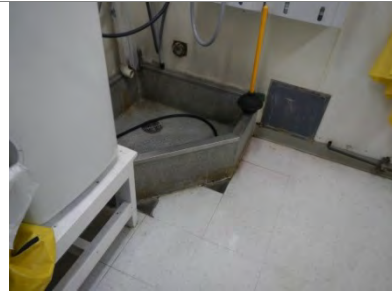
### Interior Floor Finishes

Interior Floor Finishes	<p>Linoleum floor tile is found throughout the building and is original to the building. Ceramic tile floor is present in the restrooms. The administration offices, library, and some classrooms are finished with carpet. It was reported that the carpet in the 100- and 500-wing classrooms needs to be replaced due to water damage and staining. Visual observation of these classrooms</p>	Average

System	Subsystem	Condition and Deficiency Overview	System Condition Rating
		confirmed that the carpet was in poor condition. Apart from the poor condition of the carpet in some classrooms, the flooring appeared to be in average condition as only minor cracking was observed throughout some areas of the linoleum flooring system.	
	Interior Ceiling Finishes	The ceilings in the building are finished with acoustic tiles. It was reported that the staining of ceiling tiles located in the art room was reoccurring and believed to be caused by rain infiltration. Stains in the ceiling tiles were located at various other locations throughout the school, including the cafeteria, corridors, and rooms 306 and 314.  The ceiling tiles were in average condition, apart from the stained ceiling tiles.	Average
Conveying	System not present.		N/A
Plumbing	Plumbing Fixtures	The building has public restrooms for men, women, and students, and separate staff restrooms located throughout the facility. These restrooms typically have vitreous china hand sinks in counters and are wall-mounted with manual faucets, along with vitreous china, floor-mount toilets with manual flushing mechanisms, and vitreous china, wall-hung urinals in the male restrooms with manual flushing mechanisms. There are service sinks in the janitorial closets, and water coolers located throughout the facility, typically near the public restrooms. The restroom plumbing fixtures were in average condition as the fixtures were typically aged but still operational.  The kitchen for the school cafeteria contained multi-basin stainless steel sinks for dishwashing and food preparation. Apart from typical wear and tear, none of these fixtures had any observed deficiencies.	Average

1. Replace all of the carpet in the 100- and 500-wing classrooms that have stains and water damage. Investigate and prevent the water damage.

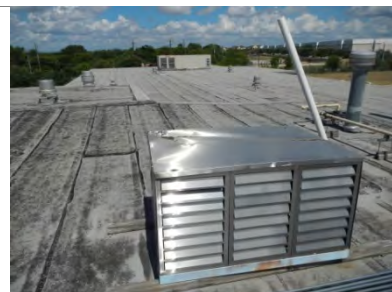
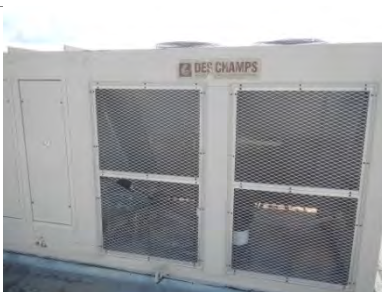
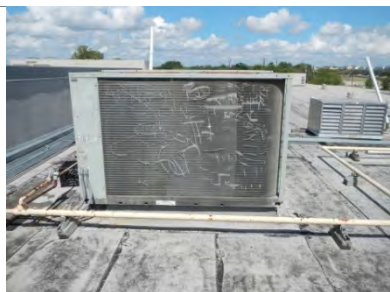
### Mechanical/HVAC System Deficiency Examples

System	Subsystem	Condition and Deficiency Overview	System Condition Rating
<b>Mechanical/ HVAC</b>	<p>The HVAC (heating, ventilating, and air conditioning) system for the building is composed primarily of package RTUs (roof top units) and individual heat pump consoles located in classrooms. It was reported that the console units functioned properly for their age but were almost at the end of their service life. It was reported that some of the RTUs leaked excessive condensation onto the roof because they were believed to not have the drainage lines plumbed properly. It was reported that the fresh air units have not be functioning properly, and there was not enough fresh air entering the building. Bad odors have been reported in the facility because of this issue, particularly in the 200-wing.</p> <p>The HVAC system for the building was reported as being in average condition with the only major deficiency being the age of the units. It was observed that vandals had damaged the fan coils and the housings on some of the units on the roof top.</p>		Average

1. Replace the fresh air units on the roof. The units were reported as not operating properly, have bad odors, are past their recommended service life and do not provide enough fresh air to the school.
