Sanchez Elementary School Site Summary

Main School Building – BLDG-127A

CRAWL SPACE – Sanchez ES – Main School Building (BLDG-127A)

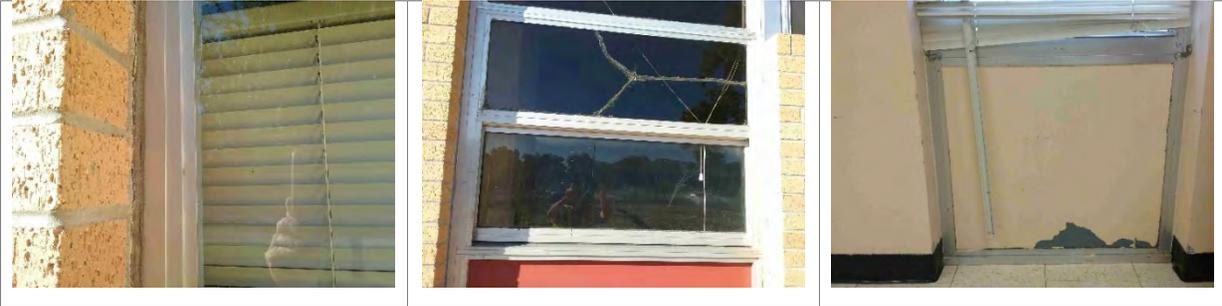
System	Subsystem	Condition and Deficiency Overview	System Condition Rating
Exterior	Exterior Walls	The exterior walls are primarily brick. An band of cement plaster is installed at the top of the walls. Cement plaster soffits are installed at entries and exits. Painted metal louvers are installed in the brick portion of the walls. Tile accent panels are installed on the west wall adjacent to the main entry. Two pre-fabricated aluminum roof ladders are installed on walls above the lower roof level. The walls, soffits, louvers, and ladders all appeared to be in good condition.	Good
	Exterior Windows	The exterior windows are aluminum, single-glazed units. Many of the units have a single-hung operable middle section with fixed, opaque panel lights above and below the operable sections. The windows appeared to be in average condition, but some required repairs and the staff reported units leaking. Some instances were observed where the perimeter sealant was aged and cracked. Several glass lights were broken. The glass putty glazing was failing on some of the sashes. Some of the opaque panel lights were peeling and require paint.	Average

1. Inspect the sealant at the perimeter of window unit installations for failure. Install new sealant where required.
2. Replace damaged glass lites.
3. Inspect window sashes for damaged, missing, or misapplied putty/seals at perimeter glass lites. Install new putty/seals where required.
4. Inspect window units for paint failure on opaque panels. Repaint as required.
5. Inspect entry/exit doors for missing or damaged weather stripping. Install new weather stripping as required including at center astragal of double doors.
6. Repaint the pair of service doors on the east side of the building.
7. Replace the overhead coiling door unit located at the kitchen loading dock.

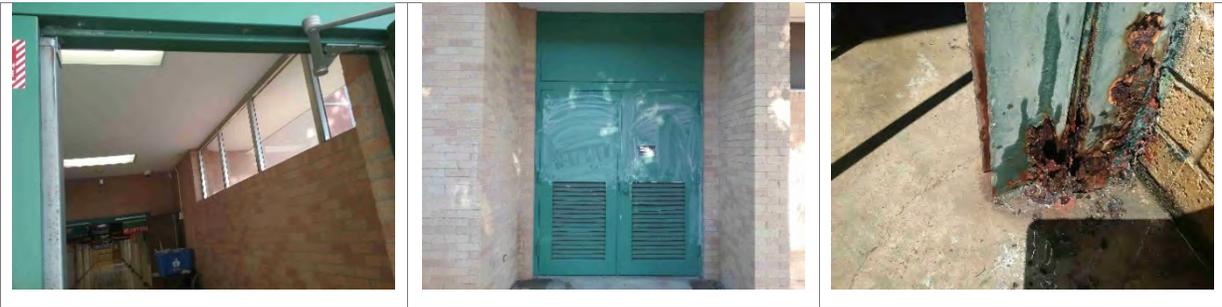
Exterior Doors	Typical doors are painted hollow metal doors installed in painted hollow metal frames. Two painted steel, overhead, coiling doors are installed at the kitchen receiving dock and at the adjacent walk-in cooler. Some doors required weather stripping. The paint finish	Average

System	Subsystem	Condition and Deficiency Overview	System Condition Rating
		<p>on doors and frames appeared to be old but little or no peeling was observed. The finish of one service door, however, appeared to be ruined. The receiving dock overhead door frame was severely rusted. The staff reported several doors as being rusted and a security threat. The cooler installation door was in average condition. Both coiling doors were operable.</p>	
Roofing		<p>The roof consists of four different roof systems. There is a single ply system of about 5,600 square feet on the north portion of the building. This roof drains to edge gutters and downspouts. There is a built-up system of about 19,250 square feet covering the east wing. This roof drains through a low parapet through scuppers to leader boxes and downspouts. The largest area is a modified bitumen system of approximately 42,250 square feet. An upper area over the gymnasium and cafeteria drains to gutters which discharges through downspouts to the lower area. A small portion of the lower roof area of this system is internally drained north and east of the gym, but the majority of it drains to gutters located at the perimeter of the building which has downspouts that discharge at grade. The fourth system appears to be a built-up system that was applied over a modified bitumen system and is approximately 10,800 square feet in size. An approximate four foot wide strip of modified bitumen is installed along the perimeter of this surface. It too drains to gutters and downspouts.</p> <p>The single ply system appeared to be a new application and was in good condition. The built-up system appeared to be in average condition with a little less than half of the life remaining. Tree debris was collected near the scuppers. The modified bitumen system appeared to be in good condition with over half the life remaining. The age and condition of the patched system was difficult to ascertain. The campus staff indicated that during rainstorms, a leak exists below this area in restroom-110RR. Sheet metal flashings, coping caps, drip edges, scuppers, gutters, leader boxes, and downspouts all appeared to be in good condition. The boots at the base of downspouts appeared to require paint.</p>	Average

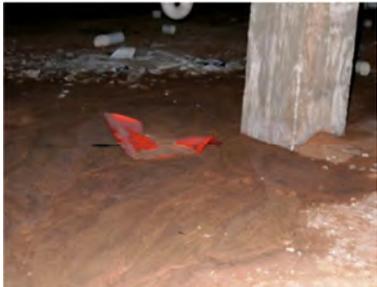
<p>Damp Soil</p>

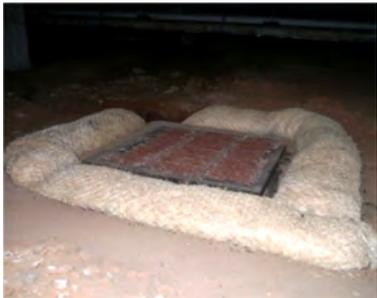
<p>Drain inlet blocked with sand bags</p>

1. Re-grade as need to repair eroded areas and provide positive drainage into drainage inlet
2. Remove sand bags from around inlet & verify drain is functioning - repair inlet and/or drainage pipe as needed
3. Remove debris blocking areaway grates
4. Investigate need to improve ventilation

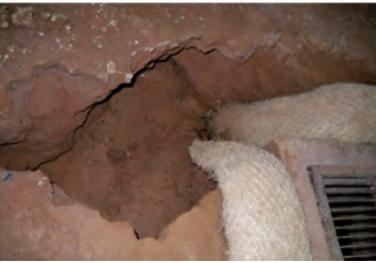
<p>Significant erosion around blocked inlet</p>

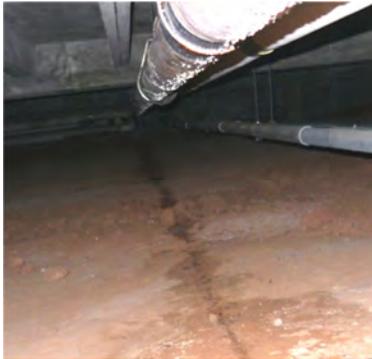
<p>Condensation & damp soil due to poor ventilation</p>

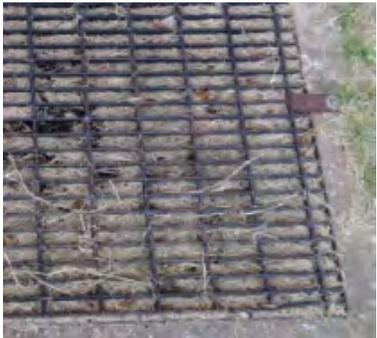
<p>Blocked areaways limit ventilation in crawl space</p>

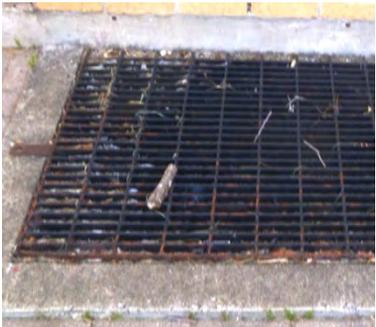
<p>Areaway grate is rusted</p>

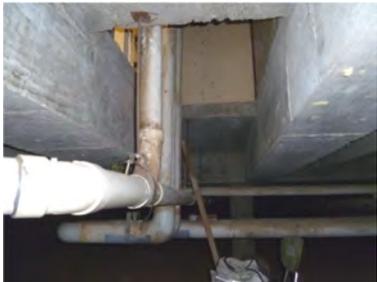
<p>Dangerous descent from wall hatch down to crawl space</p>

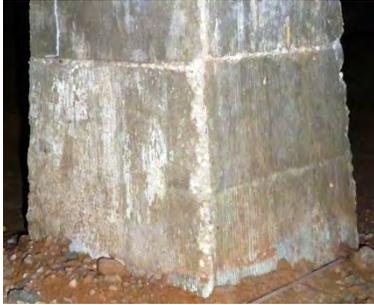
<p>Column Minor spalling</p>

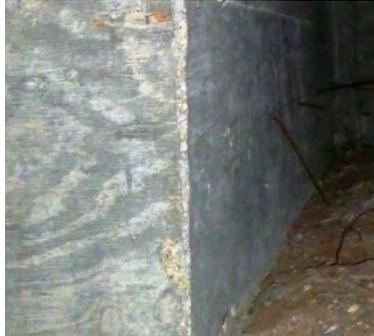
<p>Grade Beam spalling</p>

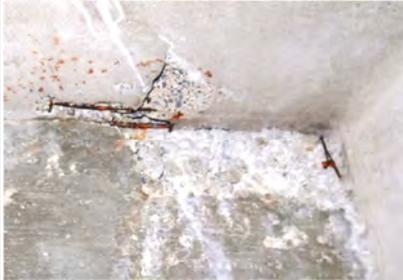
<p>Spalling/Honeycombing on precast pan joists and suspended beam, exposed/corroded reinforcement</p>
--	--	--

1. Clean exposed reinforcement and paint with a rust-inhibiting primer to prevent further corrosion

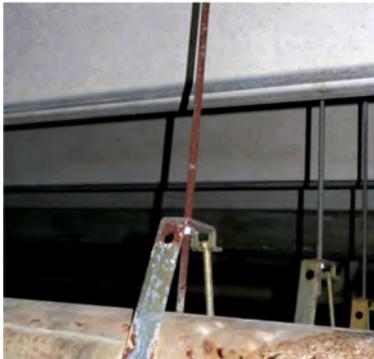
<p>Rusted hanger/rod</p>

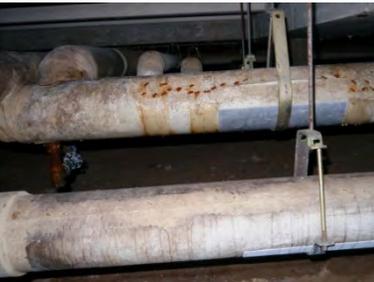
<p>Degraded pipe insulation</p>

1. Replace degraded/torn pipe insulation

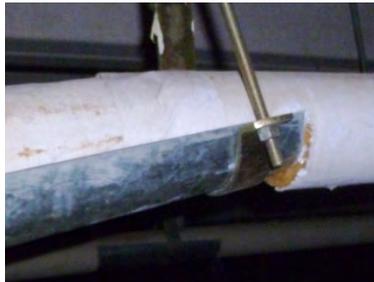
<p>Torn pipe insulation</p>
---	--	--
