Sims Elementary School Site Summary

Address	1203 Springdale Road Austin, TX 78721
Number of Permanent Campus Facilities	6
Original Year of Construction	1956
Total Campus Building Area (combined)	44,337 SF

Classroom and Gymnasium Building – BLDG-139A

Classroom and Library Building – BLDG-139B

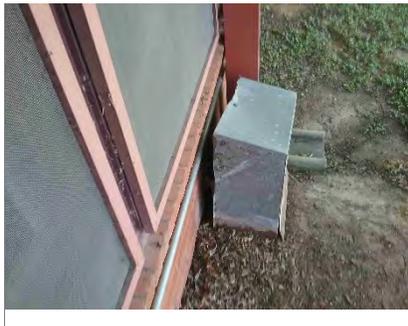
System	Subsystem	Condition and Deficiency Overview	System Condition Rating
Exterior	Exterior Walls	<p>The exterior of the building consists of the original, single-story brick façade. Plaster finish is included at the exterior walls of the gymnasium located at the east end of the building. The exterior wall of the gymnasium is currently being remodeled. The brick, other than at the gymnasium, terminates above at a 24-inch to 36-inch-wide painted panel soffit.</p> <p>The wide eaves appeared to do a good job of protecting the walls from deterioration. Several sheet metal housings were observed at the base of the walls which served to cover ground-level utility line penetrations into the walls. It was recently reported that rodents are prevalent, and these penetrations could serve as a source of entry.</p>	Average
	Exterior Windows	<p>The exterior windows are single-hung, single-glazed and are made of aluminum. All windows have been retrofit on their interior sides with newer single-hung, single-glazed windows.</p> <p>The retrofit interior windows appeared to provide insulation to the original windows. Some glazing was observed to be scratched. All assemblies appear to be in good condition.</p>	Good

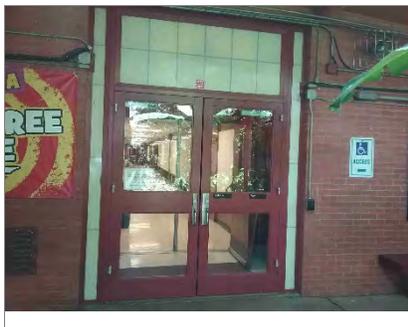
Exterior Doors	<p>Exterior doors are painted, hollow metal doors set in painted, hollow metal frames. Some of the doors have single-glazed view panels. Double-walled, translucent fiberglass panels surround the entrance doors.</p> <p>Assemblies appeared to be in good condition, and all</p>	Good

System	Subsystem	Condition and Deficiency Overview	System Condition Rating
		hardware appeared to be operational. The staff reported that the fiberglass panels surrounding the entrance doors are scratched and that visibility through these panels is desired.	
Roofing		<p>There are three roof surfaces on this building. The largest roof surface of approximately 12,300 SF (square feet) covers the classroom wing. The next largest surface of approximately 1,940 SF covers the gymnasium. A third, smaller roof area of approximately 220 SF covers the gymnasium office on the north side of the gymnasium.</p> <p>A modified bitumen roof system is installed on all three surfaces. Painted metal gutters and downspouts discharge to concrete splash blocks.</p> <p>The three roof surfaces appeared to be of a similar age and appeared to have approximately ten years of life remaining. An area of membrane degradation is located at the center ridge of the gymnasium roof. There is also some ballast aging adjacent to the roof-mounted AHU (air handling unit) caused by condensation dripping from the uninsulated refrigerant line. Sheet metal, including gutters and downspouts, appeared to be in good condition.</p>	Average

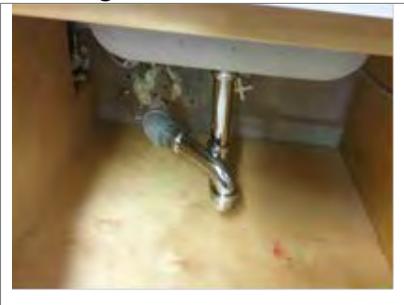
Conveying	System not present.		N/A
Plumbing	Plumbing Fixtures	<p>The building contains predominantly single-use restrooms throughout the facility, with multi-use restrooms found outside of the gymnasium. Typical restrooms have floor and wall-mounted vitreous china water closets with manual flush valves. Typical classrooms contain a single-basin stainless steel sink with a drinking fountain attached. Stainless steel and vitreous china drinking fountains can be found throughout the buildings, typically in the corridor close to the restroom facilities; the majority were operational, but some were not delivering water or were delivering poor flow at the time of assessment. The gymnasium office restroom contains a handicap-accessible single stall shower with a detachable shower head; the shower appeared to be in good working condition.</p> <p>The majority of plumbing fixtures were in working condition, but showed minor signs of deterioration. Some plumbing fixtures showed signs of corrosion around their base.</p>	Average

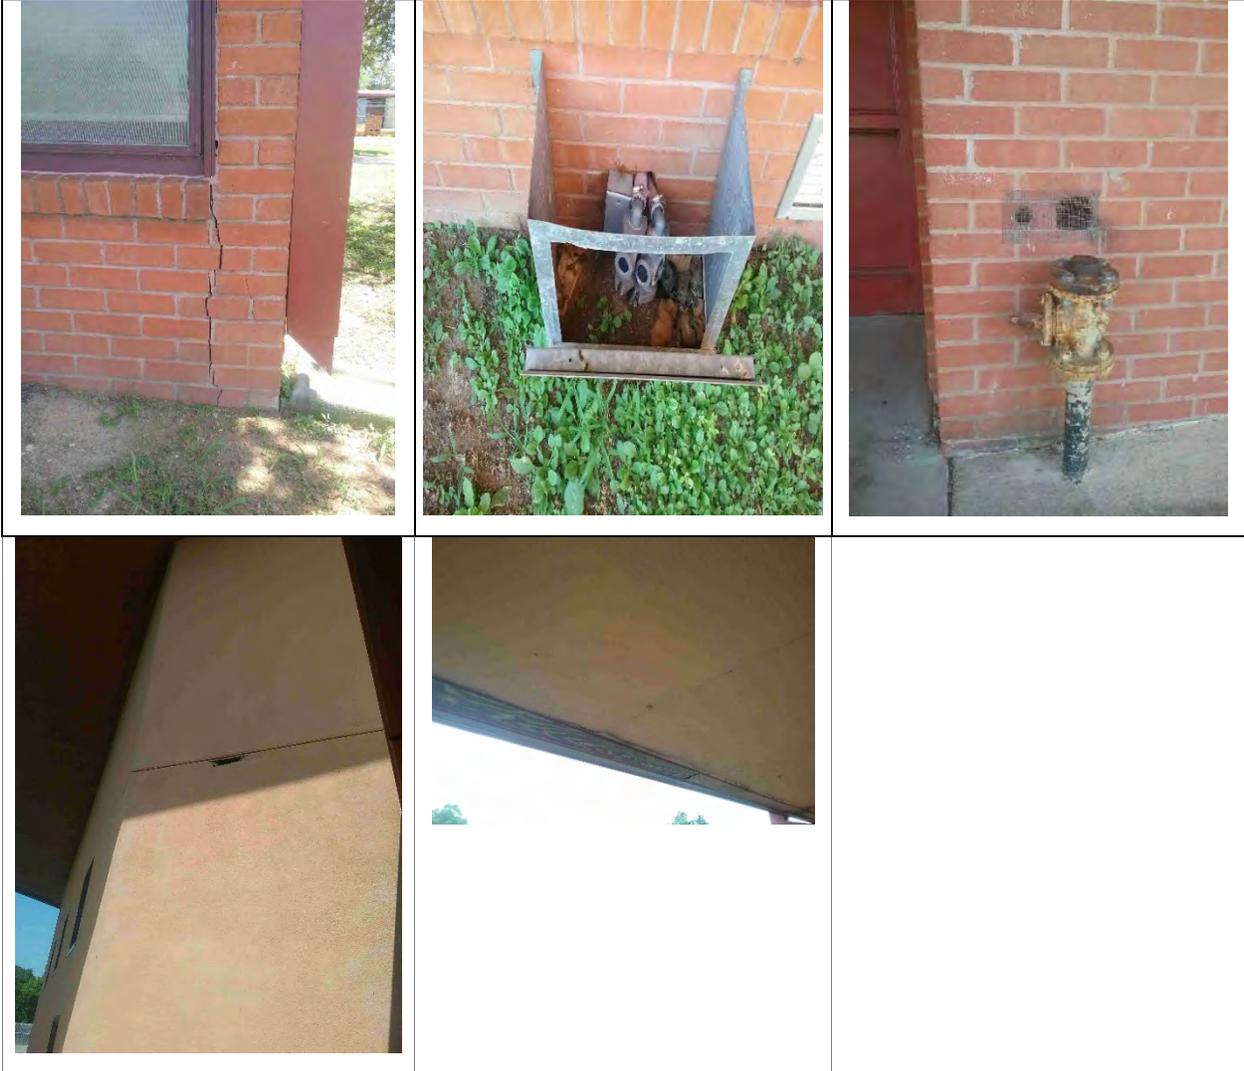
System	Subsystem	Condition and Deficiency Overview	System Condition Rating
Exterior	Exterior Walls	<p>The exterior of the building consists of the original, single-story brick façade. Double-walled, translucent fiberglass panels surround the entrance doors. A plaster finish is included at the exterior walls of the library located at the northeast corner of the building. The brick, at the classroom wing, terminates above at a 24-inch to 36-inch-wide painted panel soffit.</p> <p>The wide eaves appeared to do a good job of protecting the walls from deterioration. The most critical deficiency observed occurred at the bottom of a corner window at the northwest end of the building. Cracking had occurred through the brick. There are several sheet metal housings located at the base of the classroom walls which serve to cover ground-level utility line penetration into the walls. One housing on the north side of the building had separated from the wall. Utility lines penetrating the brick did not appear to be sealed. Elsewhere, temporary patching was applied at brick penetration locations. An open hole in the plaster at the library exterior wall was observed. It was recently reported that rodents are prevalent, and these penetrations could be serving as a source of entry. The soffit along the north side of the building had been patched but appeared to be rotted at the outer edge from subsequent water damage.</p>	Average

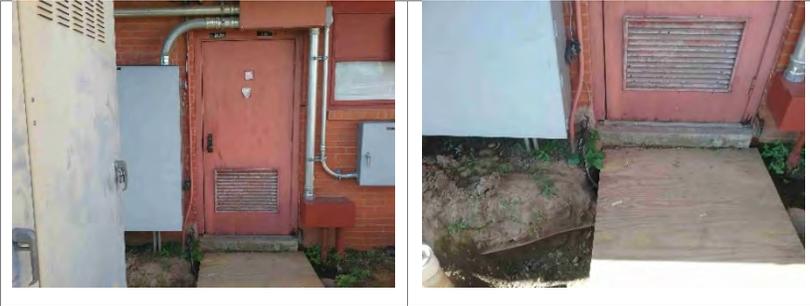
Exterior Doors

System	Subsystem	Condition and Deficiency Overview	System Condition Rating
		The doors appeared to be in good serviceable condition. However, the electrical closet door assembly was rotted and requires replacement. A large hole existed at the exterior of this door, and no landing existed.	
Roofing	<p>There are two roof surfaces on this building. The largest roof surface of approximately 2,820 SF covers the older administration building. This surface is a modified bitumen system that drains to perimeter gutters and downspouts. The other roof surface is about 1,000 SF in size and covers the newer addition to the building. This smaller surface is also a bitumen roof system. It has a painted metal drip edge and fascia but no gutters and downspouts.</p> <p>The two roof surfaces appeared to be of a similar age and appeared to have approximately ten years of life remaining. Electrical conduit was well supported by chairs above the roof surface. Gutters, downspouts, and splash blocks appeared to be in good condition. There were several trees, however, that were in contact with the west end of the roof.</p>		Average

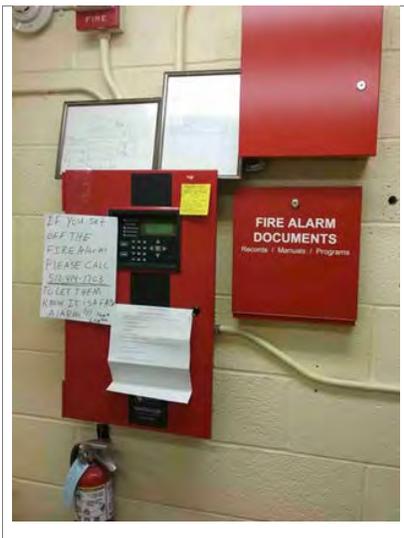
System	Subsystem	Condition and Deficiency Overview	System Condition Rating
		the unit. This unit is using R22 refrigerant, which is out of date. Roof top vents showed signs of age and rust.	
Fire Protection	Fire Alarm	Fire detection and indication (strobes and annunciators) are located in all living spaces within the building. The building houses the main control panel for the complex. Faculty reported that the fire alarm trips randomly on a regular basis. A random fire alarm trip was observed during the assessment on June 15-16, 2016.	Average
	Fire Protection/Suppression	No sprinkler systems were detected in BLDG-139C. Visual assessment of the fire extinguishers determined they were in average condition	Average
Electrical	Electrical Distribution	<p>The main power feed for the facility is fed from the city transformer on the north side of the building near the street. Power is distributed throughout the facility from two main switchboards: a large three-cabinet 2000-amp switchboard and Panel DS, a smaller 1600-amp switchboard. These switchboards feed several 800-amp and 400-amp panels throughout the campus, which feed smaller panels throughout the buildings.</p> <p>The majority of the panels located throughout the building were in good condition. Exterior panel cabinets appeared aged due to weather exposure, but the internals were in good condition. The majority of the larger amp panels had been replaced in the past 20 years.</p> <p>Switchboard Panel DS has excessive debris inside the cabinet from an opening in the side of the cabinet. It is recommended that these gaps be sealed to prevent debris from entering. Panel HA, outside exterior room 'ELECADM', was locked and unable to be assessed. There is another panel to the right of room 'ELECADM' with no label that appeared to feed the administration area and provide spares. This panel appeared to be at least 30 years old and should be replaced due to its age. There is one interior main panel marked LP1 that should be replaced due to its age. The faculty have reported that this panel trips occasionally when several outlets are used at once.</p> <p>There is an extremely old main 400-amp breaker, dated from the 1960s, located in room 'ELECADM'. This breaker was off and is believed to have been decommissioned/abandoned in place.</p> <p>Room 'ELECADM' within the fenced-in electrical utility area has branch wiring deficiencies due to extension</p>	Average

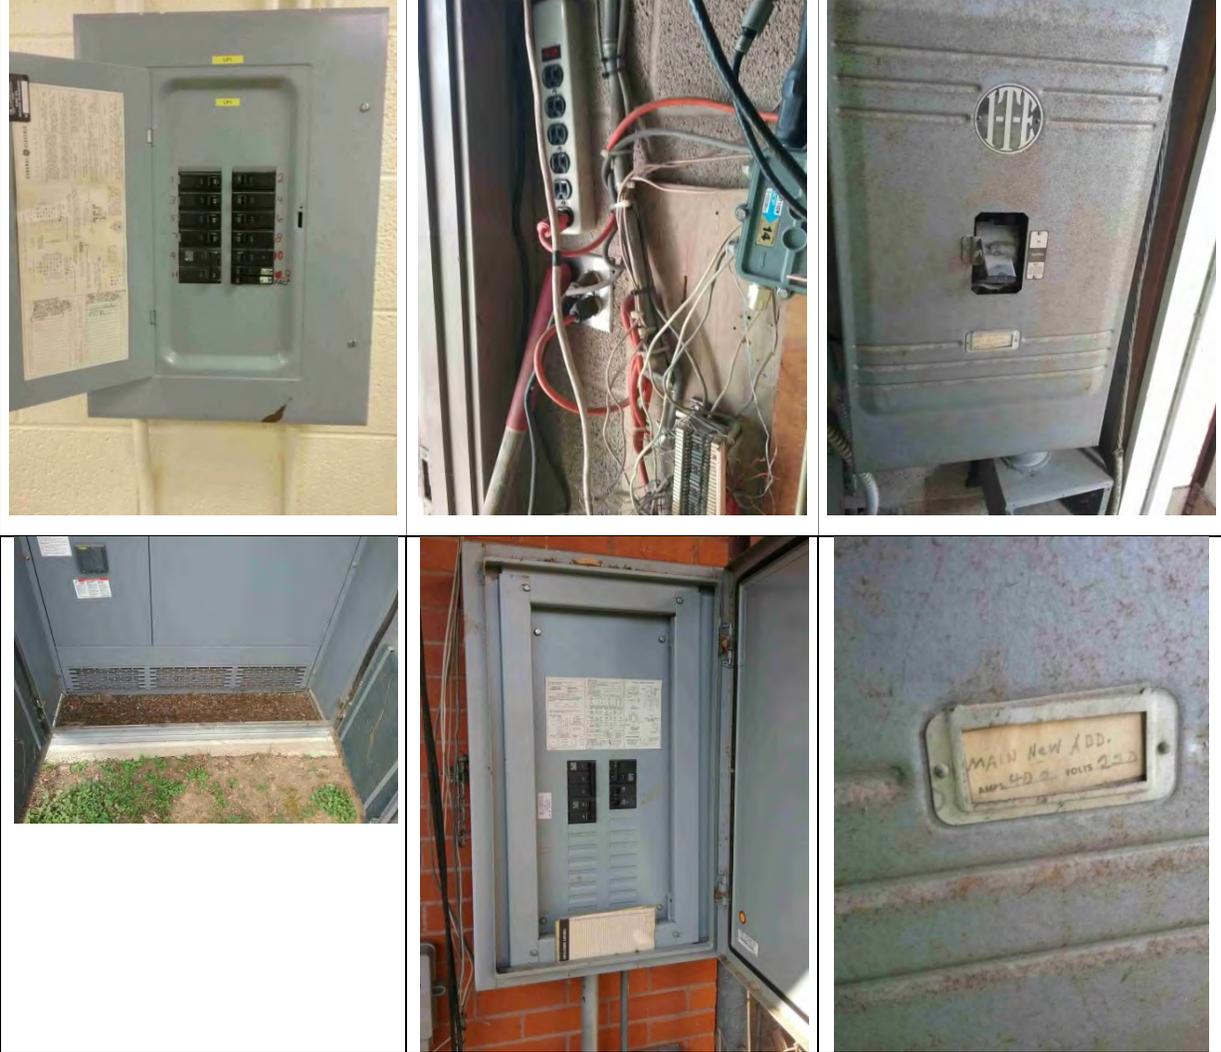
Electrical Distribution

System	Subsystem	Condition and Deficiency Overview	System Condition Rating
		<p>cords being used in a permanent configuration. The extension cords were used to power equipment associated with the telephone system. It is strongly recommended that permanent wiring be used for permanent equipment.</p>	
	Lighting	<p>All interior lighting is fluorescent fixtures, either mounted on the ceiling or in the ceiling. All interior lighting appeared to be in good condition.</p> <p>Exterior lighting is limited to the covered walkway on the courtyard side adjoining BLDG-139A. The exterior lighting varied in age, and some fixtures were melted or cracked. The exterior lighting appeared to be in poor condition and inadequate for the entire building.</p>	Average
	Communications & Security	<p>Room 'ELECADM' located in the fenced-in utility feed area houses the existing phone system. It was not determined if this equipment is abandoned or still functioning. The overall condition of this equipment was poor, if still in operation. There was also a portion of phone wire that was hanging and frayed near the electrical maintenance room. It is believed the school now uses VOIP.</p> <p>Three security cameras (one interior and two exterior) were identified during the assessment. One was located within the admin front office. There were two exterior cameras: one located at the front entrance to the admin office and one facing north (towards BLDG-139B). There is no security coverage overlooking the fenced area of the electrical service equipment. Exterior security was inadequate, which was a common comment from the faculty for the entire campus.</p> <p>Clocks throughout the building are battery powered.</p>	Average

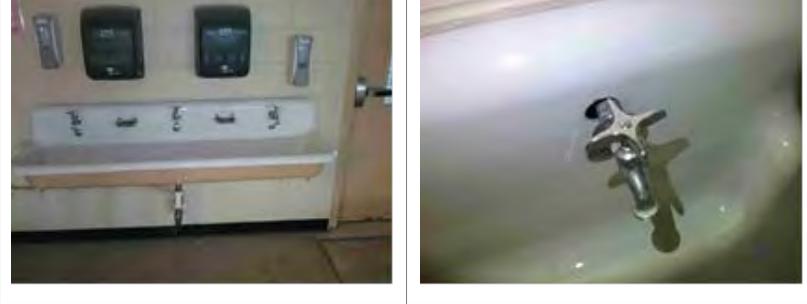
System	Subsystem	Condition and Deficiency Overview	System Condition Rating
Conveying	System not present.		N/A
Plumbing	Plumbing Fixtures	<p>The building contains a stand-alone cafeteria with commercial kitchen attached. There is one single-use restroom located within the kitchen locker room (KITLOCRM) for kitchen staff to use. It contains a floor-mounted vitreous china water closet with manual flush valve. Various stainless steel and vitreous china wall-hung sinks are found throughout the kitchen for personal use. The kitchen contains stainless steel kitchen equipment, including a three-basin prep sink. Wall-hung vitreous china and stainless steel drinking fountains and vitreous china basin sink for hand washing can be found inside the cafeteria.</p> <p>The majority of plumbing fixtures were in average operational condition, but showed minor signs of deterioration. Some plumbing fixtures showed signs of corrosion around their base. This should be addressed to avoid further deterioration.</p>	Average

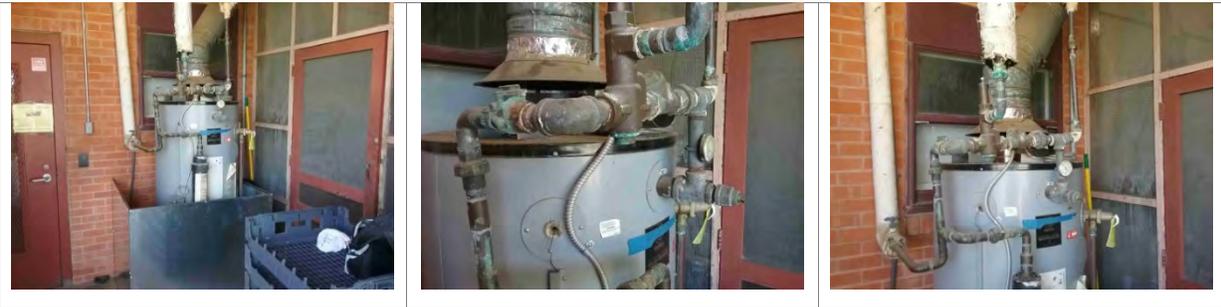
Domestic Water Distribution	<p>Domestic hot water to the kitchen is provided by a 70-gallon EWH that is stored outside the kitchen and is exposed to the elements. The unit should be enclosed or moved indoors to prevent excessive wear or failure.</p> <p>The unit appeared in good working condition and was supplying hot water to the kitchen in a timely manner. The domestic water system was in average condition with typical wear and tear associated with the system's age and general daily use.</p>	Average
	Other Plumbing	<p>The floor drain underneath the three-basin stainless steel prep sink emitted a musty odor, but did not appear to be clogged. The drain should be cleaned and flushed. Facility staff reported the grease line in the kitchen to be undersized; this should be upgraded to ensure proper containment and disposal of grease. The plumbing distribution equipment was in average condition. Some damaged insulation and corroded piping was seen in some of the spaces. Repair or replace any damaged or missing piping insulation as needed, and address any corrosion issues by cleaning, repainting, and/or repairing to prevent further deterioration.</p>	Average

9. Kitchen hot water heater should be enclosed or moved to an indoor space to minimize deterioration due to the outdoor elements.
10. Verify adequacy of the grease line's size in the kitchen and update or replace as necessary.

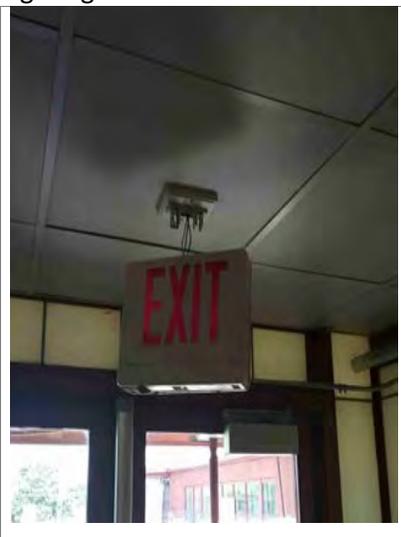
Lighting	Interior lighting is typically fluorescent fixtures throughout the building. Exterior lighting is limited to the covered walkway areas. The front entrance to the building has an interior exit light that is hanging by the wiring and was found to be deficient.	Average
	Communications & Security	The building has modern network distribution throughout the building and appears to utilize VOIP for phone service. The building also has existing phone service lines which could not be assessed for functionality. The exterior room space 'OSSTO' has a junction box for the phone cabling, which was found to be in poor condition. Sr. Architect Florence Rice reported that the abandoned CATV and telephone receptacles were removed during Summer 2016. Security for the building was in poor condition. There are two interior security cameras at the end of the corridor near the two entrance/exits. Interior classrooms appear to have motion detectors installed. No exterior security cameras were observed during the assessment. Exterior cameras should be installed for additional security coverage. Clocks throughout the building are battery powered.	Average
