St. Elmo Elementary School Site Summary

Main School Building, BLDG-136A

Building Purpose	Administrative Offices, Classrooms, Cafeteria and Gymnasium
Building Area	48,922 SF
Inspection Date	July 21, 2016
Inspection Conditions	99°F - Hot and sunny
Facility Condition Index

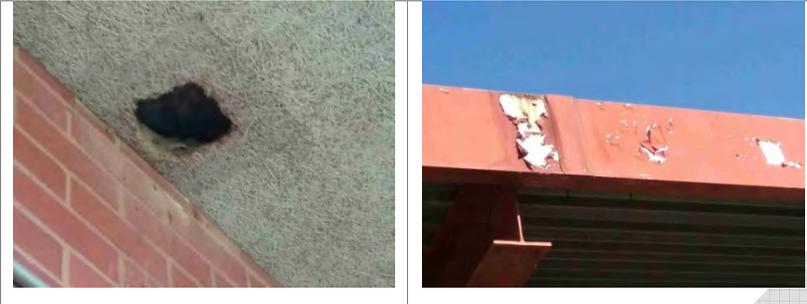
System	Subsystem	Condition and Deficiency Overview	System Condition Rating
Exterior	Exterior Walls	<p>The exterior of the building consists of a 100% brick façade. The building is one story, built in 1960. There is a basement that houses mechanical rooms and a few offices.</p> <p>The exterior of the building was observed to be in good condition. There were holes in the soffit around the entire building where there were once downspouts. The metal fascia was peeling along the library window wall.</p>	Good
	Exterior Windows	<p>The windows are aluminum framed inset into the brick façade. They appear to be single paned.</p> <p>The exterior windows along the library corridor were scratched and faded.</p> <p>Overall, the windows appeared to be in good condition.</p>	Good
	Exterior Doors	<p>There are many double exterior metal doors throughout the building.</p> <p>The exterior doors were observed to be in good condition.</p>	Good

1. Repair holes in the soffit left by former downspouts.
2. Repair the horizontal support beam that is supporting the exterior stair cases on the east end of the building.
3. Touch up the paint on the east end of the library fascia where paint is peeling.
4. Replace or reglaze windows in the corridor across from the library.

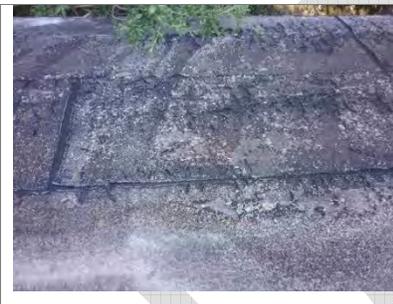
Roofing Deficiency Examples

Roofing		<p>The main building has a single-ply roof and has been recovered in recent years.</p> <p>The area A-05 near the east end was showing some wear and flaking due to the adjacent trees. Staff reported that downspouts on the east side of the building were not working properly, and that the downspout at room 202 was damaged and leaked into the building.</p> <p>The roofing appeared to be in average condition.</p>	Average
Interior	Interior Walls	<p>The interior walls are made up of the following materials: brick in the corridors and some classrooms;</p>	Good

1. Keep trees trimmed back so they are not touching the roof. Repair roofing wear due to tree.
2. Investigate downspouts reported to not function and repair

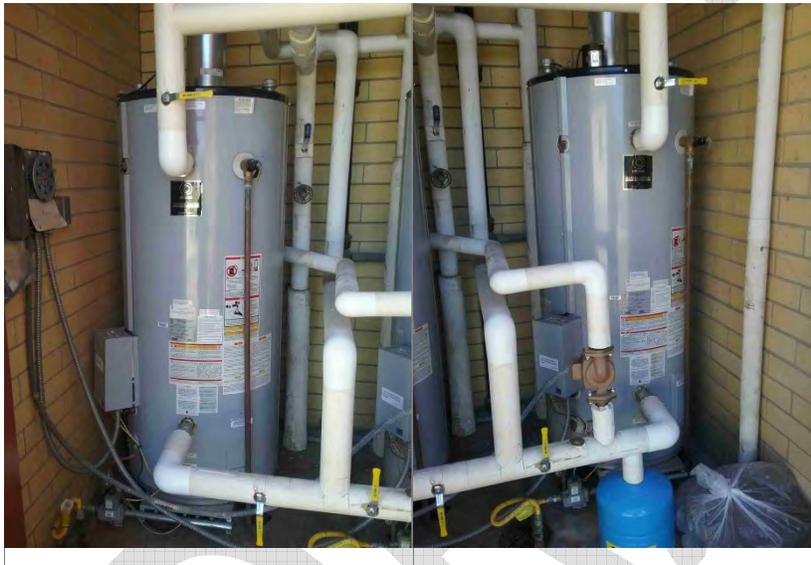
Domestic Water Distribution Deficiency Examples

Domestic Water Distribution	<p>The majority of the plumbing fixtures are not serviced by any domestic water distribution equipment, except the plumbing fixtures in the commercial kitchen.</p> <p>The two vertical gas water heaters observed near the</p>	Average

System	Subsystem	Condition and Deficiency Overview	System Condition Rating
		<p>kitchen (99-gallon capacity) had no reported deficiencies at this time; however, they were observed to have a manufacturing and installation date of 2006 and have both reached the end of their projected service life.</p> <p>The staff reported that the domestic water distribution piping had a number of deficiencies. The shut-off procedure for the plumbing distribution piping was outdated and should be updated to provide a more efficient way to isolate specific parts of the facility when repairs are required. The staff reported that the janitorial closet by the gymnasium had a damaged sink drain that needs to be rerouted. The mechanical room that houses Boiler 1 had piping that is reported to leak, although no leaks were observed at the time of assessment. The sewer lines were reported to continually backing up and were not functioning properly. At the time of assessment, a sewage back-up was not observed. It was reported that the plumbing for the gymnasium shower needs to be replaced. Plumbing for the shower fixture was not accessible at time of assessment.</p> <p>The domestic water distribution system for this facility was rated to be in average condition at the time of assessment.</p>

1. Plan for future replacement of commercial kitchen hot water heaters based on recommended service life.
2. Planning to update shut-off procedures for plumbing distribution piping.
3. Investigate the sink in the janitorial closet near the gymnasium and repair drain line as needed.
4. Investigate piping in mechanical room that housing Boiler 1 and repair as needed.
5. Investigate the sewer lines reported to continually back up and not function properly and repair as needed.
6. Plan to replace the plumbing for the gymnasium shower.

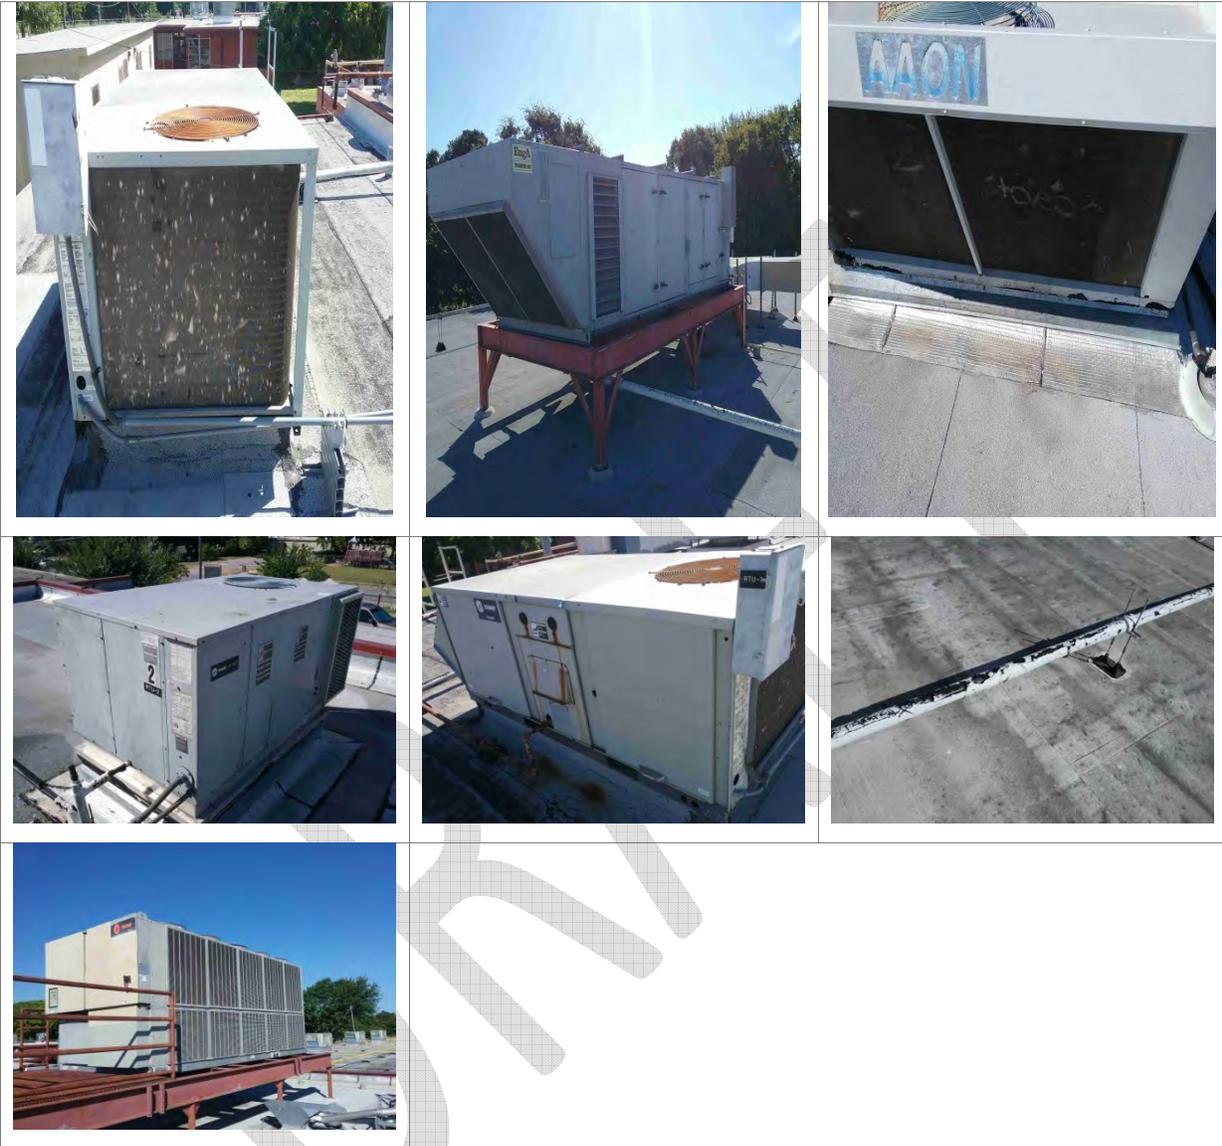
Mechanical/HVAC System Deficiency Examples

Other Plumbing	<p>The roof drains on this facility are predominantly designed with an exterior type drainage system that drains to daylight.</p> <p>The drains observed at the time of assessment were in good condition.</p>	Good
Mechanical/ HVAC		<p>This building has multiple HVAC (heating, ventilating, and air conditioning) applications that service the single-story building. The major mechanical equipment consists of RTUs (roof top units), split system heat pump/air conditioning units, indoor AHUs (air handling units), and floor-mounted horizontal packaged unit ventilator systems. The HVAC system also includes one large roof-mounted rotary air-cooled chiller that has a refrigeration cooling capacity of 90-TON and two horizontal gas-fired boilers with rated output capacities of 1,260 MBH and 990 MBH.</p> <p>Thirty-one HVAC systems were assessed throughout the building. The estimated capacities of the roof-mounted exhaust fans ranged from 150 to 2000 CFM (cubic feet per minute). The refrigeration capacities of the HVAC units ranged from 2.5- to 20-TON.</p> <p>Many of the deficiencies observed were typical aging of equipment, e.g., compressor fin damage due to vandalism/weather, and enclosure and insulation</p>	Average

System	Subsystem	Condition and Deficiency Overview	System Condition Rating
		<p>damage due to excessive exposure to the elements. The use of the outdated R22 refrigerant in some of the existing HVAC systems was another observed deficiency.</p> <p>The roof-mounted chiller that was installed in 2001 and was charged with R-22 refrigerant and is nearing the end of its projected service life. The Horizontal floor units in the 200- and 100-wings were replaced in 2006; however, when installed, they were potentially charged with an outdated refrigerant type R-22. The kitchen HVAC RTUs have met their projected service life and have been reported to no longer run efficiently.</p>	
Fire Protection	Fire Alarm	<p>The building contains a fire alarm system by Silent Knight consisting of detectors, pull stations, and horn/strobe combination units.</p> <p>The equipment appeared to be in good condition. The main panel was not located but assumed to be in the MDF (main distribution frame) room, which was not accessible.</p>	Good

1. Address any rust or corrosion observed on the equipment, its associated piping, or any other sub-asset by cleaning, repainting, or repairing to prevent further deterioration.
2. Plan for and track equipment that uses R-22 refrigerant. The refrigerant is being phased out of manufacturing and construction use in the near future, and will make all equipment that utilizes R-22 refrigerant obsolete.
3. Continue conducting preventive maintenance checks and services for HVAC systems.
4. Plan to replace or repair aged HVAC equipment, including the following specific equipment: Kitchen RTU-01, Kitchen SF-1 and Rotary Chiller CH-2

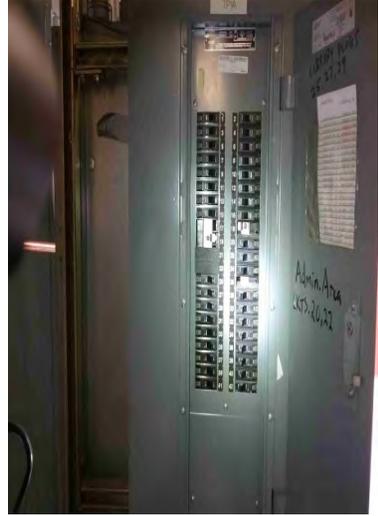
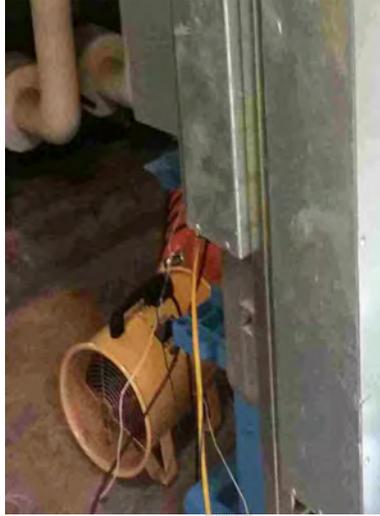
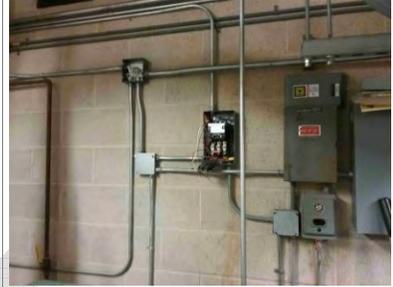
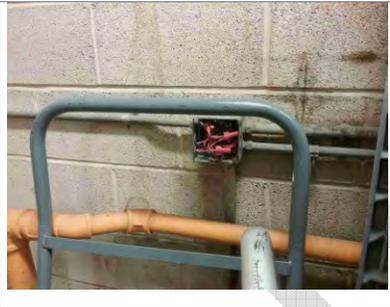
Fire Protection/Suppression	<p>The building is not equipped with a fire sprinkler/suppression system; however, it is protected by portable fire extinguishers stationed throughout the building.</p> <p>All portable fire extinguishers observed were inspected within the last year.</p>	N/A
Electrical	Electrical Distribution	<p>The electrical service transformer is located on the south side of the building between the parking lot and the sidewalk. There is another switchboard located in the courtyard east of the library. It appears that the switchboard feeds main electrical distribution panels in a main mechanical room located in the basement area below room 105.</p> <p>TP1A in the main mechanical room had breakers and breaker void covers missing. These need to be installed. There were extension cords constructed out of single-conductor cable in the "home-made" fashion that travelled into a crawlspace to feed power to an unknown user. If this user is of a temporary nature, a correctly sized extension cord should be implemented.</p> <p>Numerous junction and pull boxes in the electrical room west of classroom 202 did not have enclosure covers or plates installed. Some of the cables were verified energized. The facility needs to install the enclosure plates.</p>	Average

4. Verify all Exit signs are operational.
5. Install breaker covers in panels that have uninstalled breakers.
6. Install plates on junction boxes and pull boxes that do not have them.
7. Implement extension cords rated for proper size where temporary power is required.

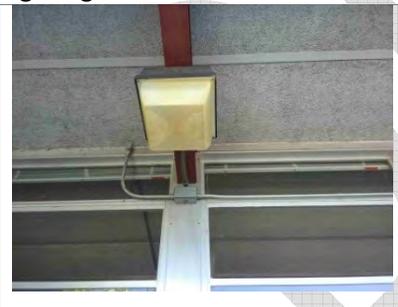
Lighting	<p>There are numerous types and styles of lighting on the exterior of the building. Lighting around the front entrance appears to be exterior LED (light-emitting</p>	Good

System	Subsystem	Condition and Deficiency Overview	System Condition Rating
		<p>diode) fixtures. HID (high-intensity discharge) style fixtures are mounted at the roof line surrounding the building with the occasional screw-in flood-style fixtures installed at various locations.</p> <p>The interior lighting is mainly fluorescent surface-mount or troffer fixtures with the occasional incandescent fixture in closets. The gymnasium is equipped with hanging fluorescent fixtures.</p> <p>The majority of the exterior and interior lighting appeared to be in good condition. There are exit signs at every exit; however, various signs were not illuminated. Facility should verify operation. There were a small number of fixtures that appeared to be near the end of their life expectancy. The facility reported that lighting north of the gymnasium and in the parking lot should be added.</p>	
	<p>Communications & Security</p>	<p>There is a Gemini security system currently installed with keypads at various entrances. Motion detectors are installed in interior areas and wall-mount and column-mount security cameras are installed throughout the interior of the building and strategically on exterior corners. There were no damaged security panels or cameras observed.</p> <p>There are door frame-mount proximity readers for access into certain entrances and a call box to reach administration at the front entrance.</p> <p>The MDF room was not accessible, therefore, the main communications rack and any additional electrical equipment were not observed.</p> <p>The facility staff reported that the telecommunications systems were not functioning properly, but that the public address system was functioning.</p> <p>The equipment was observed in good condition.</p>	<p>Good</p>

1. Consider adding lighting north of the gymnasium and in the parking lot.
2. Assess the telecom system and determine if an upgrade is necessary.
3. Assess exterior lighting to verify operation.
