Summitt Elementary School Site Summary

Address	12207 Brigadoon Lane Austin, TX 78727
Number of Permanent Campus Facilities	2
Original Year of Construction	1986
Total Campus Building Area (combined)	75,903 SF

Introduction

Main School Building – BLDG-138A

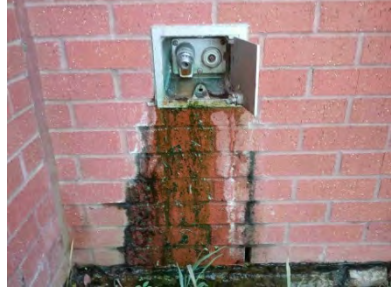
Exterior System Deficiency Examples**Exterior Walls**

System	Subsystem	Condition and Deficiency Overview	System Condition Rating
Exterior	Exterior Walls	The exterior of the building consists of a brick façade. The exterior of the building appeared to be in good condition. There was a leaking hose bib on the north wall, which was leading to algae on the brick façade.	Good
	Exterior Windows	The windows are single-pane aluminum metal-framed inset into the brick façade. The windows appeared to be in good condition. The caulk on the triangular windows above the common areas was cracking and separating.	Good
	Exterior Doors	There are many double exterior metal doors with lites throughout the building. Some exterior doors are solid metal with no lites. The exterior doors appeared to be in good condition. Paint on the door frames and on the insides of the doors was chipped in well-used areas.	Good
Roofing	The main part of the building has a single-ply roof. The lobby, library, gymnasium, cafeteria, and common areas are covered by a standing seam metal roof system. The roofs appeared to be in good condition. Roof A01 had tree limbs lying on it. Roof A10-11, which covers the lobby, had significant ceiling stains along the ridge of this area. Roof A08, covering the library, showed ceiling stains at the gypsum board and tile intersection.		Good

1. Repair the caulking at the triangular window areas.
2. Clean algae off the north wall.

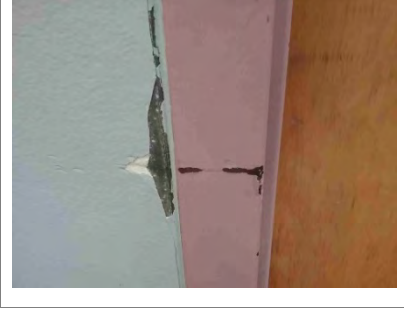
Interior Construction Deficiency Examples**Interior Walls**

System	Subsystem	Condition and Deficiency Overview	System Condition Rating
		<p>laminate from the floor up to six feet.</p> <p>The walls appeared to be in good condition. There were some areas where the gypsum board had been scraped down to the metal edging.</p>	
	Interior Doors	<p>The interior doors are wood veneer with a lite in metal frames. Some are solid wood doors without side lites.</p> <p>The interior doors appeared to be in average condition. The paint at door window frames and astragals was chipped. Classroom restrooms door frames were rusted, particularly at the bottom.</p>	Average
	Interior Specialties	System not present.	N/A
Stairs	Exterior Stairs	System not present.	N/A
	Interior Stairs	System not present.	N/A
Interior Finishes	Interior Wall Finishes	<p>The interior walls are painted gypsum board in the classrooms, administration area, library, and lobby. There is painted CMU in the gymnasium and cafeteria areas. The corridors are gypsum board at the top, and plastic laminate from the floor up to 6 feet.</p> <p>The wall finishes were in good condition.</p>	Good

1. Repair gypsum board tears at wall corners where damaged.
2. Repaint chipped door frames and exit door interiors.
3. Replace classroom restroom rusted door frames.

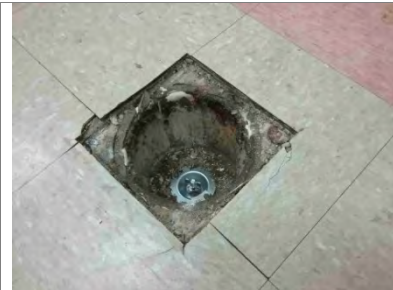
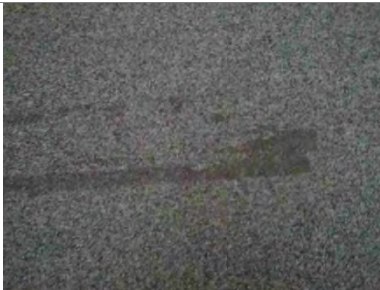
**Interior Finishes Deficiency Examples****Interior Floor Finishes**

Interior Floor Finishes	<p>The interior floor finishes are VCT (vinyl composition tile) in the administration offices, corridors, cafeteria, and classrooms. Ceramic tile is in the restrooms and kitchen. The flooring is carpet in the library, administration offices, and common areas located outside the classrooms. There is a rubber sport court in the gymnasium. There is wood flooring on the stage.</p> <p>All floor finishes were in good condition. There were some stains on the carpet in the library area. There were three open holes in the cafeteria where floor drains were plugged, and the floor was never repaired. AISD staff reported that the floor was repaired in Summer 2016.</p>	Good
	Interior Ceiling Finishes	<p>The interior ceilings are ACT (acoustical ceiling tile) in metal grid in the classrooms and administration areas. There are 12x12 perforated tiles on the ceiling in the lobby, library, and cafeteria. There are gypsum board ceilings in the restrooms and partially in the library. The gymnasium has tectum acoustical panels in metal grid.</p> <p>The ceiling systems were observed to be in average condition. The perforated tiles were stained in the lobby and library in a pattern indicating a possible roof leak. The ceiling grid in the kitchen area was significantly rusted.</p>	Average

1. Replace stained, yellowed perforated ceiling tile in the lobby and library as needed.
2. Repair the vinyl tile floor in the cafeteria where piping was plugged.
3. Clean the carpet in the library to eliminate stains.

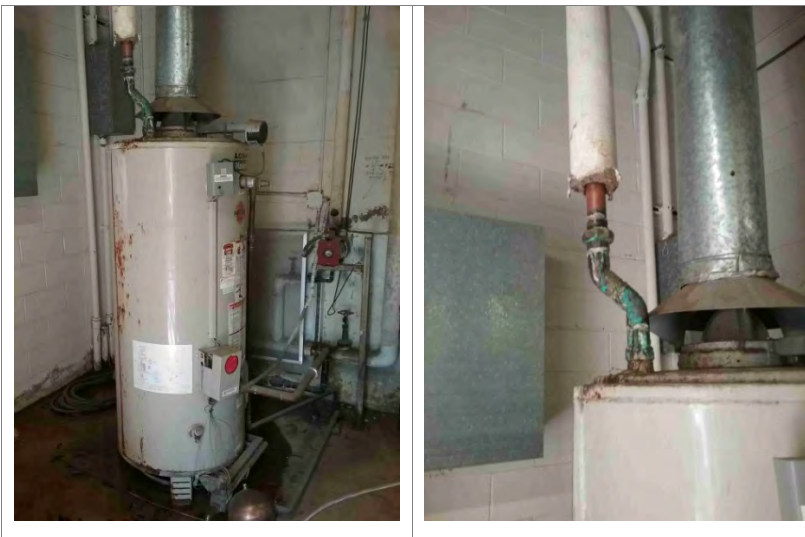
Domestic Water Distribution	<p>The majority of the plumbing fixtures observed in this facility are not serviced by any domestic water distribution equipment, such as large vertical water heaters (greater than 30-gallon capacity).</p> <p>The remainder of the plumbing fixtures serviced by domestic water distribution equipment are located in the in the commercial kitchen. The fixtures in the commercial kitchen appear to be serviced by one vertical GWH (gas water heater) located in the main mechanical room. This water heater has the ability to produce 365 MBH and hold 85 gallons.</p> <p>The domestic distribution system was in average condition. Staff reported that the domestic water distribution piping for the entire building was aged and</p>	Average

System	Subsystem	Condition and Deficiency Overview	System Condition Rating
		was original to the school's construction. The vertical GWH-1 (SC013110) had an installation date of 1998. The water heater had a boiler certificate of operation that expires in 2018; however, the unit had corrosion on the external shell and piping as well as small leaks on the piping. The water heater's piping insulation appeared to have been damaged by the leak and corrosion. AISD staff reported that the water heater was replaced in August 2016.	
	Other Plumbing	<p>The roof drains for this facility were predominantly designed with an external-type drainage system equipped with gutters and downspouts. A new grease trap and associated piping were installed during the summer.</p> <p>The other plumbing systems were observed to be in good condition during the assessment with isolated instances of deterioration. Staff reported two deficiencies for the facility's other plumbing systems including continuously leaking exterior water spigots outside rooms 128 and 211. The exterior water spigot next to CWP-1 and CT-1 could not be used because it backed up and flooded the gymnasium storage room (GYMOSSTO).</p>	Good

1. Continue preventive maintenance on aged plumbing fixtures and plan for replacement of the fixtures in the future as they continue to age.
2. Further investigate the downstream piping associated with the plumbing fixtures in classroom restrooms 159 and 160 to determine if it can be repaired or replaced to avoid back-up/flooding issues in the future.
3. Repair exterior water spigots outside rooms 128 and 211 that are continuously leaking.
4. Further investigate the upstream piping associated with exterior water spigot next to CWP-1 and CT-1 to determine if it can be repaired or replaced to avoid back-up/flooding issues in the future.
5. Replace aged and out of dated GWH-1. [AISD staff reported that the water heater was replaced in August 2016.](#)
6. Repair the hose bib leak on north wall.

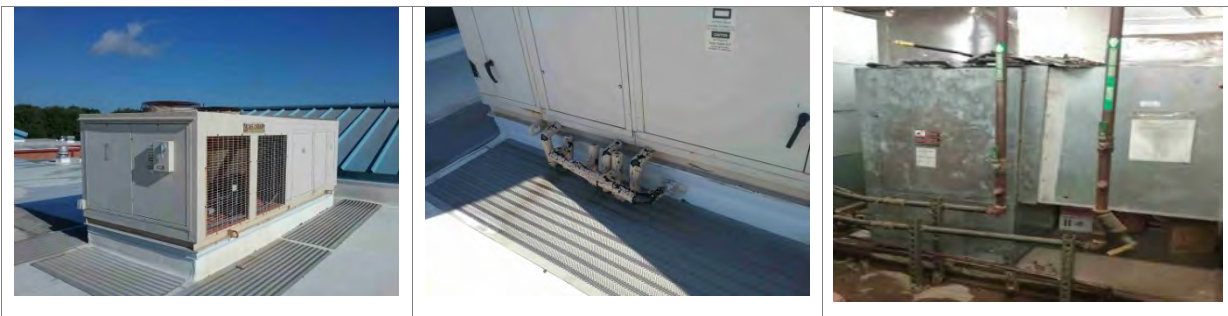
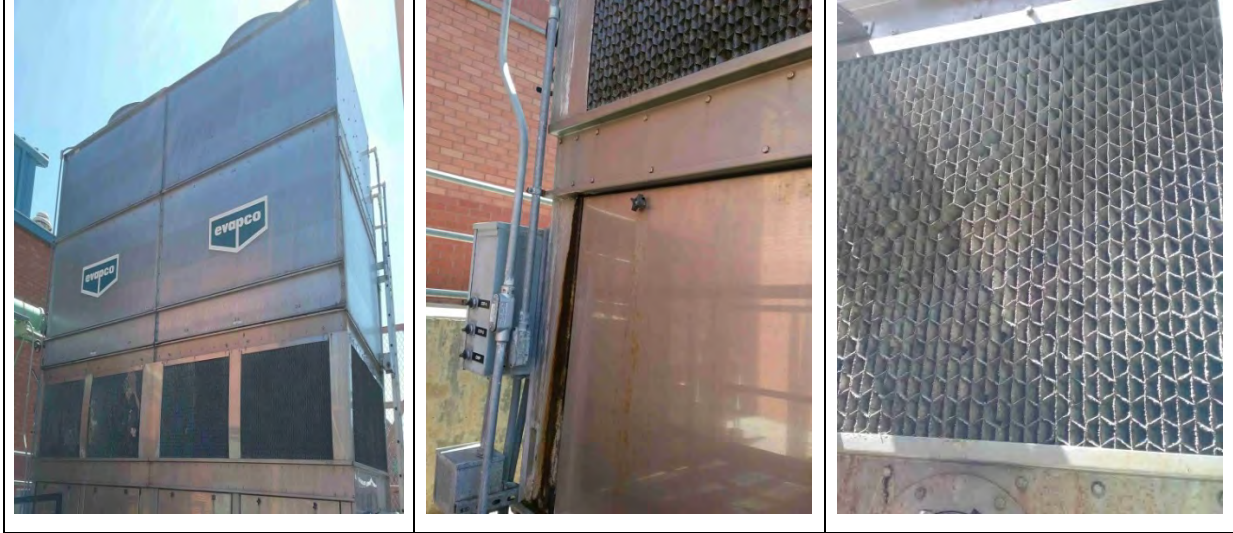
Mechanical/HVAC System Deficiency Examples

Mechanical/ HVAC	<p>This building has multiple HVAC (heating, ventilation, and air conditioning) applications that service one floor level. The major mechanical equipment consists of indoor water source heat pump units, packaged RTUs (roof top units)/HRUs (heat recovery units), small to large roof top exhaust/supply air fans and split system air conditioning units. All of the indoor water source heat pump units are supported by a common water loop system. The system has an in-line external packaged fluid cooler tower with a flow capacity of 478 GPM (gallons per minute) and two horizontal gas-fired boilers with rated output capacities of 1,919 MBH.</p> <p>There were 17 HVAC systems assessed throughout the building. The estimated capacities of the roof-mounted exhaust fans ranged from 200 to 1,300 CFM (cubic feet per minute), and the estimated capacities for the HRUs/outdoor air units were 2,500 to 5,000 CFM. The refrigeration capacities of the HVAC units ranged from 2.5 to 35 tons. Staff reported that in 2015, 56 new water source heat pumps were installed, suspended above the ceiling tile.</p> <p>The mechanical/HVAC for this facility was in average condition. Staff reported the multiple deficiencies for the facility's mechanical/HVAC systems. The new HP-162 had multiple condensation leaks/floods. All of the roof top-mounted outdoor air units/HRUs could not be used, because they leaked into classrooms or had electrical issues. All of the exhaust fans in the building were not used because of electrical issues.</p> <p>Many of the deficiencies observed were general aging of equipment and</p>		Average

System	Subsystem	Condition and Deficiency Overview	System Condition Rating
		enclosure and piping/insulation damage due to excessive corrosion. Another widespread observed deficiency was the use of outdated R-22 refrigerant in some of the existing HVAC systems. Another deficiency observed was that all of the roof top outdoor air units/HRUs had electrical disconnect switches in the off position. The units utilized outdated R-22 refrigerant and were nearing the end of their typical design service life. The large water source heat pumps that serviced the gymnasium and the cafeteria were installed in 2001 and were nearing the end of their typical design service life. The fluid cooling tower (CT-1 SC01817) was nearing the end of its typical design service life, had corrosion on its enclosure (possibly from previous leaks), and the fill material installed was dirty, scaled, and blocked by debris. It was reported by AISD Construction Management that the HVAC system upgrades including; two new boilers, new RTU for the administration area, and new Lon-Tridium Control System were completed as part of the recent bond program.

1. Plan for and track equipment that uses R-22 refrigerant. The refrigerant is being phased out of manufacturing and construction use in the near future and will make all equipment that utilizes R-22 refrigerant obsolete.
2. Continue conducting preventive maintenance checks and services for the HVAC systems. Plan to repair or replace all aged and out-of-date HVAC equipment.
3. Clean and clear cooling tower's fill. It is also recommended that the fluid cooler enclosure be cleaned or repaired to prevent any further corrosion from occurring.

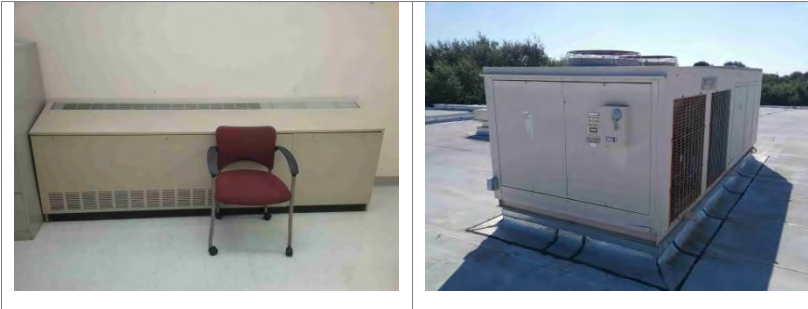
Mechanical/HVAC System Deficiency Examples

Domestic Water Distribution	The majority of the plumbing fixtures observed in this facility are not serviced by any domestic water distribution equipment. There were no staff-reported deficiencies or planned/requested renovations for the facility's domestic water distribution system. The domestic water distribution plumbing and equipment observed during the assessment were in good condition.	Good
	Other Plumbing	The drains for this facility were predominantly designed with an external-type drainage system equipped with gutters and downspouts. The other plumbing system observed during the assessment was in good condition. There were no reported deficiencies.	Good
Mechanical/ HVAC	This building has two types of HVAC applications that service one floor level. The major mechanical equipment consists of floor-mounted horizontal packaged unit ventilator systems and one large roof top-mounted outdoor air unit/HRU. There were 13 HVAC systems assessed throughout the building. The estimated capacity of the large roof top-mounted outdoor air unit/HRU is 2,500 to 3,000		Average

System	Subsystem	Condition and Deficiency Overview	System Condition Rating
		<p>CFM. The refrigeration capacities of the individual classroom unit ventilators ranged from 1- to 1.5-TON.</p> <p>The mechanical/HVAC for this facility was rated to be in average condition. The staff reported the air conditioning units installed were original to the building and were very loud and disturbing. Staff also reported that OAU-5 had electrical issues, and at times, discharged toxic exhaust fumes from adjacent mechanical equipment into the building. The classroom HVAC units had an estimated installation date of 1989 and had surpassed their typical design service life. The units were also potentially charged with R-22 refrigerant. R-22 refrigerant is being phased out of use and eventually will render equipment that utilizes it obsolete. The roof top outdoor air unit was installed in 2003 and was nearing the end of its typical design service life. The unit also utilized R-22 refrigerant.</p>

1. Plan for and track equipment that uses R-22 refrigerant. The refrigerant is being phased out of manufacturing and construction use in the near future and will make all equipment that utilizes R-22 refrigerant obsolete.
2. Continue conducting preventive maintenance checks and services for the HVAC systems. Plan to repair or replace all aged and out-of-date HVAC equipment.
